**THE COLLECTION OF LANDFILL
MONITORING DATA AT THE FORMER
PIN-2 DEW LINE SITE**

Cape Young, Nunavut

FINAL REPORT– 2013 SEASON

DEFENCE CONSTRUCTION CANADA

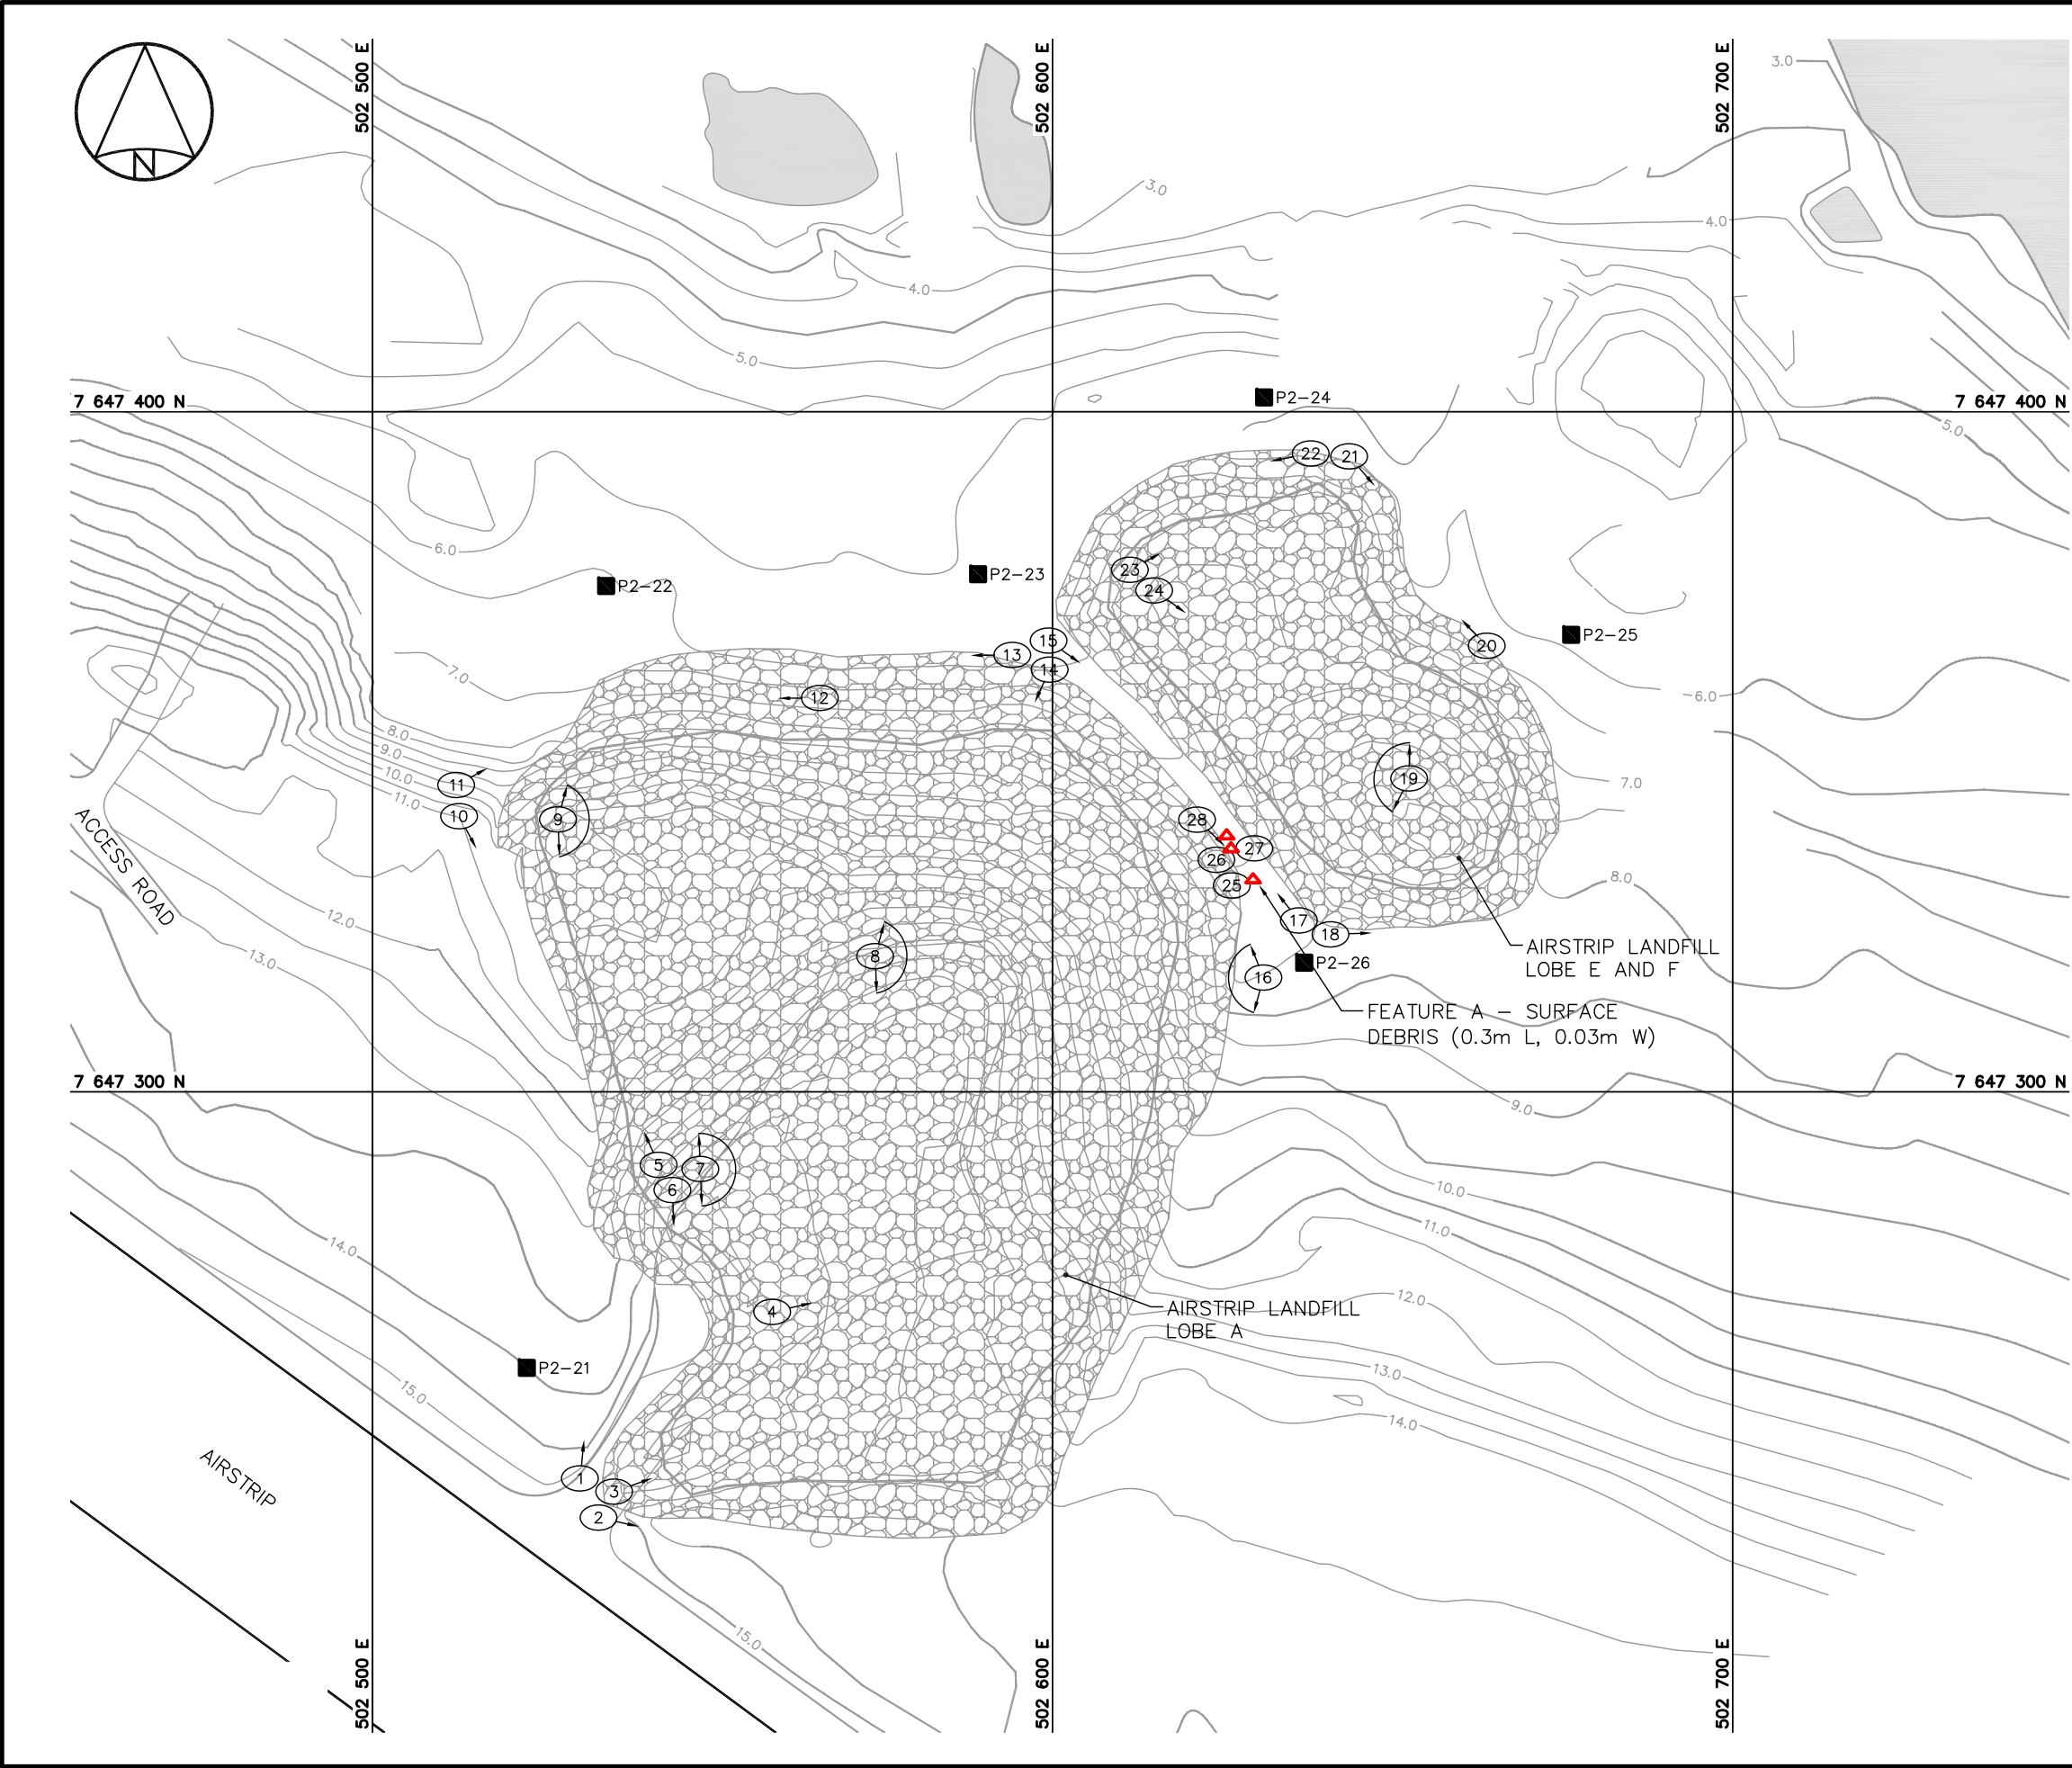
The Location Plan for the Airstrip Landfill has been completed as per the TOR and is presented in Figure PIN-2.2.

Evidence of exposed debris was not noted at the landfill, however three small pieces of surface debris (Feature A) were noted between the two lobes (see below).

As noted above, three small pieces of miscellaneous metal debris (strapping) were noted on the gravel surface between the lobes (Feature A). The debris did not appear to be related to the landfill regrades.
