Long Term Monitoring, 2011 PIN-B, Clifton Point, Nunavut

FINAL REPORT

Aboriginal Affairs and Northern Development Canada
Nunavut Regional Office
Iqaluit, Nunavut
X0A 0H0

Franz Environmental Inc.
329 Churchill Avenue, Suite 200
Ottawa, Ontario
K1Z 5B8
Tel. (613) 721-0555
Fax: (613) 721-0029

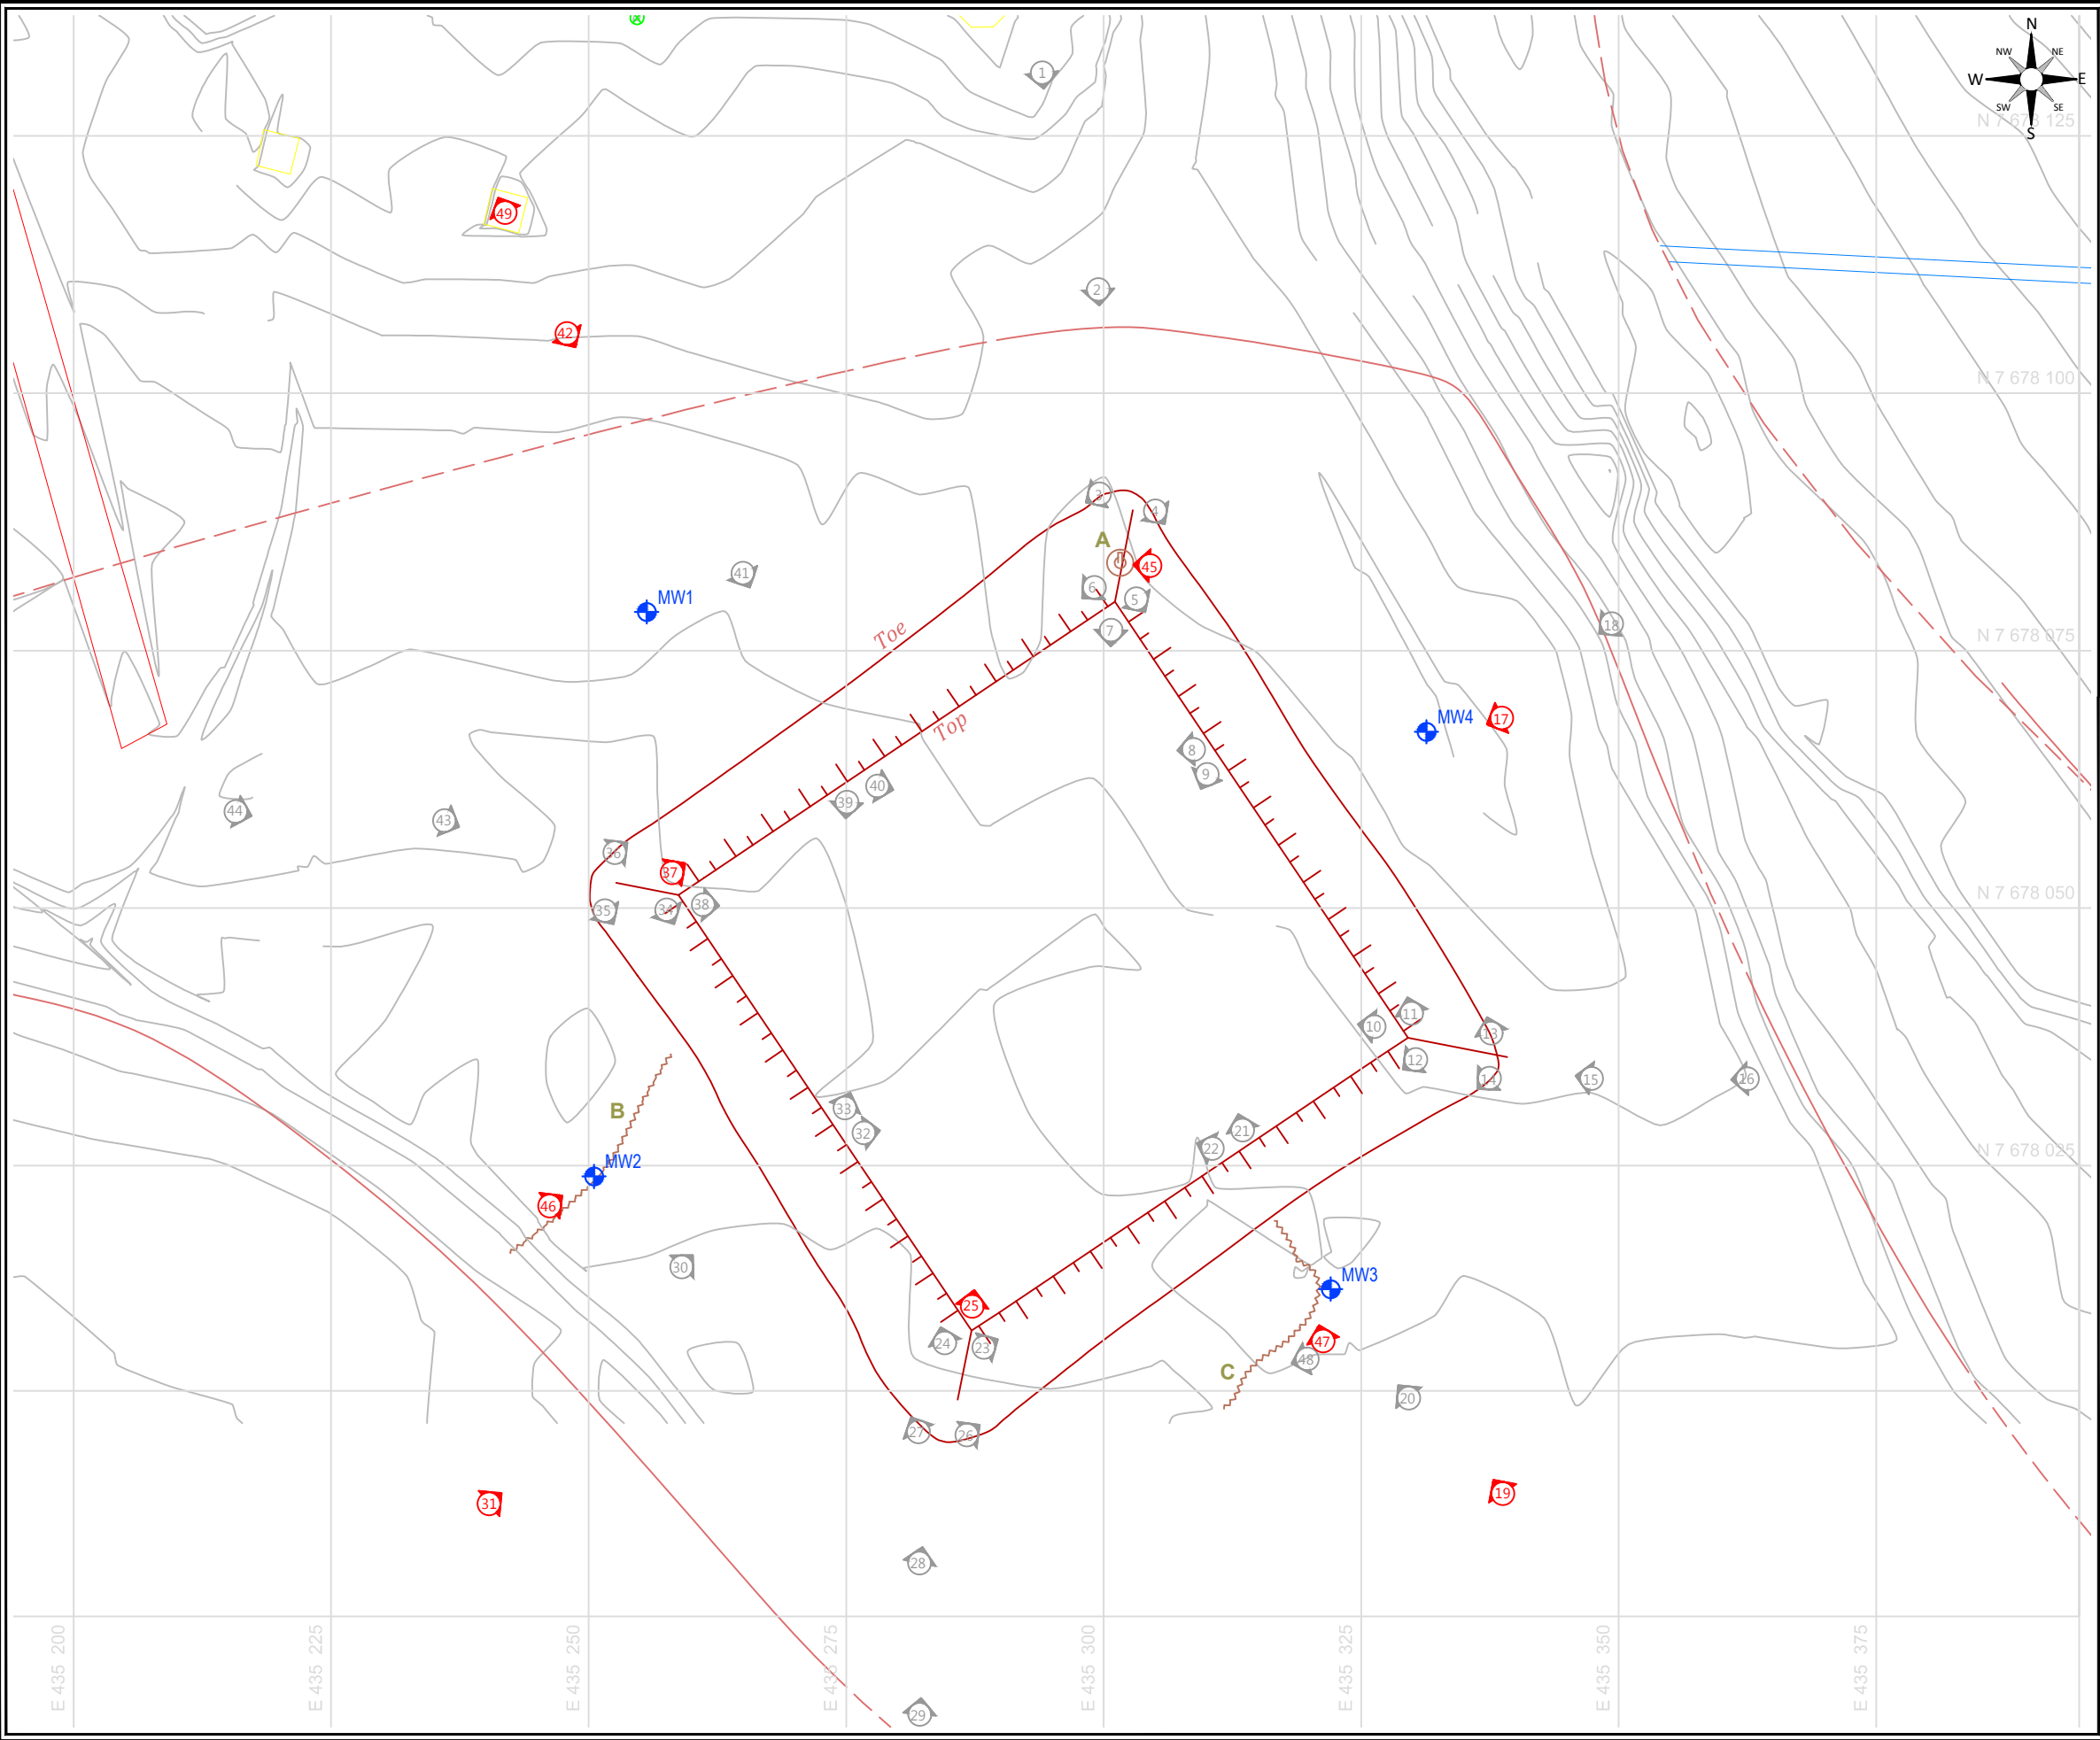
Title: Non-hazardous Waste Landfill	
 CONSULTING ♦ ENGINEERING ♦ TECHNOLOGIES ♦	Project: PIN-B Clifton Point 1697-1101
Date: January 2012	Client: Aboriginal Affairs and Northern Development Canada
1:650	
Figure A-2

No indication of frost action was observed in the area of the NHWL.

No staining was observed in the area of the NHWL.

Seepage was not observed during the NHWL inspection.

Exposed debris was not observed.
