**RE: CORAL HARBOUR PROJECT NWB LLICENSE NO. 1BR-COR2325 ANNUAL
REPORT, 2024**

NWB Annual Report

Project Name: Coral Harbour Remediation Project

APPENDIX B
PHOTOGRAPHIC LOG

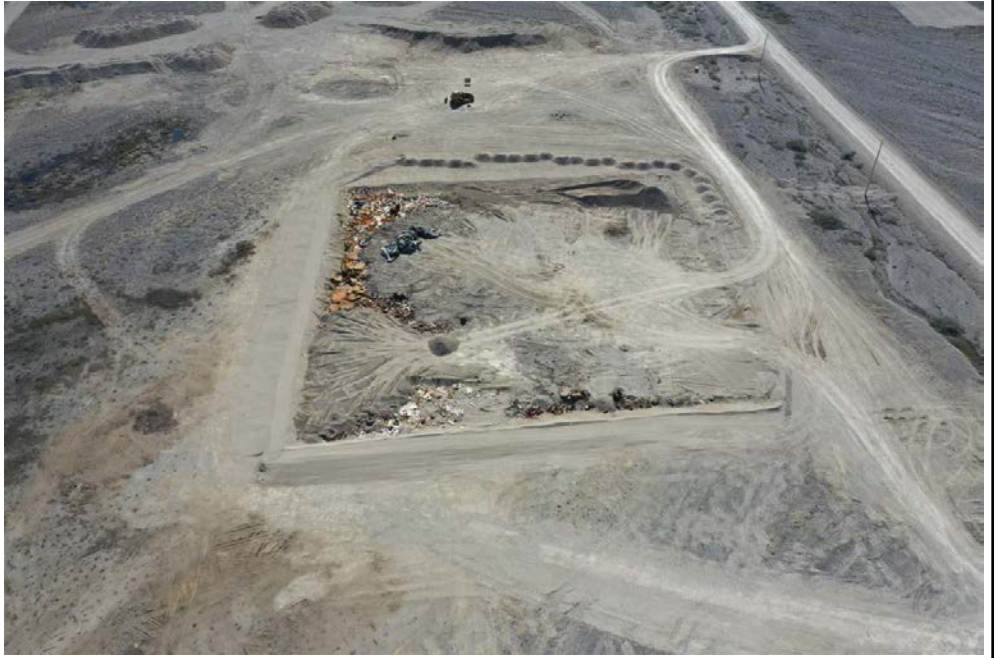
Photo Location: NHW Facility			
Direction: S			
Survey Date: 8/9/2024			
Comments: Aerial view of waste placement and berm construction at the NHW Facility.			
Photograph ID: 2

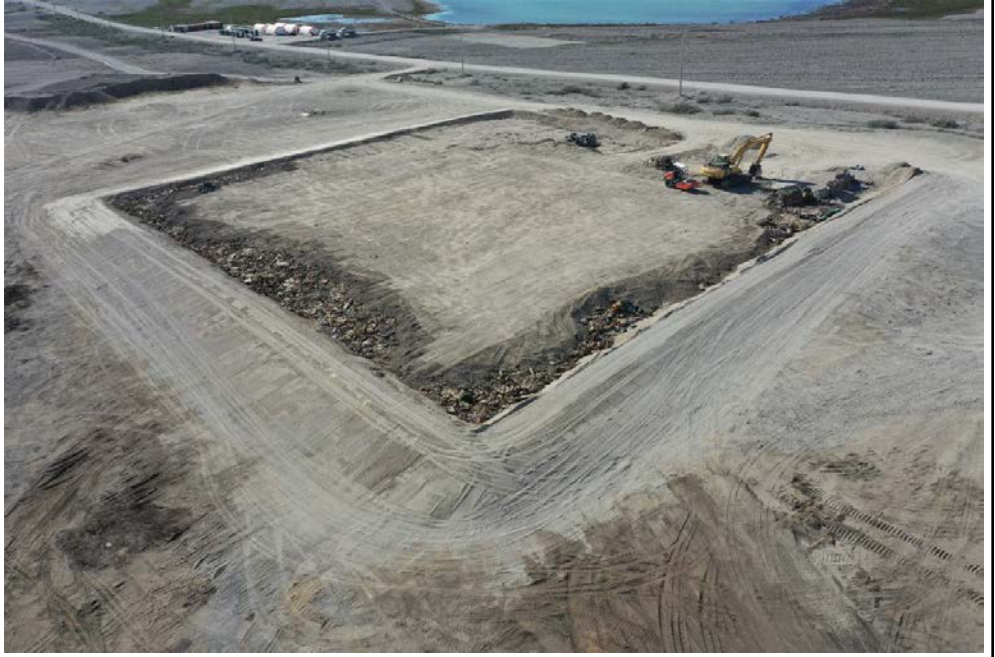
Photo Location: NHW Facility			
Direction: SW			
Survey Date: 8/18/2024			
Comments: Aerial view of an intermediate fill layer being placed and compacted in the NHW Facility.

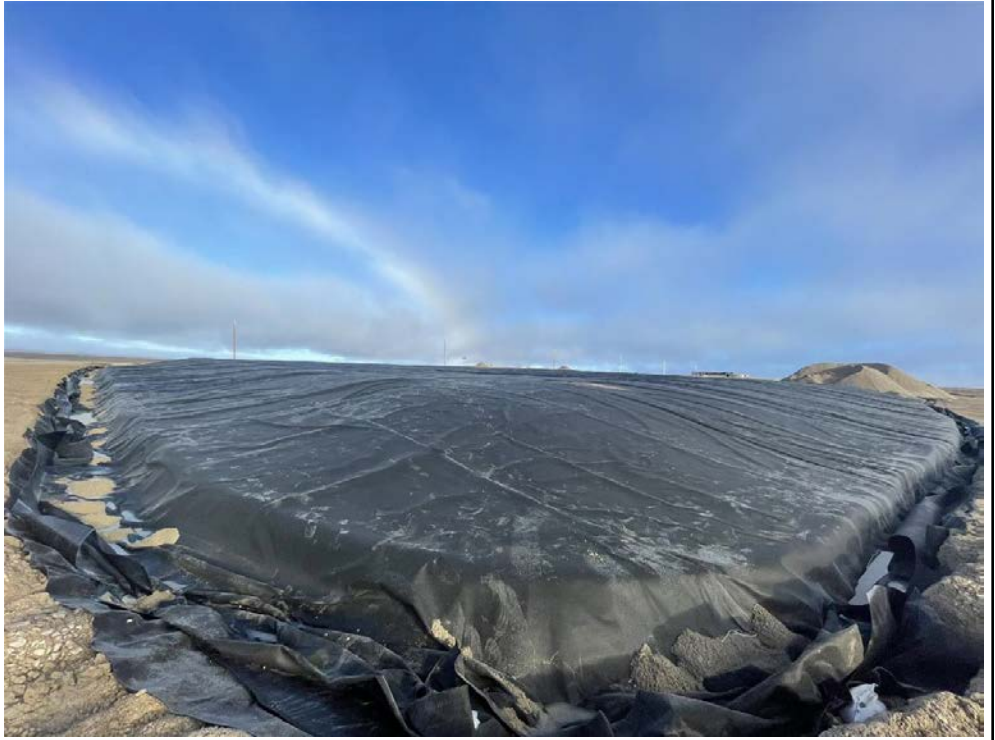
Photo Location: NHW Facility			
Direction: N			
Survey Date: 9/12/2024			
Comments: View of completed geomembrane liner at the NHW Facility.			
Photograph ID: 8

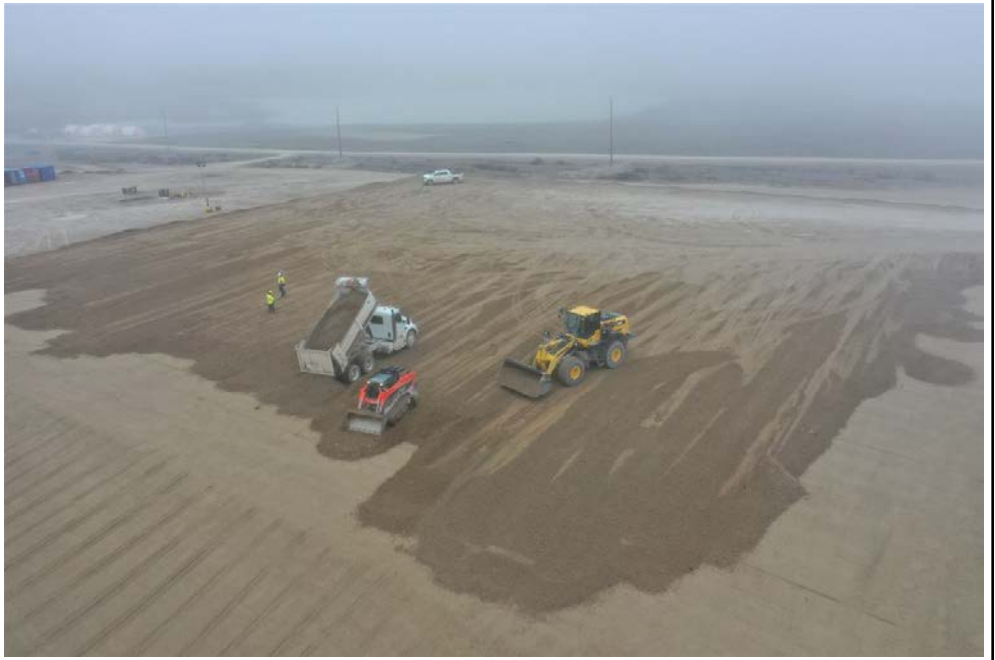
Photo Location: NHW Facility			
Direction: SW			
Survey Date: 9/19/2024			
Comments: Aerial view of Type 4 placement during construction of the NHW Facility cap.

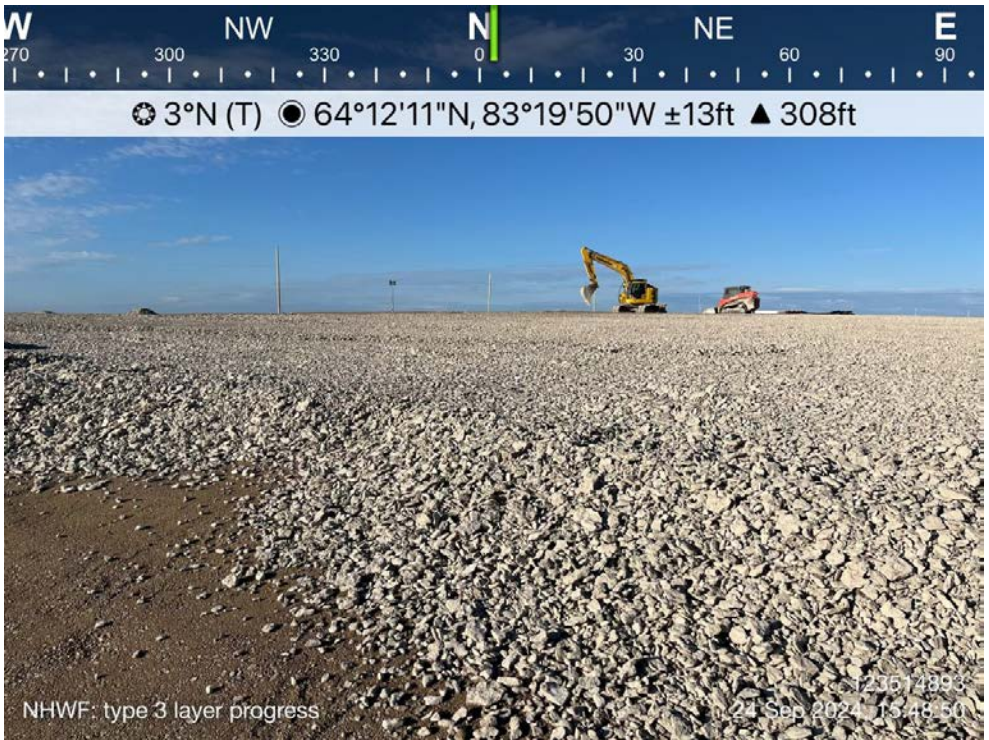
Photo Location: NHW Facility			
Direction: N			
Survey Date: 9/24/2024			
Comments: Placement of final layer of Type 3 material during capping of the NHW Facility.			
Photograph ID: 10

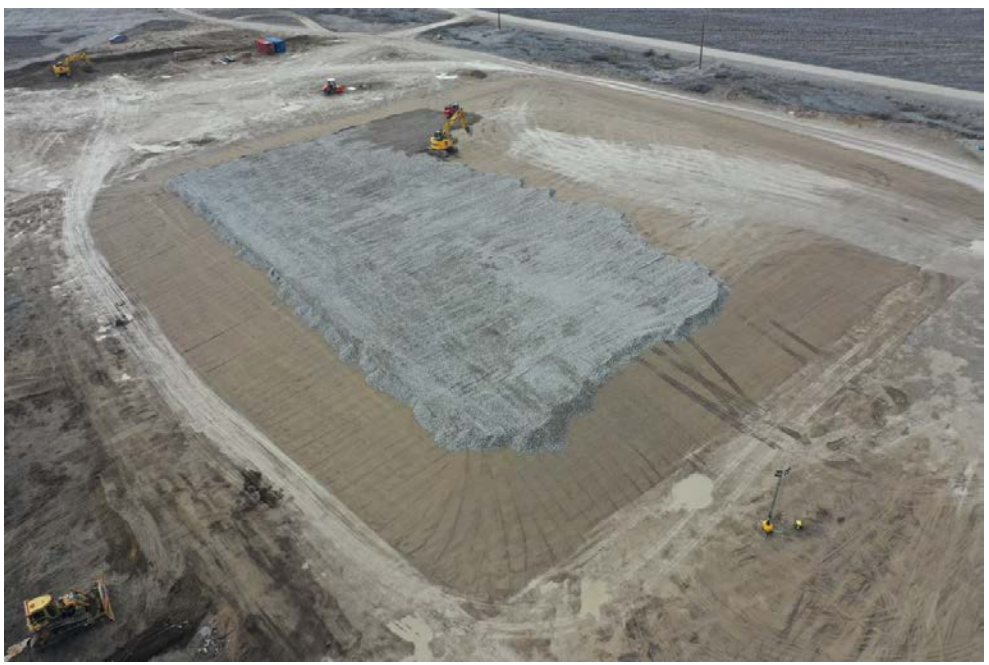
Photo Location: NHW Facility			
Direction: SW			
Survey Date: 9/24/2024			
Comments: Aerial view of the NHW Facility during placement of the final Type 3 material layer.

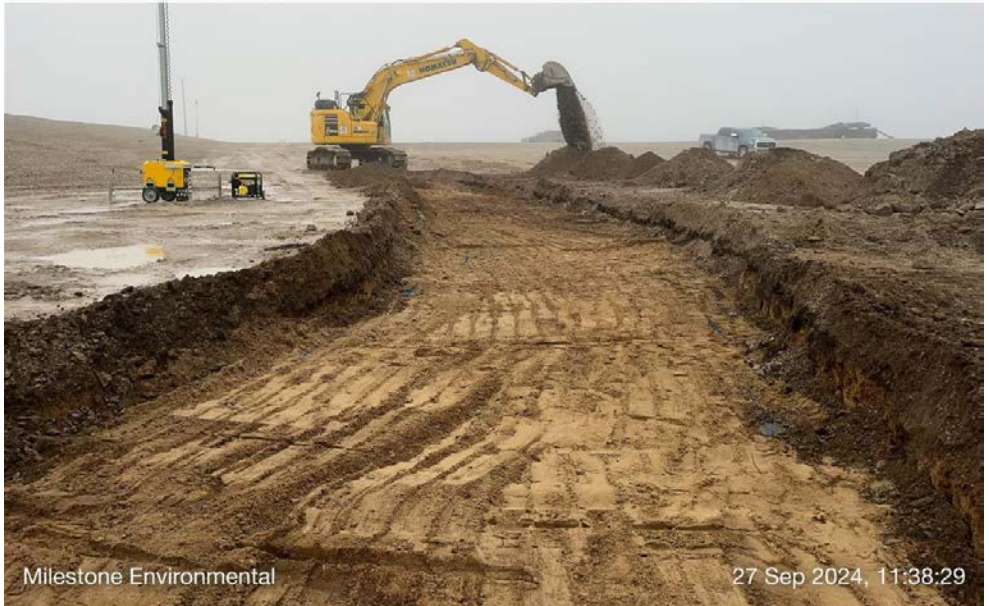
<div> Milestone Environmental 27 Sep 2024, 11:38:29 </div> </div>		
Photo Location: NHW Facility			
Direction: NW			
Survey Date: 9/27/2024			
Comments: Excavation of NHW Facility perimeter ditch in progress.			
Photograph ID: 12	 		
Photo Location: NHW Facility			
Direction: SW			
Survey Date: 9/28/2024			
Comments: Aerial view of the NHW Facility during construction of the perimeter ditch.

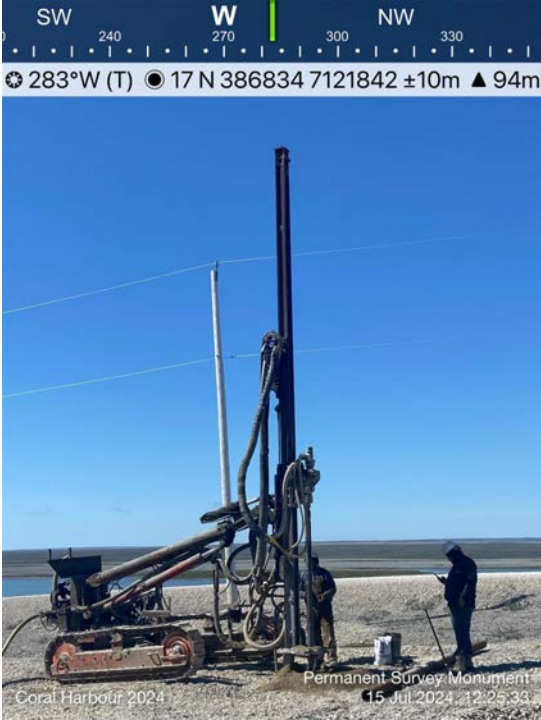
Photo Location: NHW Facility			
Direction: W			
Survey Date: 7/15/2024			
Comments: Installation of permanent survey control monument near the NHW Facility. Monument was installed using a drill rig supplied by Canadrill Ltd.			
Photograph ID: 16

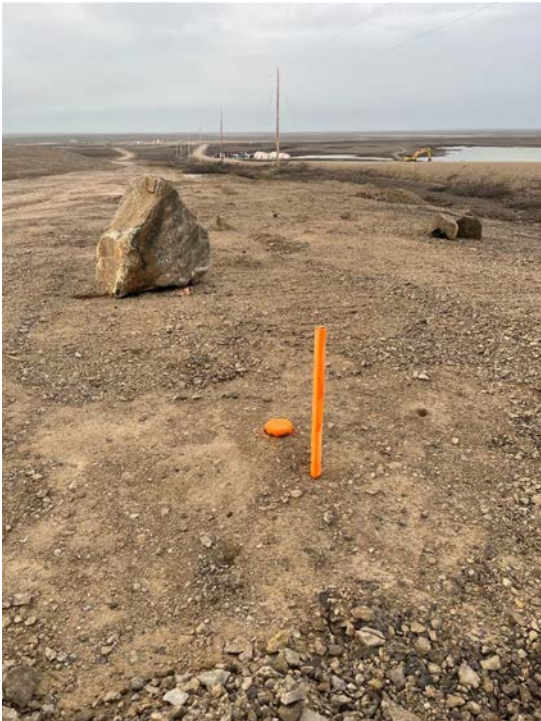
Photo Location: NHW Facility			
Direction: S			
Survey Date: 10/5/2024			
Comments: View of permanent survey control monument near the NHW Facility.

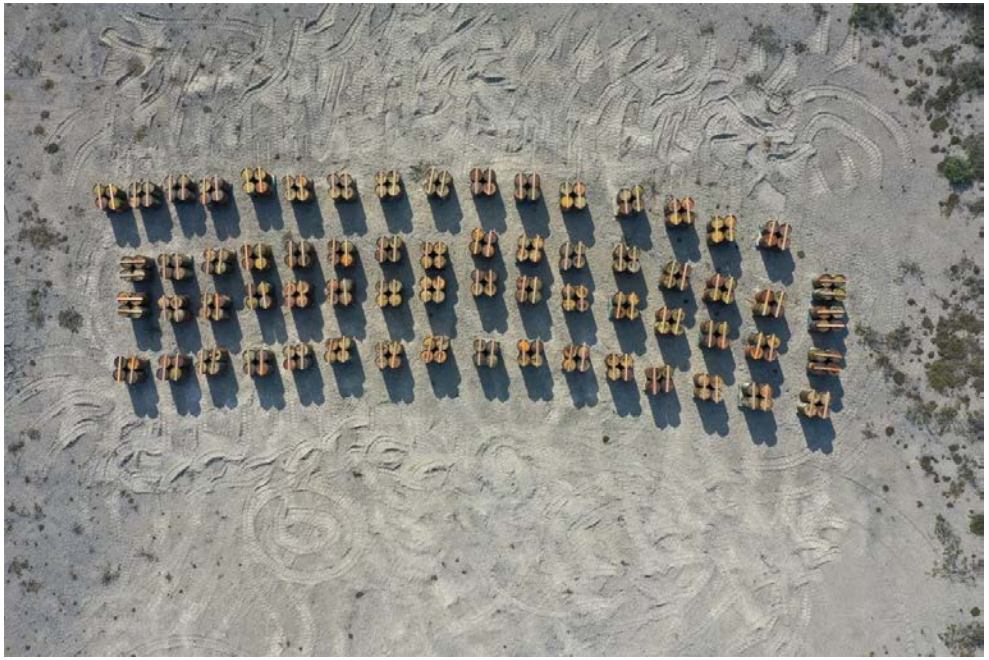
Photo Location: AEC 2			
Direction: N/A			
Survey Date: 8/22/2024			
Comments: Aerial view of barrels strapped on pallets for future off-site disposal.

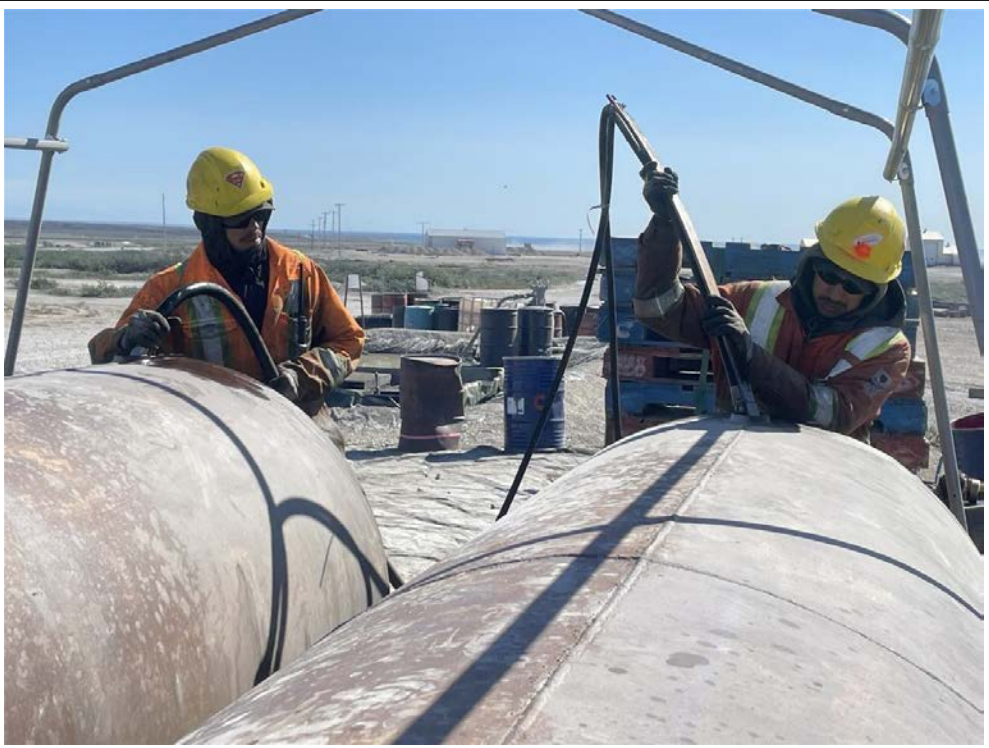
Photo Location: AEC 2			
Direction: S			
Survey Date: 8/4/2024			
Comments: Contractor preparing a batch of barrel contents for incineration in the HMPA.

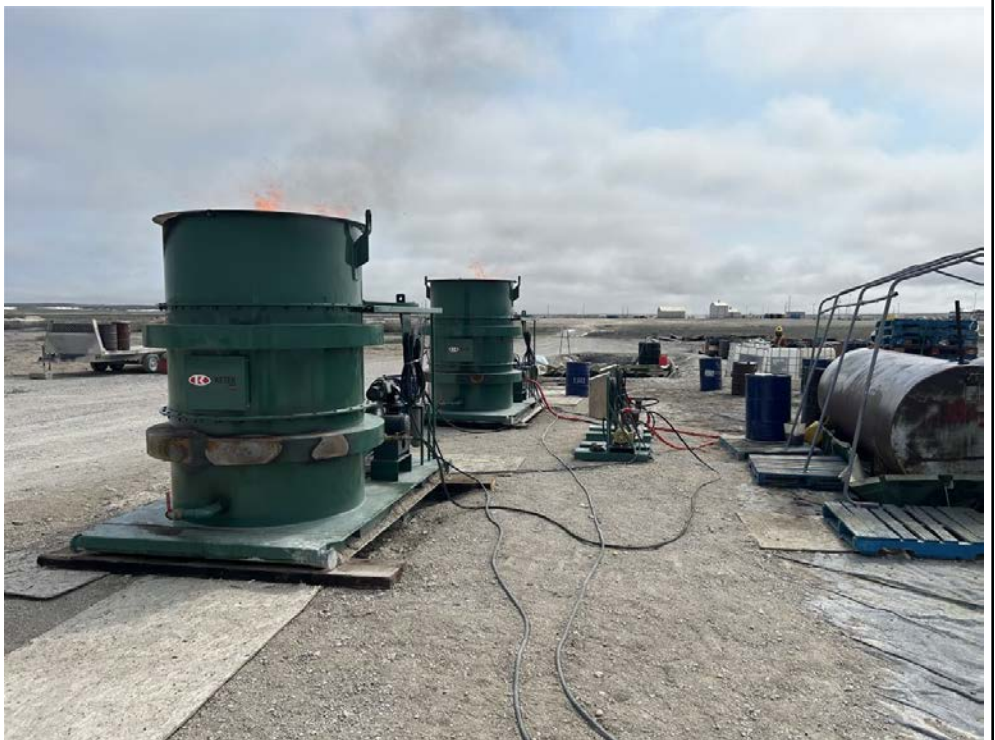
Photo Location: AEC 2			
Direction: S			
Survey Date: 7/2/2024			
Comments: Incineration of barrel contents in progress in the HMPA.			
Photograph ID: 24

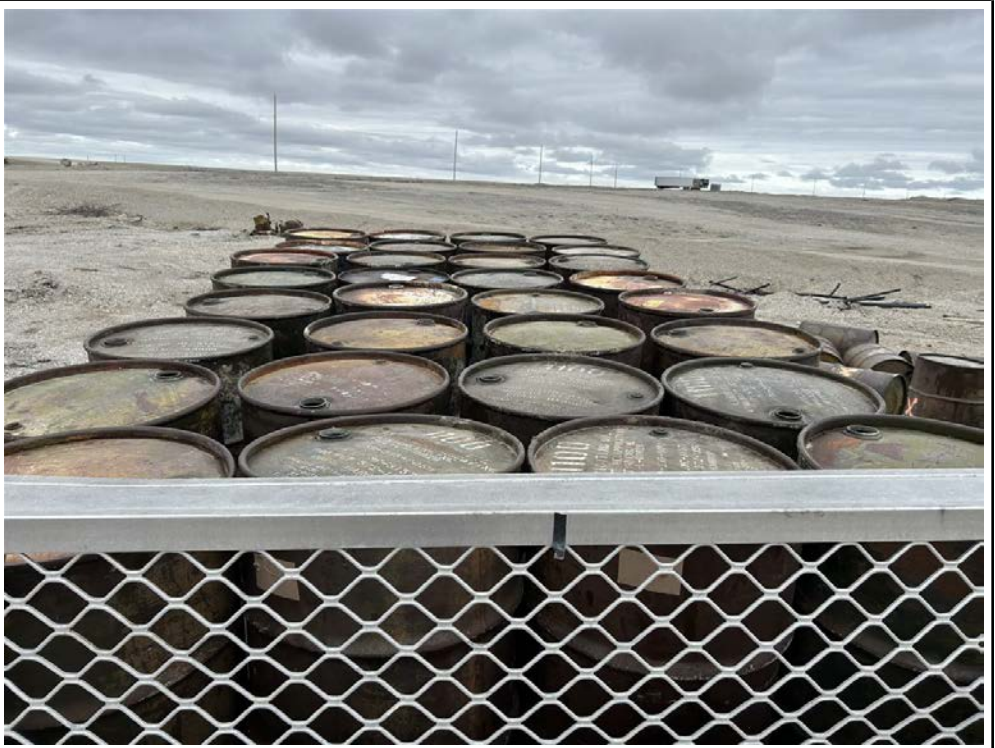
Photo Location: AEC 2			
Direction: N			
Survey Date: 6/24/2024			
Comments: Empty and cleaned barrels strapped on a trailer for transport to the NHW Facility for crushing and disposal.

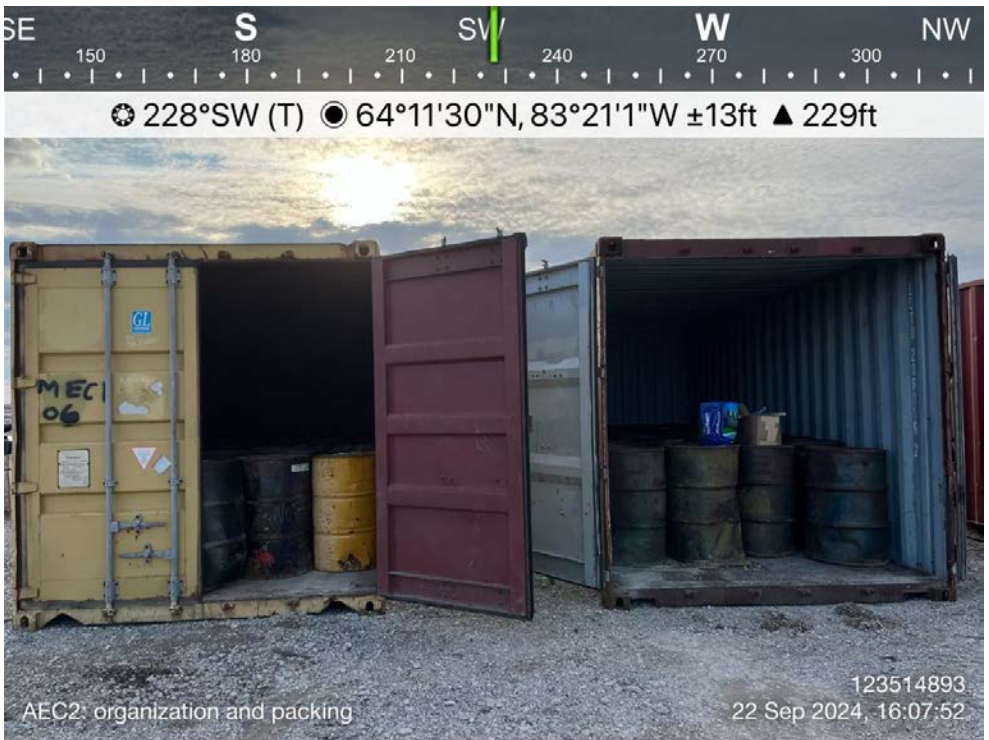
<p>SE 150 S 180 210 SW 240 W 270 300 NW</p> <p>☀ 228°SW (T) ● 64°11'30"N, 83°21'1"W ±13ft ▲ 229ft</p> <p>AEC2: organization and packing</p> <p>123514893 22 Sep 2024, 16:07:52</p>		
Photo Location: AEC 2			
Direction: SW			
Survey Date: 9/22/2024			
Comments: Dented barrels loaded into a sea container for future off-site transport and disposal.			
Photograph ID: 26

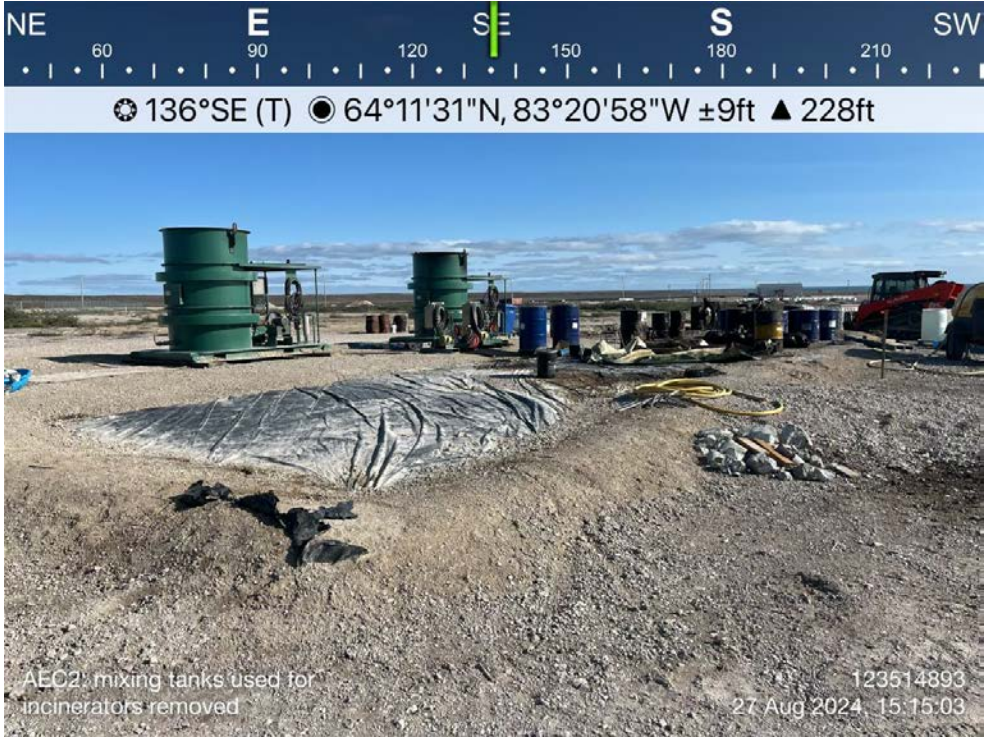
<p>NE 60 E 90 SE 120 150 S 180 210 SW</p> <p>☀ 136°SE (T) ● 64°11'31"N, 83°20'58"W ±9ft ▲ 228ft</p> <p>AEC2: mixing tanks used for incinerators removed</p> <p>123514893 27 Aug 2024, 15:15:03</p>		
Photo Location: AEC 2			
Direction: SE			
Survey Date: 8/27/2024			
Comments: HMPA decommissioning in progress. Batch tanks have been removed, cleaned, and disposed of.

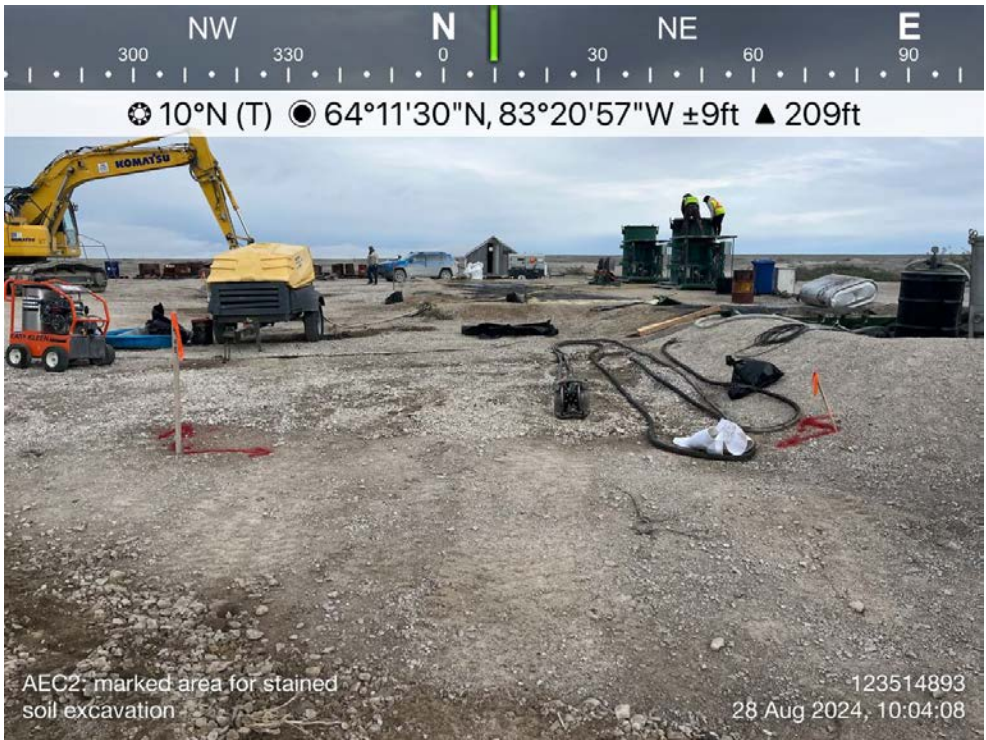
<p>123514893 28 Aug 2024, 10:04:08</p>		
Photo Location: AEC 2			
Direction: N			
Survey Date: 8/28/2024			
Comments: HMPA decommissioning in progress. Incinerators are being disconnected. A stained surficial soil area is marked for future excavation in the foreground.			
Photograph ID: 28

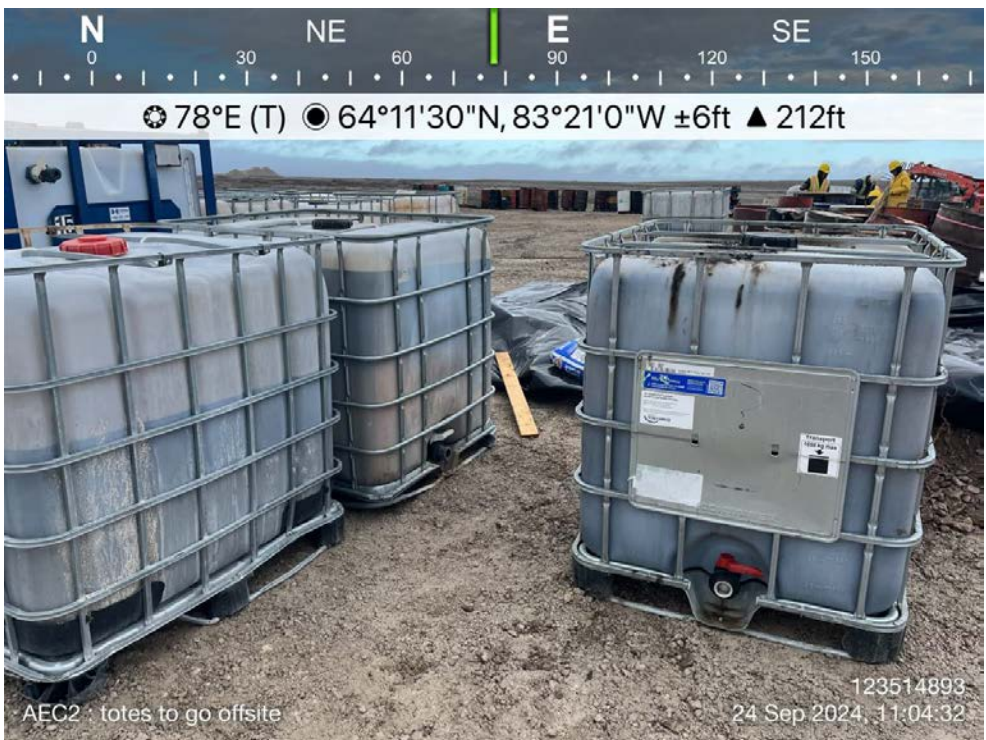
<p>123514893 24 Sep 2024, 11:04:32</p>		
Photo Location: AEC 2			
Direction: E			
Survey Date: 9/22/2024			
Comments: Totes containing oily water to be sent for off-site disposal.

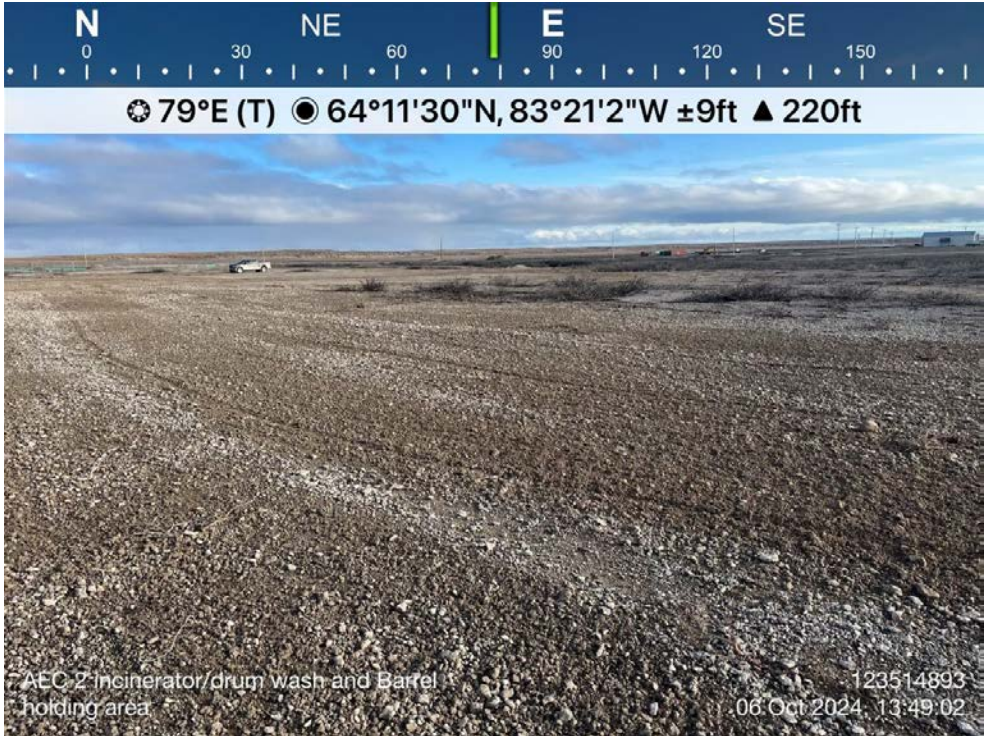
<p>AEC 2 Incinerator/drum wash and Barrel holding area</p> <p>123514893 06 Oct 2024 13:49:02</p>		
Photo Location: AEC 2			
Direction: E			
Survey Date: 10/6/2024			
Comments: View of HMPA area following decommissioning and regrading.			
Photograph ID: 30

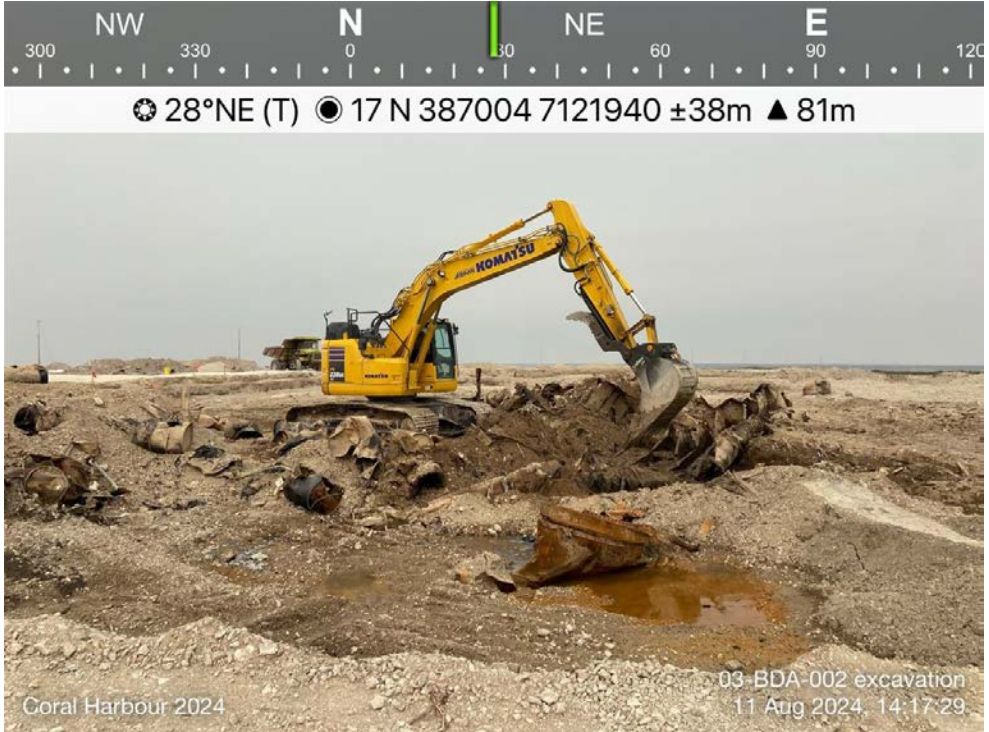
<p>03-BDA-002 excavation</p> <p>Coral Harbour 2024 11 Aug 2024 14:17:29</p>		
Photo Location: AEC 3			
Direction: NE			
Survey Date: 8/11/2024			
Comments: Excavation of 03-BDA-002 in progress.

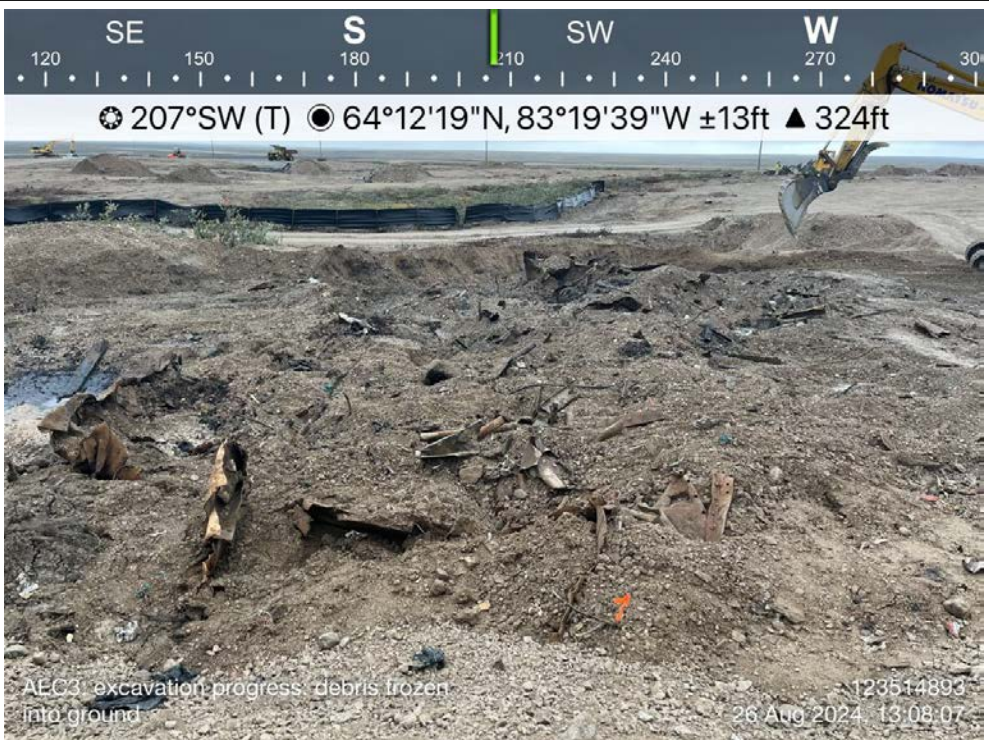
<p> SE S SW W 120 150 180 210 240 270 300 ☼ 207°SW (T) ● 64°12'19"N, 83°19'39"W ±13ft ▲ 324ft 123514893 26 Aug 2024 13:08:07 </p>		
Photo Location: AEC 3			
Direction: S			
Survey Date: 8/26/2024			
Comments: Debris frozen above the level of surrounding permafrost in 03-BDA-002.

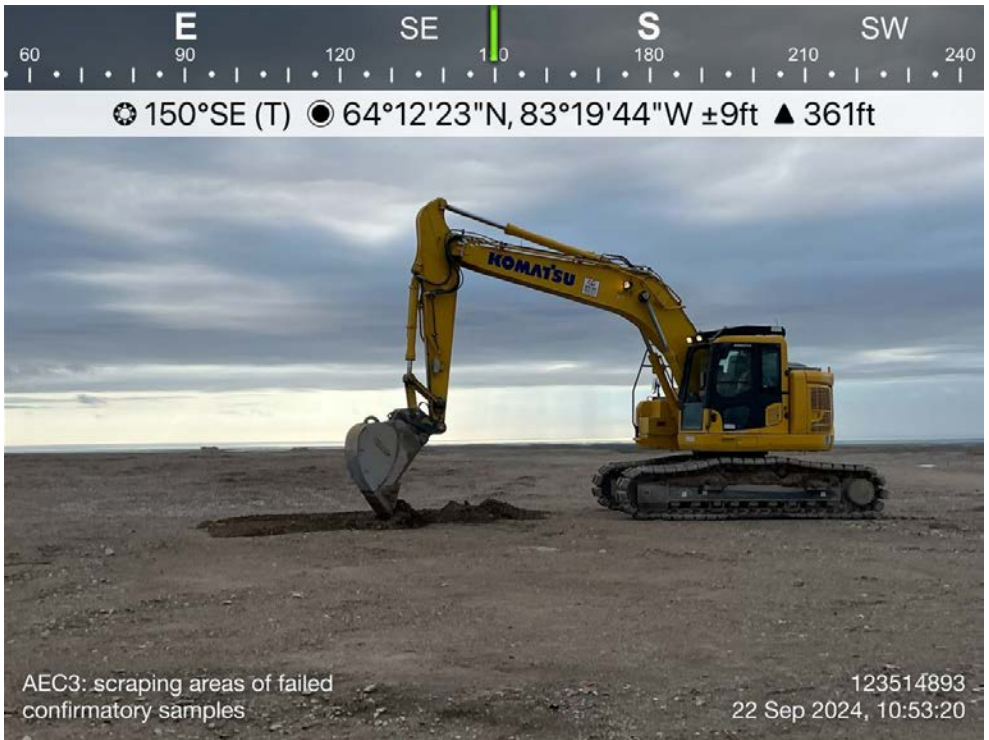
<p> Photo Location: AEC 3 </p> <p> Direction: SE </p> <p> Survey Date: 9/22/2024 </p> <p> Comments: Excavation of exceeding DCC Tier II soil in former BDA stockpile areas. </p> <p> AEC3: scraping areas of failed confirmatory samples </p> <p> 123514893 22 Sep 2024, 10:53:20 </p>		
Photo Location:			
Direction:			
Survey Date:			
Comments:			
Photograph ID: 36

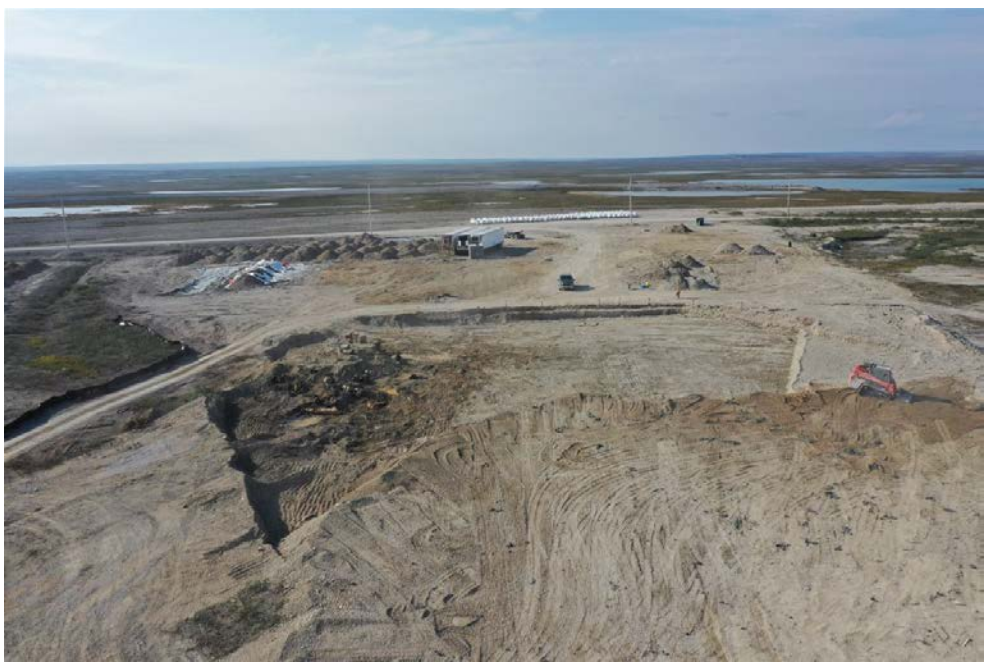
Photo Location:			
Direction:			
Survey Date:			
Comments:	Excavation of 03-BDA-002 in progress.

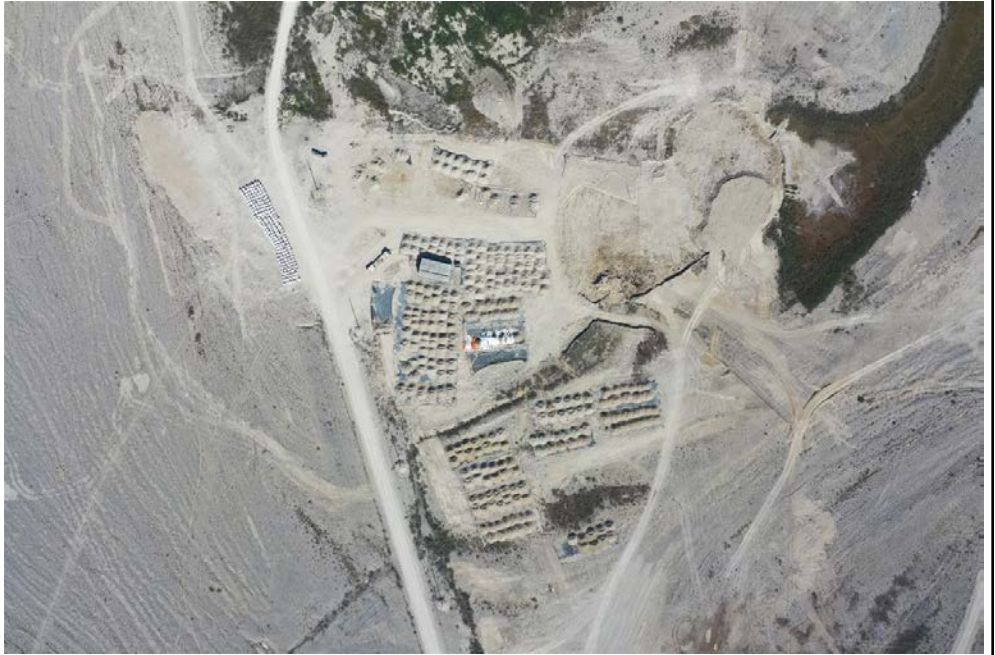
Photo Location: AEC 3			
Direction: N/A			
Survey Date: 8/18/2024			
Comments: Aerial view of BDA excavations in AEC 3, including bagged DCC Tier II soil and soil stockpiles yet to be processed. 03-BDA-002 visible in centre-right, while 03-BDA-003 is visible in upper left (previously backfilled).			
Photograph ID: 38	<div style="background-color: #333; color: white; text-align: center; padding: 5px;">Coral Harbour NU</div> <div style="background-color: #eee; text-align: center; padding: 5px;"> ☀ 18°N (T) ● 64°12'23"N, 83°19'45"W ±6ft ▲ 316ft </div>

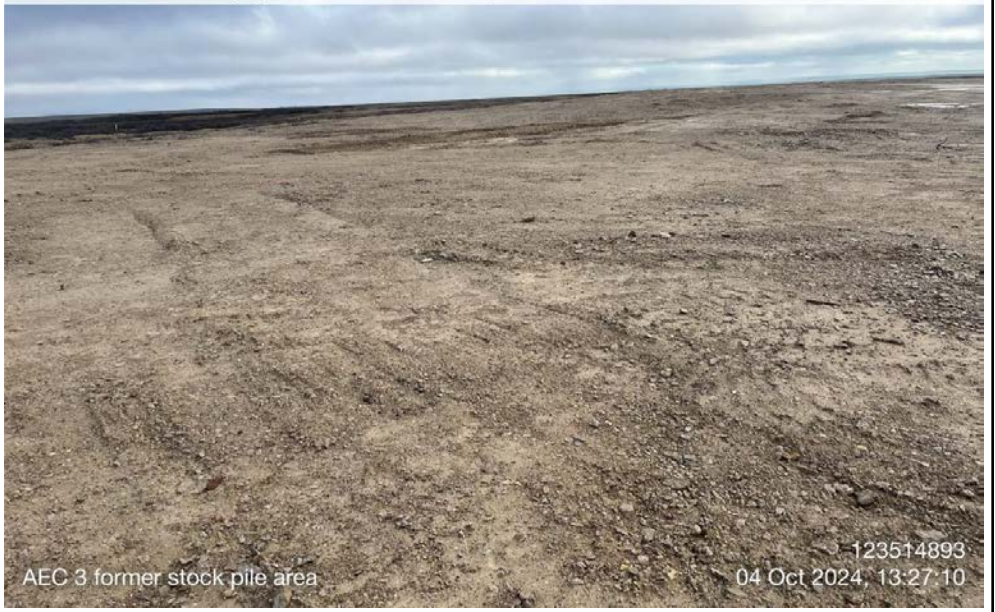
Survey Date: 10/4/2024			
Comments: View of former soil stockpile area adjacent to 03-BDA-002.

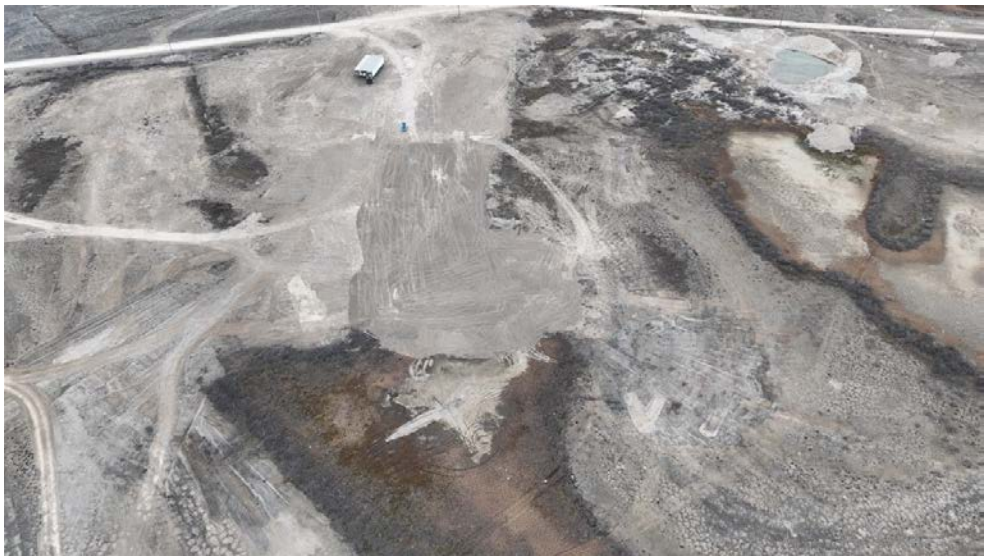
Photo Location: AEC 3			
Direction: NW			
Survey Date: 10/13/2024			
Comments: Aerial view of AEC 3 following completion of remediation activities.			
Photograph ID: 40

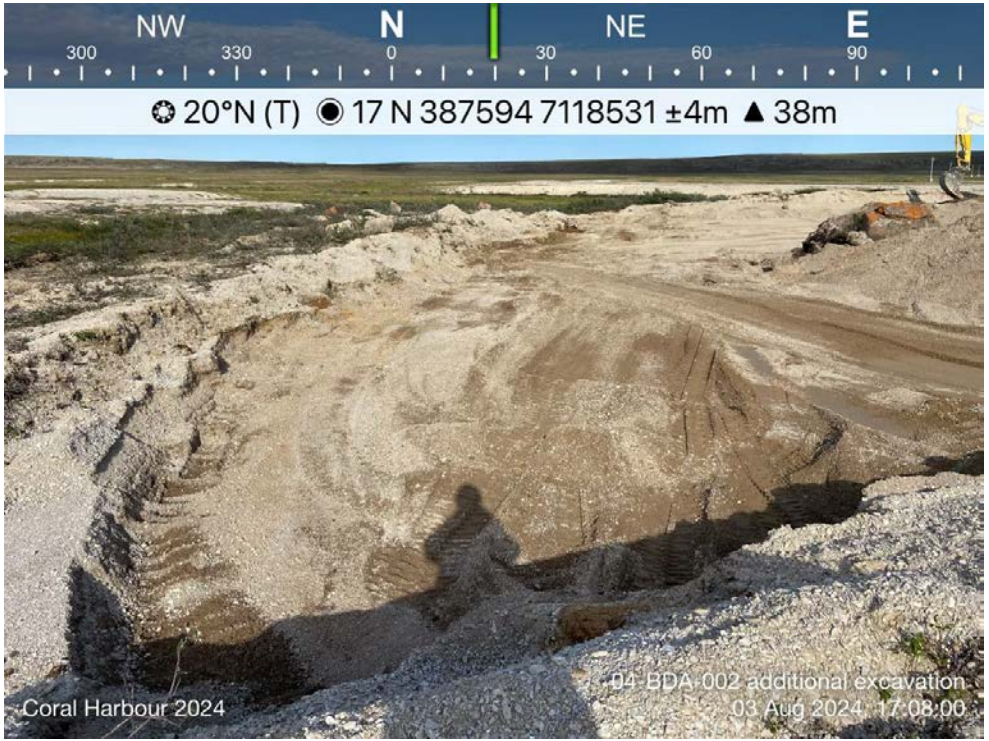
Photo Location: AEC 4			
Direction: N			
Survey Date: 8/3/2024			
Comments: Excavation of 04-BDA-002 in progress.

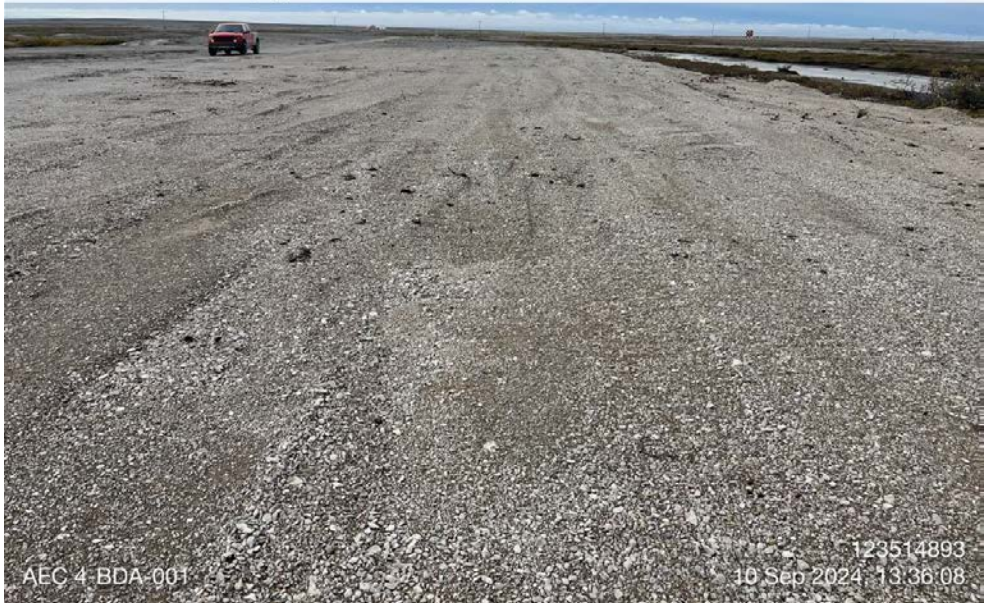
<div> AEC 4-BDA-001 123514893 10 Sep 2024, 13:36:08 </div> </div>		
Photo Location: AEC 4			
Direction: SW			
Survey Date: 9/10/2024			
Comments: View of backfilled 04-BDA-001.			
Photograph ID: 42	<div> <div>North West Elevation</div> <div> ☼ 126°SE (T) ● 64°10'27"N, 83°18'44"W ±13ft ▲ 97ft </div>

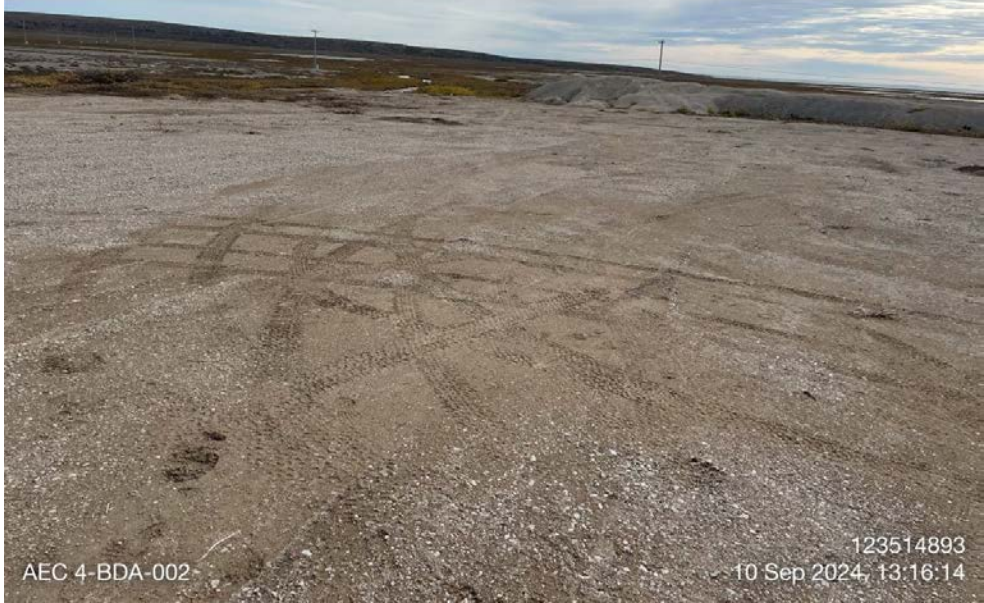
<div> AEC 4-BDA-002 123514893 10 Sep 2024, 13:16:14 </div> </div>		
Photo Location: AEC 4			
Direction: SE			
Survey Date: 9/10/2024			
Comments: View of backfilled 04-BDA-002.

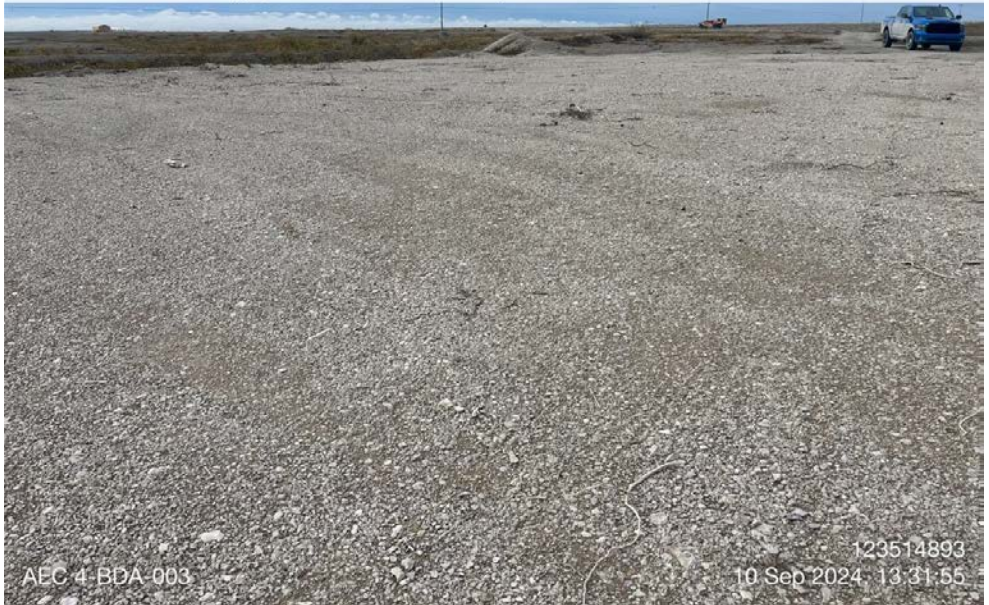
<div> AEC 4-BDA-003 <div>123514893 10 Sep 2024 13:31:55</div> </div> </div>		
Photo Location: AEC 4			
Direction: W			
Survey Date: 9/10/2024			
Comments: View of backfilled 04-BDA-003.			
Photograph ID: 44

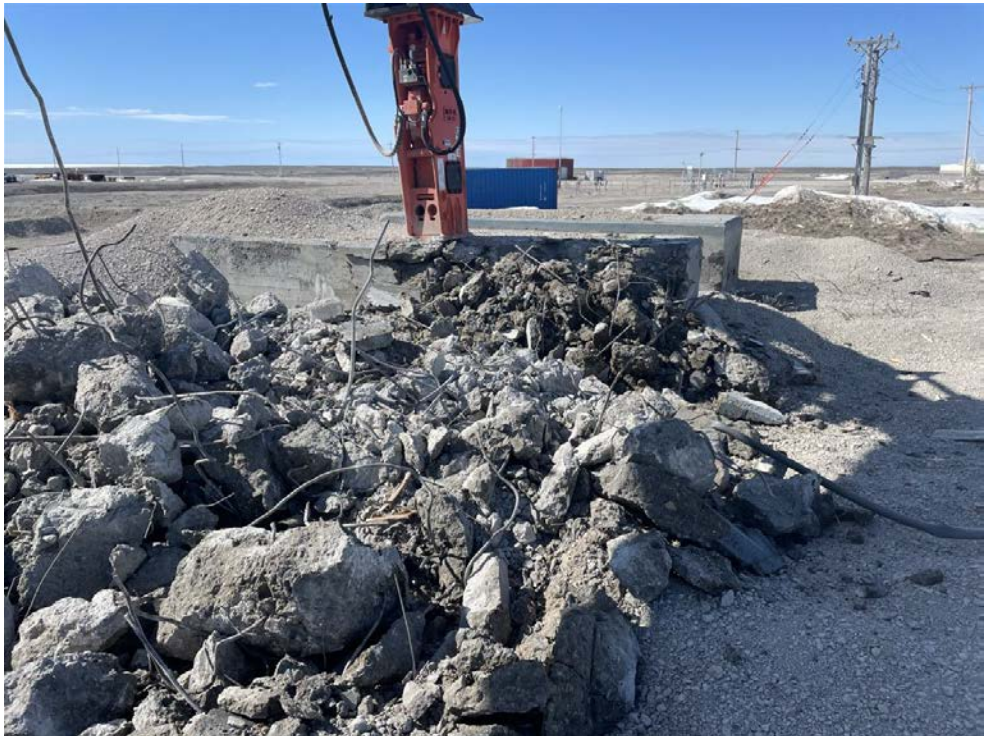
Photo Location: AEC 6 (Concrete Anchors)			
Direction: SW			
Survey Date: 6/15/2024			
Comments: Excavator equipped with hydraulic breaker breaking up concrete anchors in AEC 6.

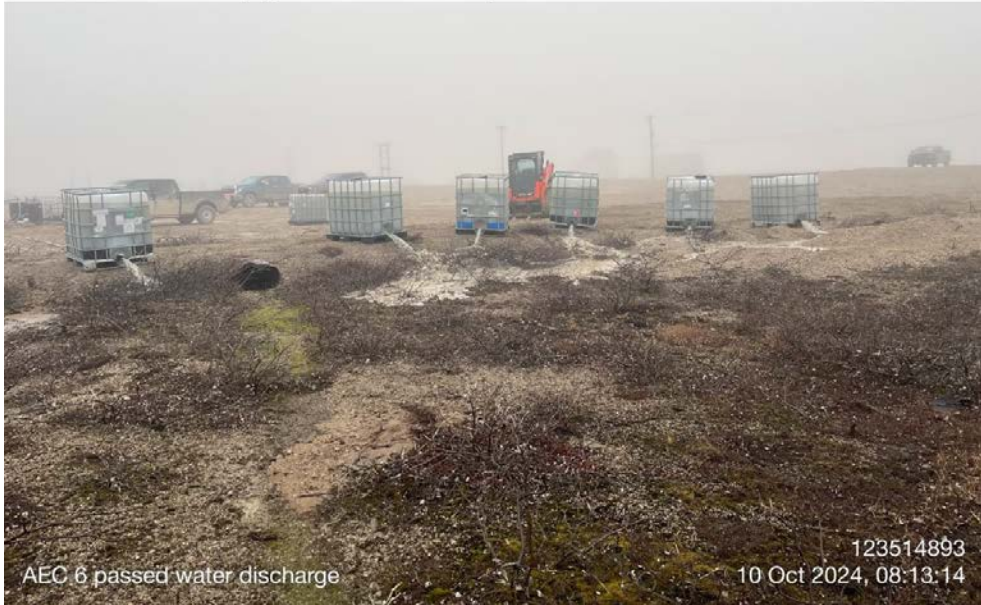
<div> AEC 6 passed water discharge 123514893 10 Oct 2024, 08:13:14 </div> </div>		
Photo Location: AEC 6 (Water Treatment)			
Direction: W			
Survey Date: 9/20/2024			
Comments: Treated and approved LTU contact water being discharged on-site in accordance with the Water Licence.			
Photograph ID: 46	<div> <div> N NE E SE S </div> <div> 0 30 60 90 120 150 180 </div> </div> <div> ☼ 92°E (T) ● 64°11'17"N, 83°20'39"W ±13ft ▲ 173ft </div>

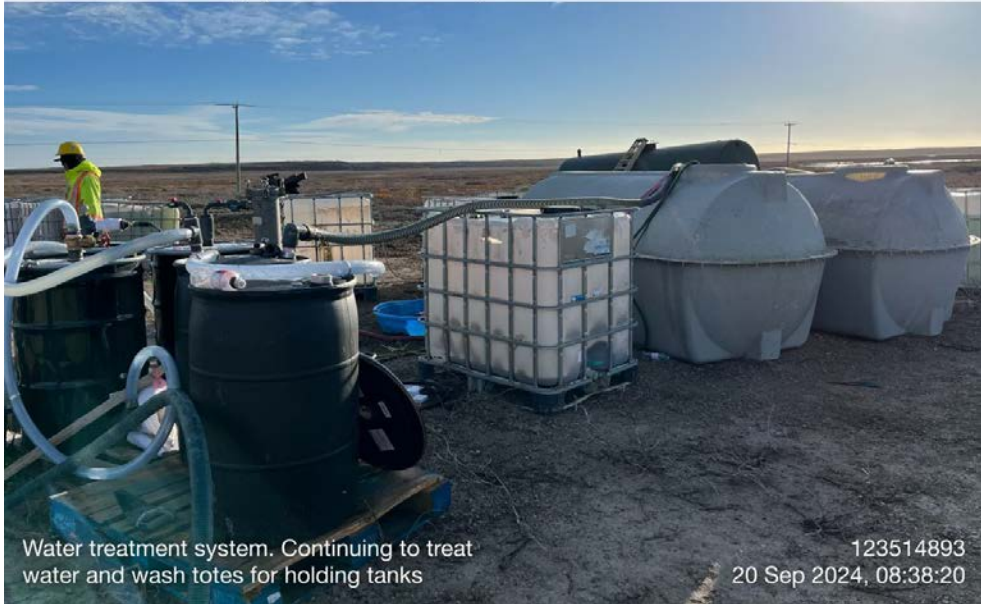
Comments: Process water treatment system in operation.
