**RE: CORAL HARBOUR PROJECT NWB LLICENSE NO. 1BR-COR2325 ANNUAL
REPORT, 2024**

NWB Annual Report

Project Name: Coral Harbour Remediation Project

APPENDIX B
PHOTOGRAPHIC LOG

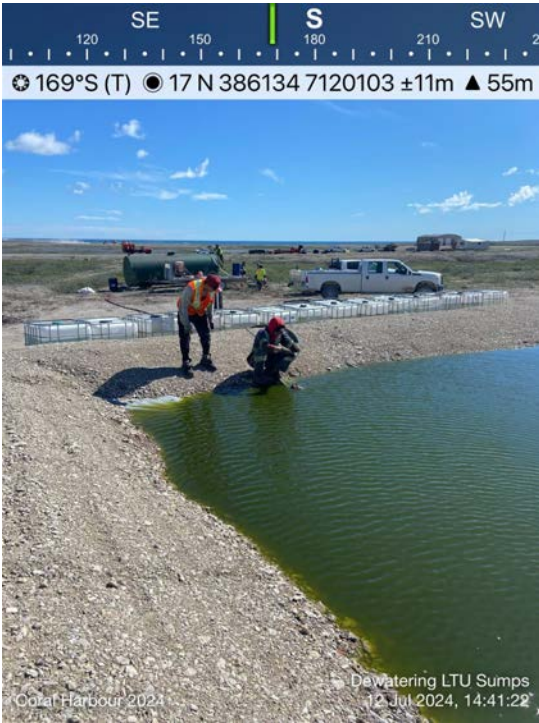
Photo Location: AEC 6 (LTU)			
Direction: S			
Survey Date: 7/12/2024			
Comments: Dewatering LTU sumps prior to LTU decommissioning. Water pumped to the totes visible in the background.			
Photograph ID: 48

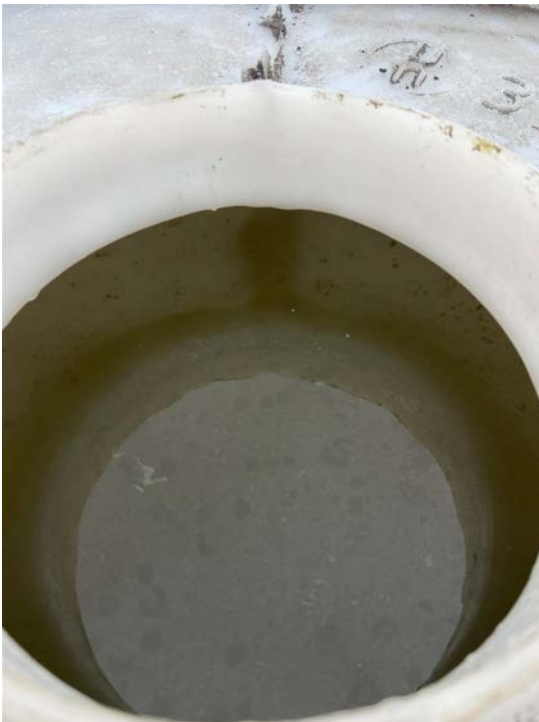
Photo Location: AEC 6 (LTU)			
Direction: N/A			
Survey Date: 7/16/2024			
Comments: PHC sheen on water recovered from LTU sumps, prior to treatment.

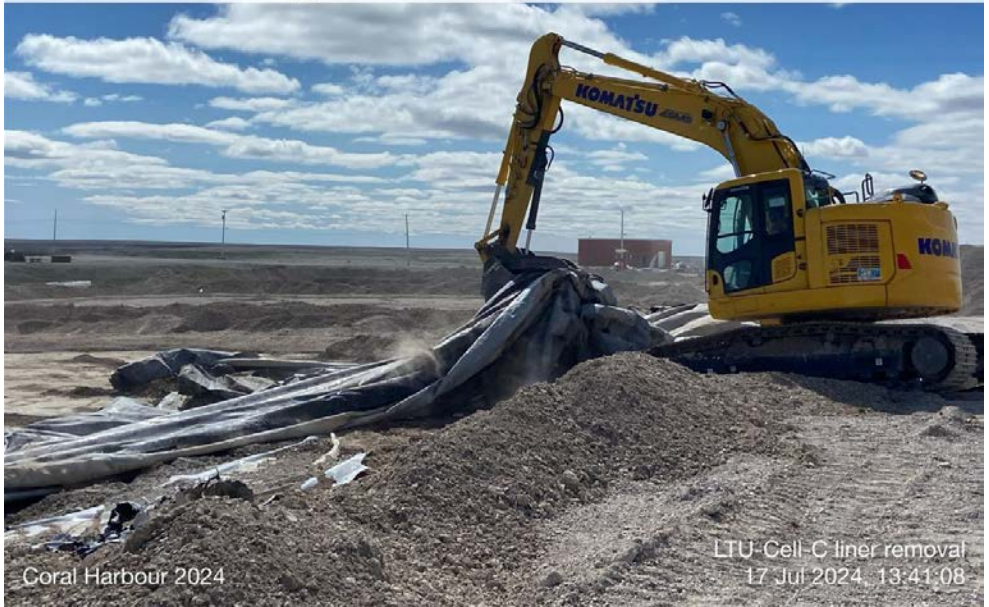
<p>SE 150 S 180 SW 210 240 W 270 300</p> <p>☼ 218°SW (T) ● 17 N 386115 7120129 ±6m ▲ 58m</p> <p>LTU-Cell-C liner removal 17 Jul 2024, 13:41:08</p> <p>Coral Harbour 2024</p>		
Photo Location: AEC 6 (LTU)			
Direction: SW			
Survey Date: 7/17/2024			
Comments: Removal of geomembrane liner during decommissioning of LTU treatment cell C.			
Photograph ID: 52

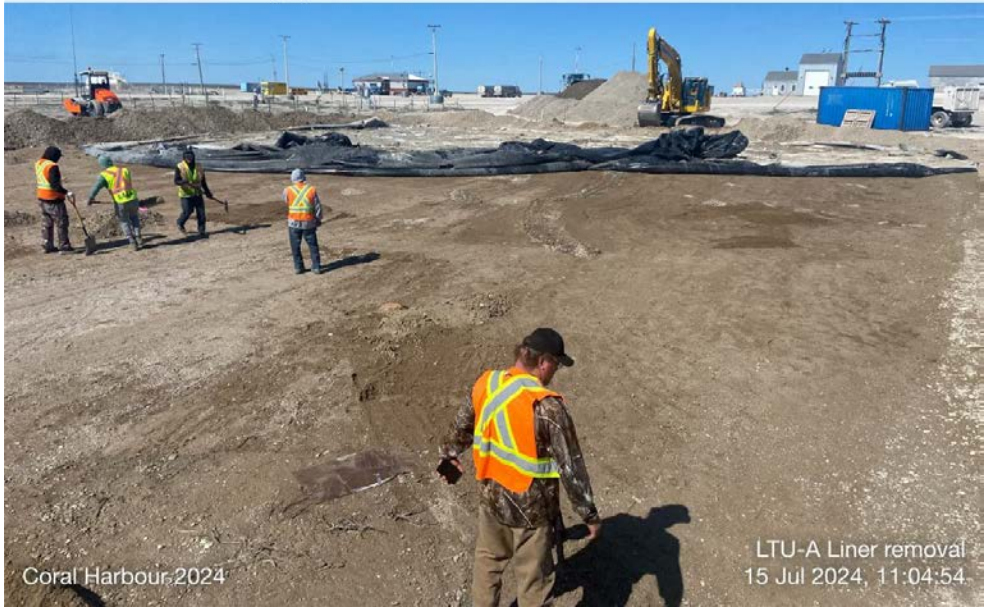
<p>SW 210 W 240 270 NW 300 330 N 0</p> <p>☼ 288°W (T) ● 17 N 386078 7120042 ±4m ▲ 58m</p> <p>LTU-A Liner removal 15 Jul 2024, 11:04:54</p> <p>Coral Harbour 2024</p>		
Photo Location: AEC 6 (LTU)			
Direction: W			
Survey Date: 7/15/2024			
Comments: Removal of geomembrane liner during decommissioning of LTU treatment cell A.

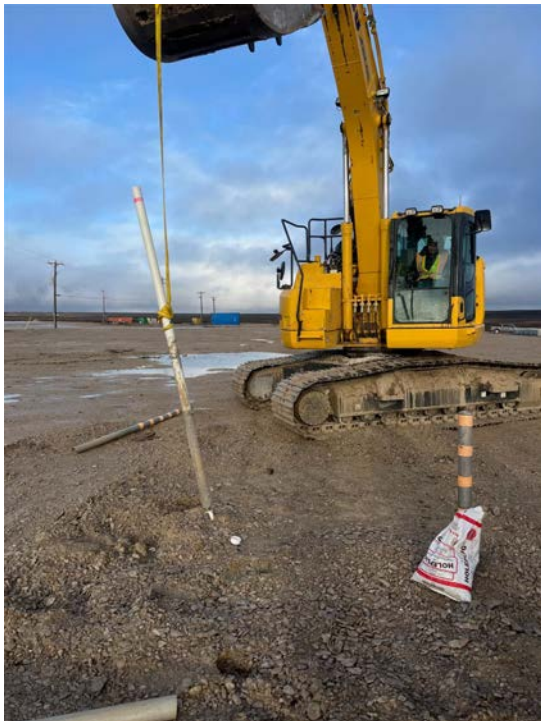
Photo Location: AEC 6 (LTU)			
Direction: E			
Survey Date: 9/22/2024			
Comments: Decommissioning of LTU monitoring well (1 of 3).			
Photograph ID: 54	<div><div><div>E</div><div>90</div><div>120</div><div>150</div><div>180</div><div>210</div><div>240</div><div>SW</div></div><div>☀ 172°S (T) 🕒 17 N 386074 7120109 ±8m ▲ 51m</div></div>

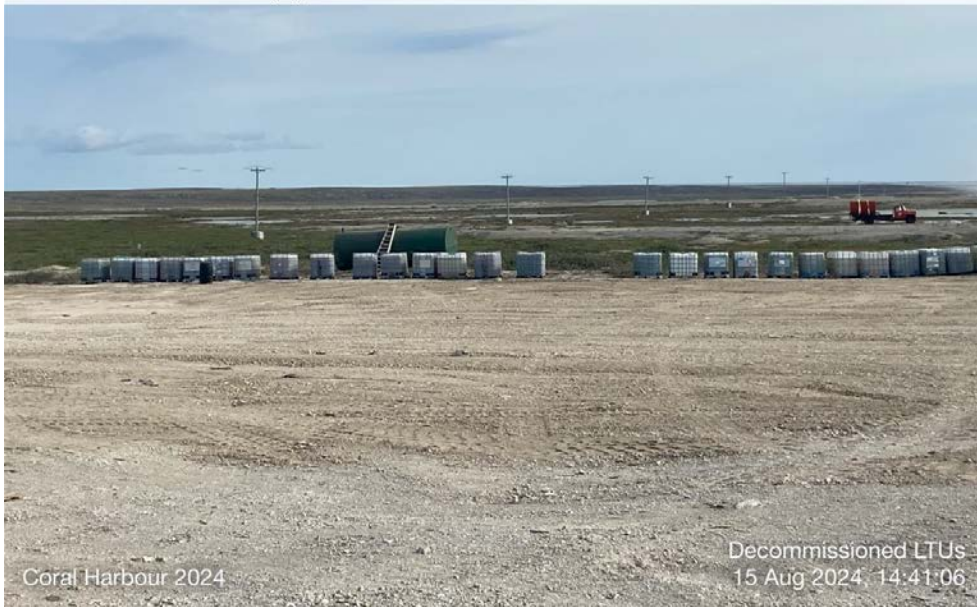
Photo Location: AEC 6 (LTU)			
Direction: S			
Survey Date: 8/15/2024			
Comments: LTU area following decommissioning. LTU contact water visible in totes in background.

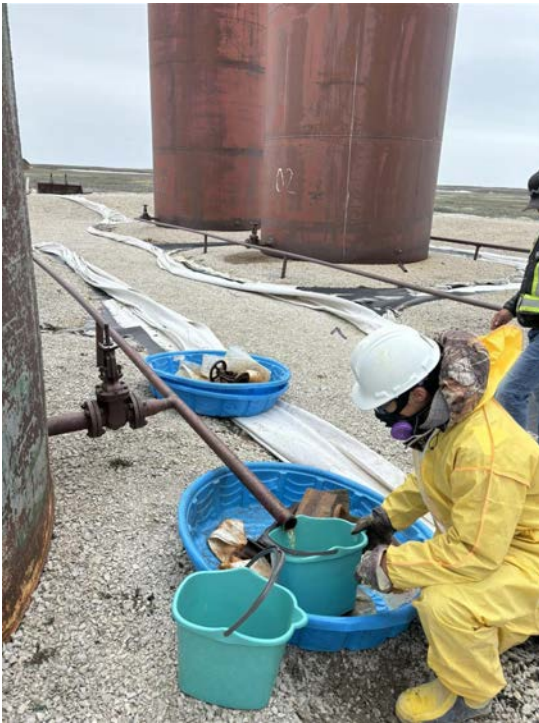
Photo Location: AEC 6 (Tank Farm)			
Direction: E			
Survey Date: 7/5/2024			
Comments: Above-ground pipes in tank farm being emptied prior to decommissioning.			
Photograph ID: 56

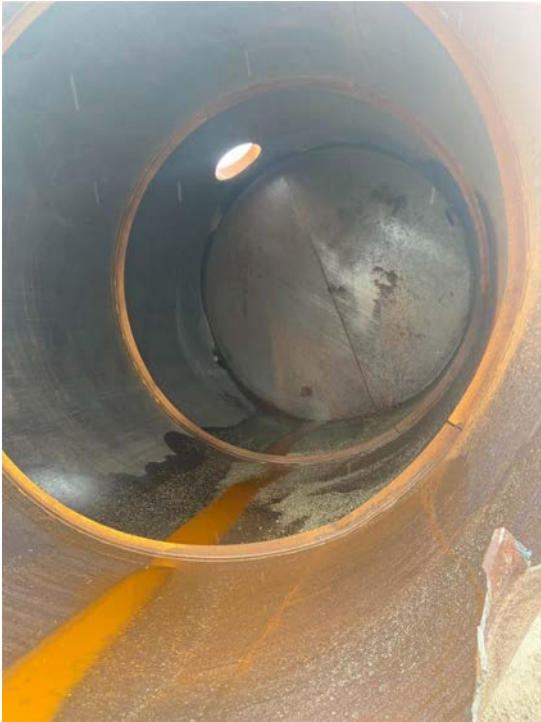
Photo Location: AEC 6 (Tank Farm)			
Direction: N/A			
Survey Date: 7/8/2024			
Comments: Interior of one of the rust ASTs following cleaning and prior to shearing.

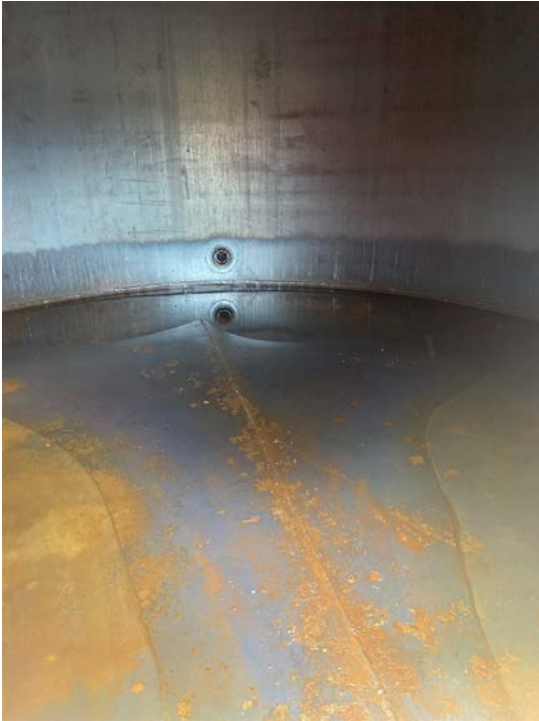
Photo Location: AEC 6 (Tank Farm)			
Direction: N/A			
Survey Date: 7/6/2024			
Comments: Interior of one of the green ASTs following cleaning and prior to shearing.			
Photograph ID: 60

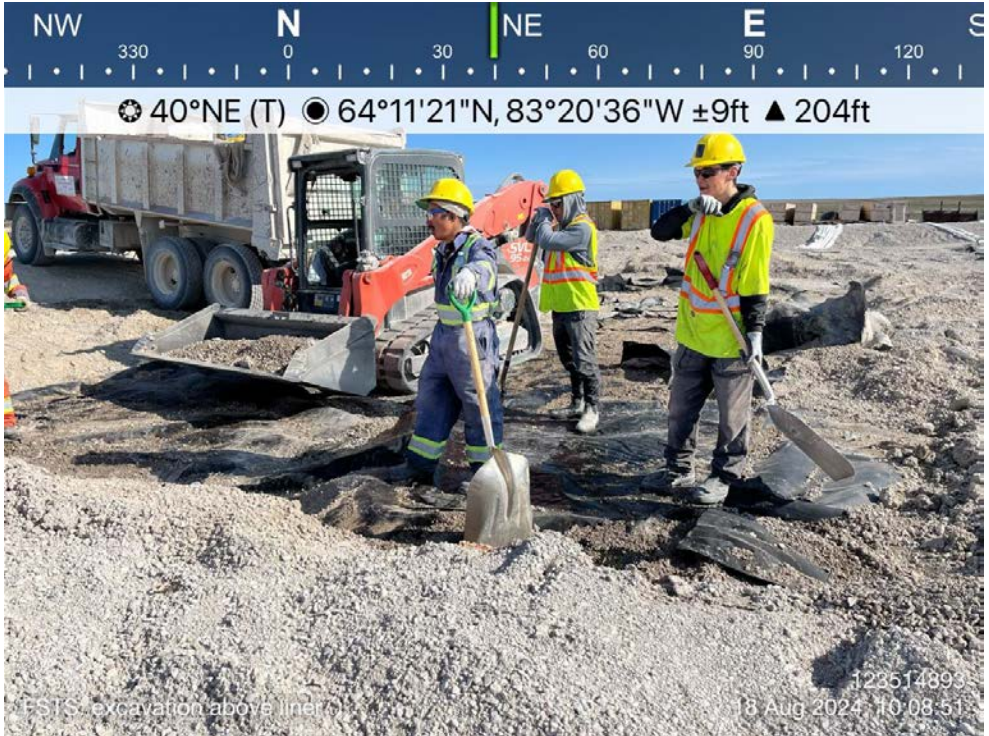
Photo Location: AEC 6 (Tank Farm)			
Direction: NE			
Survey Date: 8/18/2024			
Comments: Excavation of Type B PHC soil from above tank farm containment area liner.			
Photograph ID: 62

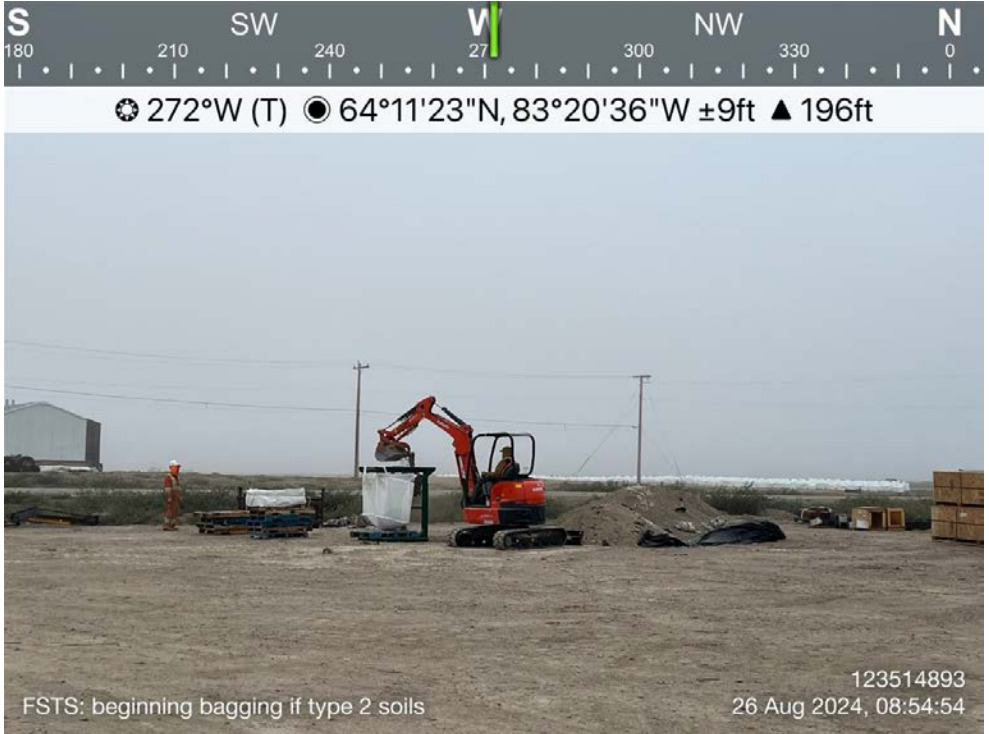
Photo Location: AEC 6 (Tank Farm)			
Direction: W			
Survey Date: 8/26/2024			
Comments: Bagging Type B PHC soil from the tank farm containment area.

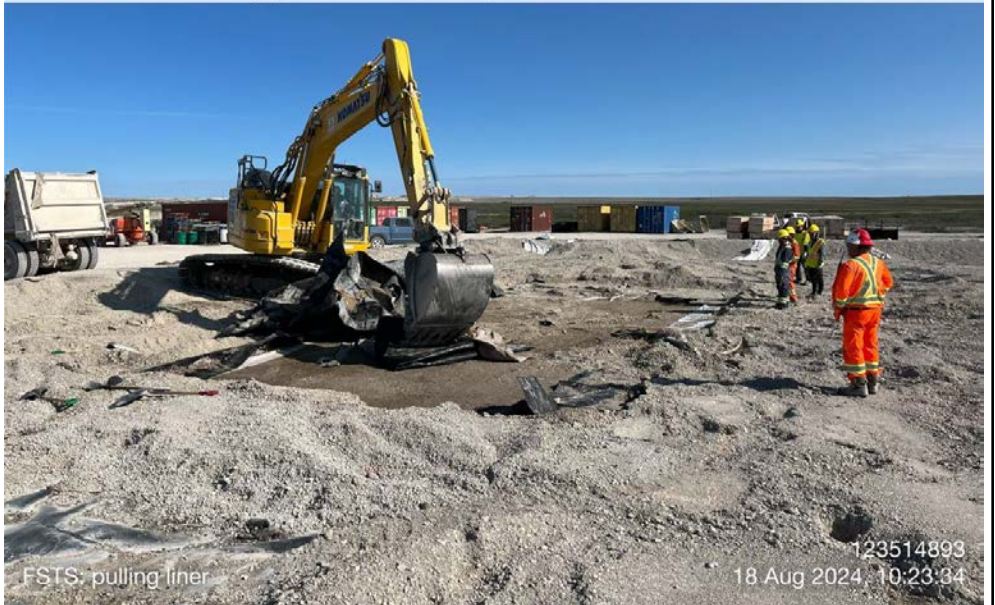
<div>123514893 18 Aug 2024, 10:23:34</div> </div>		
Photo Location: AEC 6 (Tank Farm)			
Direction: NE			
Survey Date: 8/18/2024			
Comments: Removing tank farm containment area liner during decommissioning.			
Photograph ID: 64	<div>SE S SW W NW</div> <div>150 180 210 240 270 300</div> <div> 222°SW (T) 64°11'21"N, 83°20'37"W ±13ft 192ft </div>

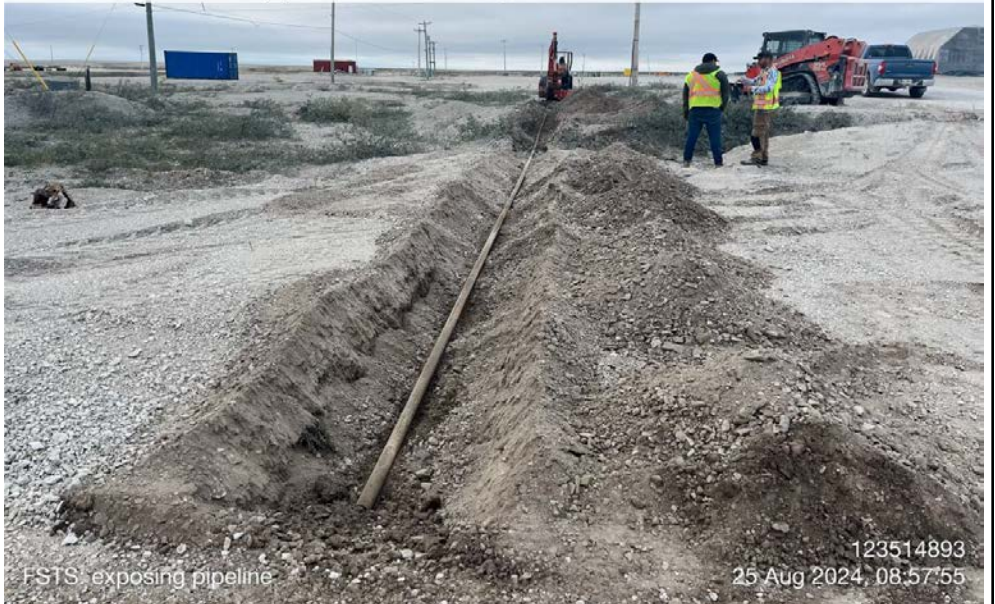
<div>123514893 25 Aug 2024, 08:57:55</div>		
Photo Location: AEC 6 (Tank Farm)			
Direction: SW			
Survey Date: 8/25/2024			
Comments: Exposing buried tank farm pipe to facilitate decommissioning and capping.

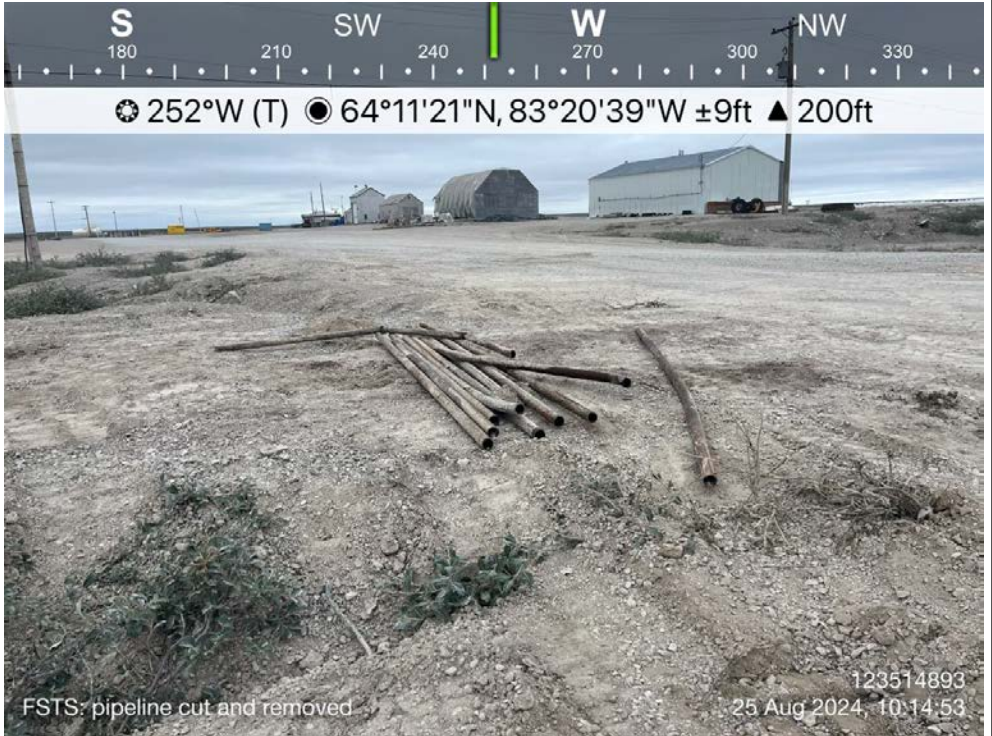
<p> S 180 210 240 270 300 330 SW W NW ☀ 252°W (T) ● 64°11'21"N, 83°20'39"W ±9ft ▲ 200ft FSTS: pipeline cut and removed 123514893 25 Aug 2024, 10:14:53 </p>		
Photo Location: AEC 6 (Tank Farm)			
Direction: W			
Survey Date: 8/25/2024			
Comments: Decommissioned sections of buried tank farm pipe prior to disposal.			
Photograph ID: 66

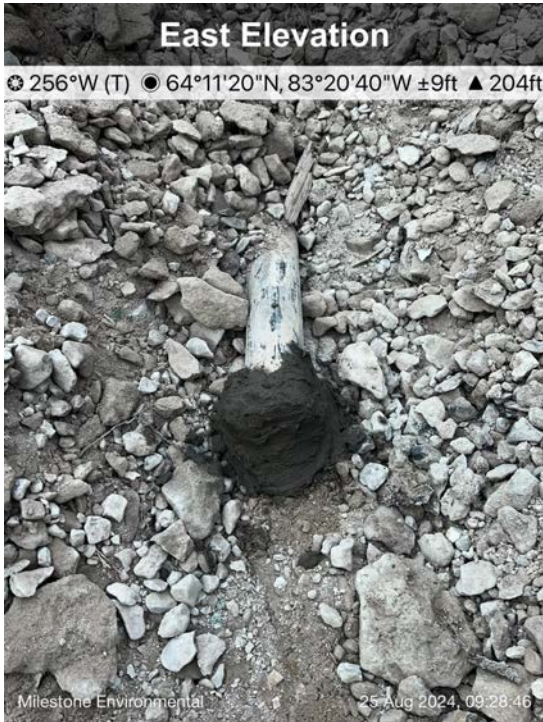
<p> East Elevation ☀ 256°W (T) ● 64°11'20"N, 83°20'40"W ±9ft ▲ 204ft Milestone Environmental 25 Aug 2024, 09:28:46 </p>		
Photo Location: AEC 6 (Tank Farm)			
Direction: W			
Survey Date: 8/25/2024			
Comments: View of capped tank farm pipeline prior to backfill of the area.

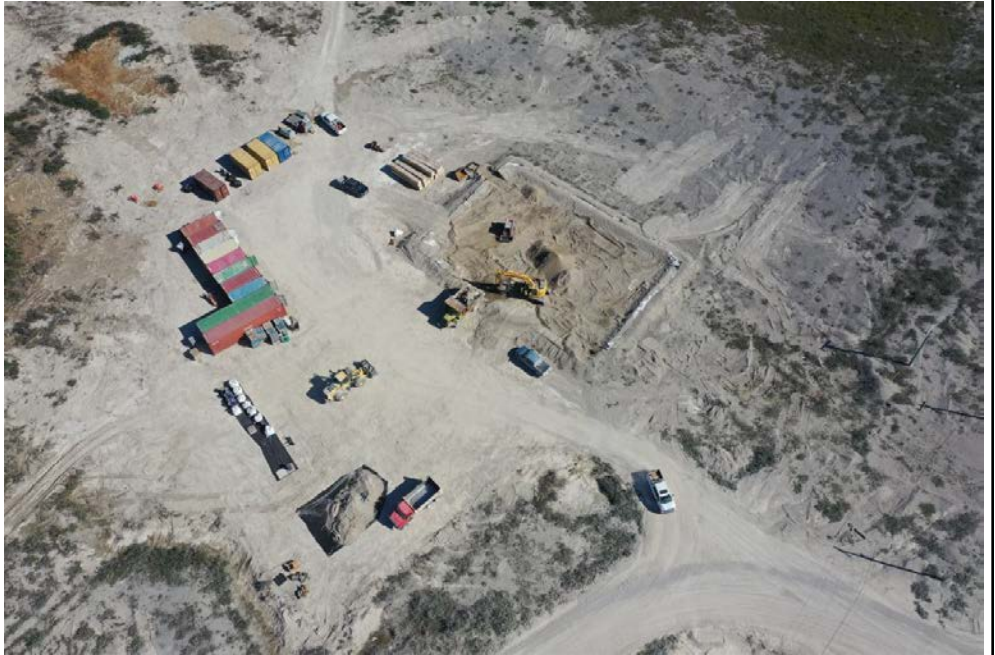
Photo Location: AEC 6 (Tank Farm)			
Direction: E			
Survey Date: 8/18/2024			
Comments: Aerial view of the AEC 6 tank farm berm being regraded. Stockpiled Type B PHC soil from above previous liner can be observed in bottom of photo.			
Photograph ID: 68	<div> West Elevation </div> <div> ☼ 71°E (T) ● 64°11'20"N, 83°20'35"W ±6ft ▲ 161ft </div>

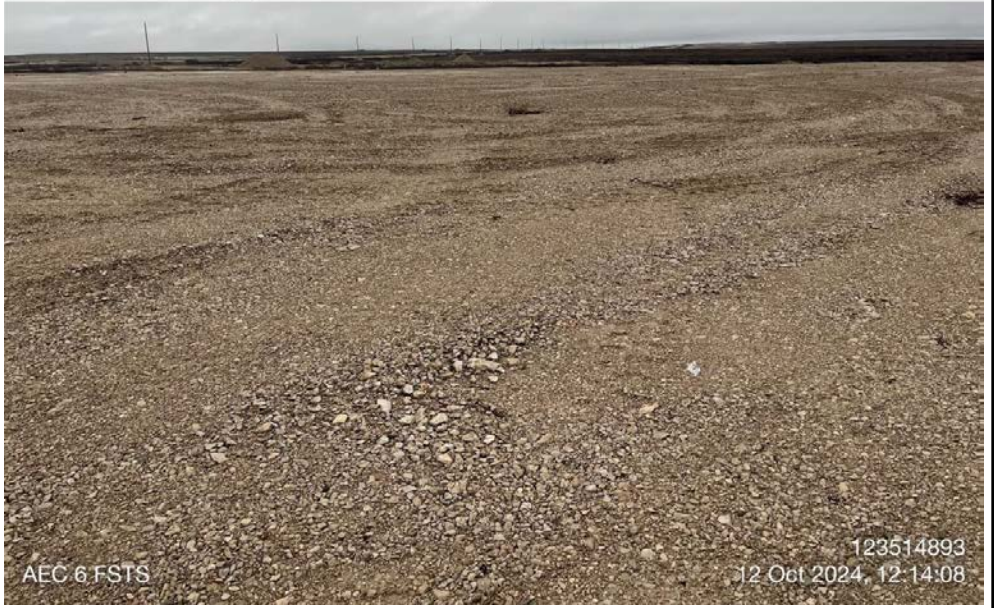
<div> AEC 6 FSTS 123514893 12 Oct 2024, 12:14:08 </div>		
Photo Location: AEC 6 (Tank Farm)			
Direction: E			
Survey Date: 10/12/2024			
Comments: View of tank farm area following decommissioning and regrading.

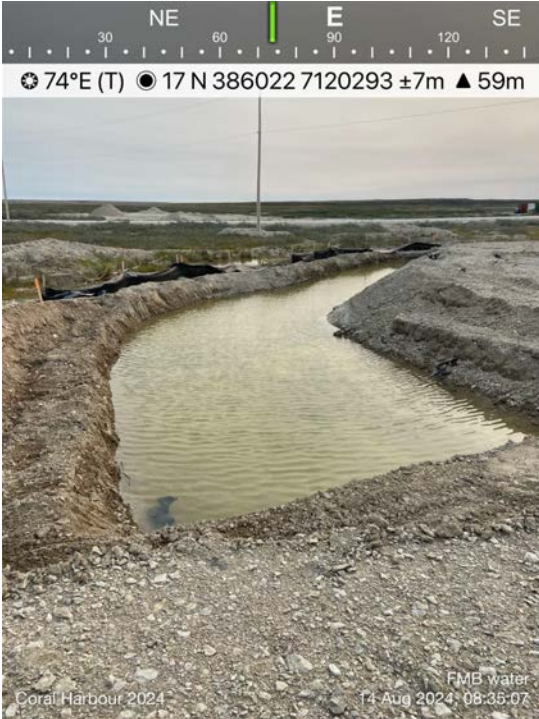
Photo Location: AEC 6 (FMB)			
Direction: E			
Survey Date: 8/14/2024			
Comments: Water accumulation within the northeast wall area of the FMB excavation, prior to backfilling.			
Photograph ID: 72	 		
Photo Location: AEC 6 (FMB)			
Direction: W			
Survey Date: 8/15/2024			
Comments: Backfilling FMB excavation with Type 4 material.

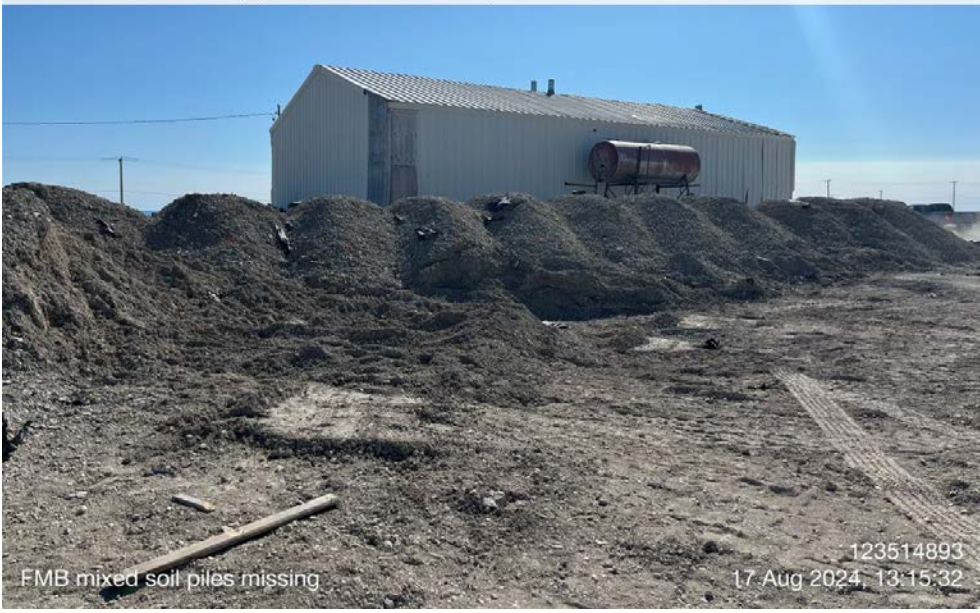
</div><div>FMB mixed soil piles missing12351489317 Aug 2024, 13:15:32</div></div></div>		
Photo Location: AEC 6 (FMB)			
Direction: S			
Survey Date: 8/17/2024			
Comments: Stockpiles of comingled clean and Type B PHC soil from the FMB excavation.			
Photograph ID: 74	<div><div><div>SESWW</div><div>120150180210240270</div><div>188°S (T) 17 N 386028 7120245 ±10m ▲ 54m</div><div>

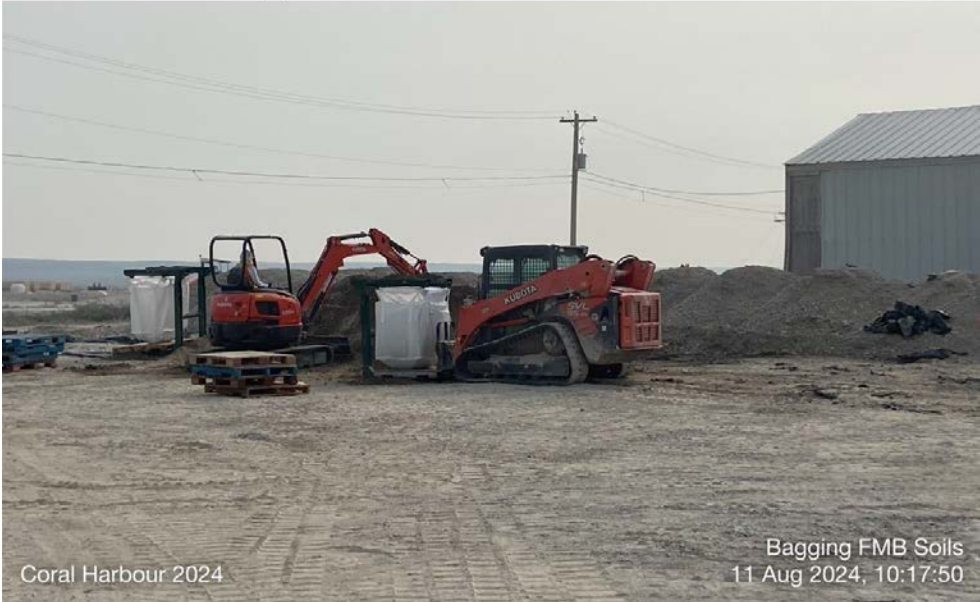
</div><div>Coral Harbour 2024Bagging FMB Soils11 Aug 2024, 10:17:50</div></div></div>		
Photo Location: AEC 6 (FMB)			
Direction: S			
Survey Date: 8/11/2024			
Comments: Bagging Type B PHC soil from the FMB excavation for off-site disposal.

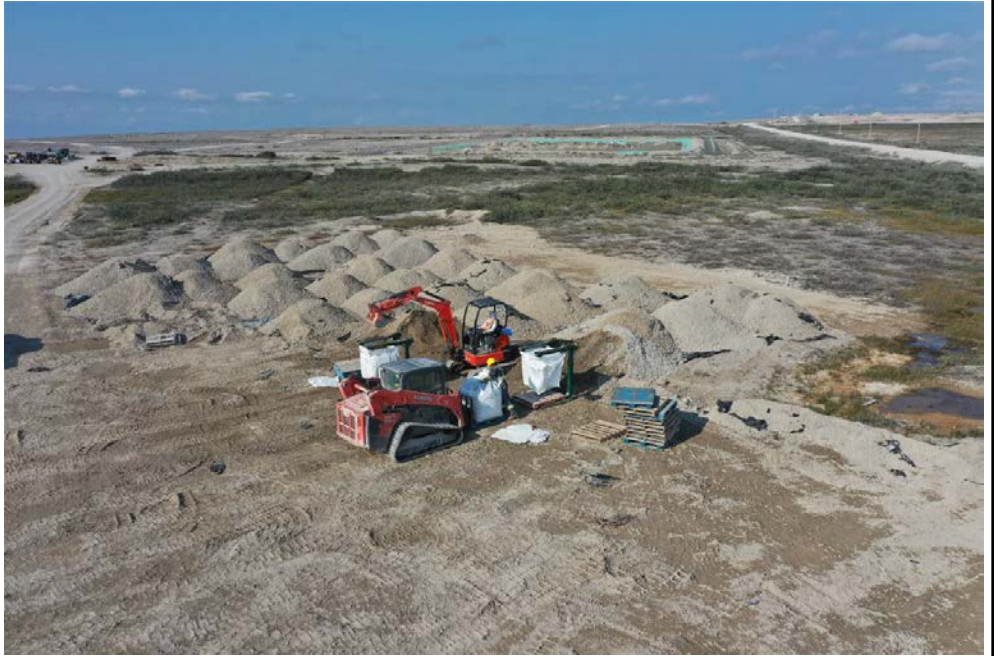
Photo Location: AEC 6 (FMB)			
Direction: N			
Survey Date: 8/22/2024			
Comments: Aerial view of bagging Type B PHC soil from the FMB.			
Photograph ID: 76	 		
Photo Location: AEC 6 (FMB)			
Direction: NW			
Survey Date: 10/16/2024			
Comments: Aerial view of Type B PHC soil bagging area. Stockpiles from FMB excavation yet to be bagged are visible (centre-right), as are completed bags (centre).

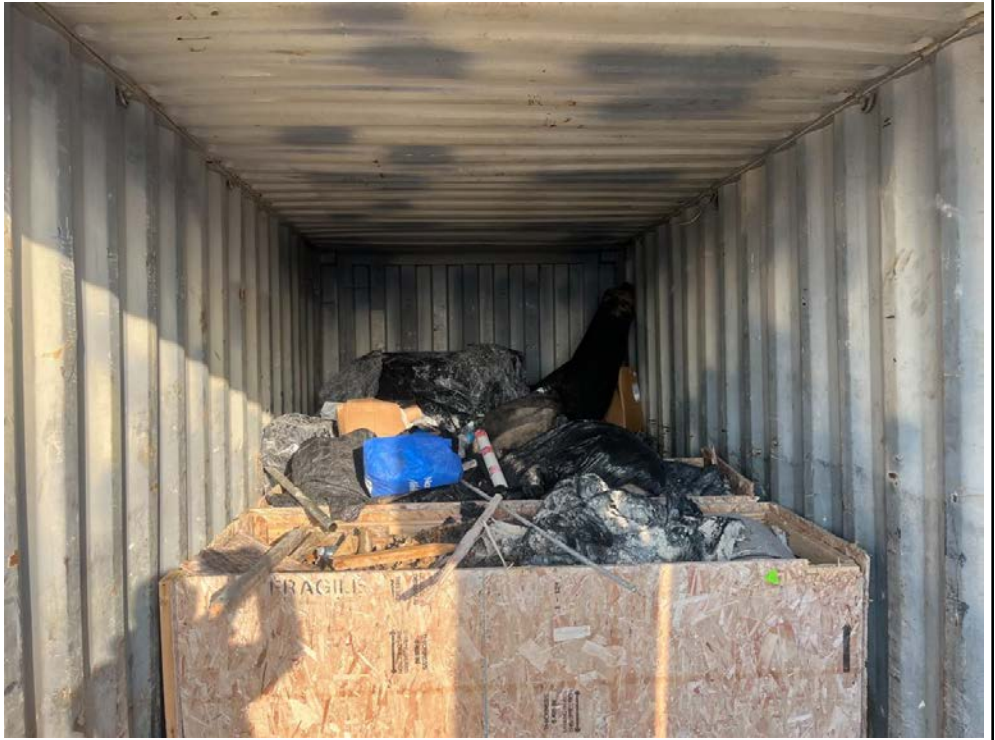
Photo Location: AEC 6			
Direction: N/A			
Survey Date: 10/8/2024			
Comments: Miscellaneous trash/debris loaded in a sea container for off-site transport and disposal.			
Photograph ID: 78

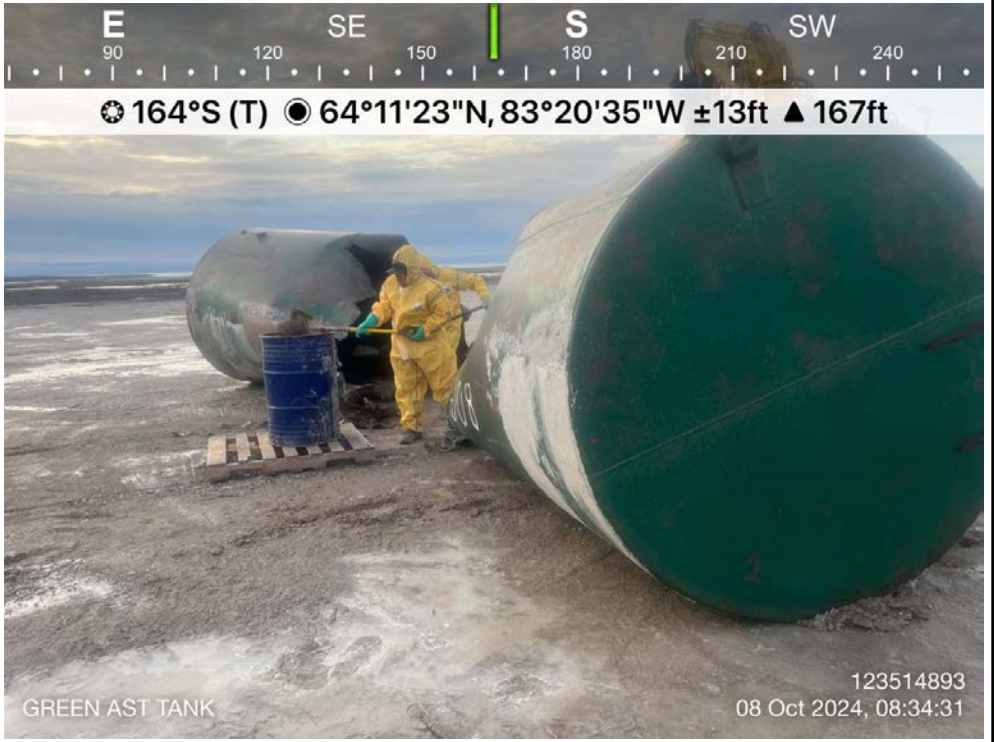
Photo Location: AEC 6			
Direction: S			
Survey Date: 10/8/2024			
Comments: Horizontal green AST being cleaned and sheared prior to packaging for off-site disposal.

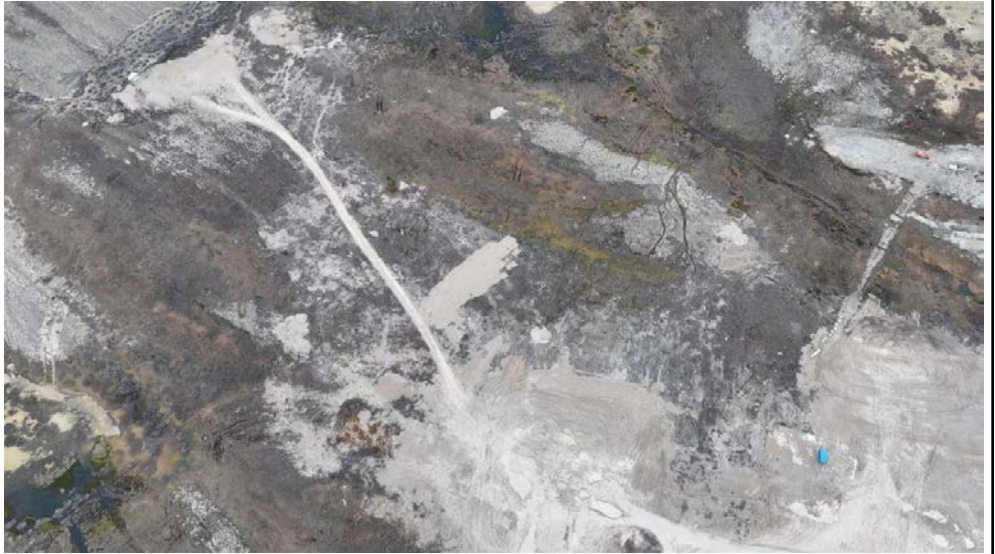
Photo Location: AEC 6			
Direction: SE			
Survey Date: 10/13/2024			
Comments: Aerial view of east side of AEC 6 following completion of remediation activities. The former tank farm area (bottom-centre) is visible).			
Photograph ID: 80

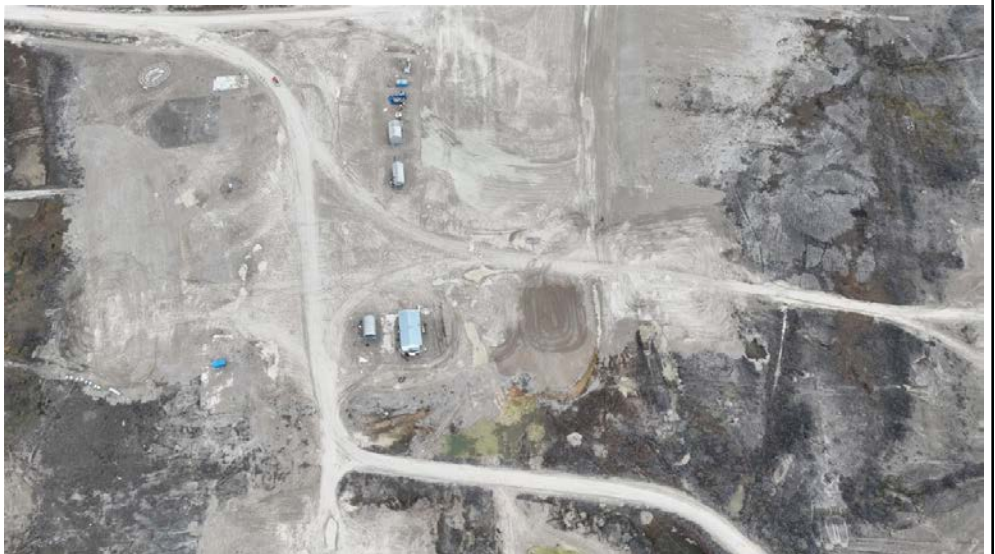
Photo Location: AEC 6			
Direction: N/A			
Survey Date: 10/13/2024			
Comments: Aerial view of west side of AEC 6 following completion of remediation activities. The former LTU area (left) and FMB excavation area (centre-right) are both visible.

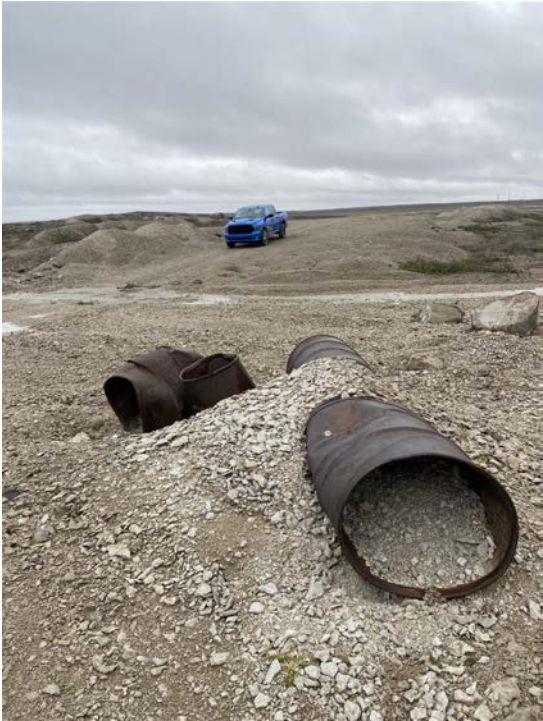
Photo Location: AEC 9 (CIAA)			
Direction: E			
Survey Date: 8/26/2024			
Comments: View of partially buried drums in AEC 9.			
Photograph ID: 84

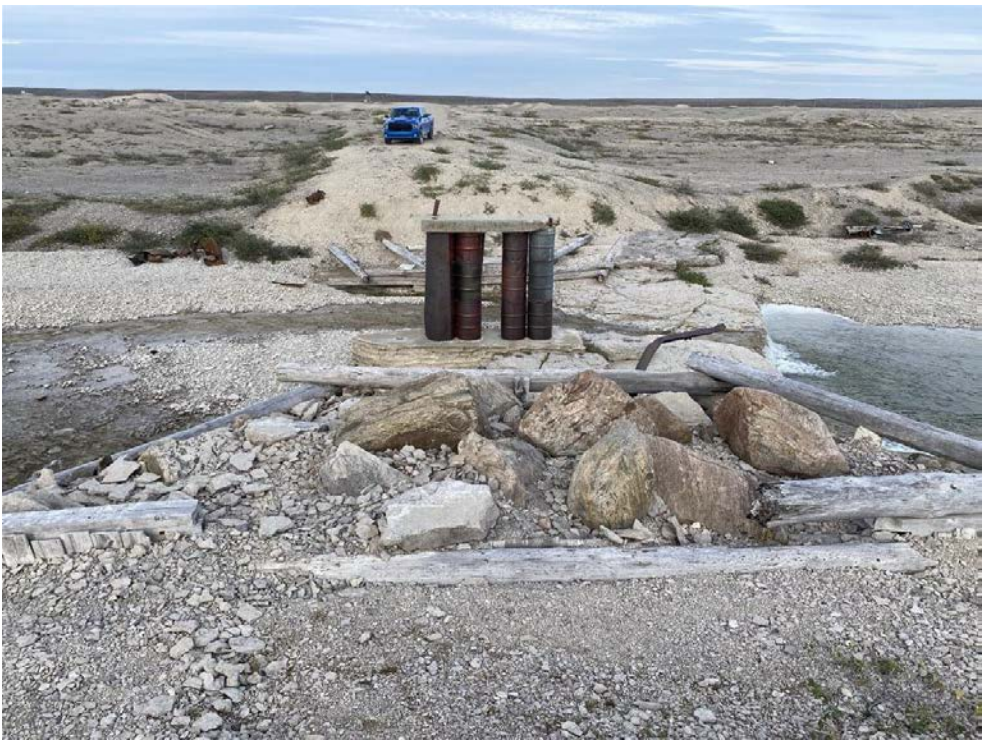
Photo Location: AEC 11 (CIAA)			
Direction: E			
Survey Date: 8/28/2024			
Comments: View of Fossil Creek Bridge infrastructure in AEC 11.

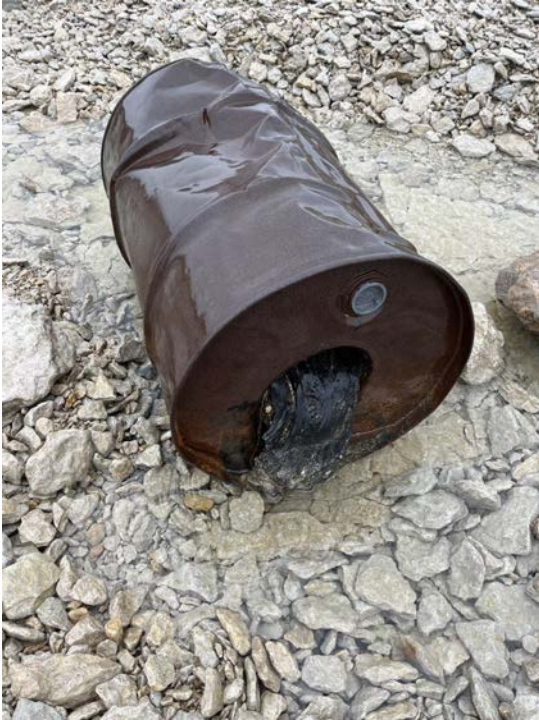
Photo Location: AEC 11 (CIAA)			
Direction: N/A			
Survey Date: 8/26/2024			
Comments: View of barrel containing hardened tar along the bank of Fossil Creek in AEC 11.			
Photograph ID: 86

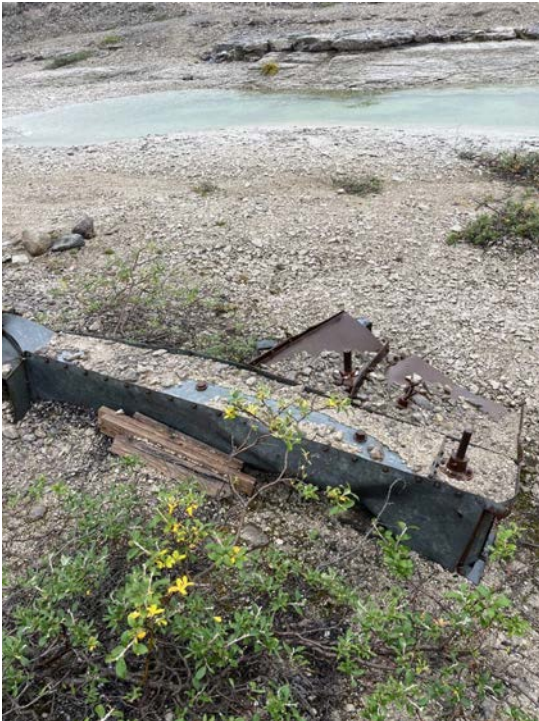
Photo Location: AEC 11 (CIAA)			
Direction: W			
Survey Date: 8/26/2024			
Comments: View of metal debris along the bank of Fossil Creek in AEC 11.

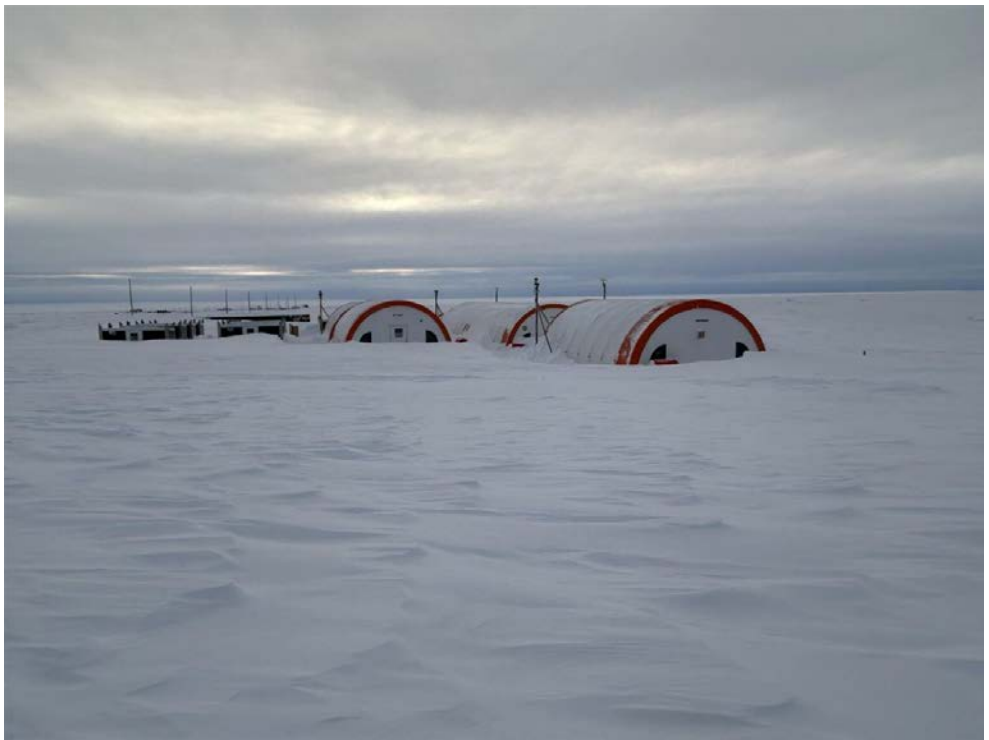
Photo Location: Camp			
Direction: S			
Survey Date: 2/7/2024			
Comments: View of camp in winter prior to snow clearing activities.

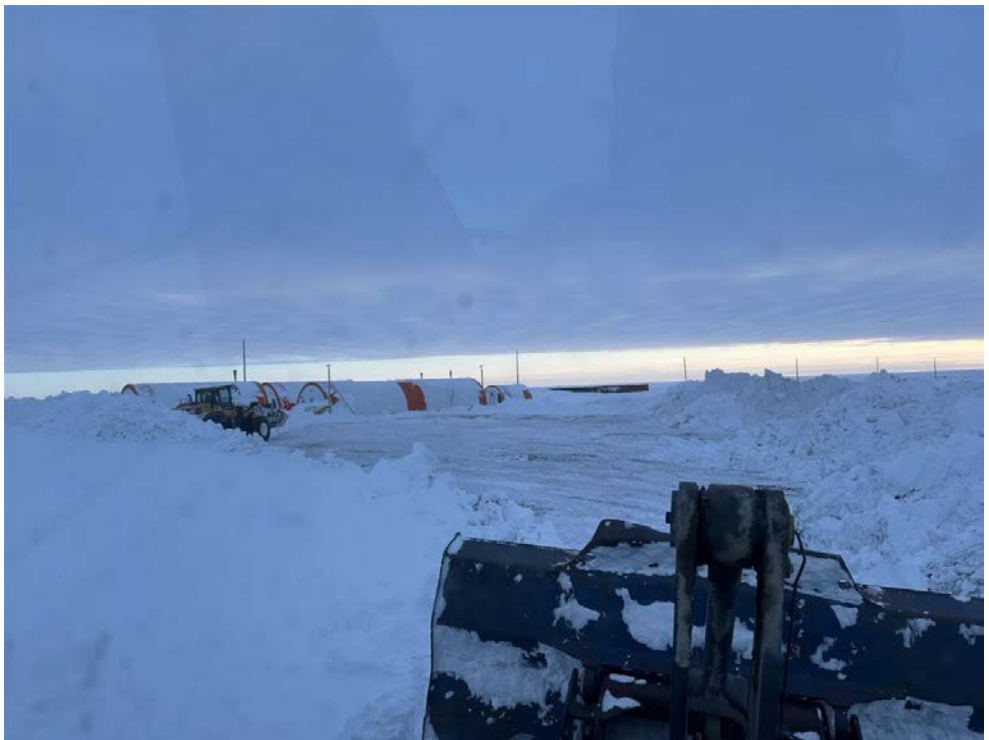
Photo Location: Camp			
Direction: SE			
Survey Date: 2/10/2024			
Comments: View of camp in winter following snow clearing activities.			
Photograph ID: 92

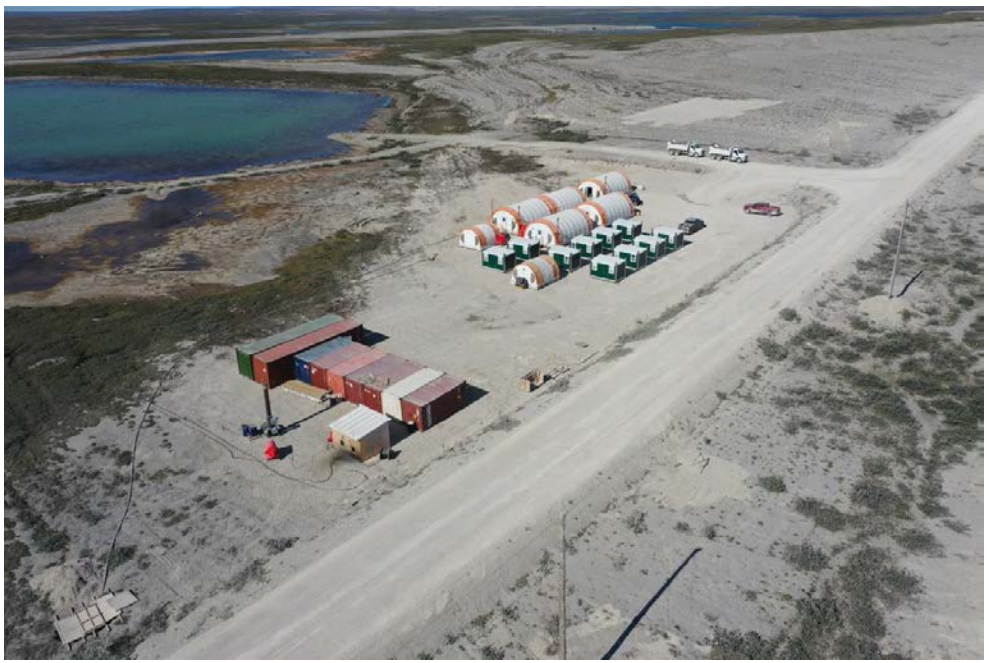
Photo Location: Camp			
Direction: N			
Survey Date: 8/18/2024			
Comments: Aerial view of the camp during the 2024 operational period.

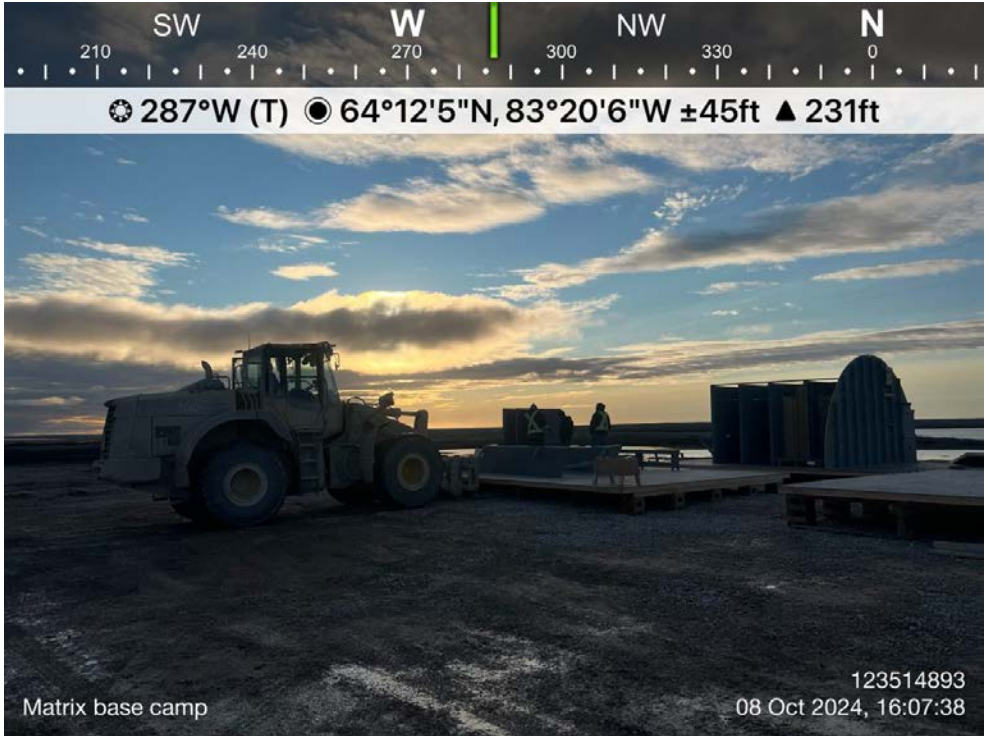
Photo Location: Camp			
Direction: W			
Survey Date: 10/8/2024			
Comments: View of camp structures being decommissioned.			
Photograph ID: 94

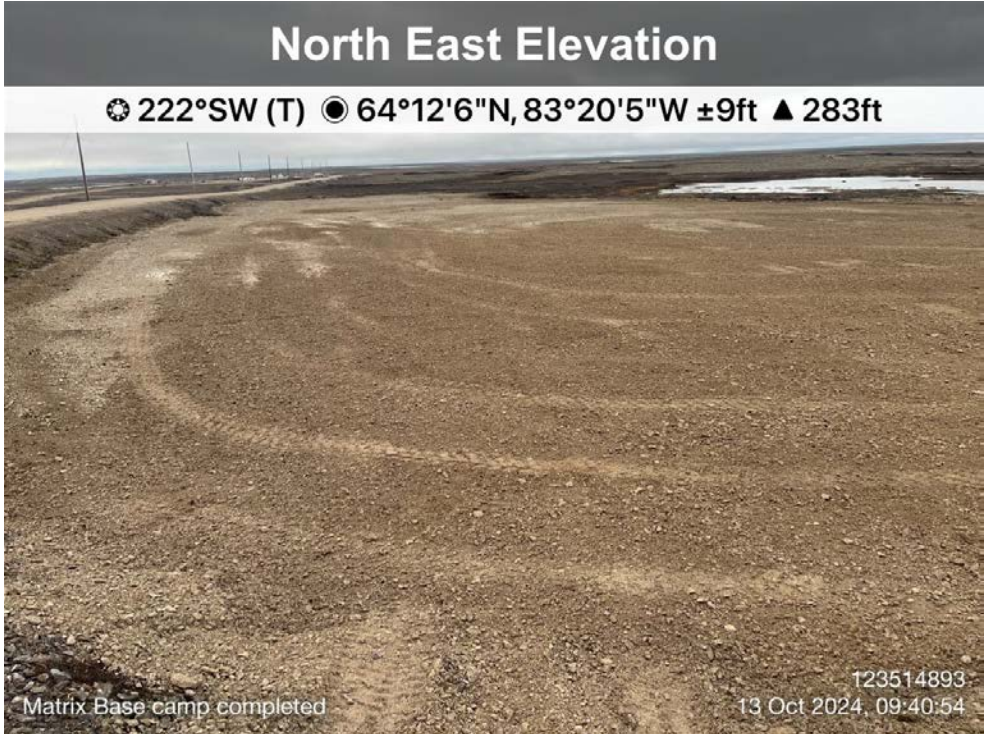
Photo Location: Camp			
Direction: SW			
Survey Date: 10/13/2024			
Comments: View of camp area following decommissioning.

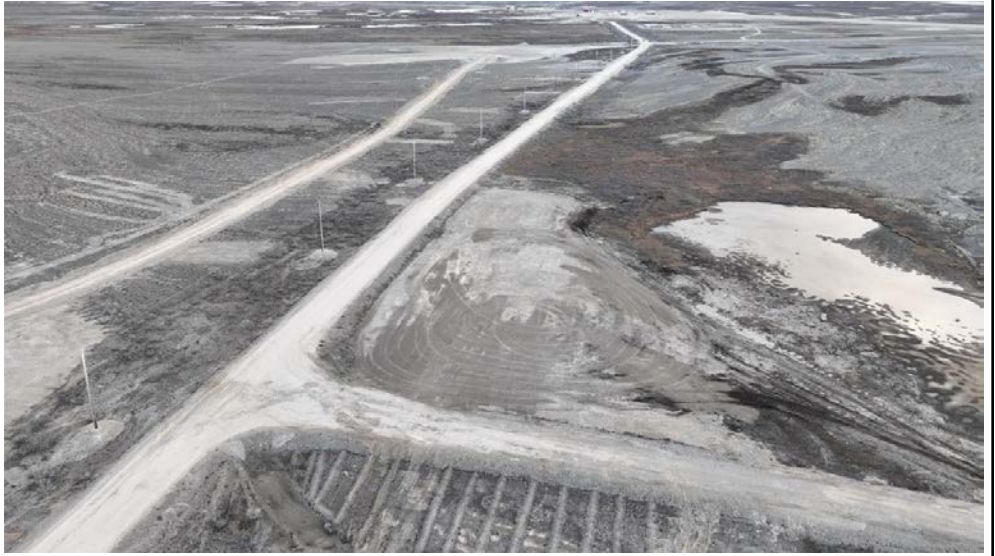
Photo Location: Camp			
Direction: S			
Survey Date: 10/13/2024			
Comments: Aerial view of camp area following decommissioning.			
Photograph ID: 96	<div> <div> <div>N</div> <div>NW</div> <div>N</div> <div>NE</div> <div>E</div> </div> <div> <div>70</div> <div>300</div> <div>330</div> <div>0</div> <div>30</div> <div>60</div> <div>90</div> </div> <div> <div>☀ 4°N (T) ● 64°12'14"N, 83°19'3"W ±6ft ▲ 298ft</div> </div> </div>

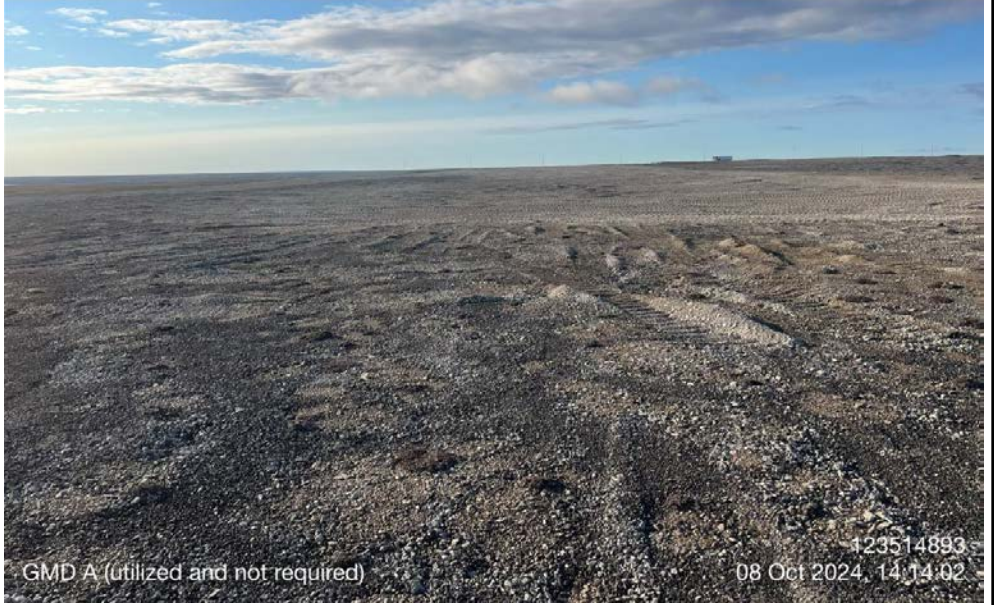
Client:	PSPC/CIRNAC	Project:	Coral Harbour Remediation Project - 123514893
Site Name:	2024 Annual Remediation Report	Site Location:	Coral Harbour, NU
Photograph ID: 97

Photo Location: GMD-A			
Direction: N			
Survey Date: 10/8/2024			
Comments: View of GMD-A following reclamation of the borrow development area.
