**RE: CORAL HARBOUR PROJECT NWB LLICENSE NO. 1BR-COR2325 ANNUAL
REPORT, 2024**

NWB Annual Report

Project Name: Coral Harbour Remediation Project

APPENDIX B
PHOTOGRAPHIC LOG

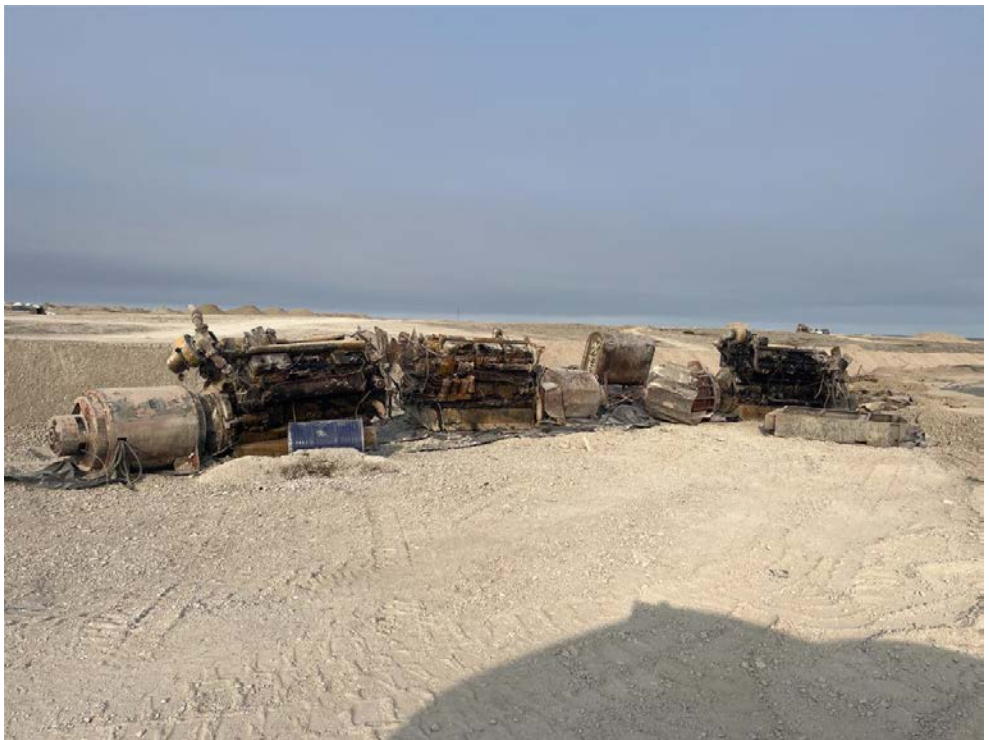
Photo Location: GMD-B			
Direction: N			
Survey Date: 8/19/2024			
Comments: View of three unearthed generators from GMD-B in the NHW Facility prior to being sheared.			
Photograph ID: 100

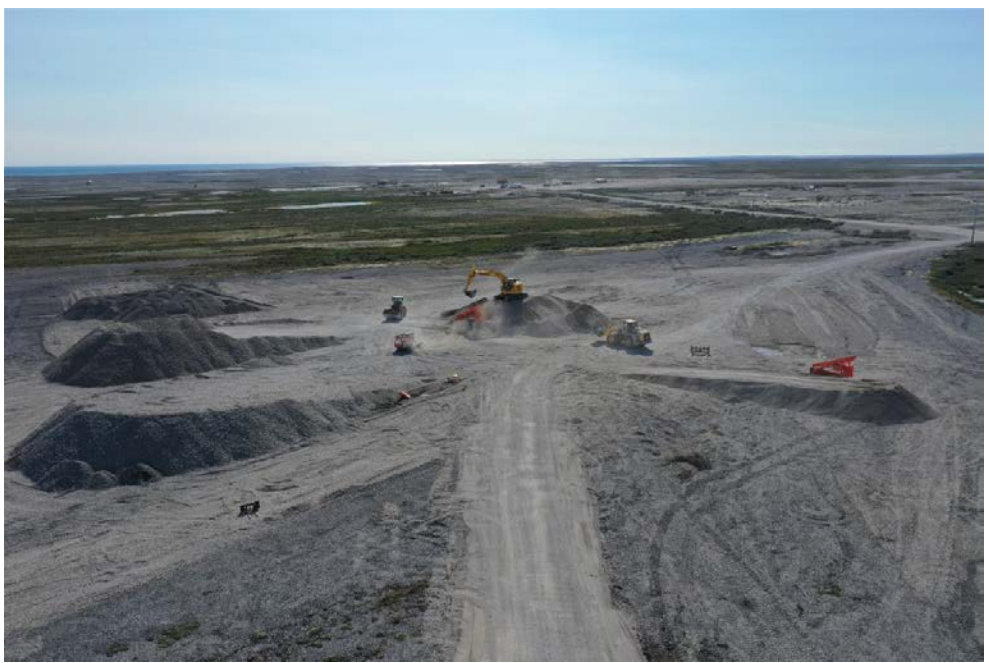
Photo Location: GMD-B			
Direction: S			
Survey Date: 8/18/2024			
Comments: Aerial view of Type 2 and Type 3 material screening in GMD-B.

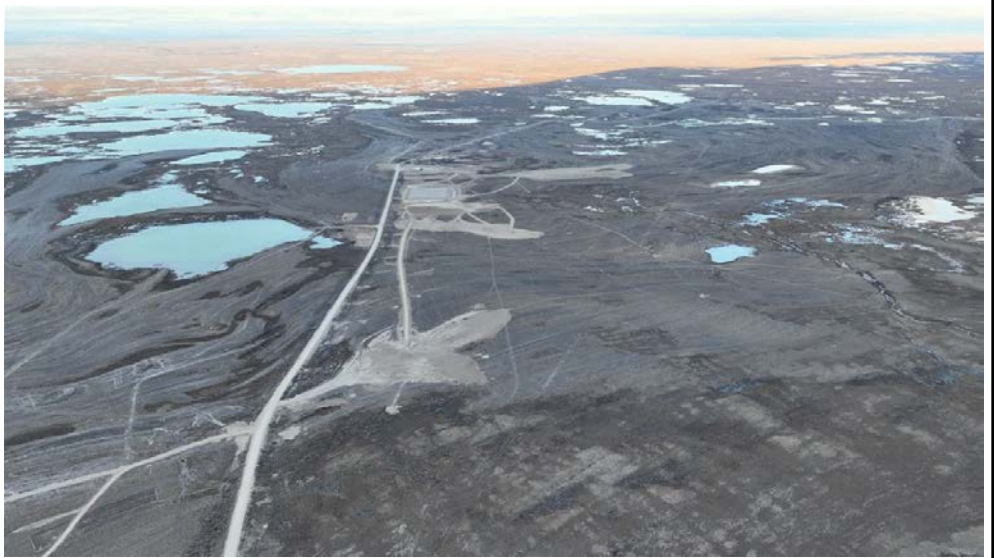
Photo Location: GMD-B			
Direction: N			
Survey Date: 10/13/2024			
Comments: Aerial view of GMD-B following reclamation of the borrow development area. The NHW facility is visible in the background.			
Photograph ID: 104

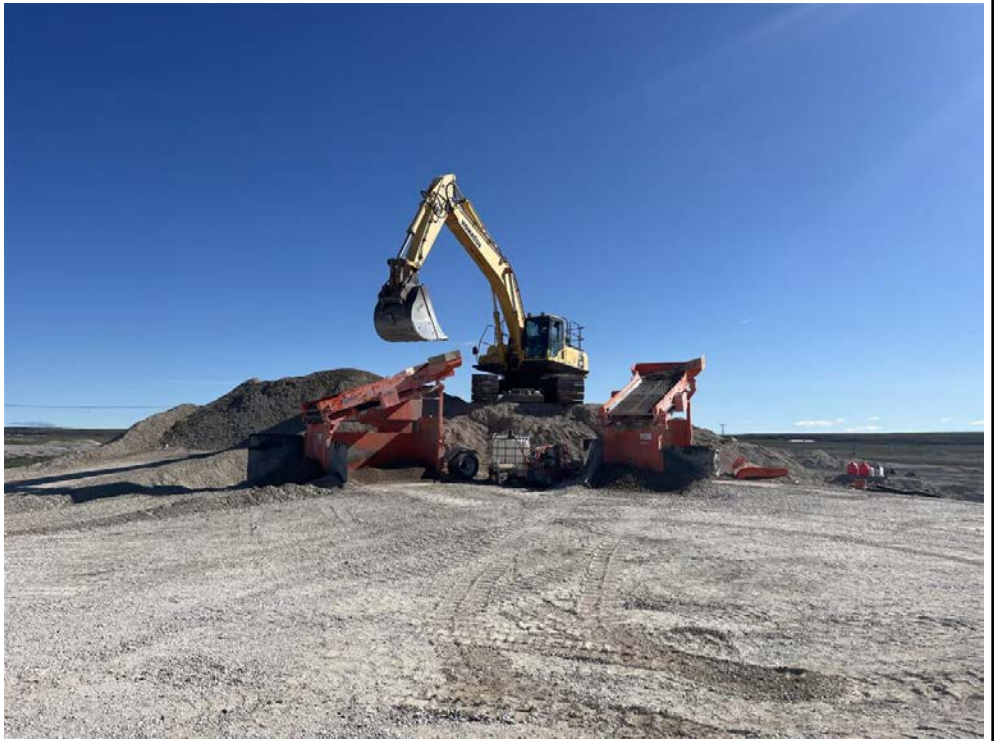
Client:	PSPC/CIRNAC	Project:	Coral Harbour Remediation Project - 123514893
Site Name:	2024 Annual Remediation Report	Site Location:	Coral Harbour, NU
Photograph ID: 105

Photo Location: GMD-D			
Direction: N			
Survey Date: 7/20/2024			
Comments: View of Type 2 material screening in GMD-D.

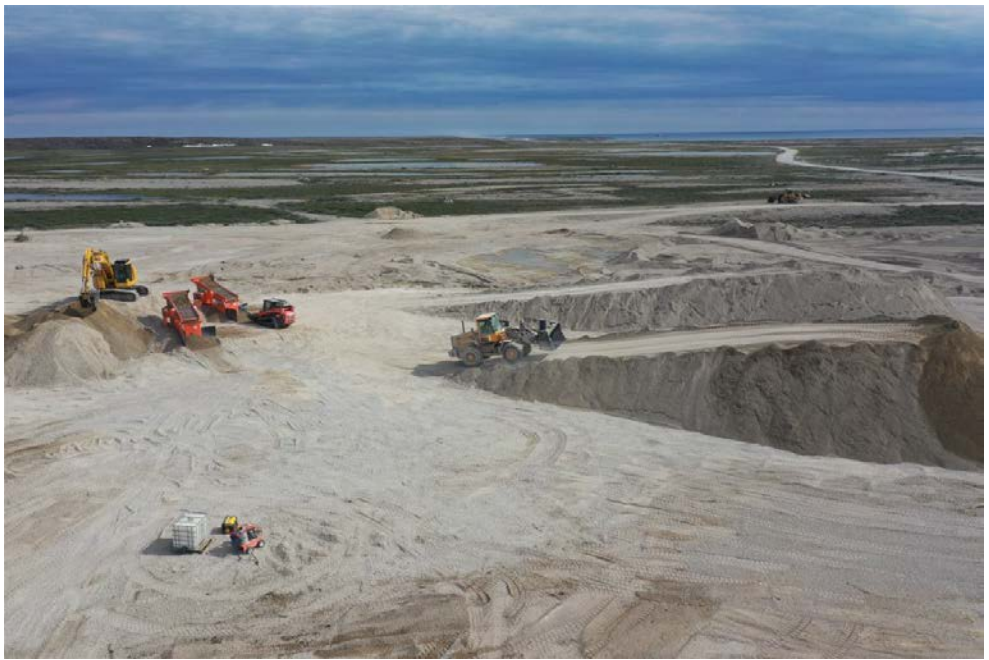
Photo Location: GMD-D			
Direction: S			
Survey Date: 7/20/2024			
Comments: Aerial view of borrow development activities in GMD-D.			
Photograph ID: 106

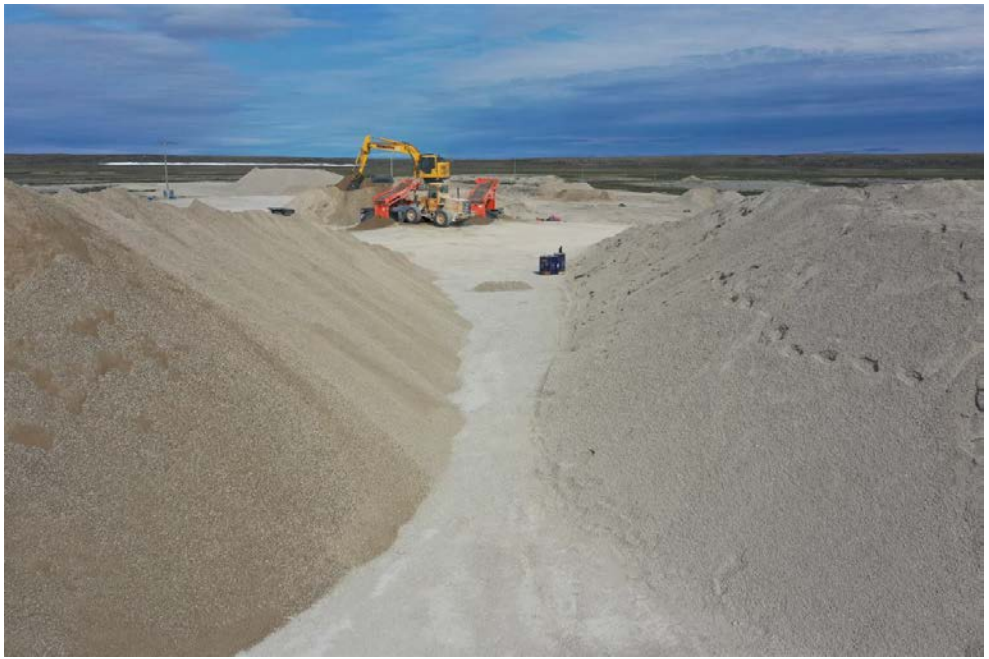
Client:	PSPC/CIRNAC	Project:	Coral Harbour Remediation Project - 123514893
Site Name:	2024 Annual Remediation Report	Site Location:	Coral Harbour, NU
Photograph ID: 107

Photo Location: GMD-D			
Direction: N			
Survey Date: 7/20/2024			
Comments: View of material screening and completed borrow piles in GMD-D.

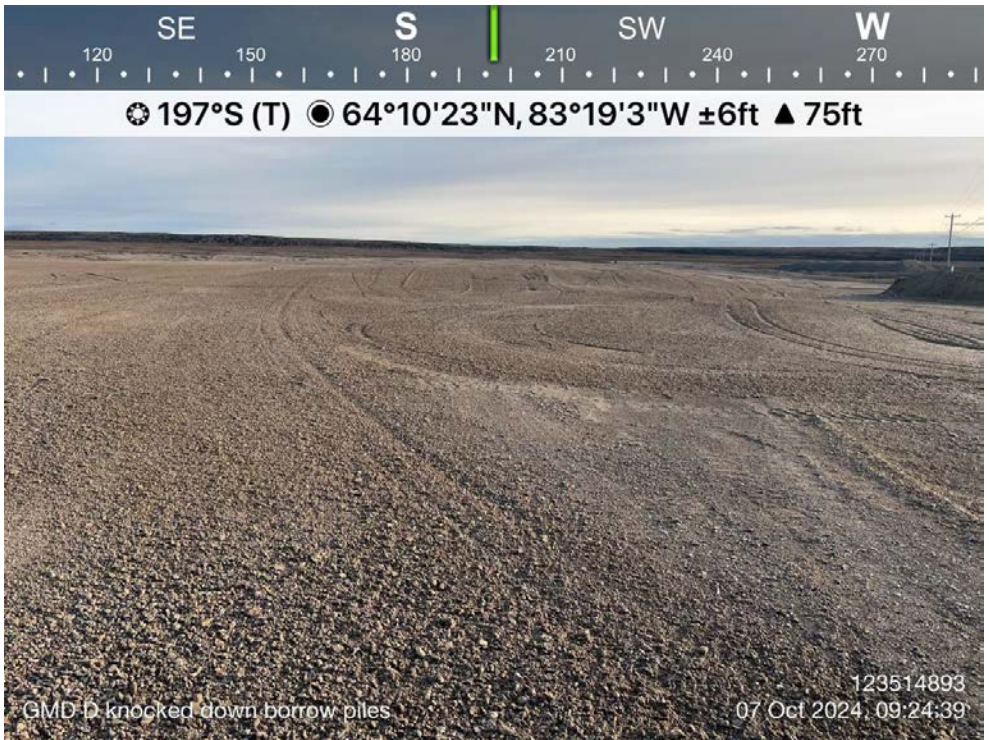
Photo Location: GMD-D			
Direction: S			
Survey Date: 10/7/2024			
Comments: View of GMD-D following reclamation of the borrow development area.			
Photograph ID: 108

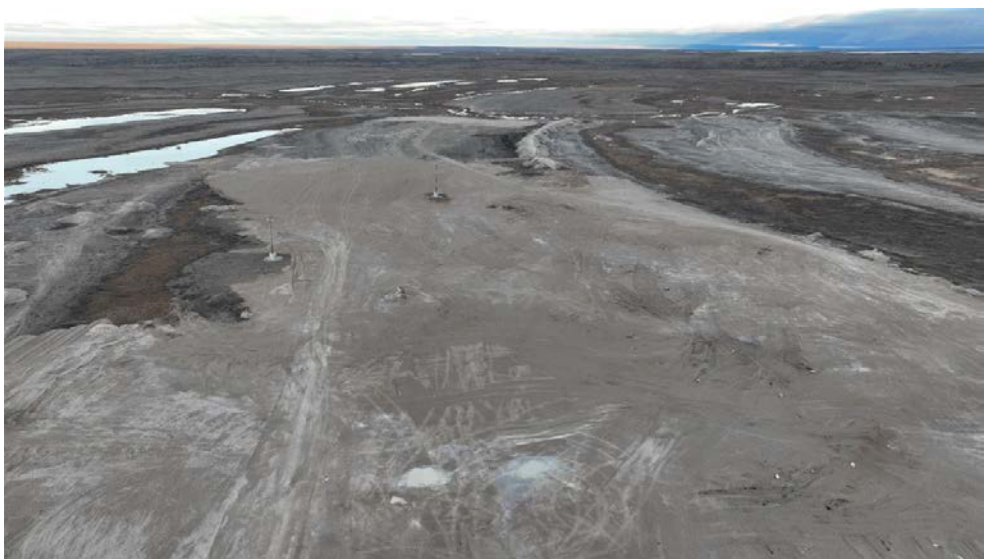
Client:	PSPC/CIRNAC	Project:	Coral Harbour Remediation Project - 123514893
Site Name:	2024 Annual Remediation Report	Site Location:	Coral Harbour, NU
Photograph ID: 109

Photo Location: GMD-D			
Direction: E			
Survey Date: 10/13/2024			
Comments: Aerial view of GMD-D following reclamation of the borrow development area.

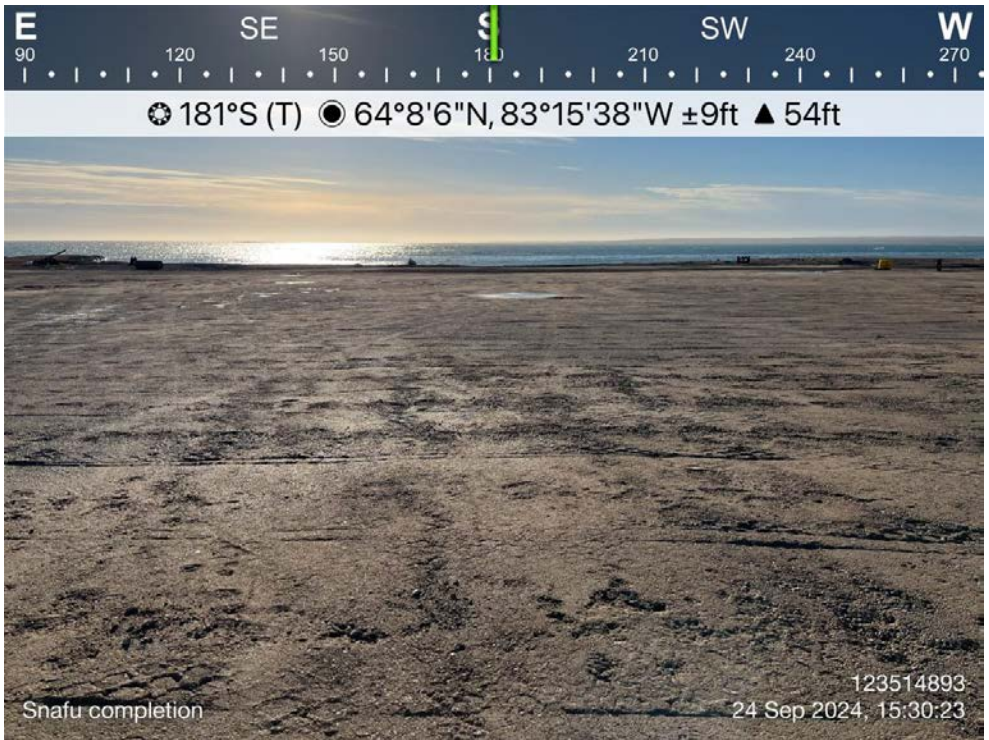
Photo Location: Barge Landing Area			
Direction: S			
Survey Date: 9/24/2024			
Comments: View of completed staging pad at the Barge Landing Area.			
Photograph ID: 110

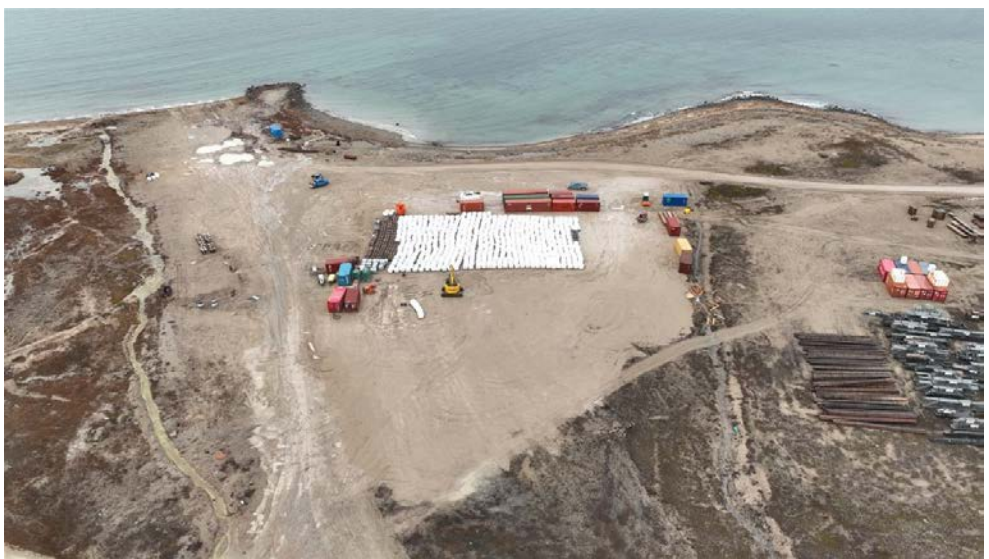
Client:	PSPC/CIRNAC	Project:	Coral Harbour Remediation Project - 123514893
Site Name:	2024 Annual Remediation Report	Site Location:	Coral Harbour, NU
Photograph ID: 111

Photo Location: Barge Landing Area			
Direction: SW			
Survey Date: 10/12/2024			
Comments: Aerial view of packaged wastes, equipment, and materials staged for off-site transport at the Barge Landing Area.

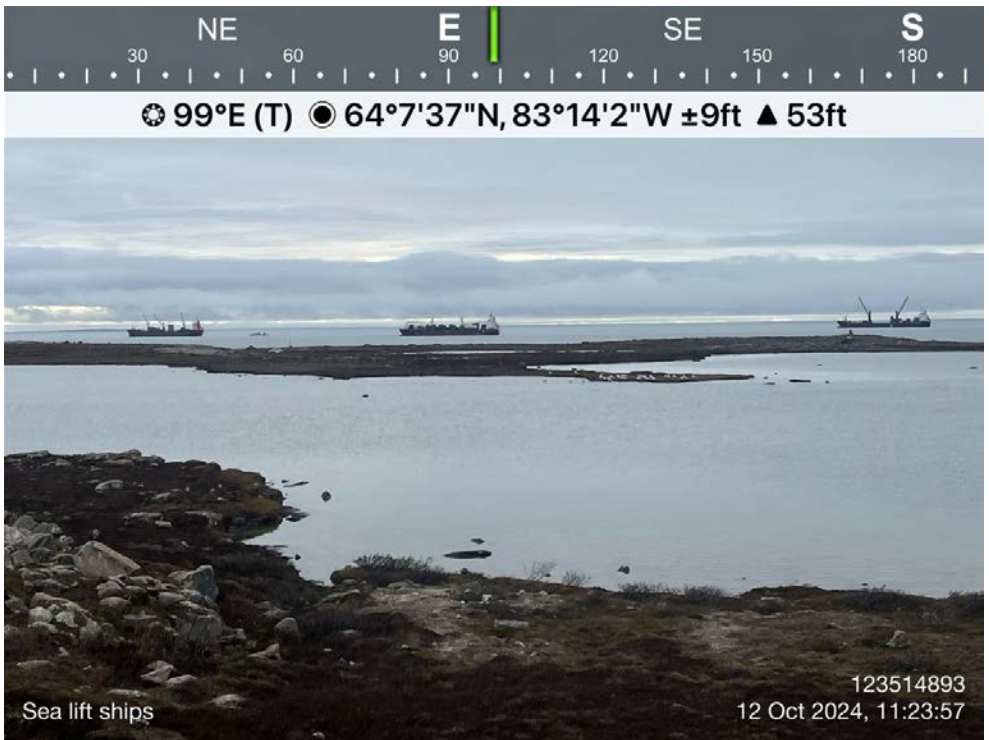
Photo Location: Barge Landing Area			
Direction: E			
Survey Date: 10/12/2024			
Comments: View of three incoming sealifts waiting in harbour on October 12, 2024.			
Photograph ID: 112

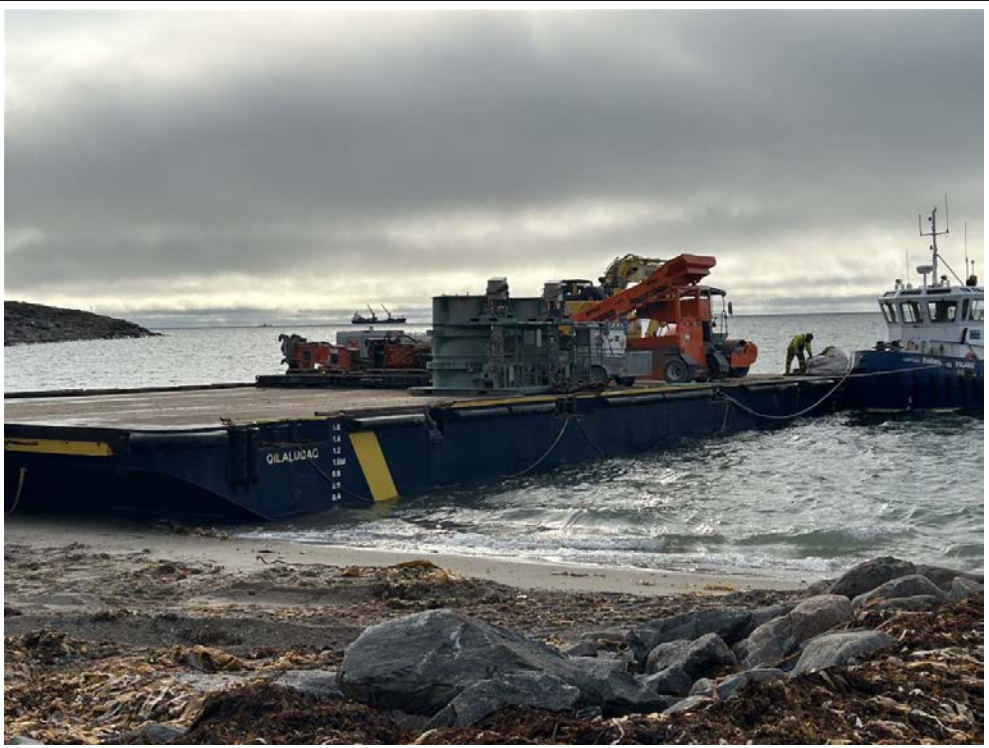
Client:	PSPC/CIRNAC	Project:	Coral Harbour Remediation Project - 123514893
Site Name:	2024 Annual Remediation Report	Site Location:	Coral Harbour, NU
Photograph ID: 113

Photo Location: Barge Landing Area			
Direction: SE			
Survey Date: 10/12/2024			
Comments: Incinerators, material screeners, and other equipment loaded on a barge for off-site transport.

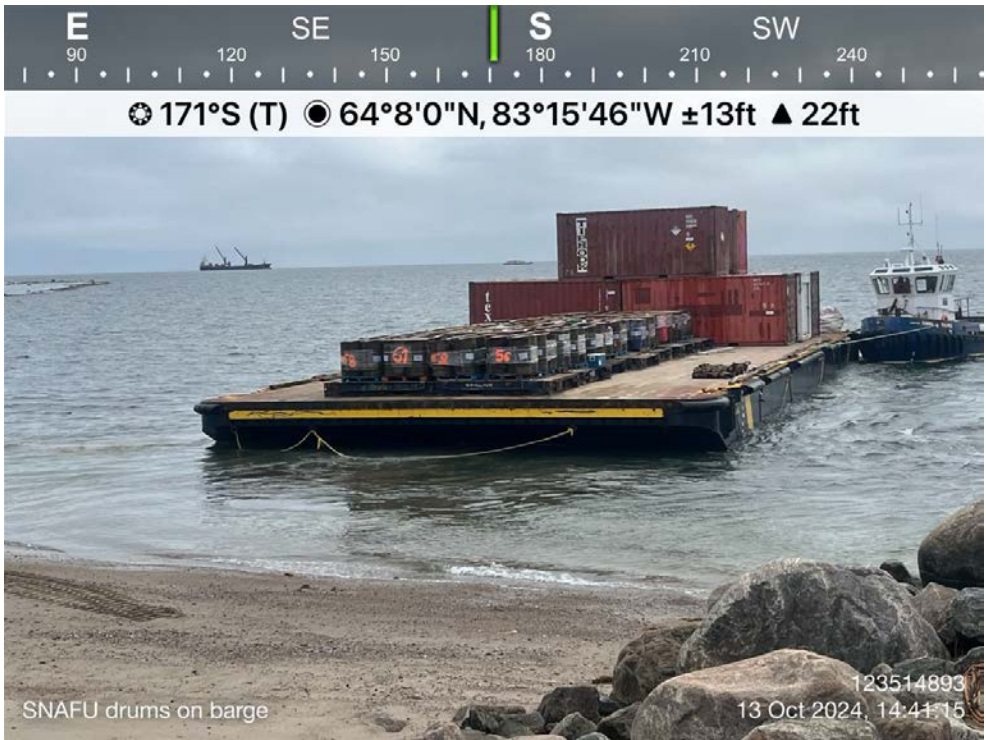
<p>Photo Location: Barge Landing Area</p> <p>Direction: S</p> <p>Survey Date: 10/13/2024</p> <p>Comments: Packaged barrels and materials/equipment in sea containers loaded on a barge for off-site transport.</p>		
Photograph ID: 114

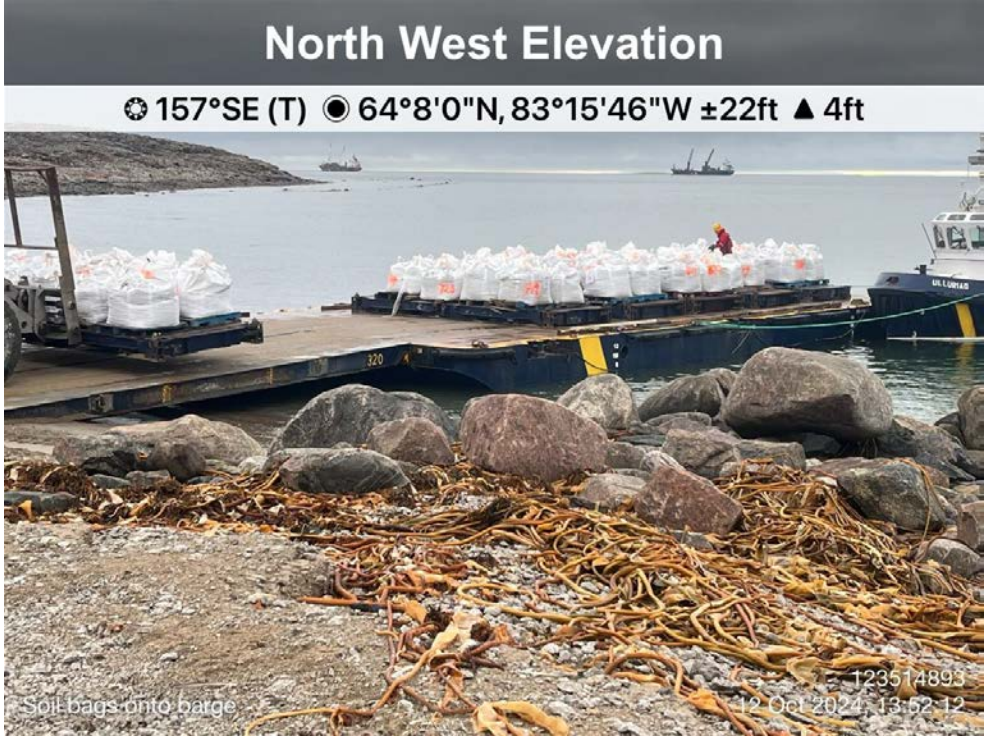
<p>Photo Location: Barge Landing Area</p> <p>Direction: SE</p> <p>Survey Date: 10/12/2024</p> <p>Comments: Type B PHC soil bags being loaded onto barge for off-site transport and disposal.</p>
