Nunavut Water Board

Notes of Site Visit Cullaton Lake Property, Nunavut August 24, 2001

September, 2001

**Acres International Limited
Winnipeg, Manitoba**

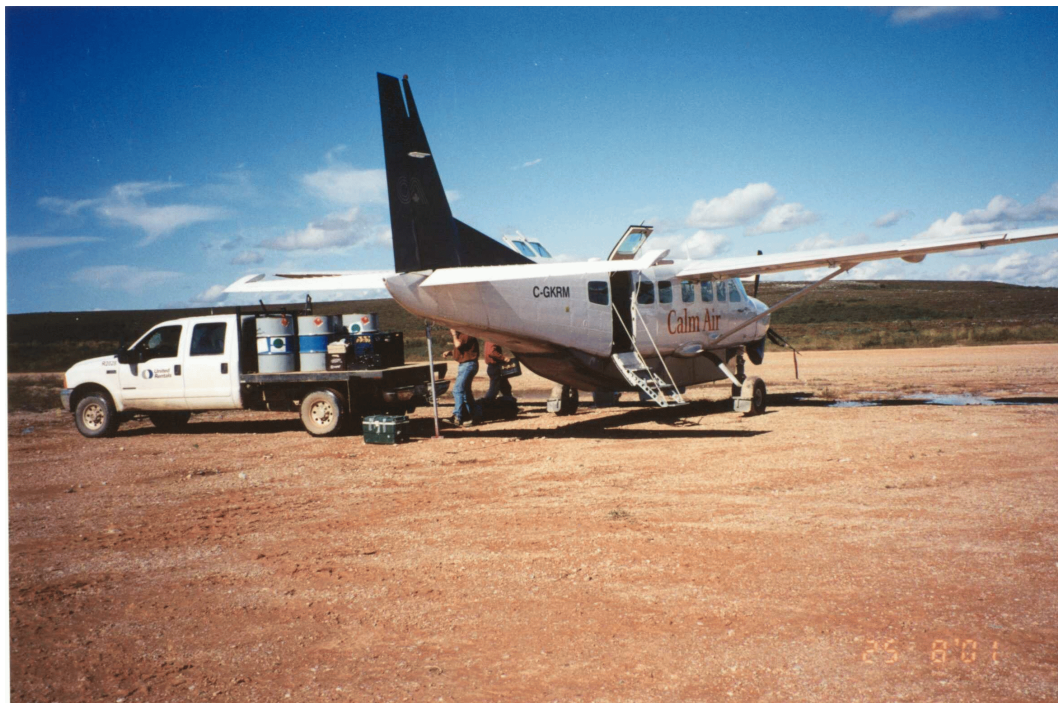
Photo 4. Loading the Calm Air's Cessna Grand Caravan before the return trip to Thompson, Manitoba.

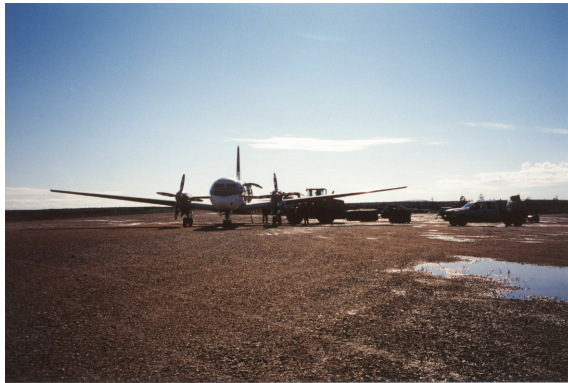
Photo 6. A HS748 turboprop airplane arrived in the morning, to load old tires.

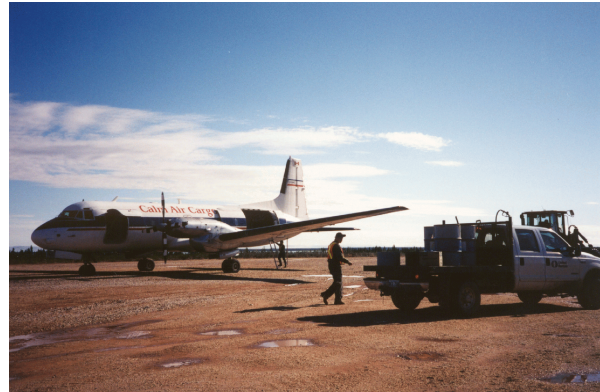
Photo 7. Another view of the HS748. The plane returned to Churchill in the afternoon.

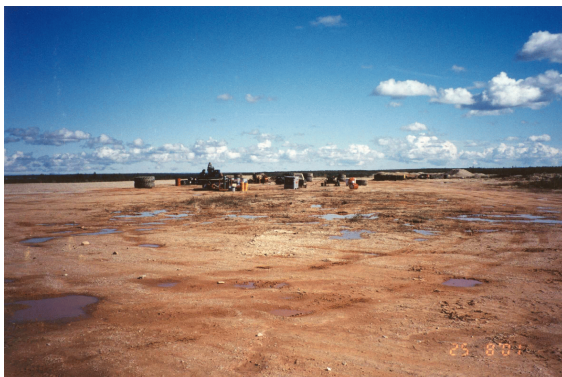
Photo 8. A working area for loading and unloading materials at the airstrip

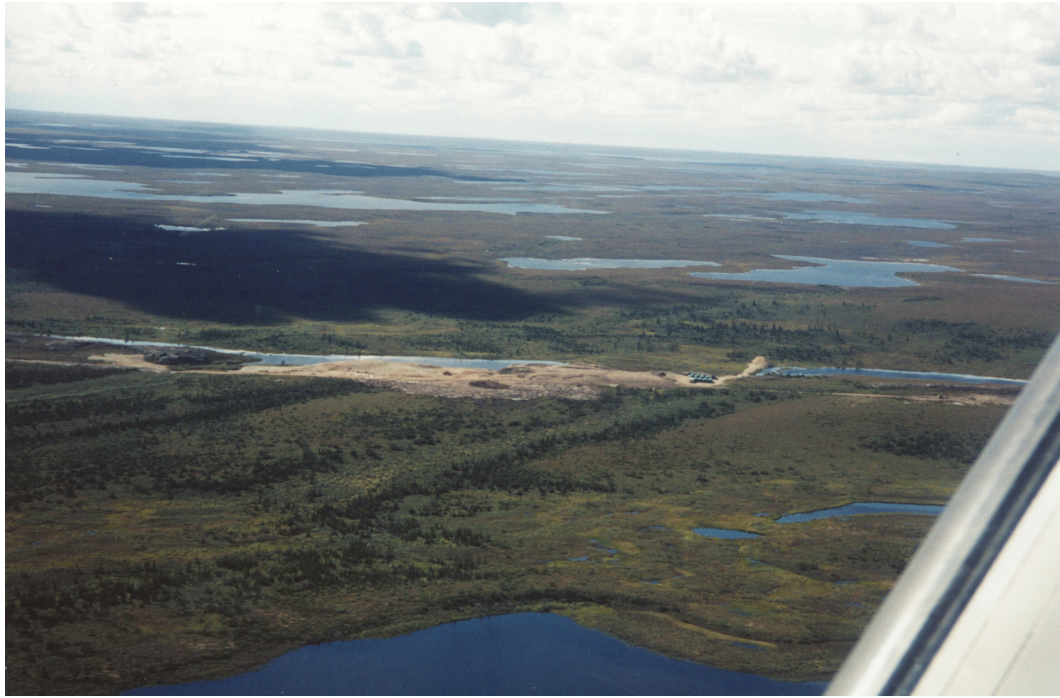
Homestake's camp site for the 2001 reclamation work was located at the north end of Shear Lake, and along the west side of the access road. The camp consisted of 5 tents for living quarters and 4 service tents (one each for dining room, kitchen, laundry/bathroom and recreation facilities). In addition, four steel containers for refrigerated food storage, water purification and a diesel generator, as well as 4 portable toilets were observed at the back of the camp site (Photos 12 and 13).

Photo 10. An aerial view of the Shear Lake Area. The camp is located on the north side (green colour tents on right side of photo, near an old gravel dam)

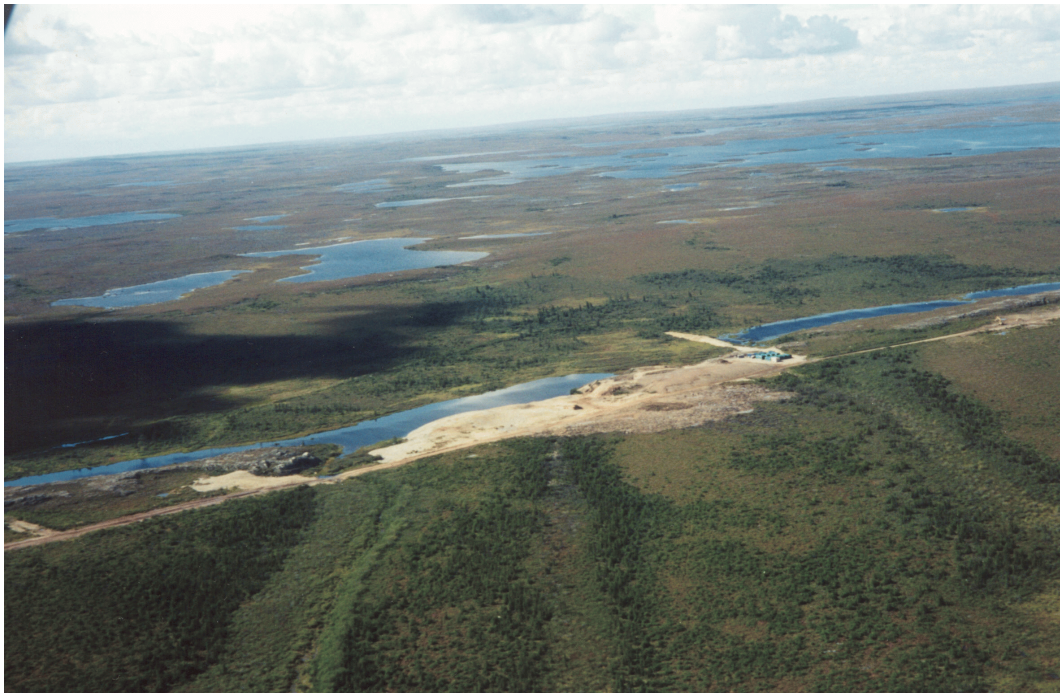
Photo 11. An aerial close up view of Shear Lake. Note the drainage creek which runs from the lake on the bottom left corner of the photo. The old waste rock site is on east side of the access road (North side is on the right of the photo).

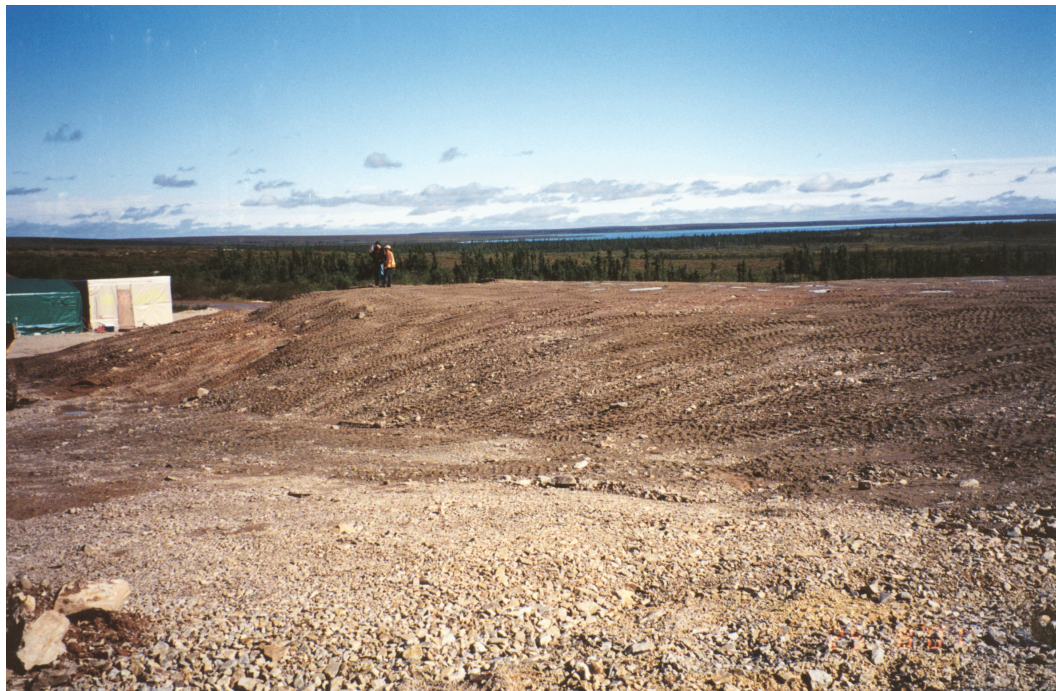
During the reclamation work this year, Homestake removed the waste rock from the old waste rock stockpile location, and placed it on another prepared location across the road from the old stockpile. Mr. Millward indicated that a base pad was prepared in the new area prior to the placement of the waste rock materials. The new site was cut into a rock outcrop along the east bank of the Shear Lake. The newly placed waste rock stockpile was then capped with a minimum 1m thick layer of glacial till materials, obtained from the surrounding area (Photos 29 to 36 inclusive). For erosion protection, they planned to seed the area prior to demobilization.

Photo 30. New waste rock pile. Photo is looking east/northeast. Note one of the living quarters at the campsite (white structure).

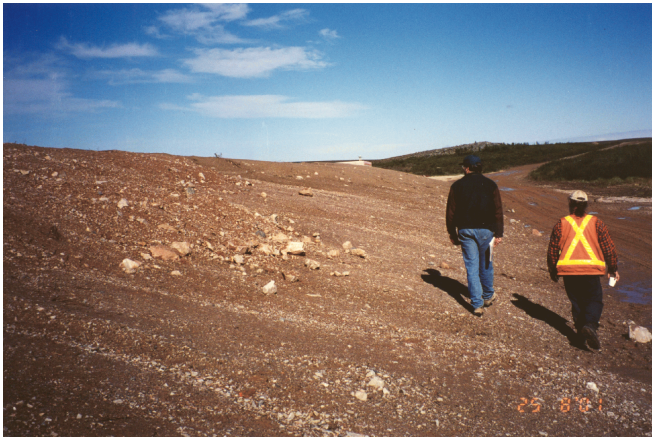
Photo 33. East slope of the new waste rock pile.
Photo is looking north.

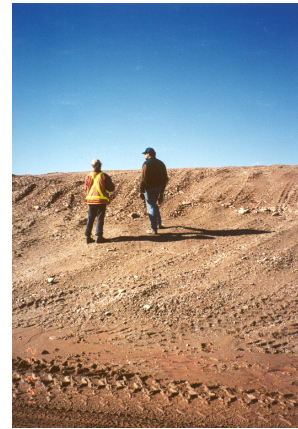
Photo 34. Another
view of the east slope
of the new pile.

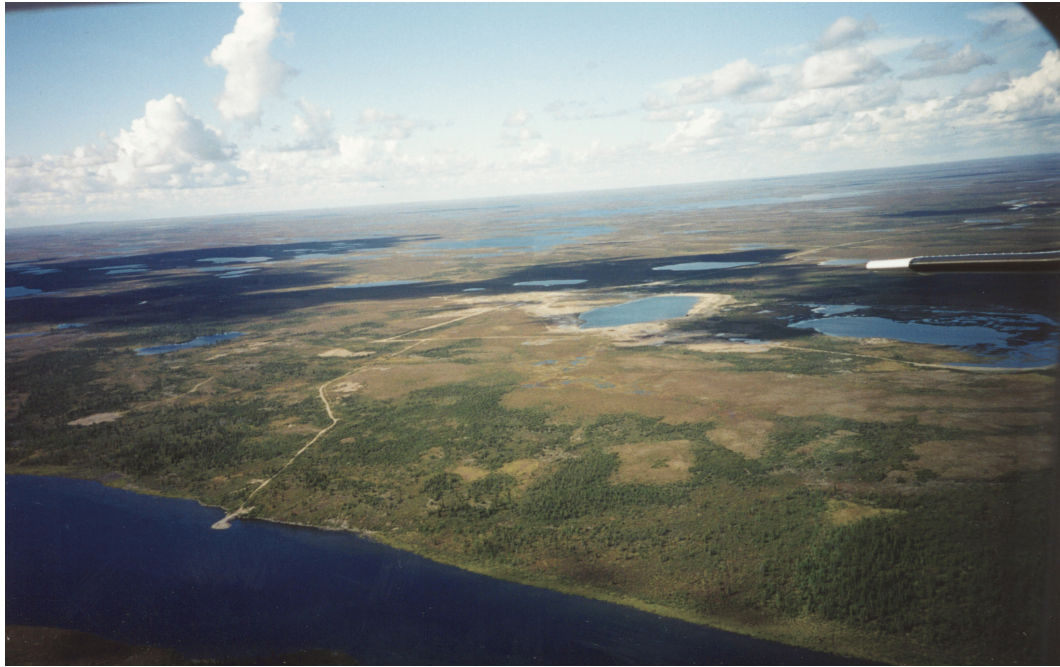
Photo 37. Aerial view of the B-zone mine and mill complex. Tailings Pond No. 1 is in the centre, and Tailings Ponds No. 2 on the centre right corner. Kognak River is on the bottom left corner. Photo is looking north to northwest.

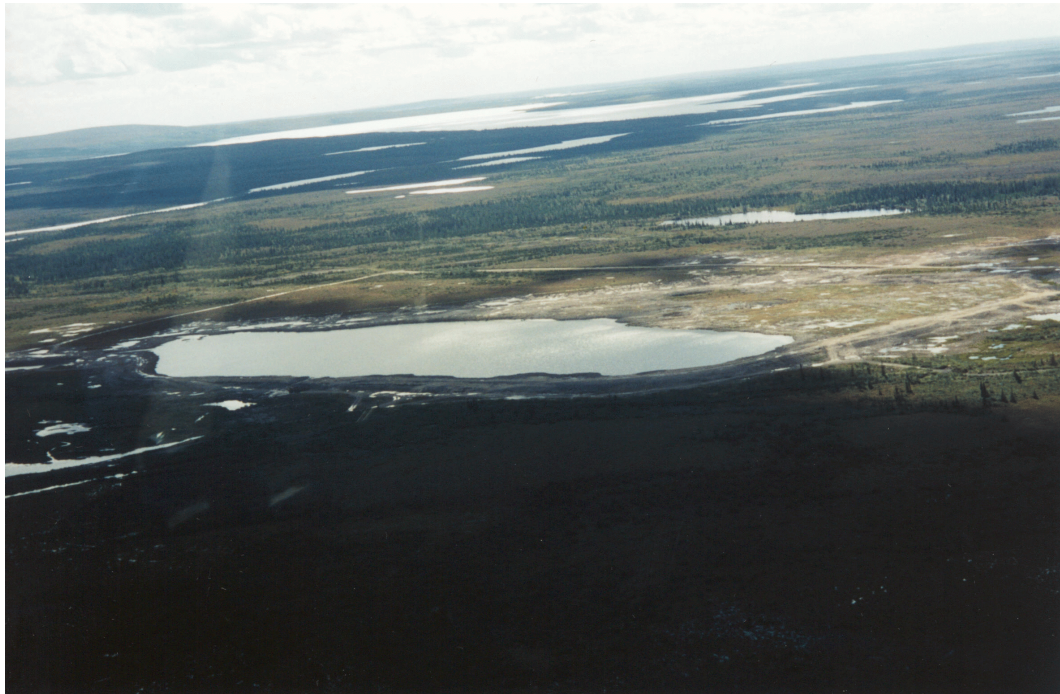
Photo 38. Aerial view of Tailings Pond No. 1. Photo is looking south /southwest. The main B-zone mine complex is located on centre right of the photo.

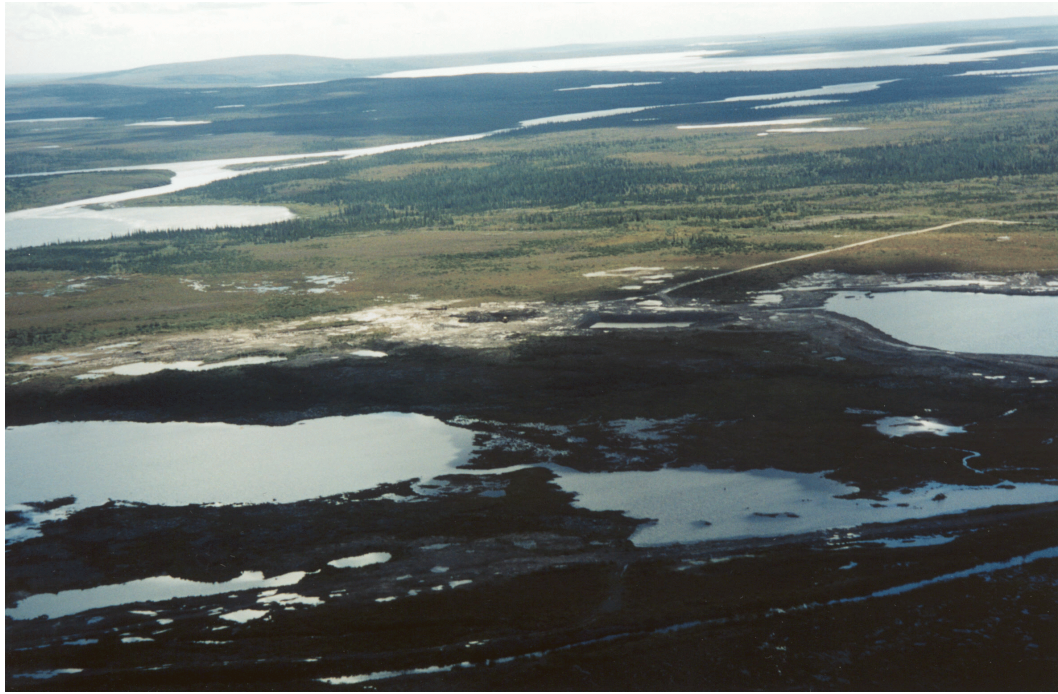
Photo 39. Aerial view of the Quarry Pit area (centre), with part of the Tailings Pond No. 1 (centre-right), and Tailing Ponds No. 2 (bottom). Kognak River is running across on top of the photo. Photo is looking southwest.

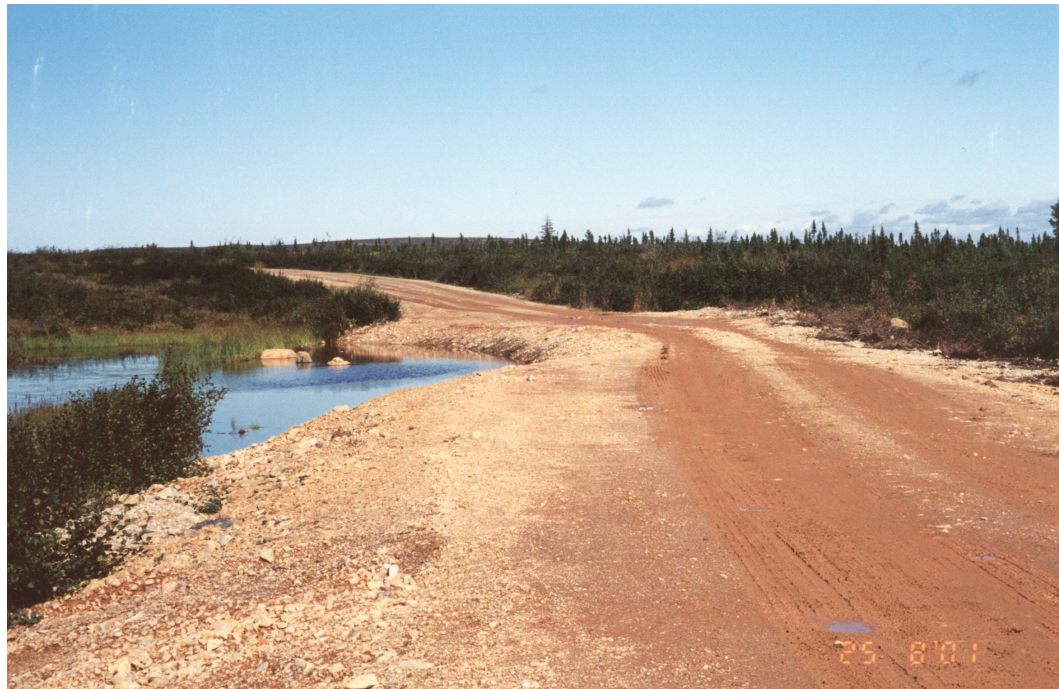
Photo 40. Typical photo of the access road connecting the airstrip, Shear Lake , and the B-zone main mine complex.

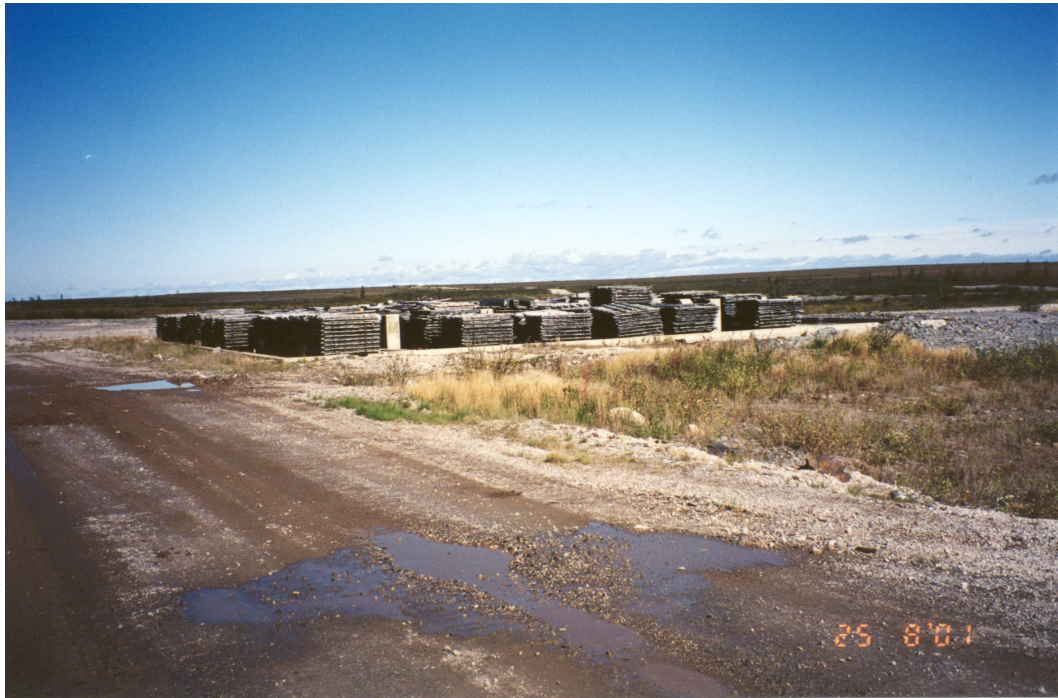
Photo 45. B-zone mine main complex. Core boxes which were stacked up and laid on top of the concrete bases, where fuel storage tanks used to be located.

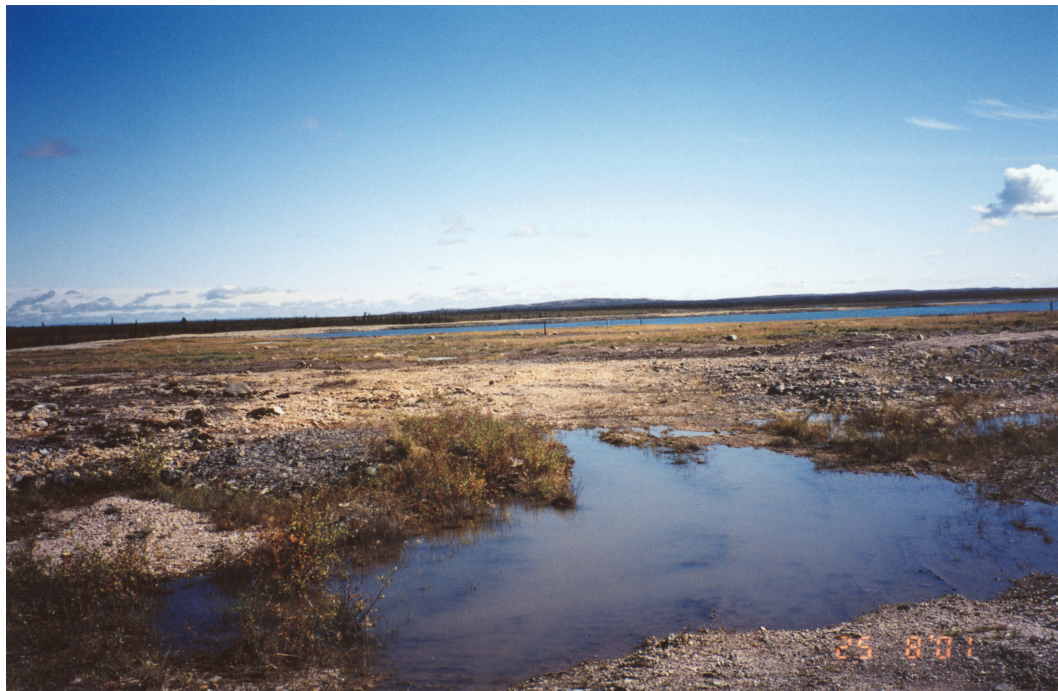
The dry tailings area is located between the mill complex and the tailings ponds. The area had been capped and seeded. Some instrumentation, such as thermocouples and some piezometers were located in this area (Photos 46 to 49 inclusive). The area, which had been seeded in the previous years, was covered with patches of arctic grass. No reclamation work is carried out in this area for the 2001 program.

Photo 46. Dry tailings area which is located west of Tailings Pond No. 1 (in the background). Thermo couples and some piezometers were located in this area.

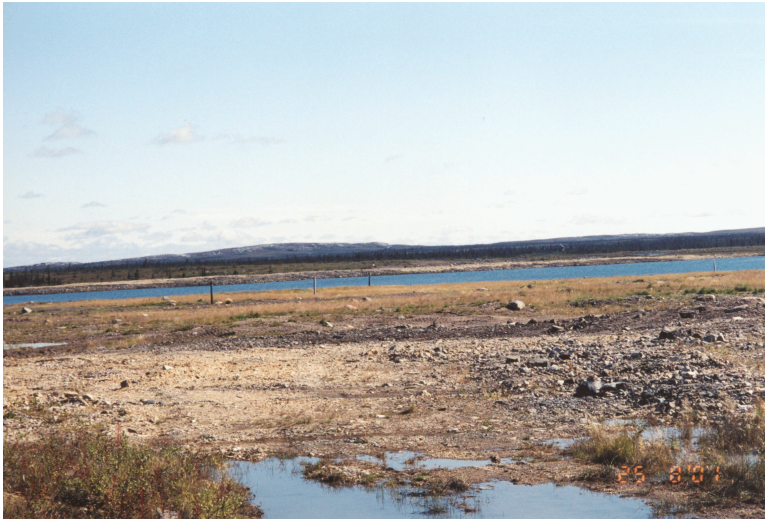
Photo 47. Dry tailings area adjacent to Tailings Pond No.1. The area was seeded with arctic grass. Photo was taken from the core boxes area.

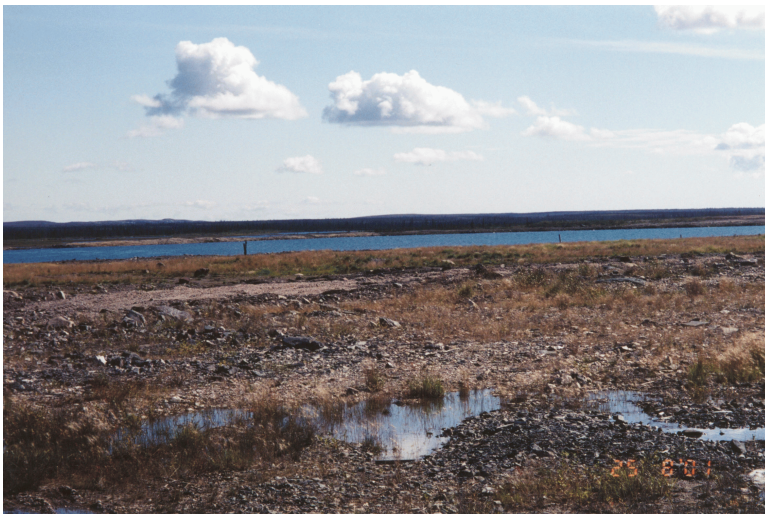
Photo 48. Close up view of the dry tailings area. Tailings Pond No. 1 is in the background.

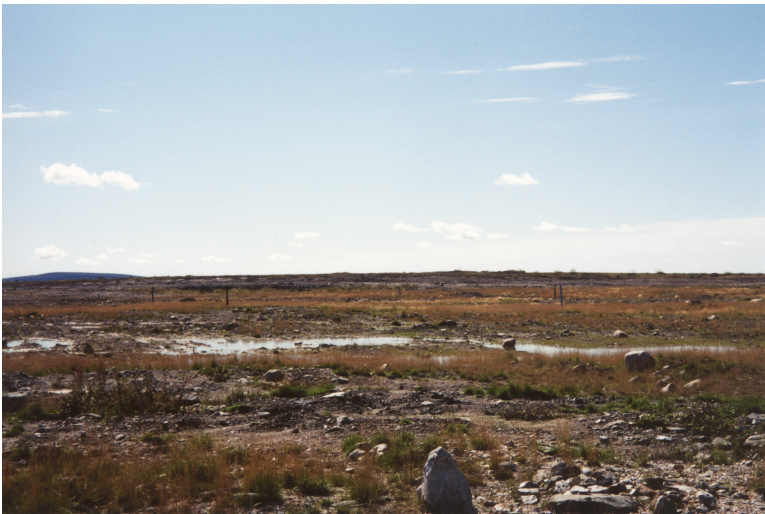
Photo 49. Another view of the dry tailings area. Black pipes show the location of the thermocouples.

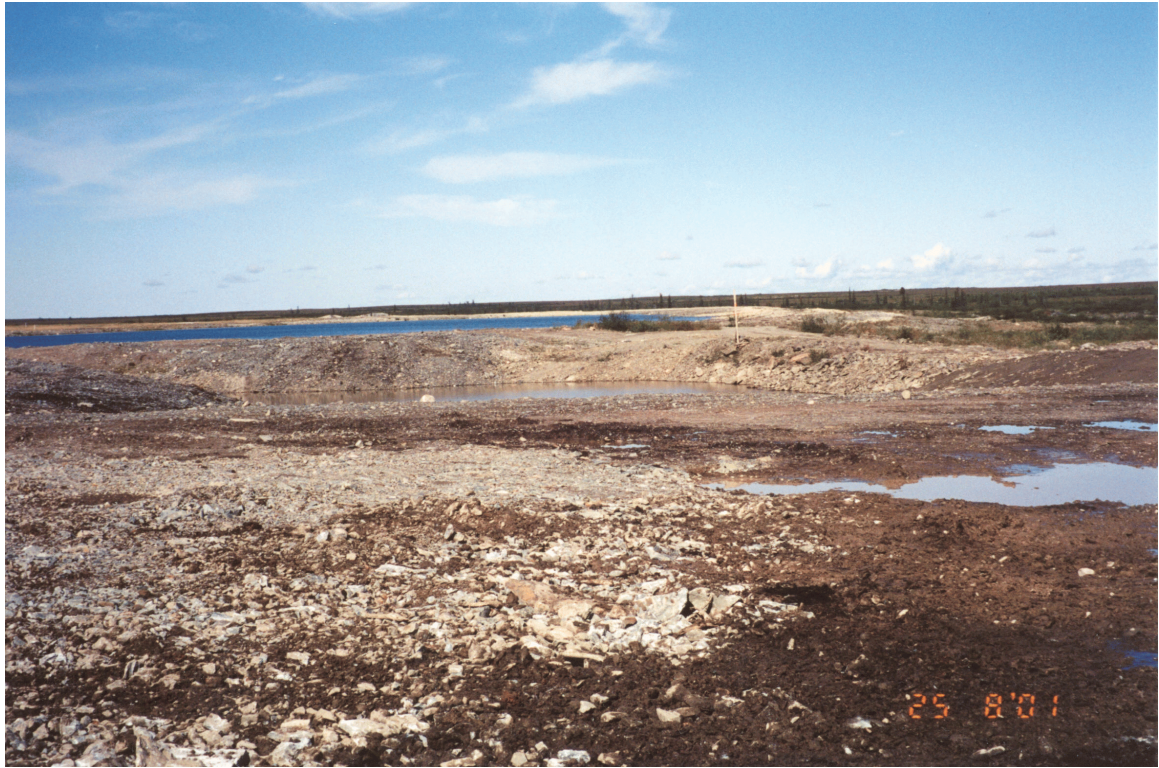
The northern portion of the pit contained some water, forming a small pond. The side slopes of the pit had been recently graded (Photos 52 and 53). This pit was proposed to be left as a pond.

Photo 52. The north portion of the Quarry Pit, where it will be left as a pond. Tailings Pond No. 1 is in the background.

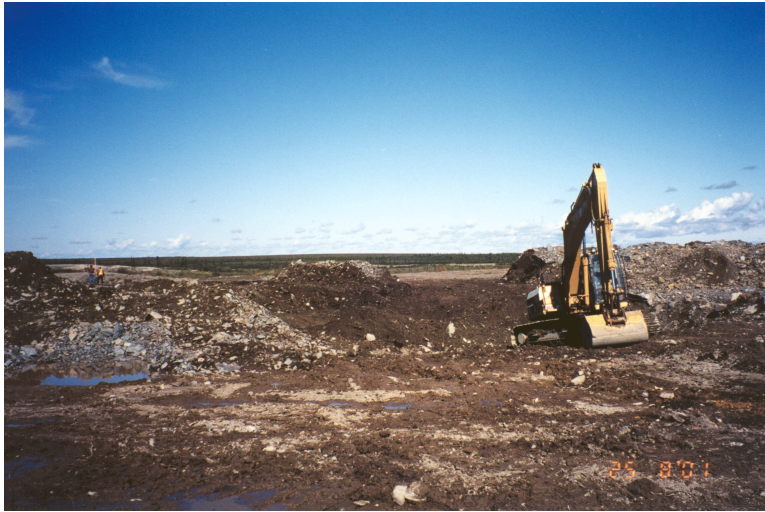
An old quarry pit is located to the south of Tailings Dam No. 1. The southern portion of the pit was used for burial of inert, waste materials, such as metal structures, concrete pads, steel tanks, old machinery parts and equipment, etc. The work in this area was almost complete (Photos 50, 51, 54 to 56 inclusive) at the time of the site visit. The area had been cleared, and some grass seeding had been undertaken in the area. A flat bed for the truck (Photo 56) would be hauled to the airstrip and would be removed from the site as part of the demobilization.

Photo 54. Burial of inert waste materials in the southern portion of the Quarry Pit.

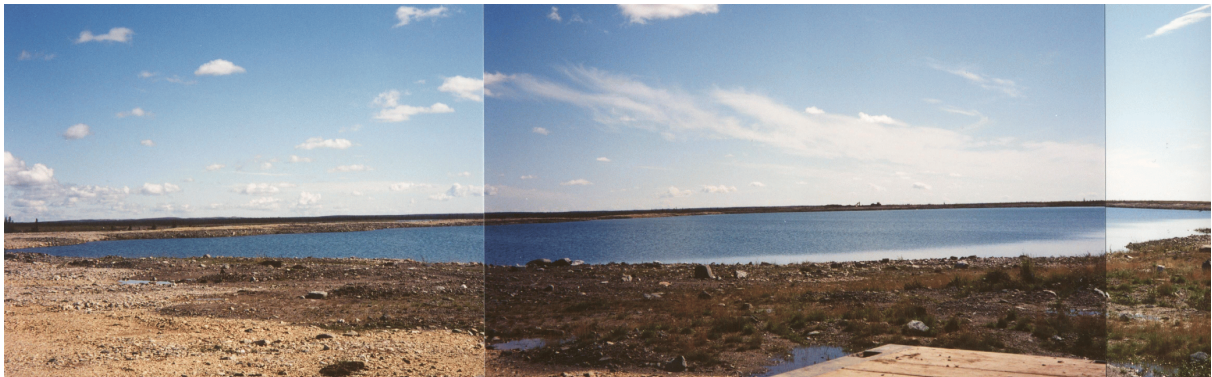
The condition of the dam at Tailings Pond No. 1 was generally satisfactory. The dam has a wide crest, and has a relatively flat downstream slope. Occasional areas of grass and weeds grow along the crest and downstream slope of the dam. It was observed that the pond appeared to have adequate freeboard. No sign of distress, slumping or stability problems were observed along the dam. No seepage nor erosion were noticeable during the site visit. The downstream toe area of the pond showed some depressions filled with water, but no seepage was evident in these areas. These water puddles were assumed to be formed from recent rainfalls in the area. Photos 57 to 68 were taken in the tailings pond area.

Photo 57. A view of Tailings Pond No. 1. Photo is looking west/northwest

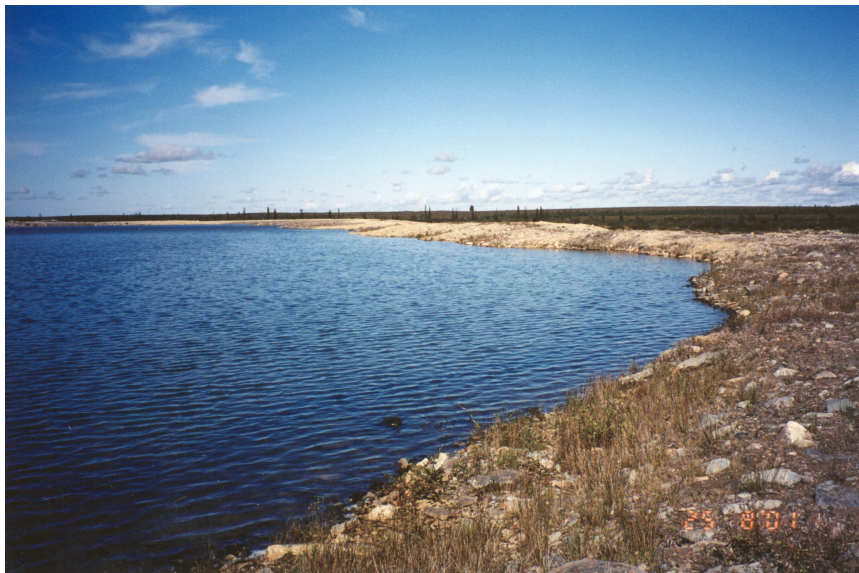
Photo 58. Upstream slope of Tailings Pond No. 1. Photo was taken from the south end.

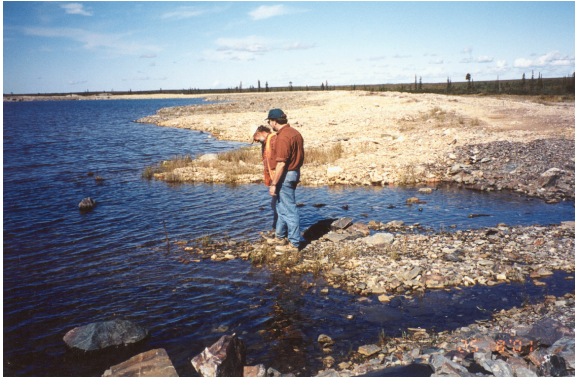
Photos 64 to 68 show the spillway conditions at Tailings Pond No. 1. Water was flowing through the spillway at the time of the site visit. The steel weir which had previously been placed at the downstream end of the spillway had been removed. Some exposed geomembrane was still visible in this area (Photo 68), and Homestake stated that they plan to cover the geomembrane before they move off the site.

Photo 64. Water entering the spillway at the upstream side of Tailings Pond No. 1

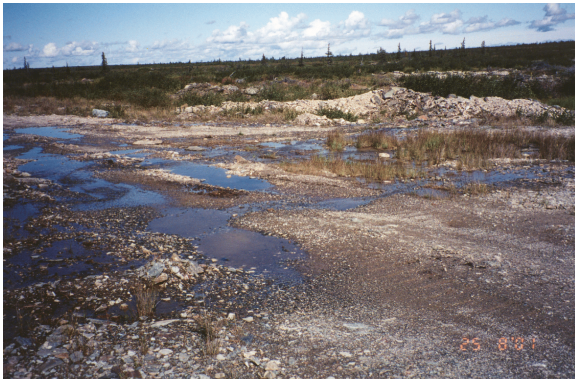
Photo 66. Water flowing downstream of the pond's spillway channel.

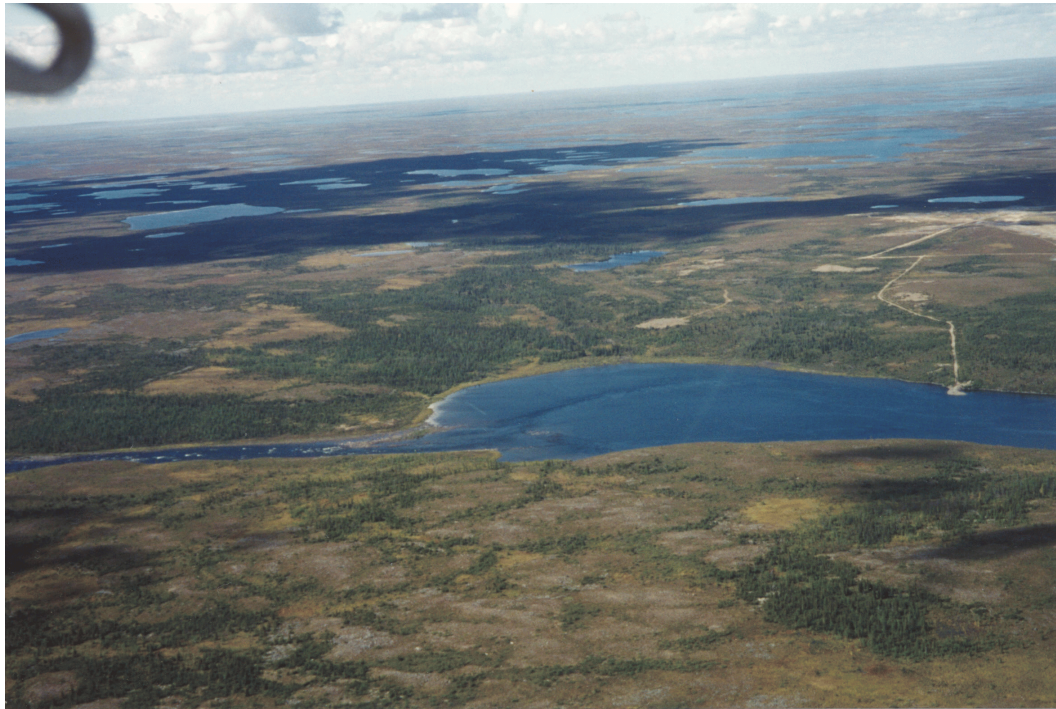
Photo 69. An aerial view of the Kognak river. Water flows from left to right. Notice the access road (also the old water line) from the B-zone mine complex to the river.

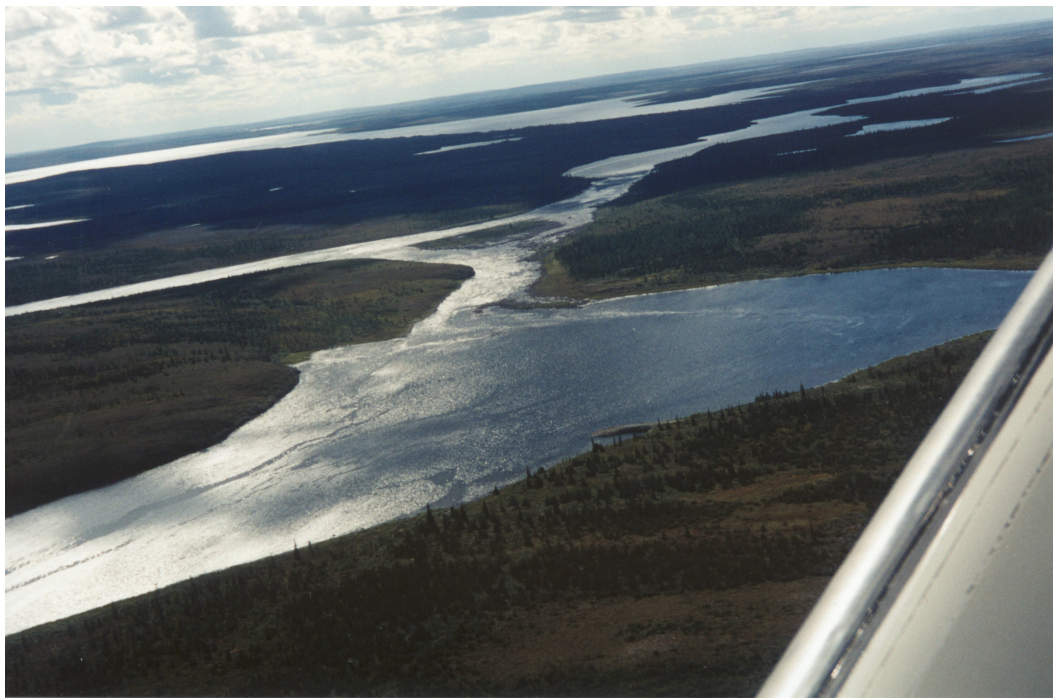
Photo 70. A close up view of the Kognak River. Water rapids are located at the end of the river constriction (centre of photo). An old camp is located to the north of the rapids. Photo is looking south.

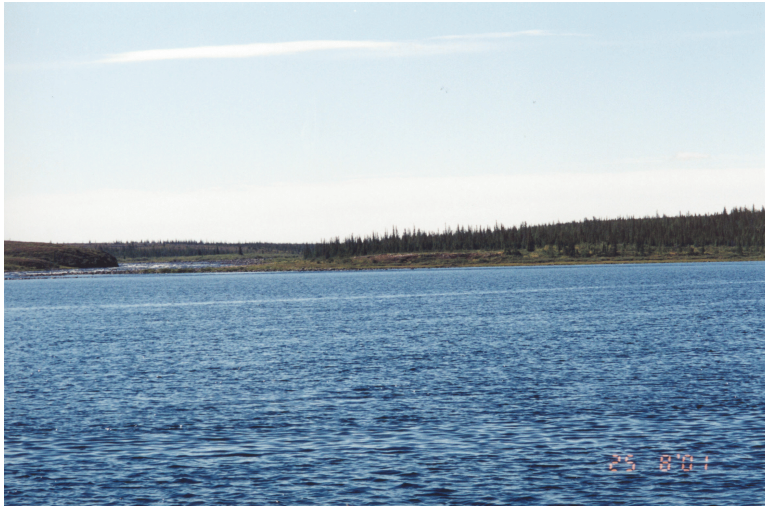
Photo 71. Kognak River. Photo was taken from the demolished pump house area, looking west. River rapids are on the left, and the old camp area is to the right of the rapids.

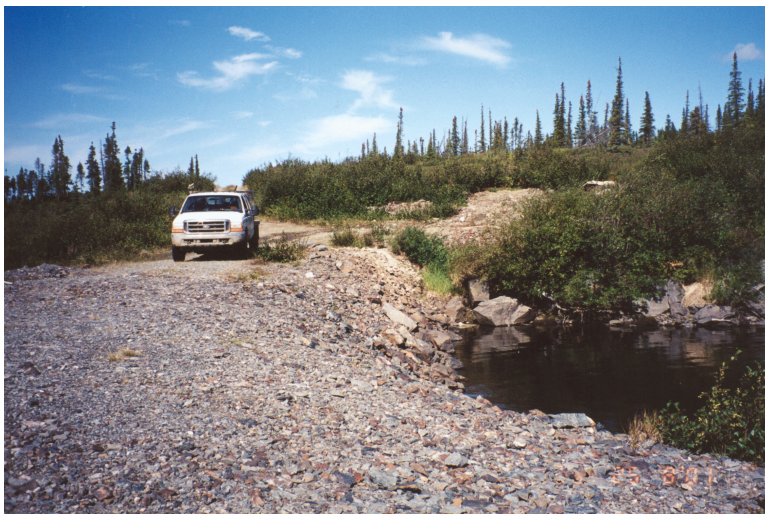
The remaining structure which can still be recognized in this area was the gravel road from the B-zone main complex. Some patches of grass and weeds have already covered some parts of this section of the road. The pump house, the water intake and pipelines were removed a long time ago, and only the gravel pads still remained in the area (Photos 72 and 73). The old exploration camp could be seen from pump house area (Photo 71), but could not be accessed due to time limitations. It is understood that this area has been abandoned for more than 15 years, and no construction activities was scheduled for the reclamation work in 2001.

Photo 72. The access road to Kognak River. The demolished pump house is on a cleared area located on the centre right.

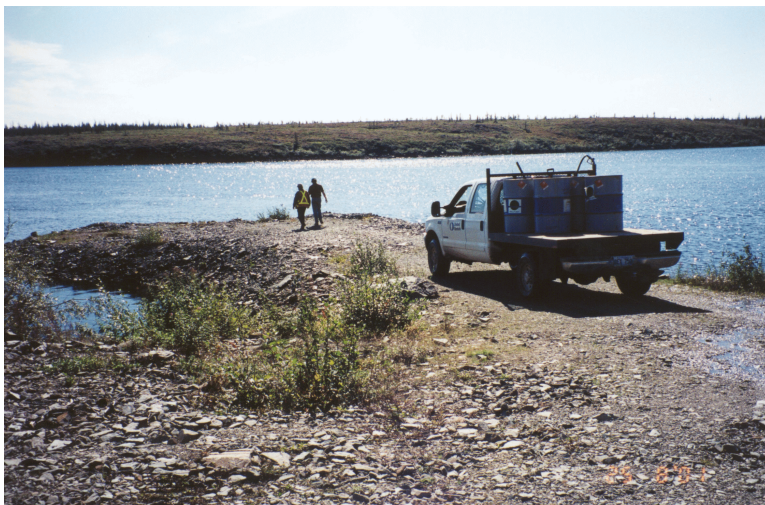
Photo 73. Kognak River at the water intake for the mine. Photo is looking south.
