CULLATON LAKE GOLD MINES LTD

WATER LICENCE N6L2-0940

**ANNUAL
WATER LICENCE REPORT
1996**

March 1997

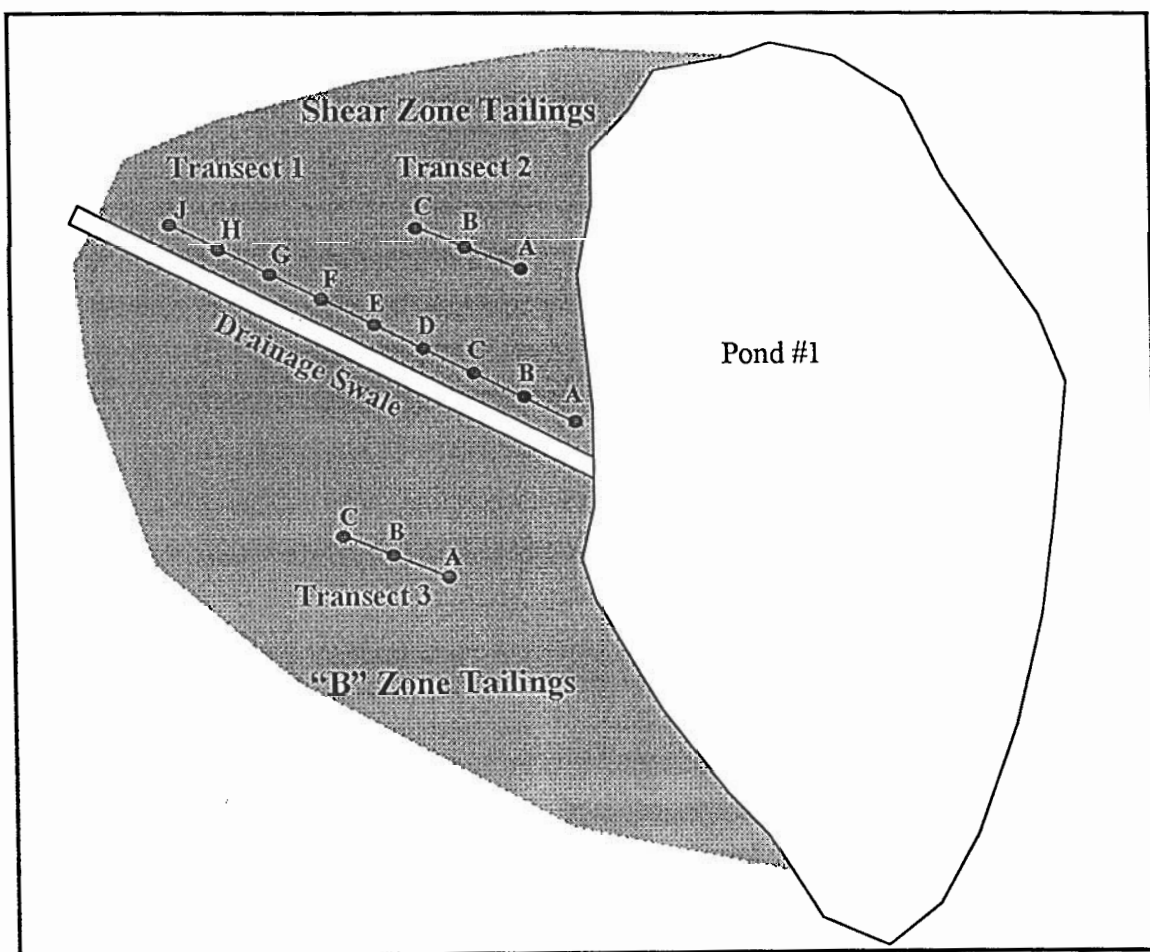
FIGURE 1: LOCATION OF OXYGEN CONSUMPTION METHOD TRANSECTS AND TEST POINTS

The overall average cover thickness based on observed data is considerably less than the designed thickness of 1.5 m. Two small areas located on the tailings impoundment exhibited bare tailings with no cover. One area was comprised of exposed tailings with partially established vegetation. This area was located on the "B" Zone tailings. The second area was located on the Shear Zone tailings and was comprised of exposed tailings with minor water ponding.

Three transects were installed on the Cullaton Lake tailings impoundment and are shown in Figure 1. Transect #1 is parallel to the drainage swale that bisects the impoundment. Transect #1 is located on Shear Zone tailings covered by cobblely till cover and consists of nine testing points at a 15 m spacing. These are labeled 1A-1J (to prevent possible confusion the letter "i" was not used). Tube 1A is located 3 m from the shore of Pond #1. Transect #2 is also located on the covered Shear Zone tailings. This transect consists of three testing points with a spacing of 15 m. These are identified as 2A, 2B, and 2C. Tube 2A is 25 m from the shore of pond #1. Transect #2 is parallel to Transect #1 at a distance of approximately 100 m. Transect #3 is located on the covered "B" Zone tailings. This transect also consists of three testing points with a spacing of 15 m. These are identified as 3A, 3B, and 3C. Tube 3A is approximately 50 m from the shore of pond #1. Transect #3 is also parallel to the drainage swale and is located approximately 200 m from Transect #1. In addition to the three transects two tests were performed on Shear Zone tailings without cover. One of these tests was conducted on the area of exposed tailings with minor water ponding. Despite the high moisture content evident by local ponding, this test yielded a high oxidation rate. This testing point is referred to as the control for Transect 1 and was located near testing point F. The second test on uncovered Shear Zone tailings was conducted by the manual removal of the cover and the installation of a testing point. This testing point is referred to as the control of Transect 2 and was located at Transect 2 testing point C.

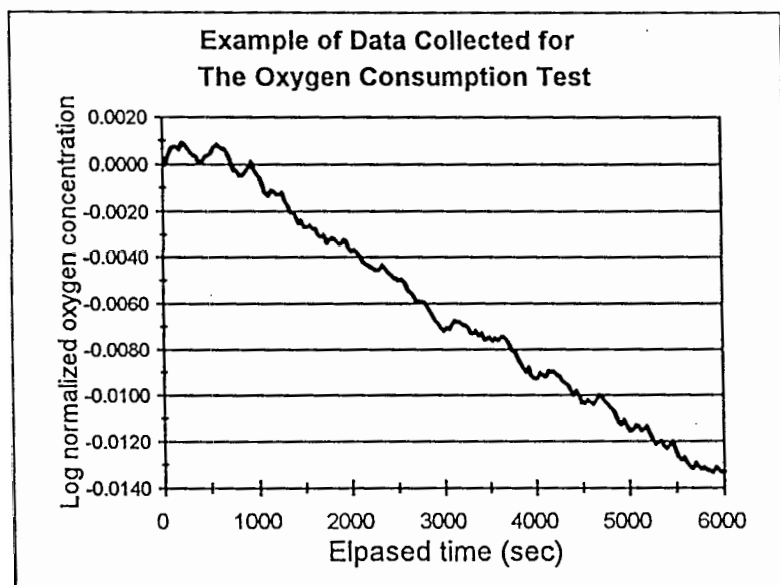
FIGURE 2: PLOT OF LOG NORMALIZED OXYGEN CONCENTRATION VERSUS TIME FOR A TYPICAL OXYGEN CONSUMPTION TEST

Due to the brevity of the field visit duplicate testing was not possible. Valid test data were collected on 13 of the 15 tubes installed in the cover and on both control testing points located on the Shear Zone tailings. An example of a plot of oxygen log normalized concentration over time in the headspace of the tube is shown in Figure 2.
