# CULLATON LAKE GOLD MINES LTD

## WATER LICENCE NWB1CUL9902

### ANNUAL WATER LICENCE REPORT 1999

PREPARED BY:  
HOMESTAKE CANADA INC  
P.O. BOX 11115, 1100 - 1055 WEST GEORGIA STREET  
VANCOUVER, B.C.  
V6E 3P3

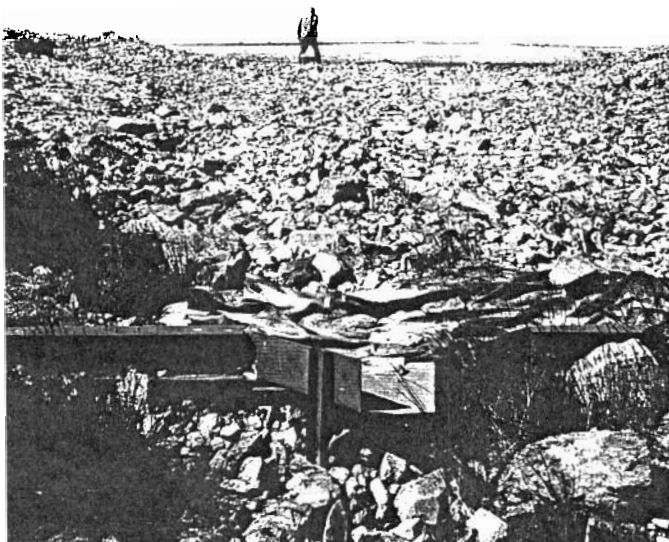
F-90132  
Photos July 24, 1999

Photos 3 and 4 show views of the dam and spillway, respectively. Typically, the embankment which is constructed principally with local cohesionless till, is irregular in section and surface grade. Average side slopes of the upstream and downstream sides were typically about 3H:1V and 6H:1V, respectively. Some small erosion scars were observed on both the upstream and downstream sides. This is likely due to adjustment of the fill that was placed several years ago during the flattening of the side slopes. The crest width varies but is in the order of 15 m. No seepages were observed on the day of inspection. Based on our 1999 examination and our previous involvement with the project, the dam is considered to be stable.

Photos 5 and 6 show views of the dam and spillway, respectively. As with the No. 1 dam, the principal construction material is local cohesionless till. The dam section and surface grade is irregular, although less so than the No. 1 dam. The crest width varies but is in the order of 15 m. No seepages were observed on the day of examination. Based on our 1999 examination and our previous involvement with the project, the dam is considered to be stable.

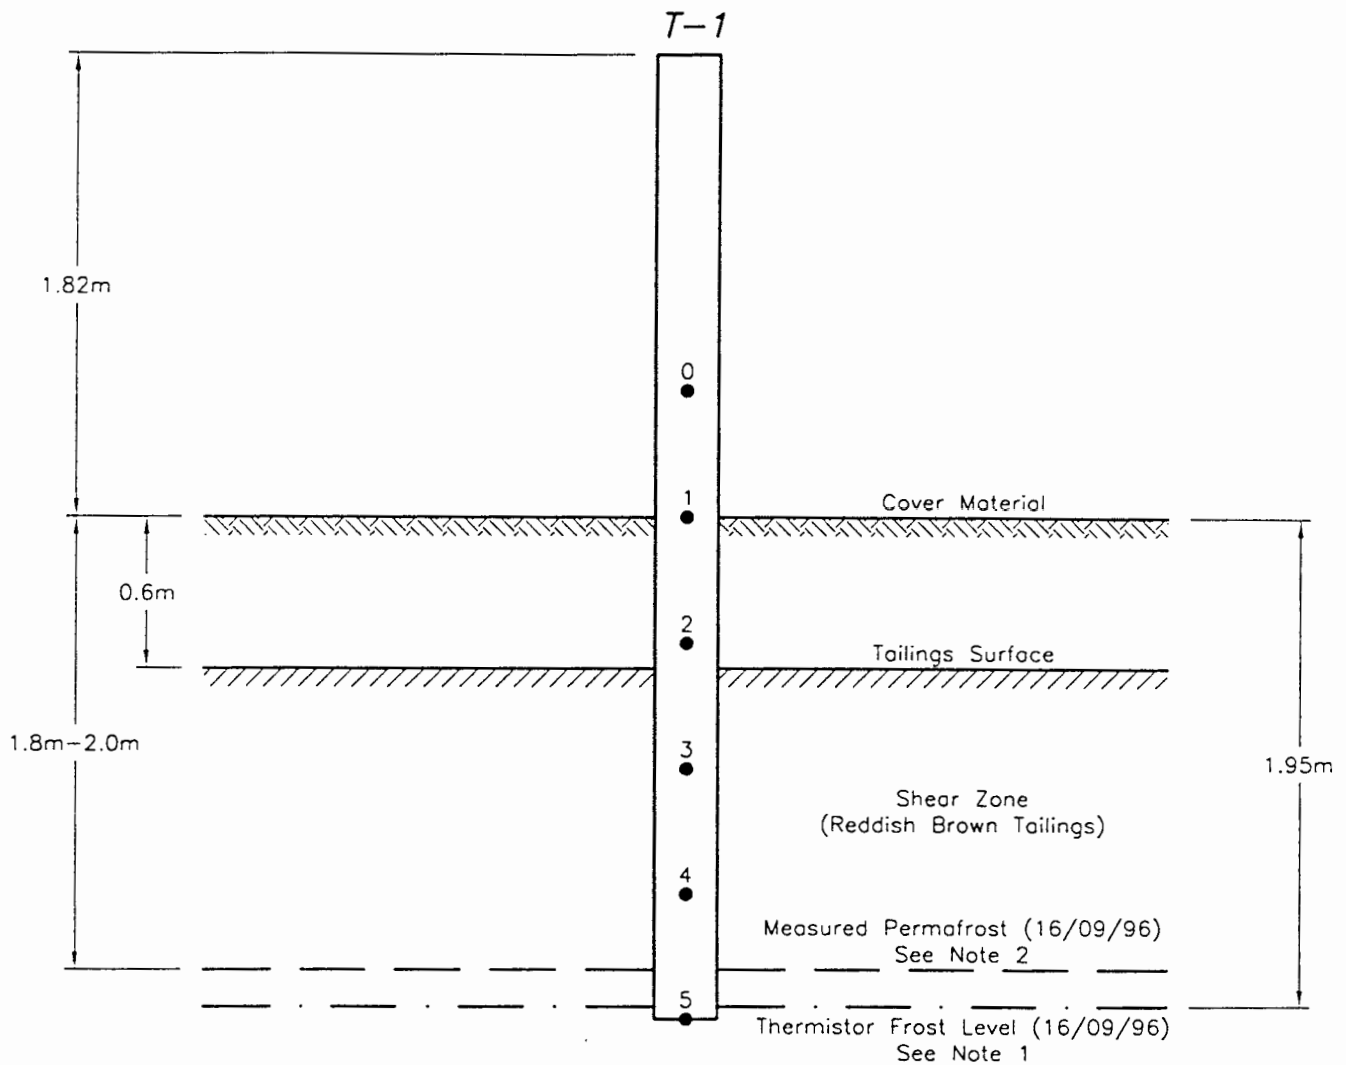
<b>TROW CONSULTING ENGINEERS LTD.</b> Thunder Bay, Ontario, Canada	DRAWN BY: DT		DATE: Oct. 29/96	
	APR. BY:		REVISED:	
CLIENT: Homestake Canada	SCALE: NTS			
PROJECT: Cullaton Lake Gold Mine	TROW FILE NO.		DWG. NO:	REV.
DWG TITLE: Thermistor String Configuration (T-1)	F-90132-B/E		3

The comparative results from the four thermistor installations indicate that there is an upward trend in the level of permafrost. The average depth of frost was approximately 400 mm below the tailings ground surface during the time of this study. This compares to a frost level of a 800 mm below the ground surface during a similar time period in 1992 (July 6, 1992). It should be noted, however, that the greatest depth of thaw occurs at the end of the summer season which will lower the level of frost to the greatest seasonal depth. To obtain the level of maximum thaw, thermistor readings should be taken sometime in the month of September. A more accurate level of permafrost can then be recorded. At the current rate of

rise in frost levels, it is expected that the covered tailings area will be in a permanently frozen state (permafrost) in 2 to 3 more years.
