**Reference F90132**

**1999 Tailings Dam Examination**  
**Cullaton Lake Gold Mine, Nunavut**

RE: Cullaton Lake Gold Mine  
Our Reference No. F-90132-B/E

REVISIONS		
No:	Date:	Revision
Client: HOMESTAKE CANADA		
Project: CULLATON LAKE MINE CLOSURE		
Title: TAILINGS POND SURVEY CULLATON LAKE, N.W.T.		
Project No. F-90132-A/G		Dwg. No.: 1
Drawn By: PW/DT		Reviewed By: DK
Date: JANUARY 30, 1995		
Scale: 1 : 2500

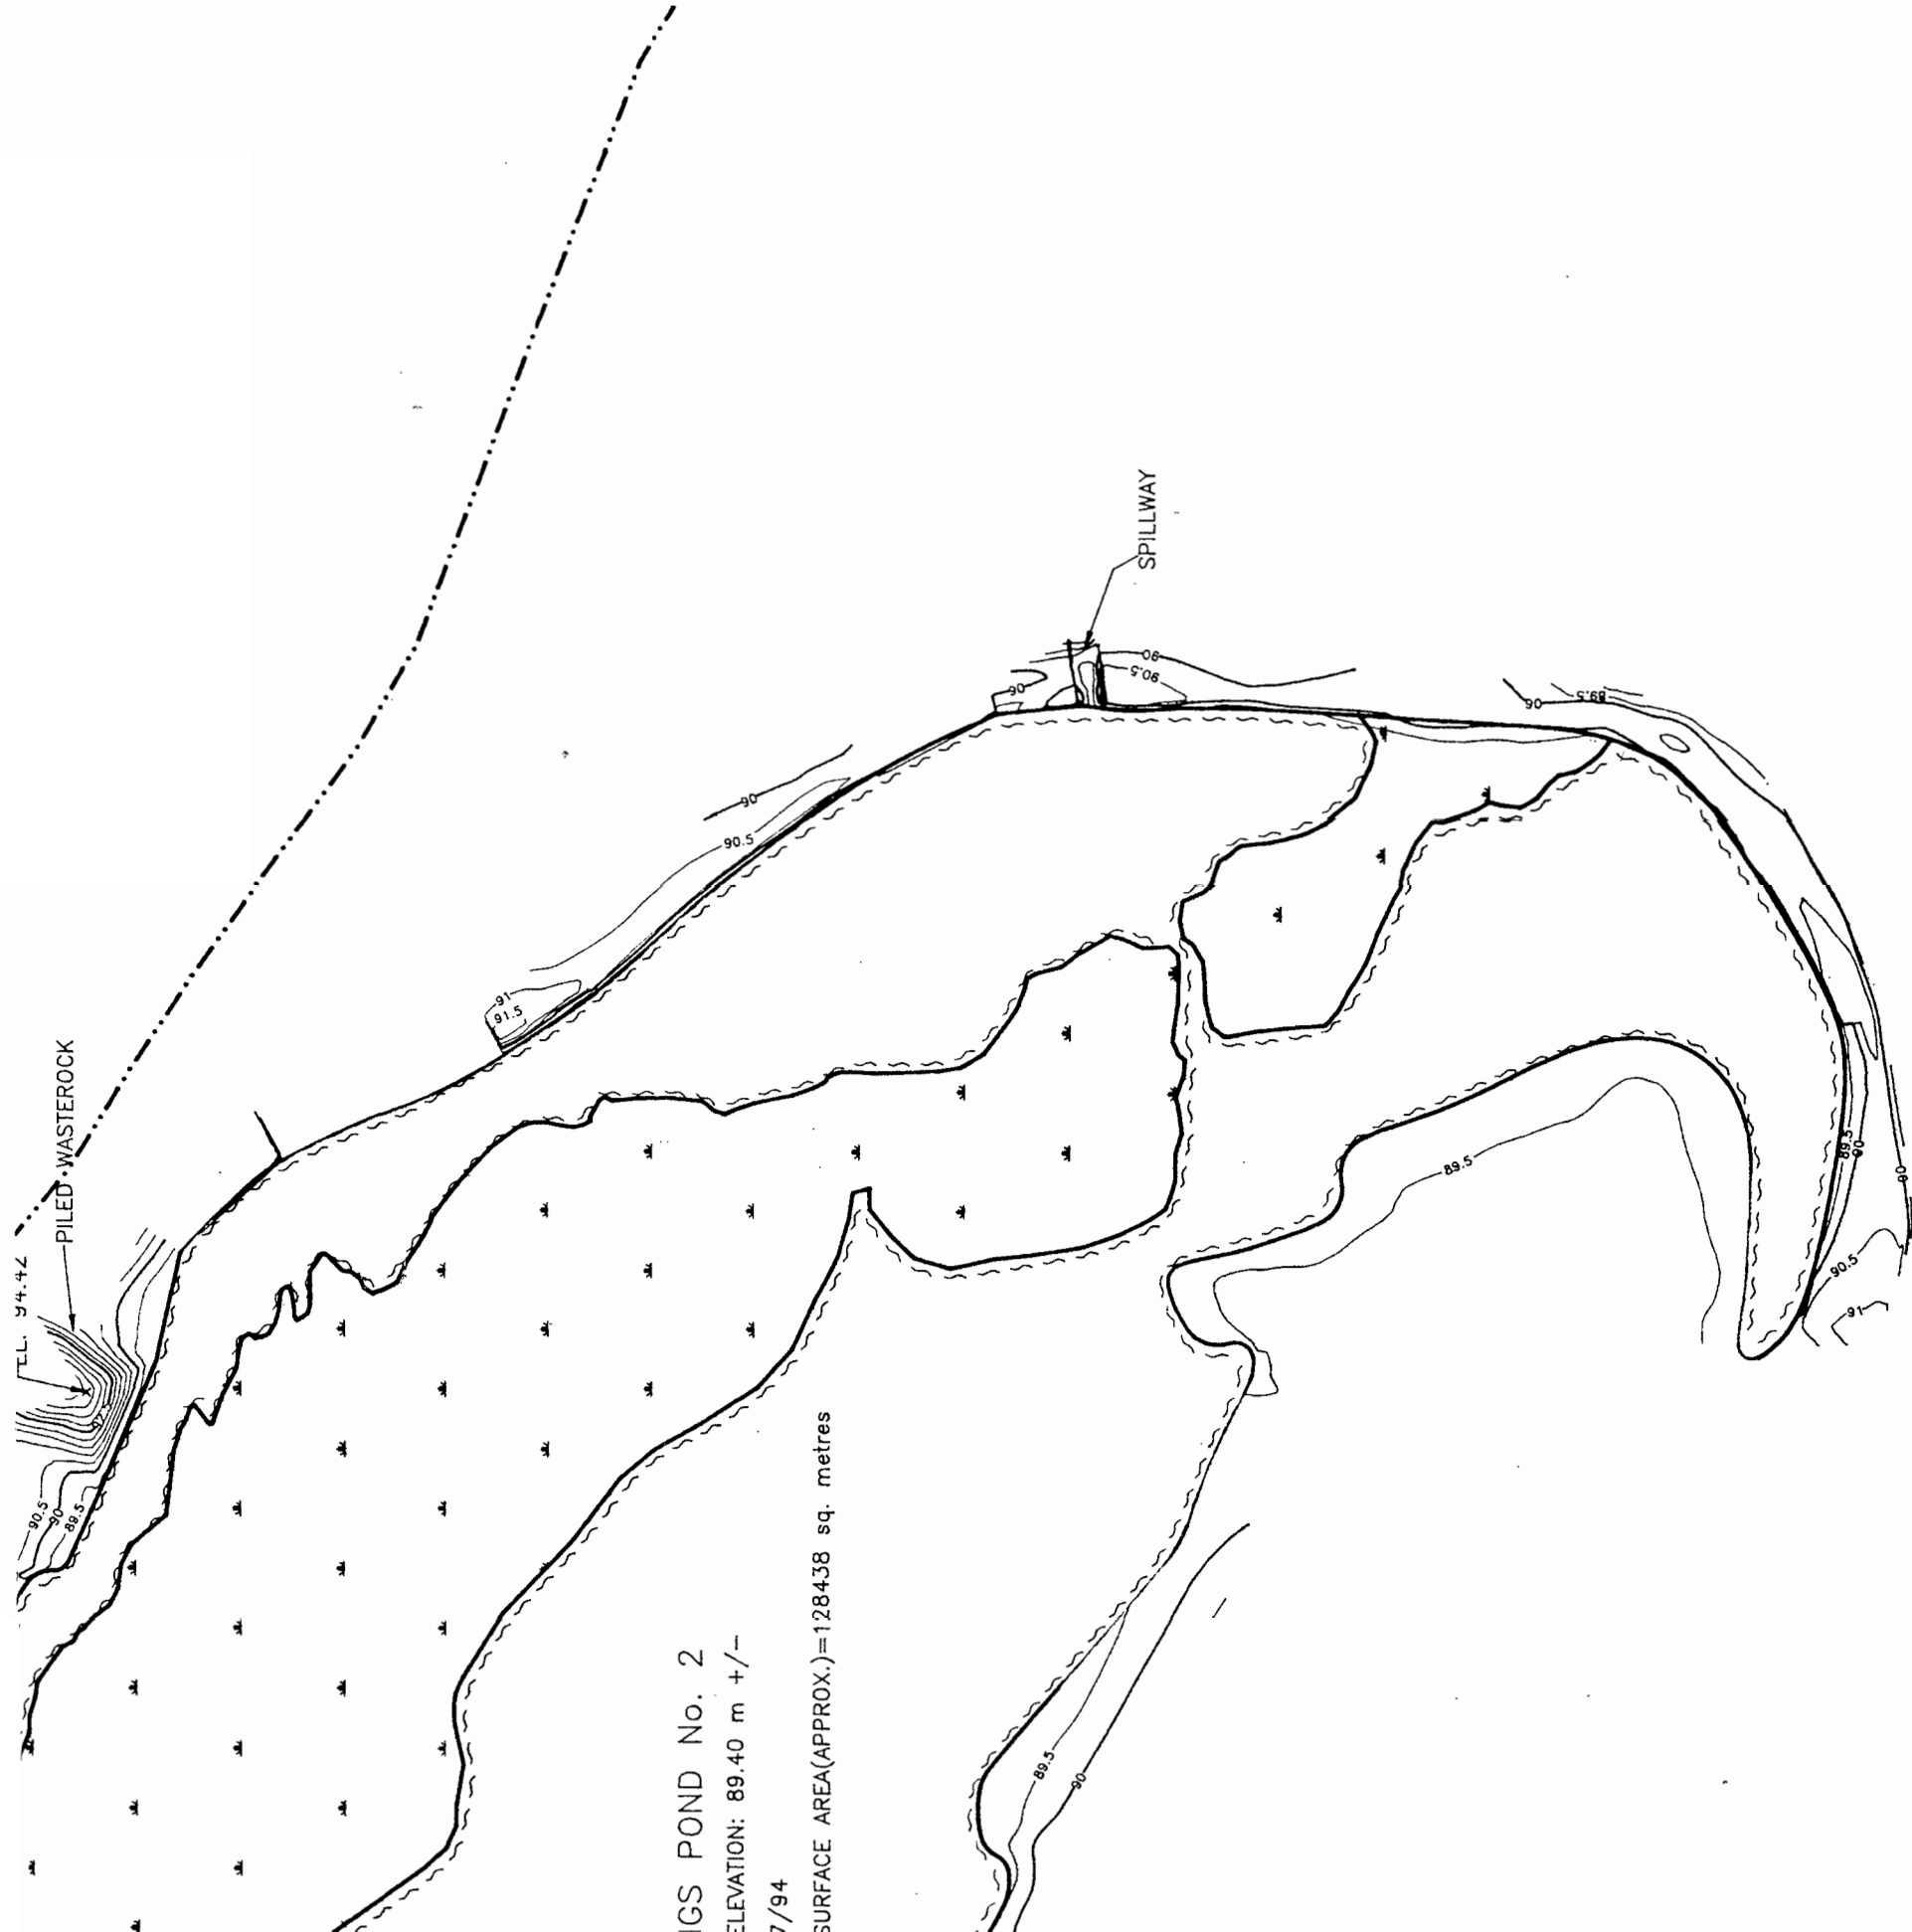
A visual examination around Tailings Area No. 1 was carried out. The containment dam appears to be in good condition with no signs of distress or erosion. Some small wet areas were present on the downstream toe at the south end of the tailings area. However, it is unclear if the wet areas are due to seepage or the large amount of rainfall which had fallen prior to this site visit. There is no evidence of soil loss in these wet areas and they do not present any instability to the dam. The approximate location of these wet areas are shown on Drawing No. 1.

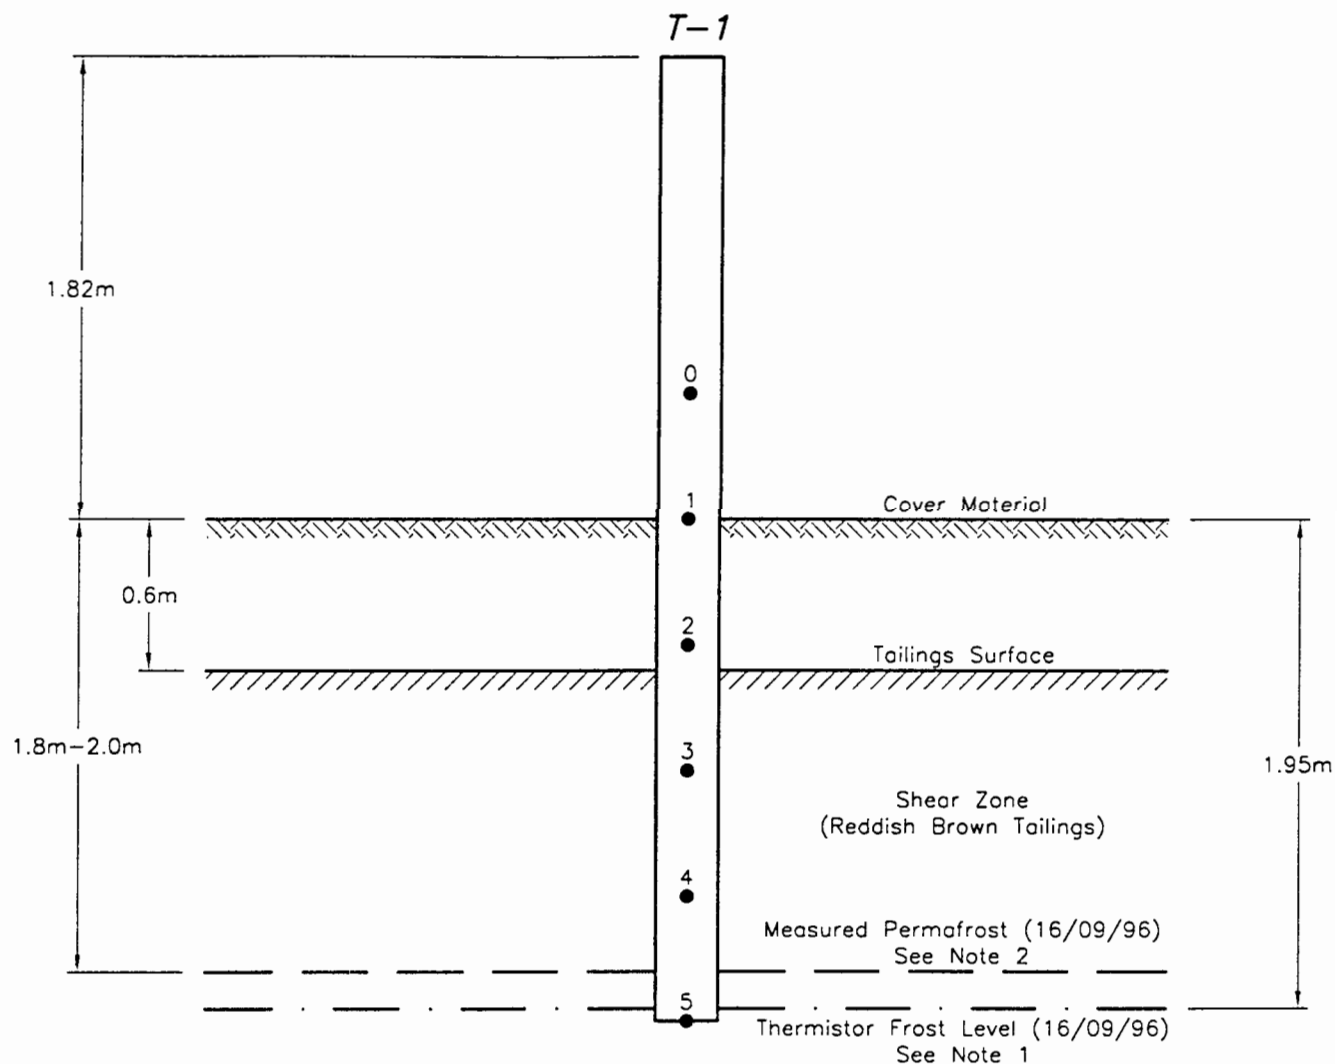
DWG TITLE: Thermistor String Configuration (T-1)

The comparative results from the four thermistor installations indicate that there is an upward trend in the level of permafrost. The average depth of frost was approximately 400 mm below the tailings ground surface during the time of this study. This compares to a frost level of a 800 mm below the ground surface during a similar time period in 1992 (July 6, 1992). It should be noted, however, that the greatest depth of thaw occurs at the end of the summer season which will lower the level of frost to the greatest seasonal depth. To obtain the level of maximum thaw, thermistor readings should be taken sometime in the month of September. A more accurate level of permafrost can then be recorded. At the current rate of

rise in frost levels, it is expected that the covered tailings area will be in a permanently frozen state (permafrost) in 2 to 3 more years.
