October 27, 2020

Re: **Project No. THB-00090132-IG**  
**2020 Tailings Facility Examination**  
**Cullaton Lake Gold Mine, Nunavut**  
**Licence No. 1BR-CUL1828**

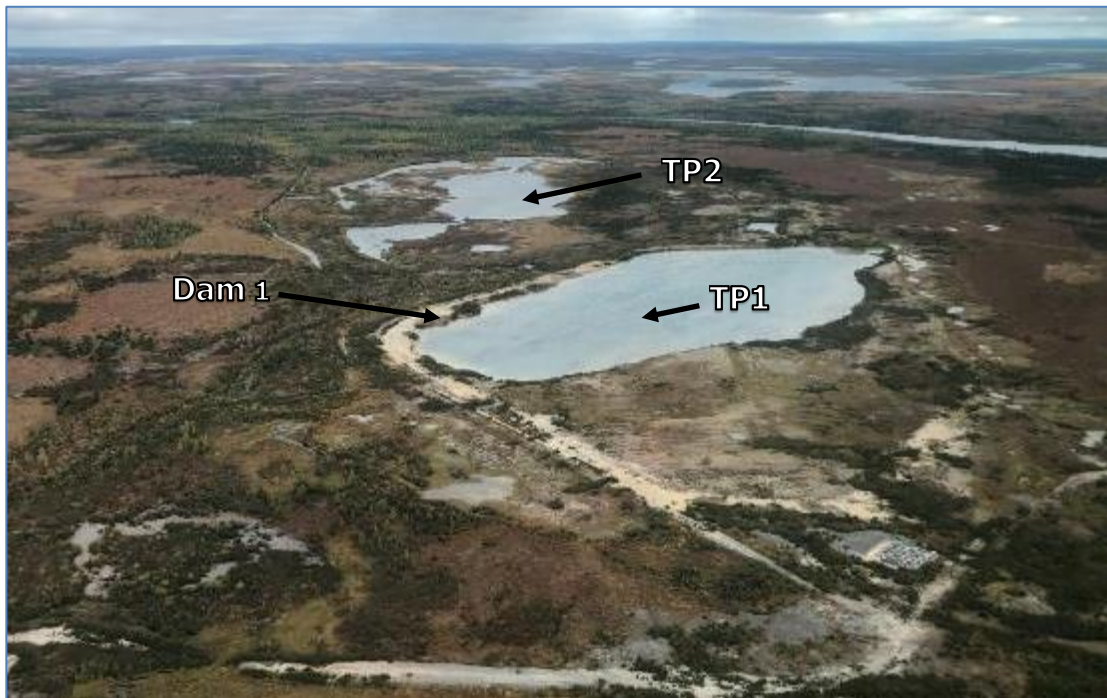
Photo 1 shows an aerial view of TP1 and its location relative to TP2. Photo 2 shows TP1, the revegetated tailings beach and Dam 1 with the spillway and the low point south of the spillway. The tailings beach adjacent to the northwest edge of the pond had been previously covered with local till as reported in Trow's/EXP's previous inspection reports.

Vegetation on the till covered tailings is increasing gradually based on the comparative visual observations of previous years. The density of the vegetation visibly increased since 2017, as shown in Photos 1 and 2.

Photo 1: Aerial view of TP1 and TP2 (looking southeast).

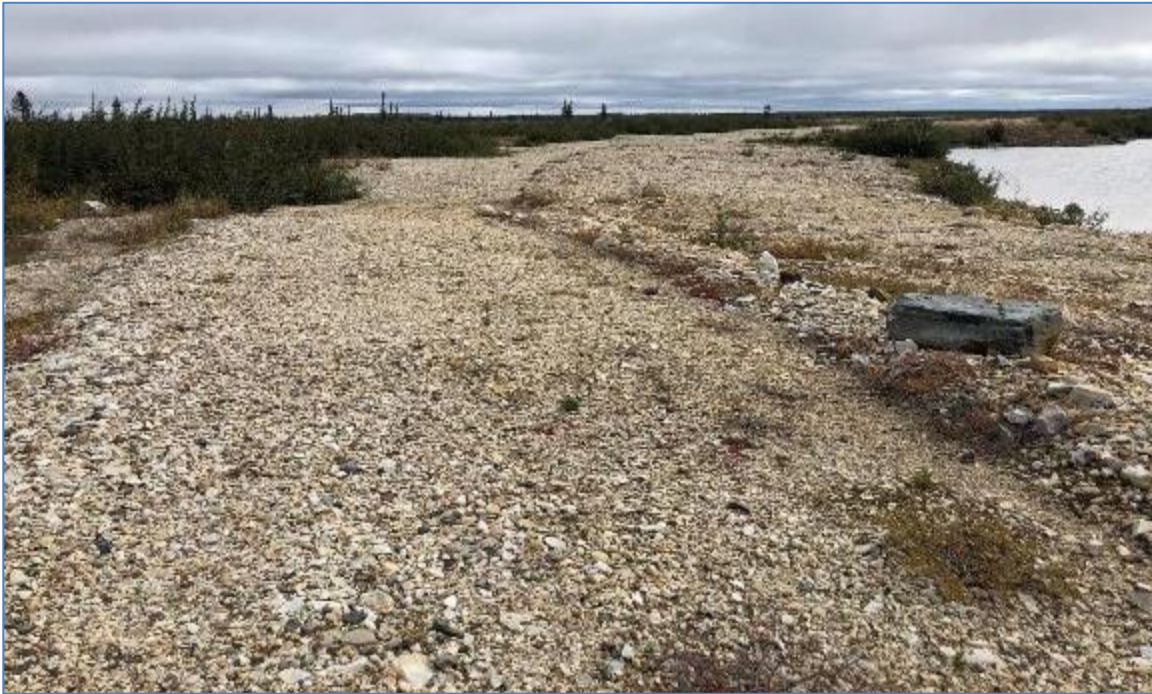
Photos 9 and 10 show views of the upstream face and crest, and downstream face of Dam 1, respectively. Typically, the embankment, which is constructed principally with local cohesionless till, is irregular in section and surface grade. Average side slopes of the upstream and downstream sides are typically about 3H:1V and 6H:1V, respectively. The downstream side is estimated to be as steep as 3H:1V in a few areas. The dam height varies up to about 4 m. The dam crest width varies but is generally in the order of 15 m.

**Photo 9: Dam 1 upstream face and crest north of TP1 spillway (looking southeast).**

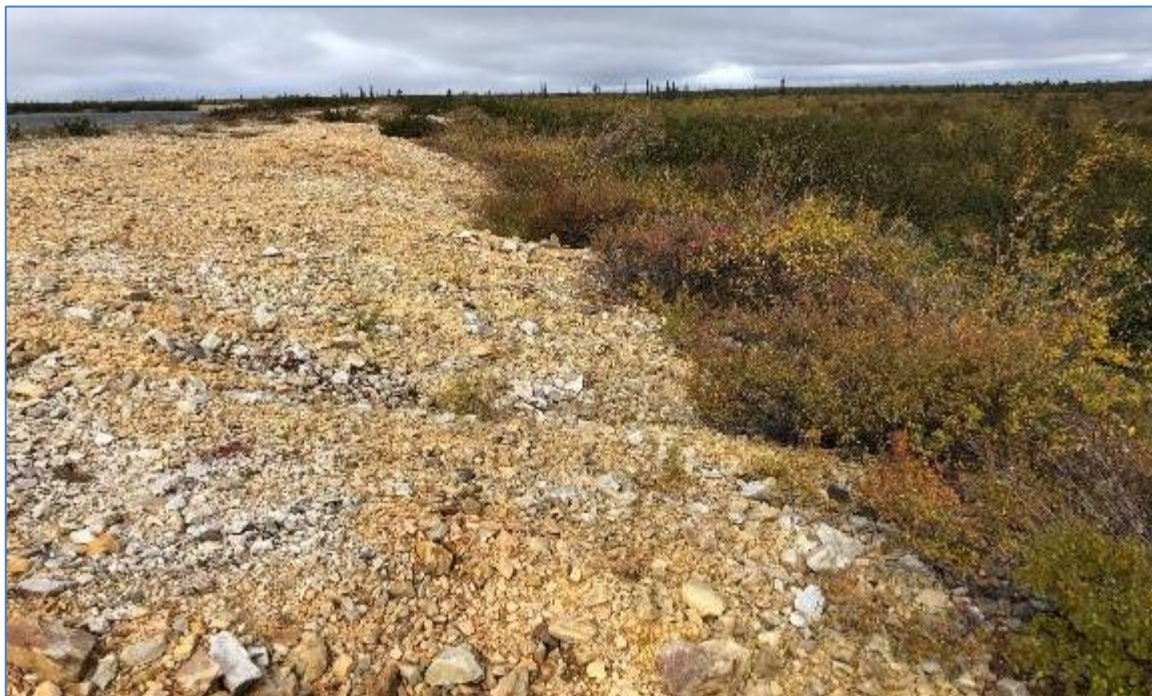
**Photo 10: Dam 1 downstream face north of the low point (looking north).**

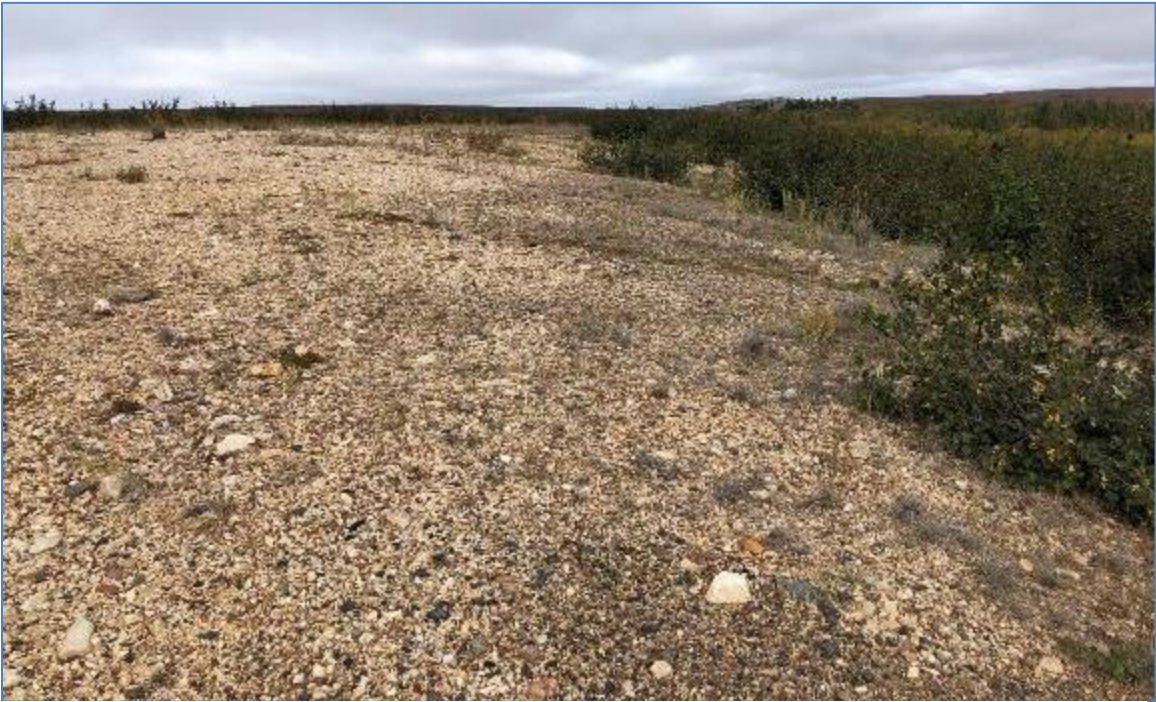
Photo 18 and 19 show improved vegetation on the east and south slopes, respectively. The vegetation growth is still sparse on the top of the pile, as shown in Photo 20.

**Photo 20: Top of Shear Lake Waste Rock Pile (looking north).**
