Re: **Project No. THB-00090132-JG**
2022 Tailings Facility Examination
Cullaton Lake Gold Mine, Nunavut
Licence No. 1BR-CUL1828

Further to your authorization, EXP Services Inc. (EXP) has performed a visual geotechnical examination of the tailings impoundment facility at the former Cullaton Lake Gold Mine (the Site) in Nunavut. The Site is owned by Barrick Gold Corporation (Barrick). The facility includes Tailings Ponds 1 and 2 (TP1 and TP2) and associated dams. The field examination was performed between August 31, 2022 and September 1, 2022 by the undersigned, Ms. Renata Klassen, P.Eng. The attached survey plan in Appendix A (January 30, 1995) illustrates the general layout of the facility.

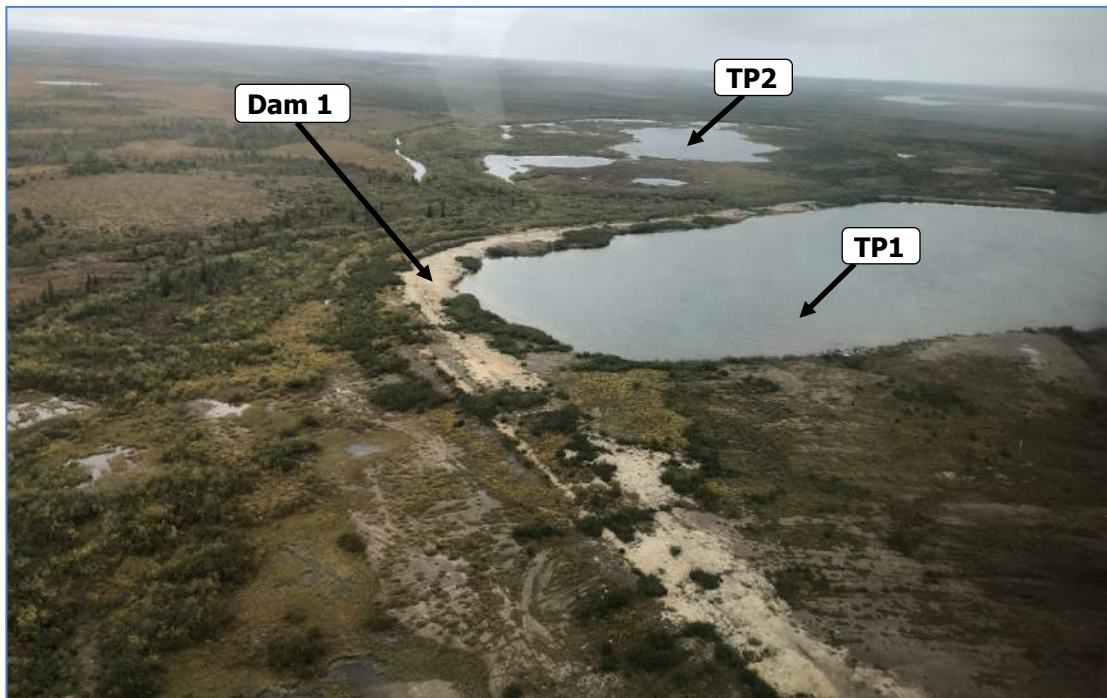
Photo 1 shows an aerial view of TP1 and its location relative to TP2. Photo 2 shows an aerial view of TP1, the revegetated tailings and Dam 1 with the spillway and the low point south of the spillway. The tailings beach adjacent to the northwest edge of the pond had been previously covered with local till as reported in Trow's/EXP's previous inspection reports.

Photo 1: Aerial view of TP1 and TP2 (looking southeast).

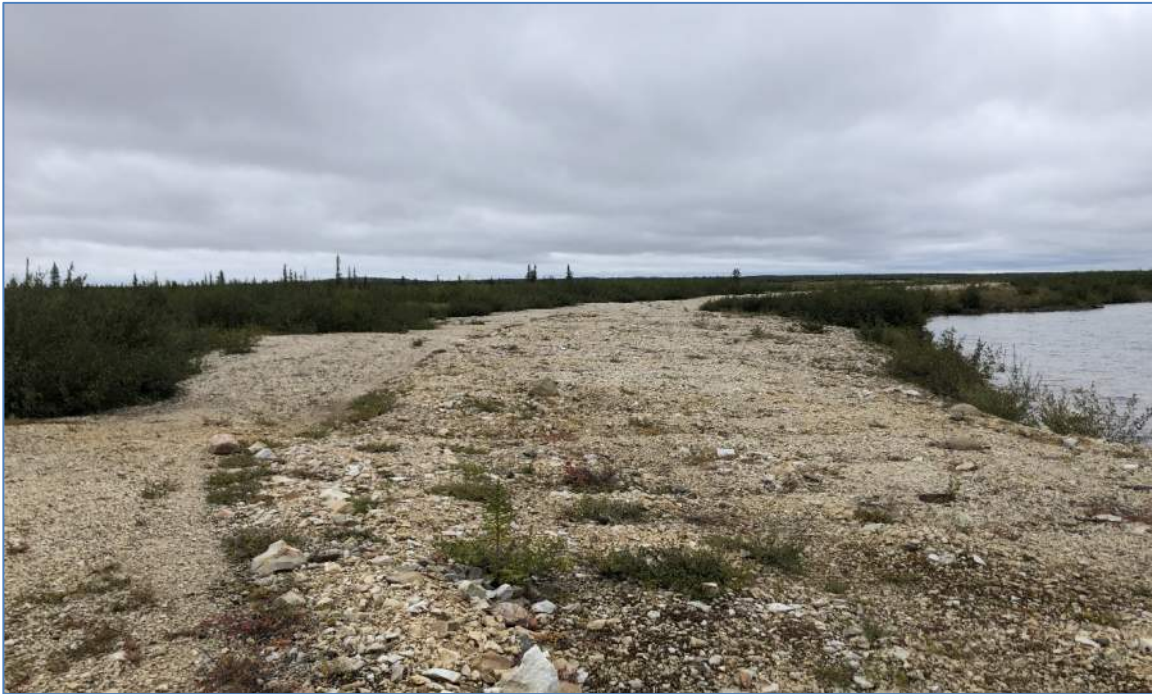
Photos 9 and 10 show views of the upstream face and crest, and downstream face of Dam 1, respectively. Typically, the embankment, which is constructed principally with local cohesionless till, is irregular in section and surface grade. Average side slopes of the upstream and downstream sides are typically about 3H:1V and 6H:1V, respectively. The downstream side is estimated to be as steep as 3H:1V in a few areas. The dam height varies up to about 4 m. The dam crest width varies but is generally in the order of 15 m.

Photo 9: Dam 1 upstream face and crest north of TP1 spillway (looking southeast).

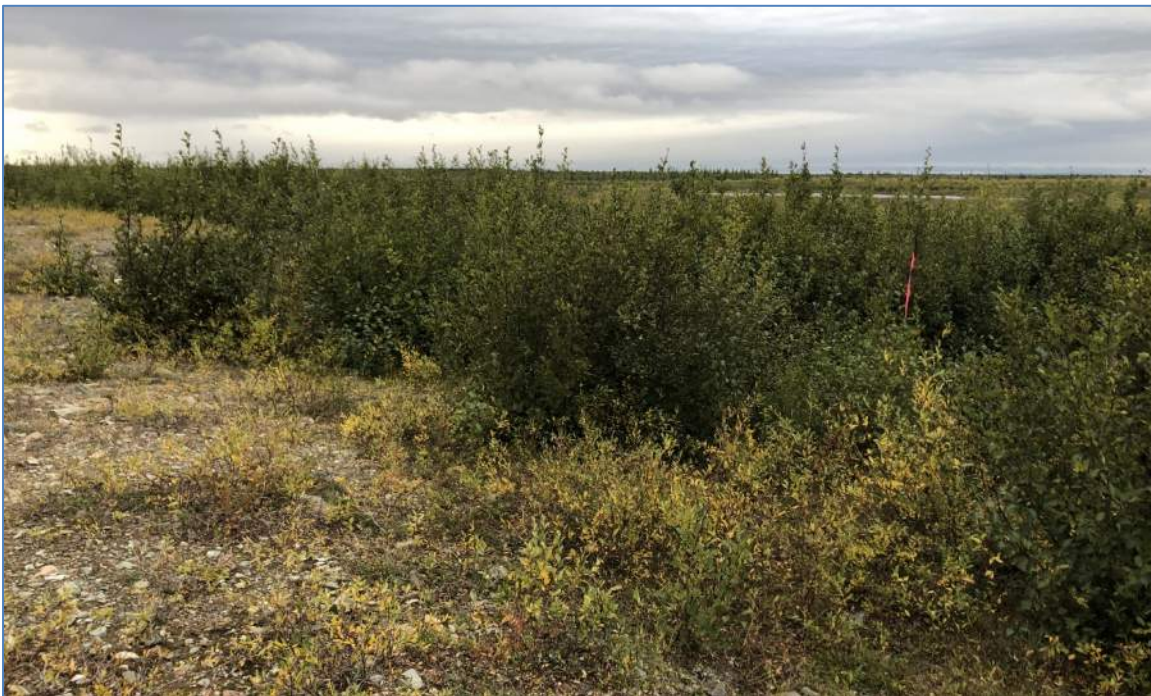
Photo 10: Dam 1 downstream face north of the low point (looking north).

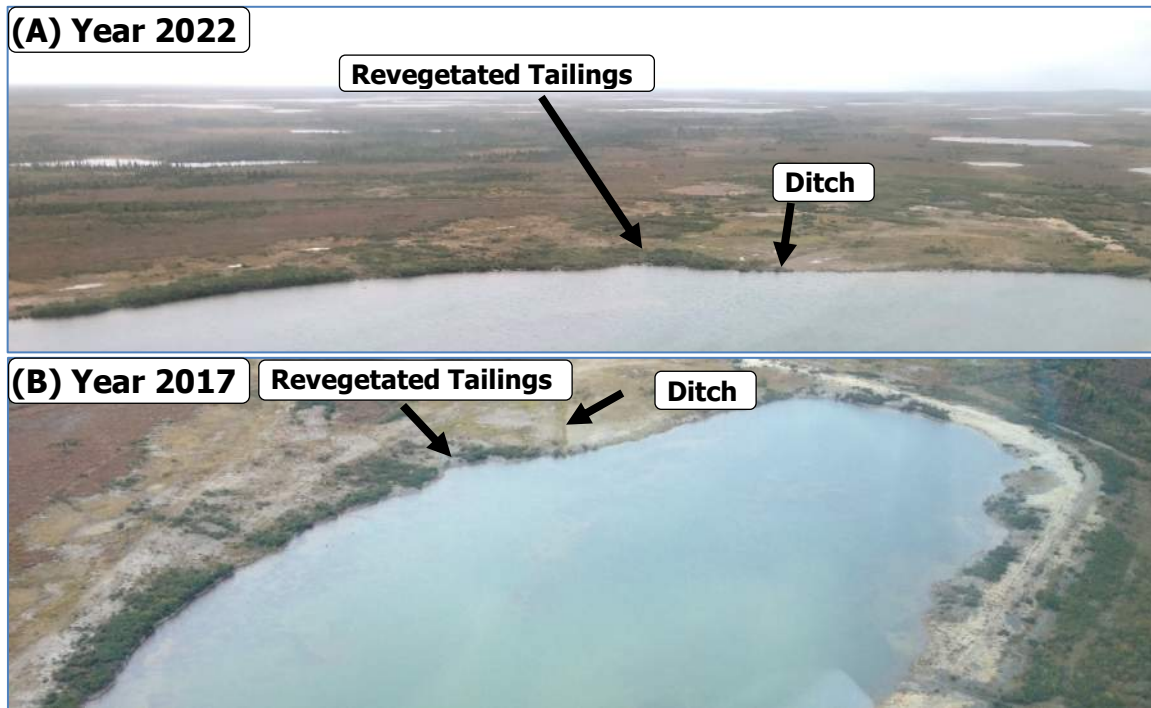
Vegetation on the till covered tailings is increasing gradually based on the comparative visual observations of previous years. The density of the vegetation visibly increased since 2017, as shown in Photo 15.

Photo 15: Revegetated tailings – comparison between 2022 (A) and 2017 (B)

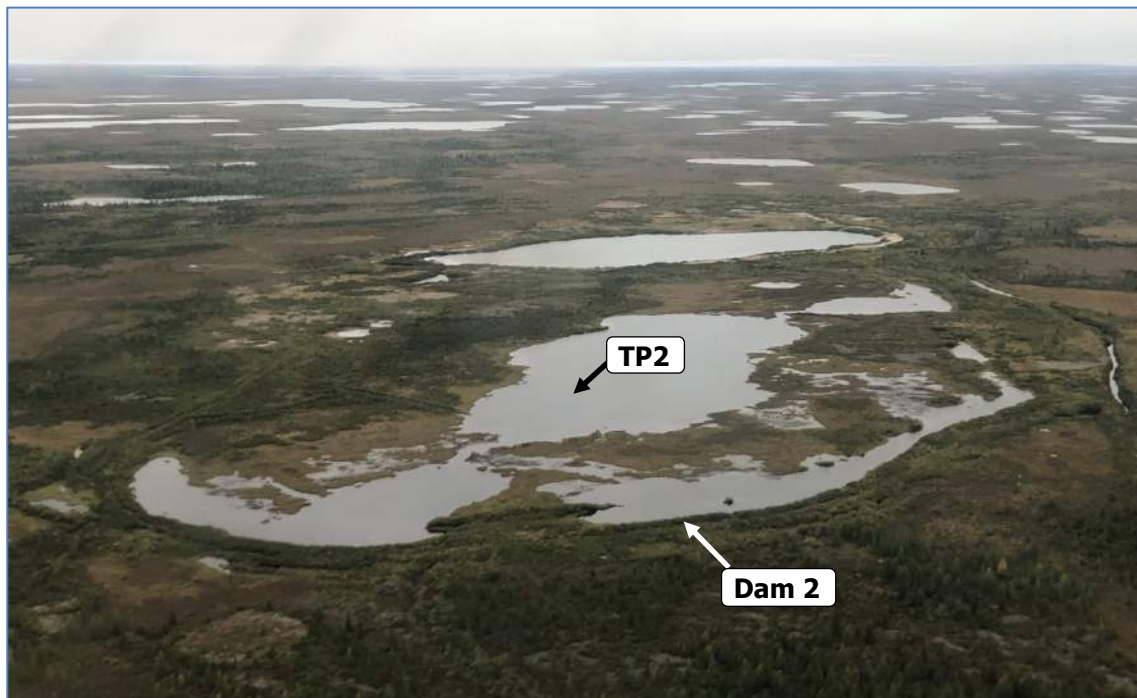
The drainage area for TP2 is significantly larger than for TP1. An area view of TP2 and Dam 2 is shown in Photo 16.

Photo 16: Aerial view of TP2 and Dam 2

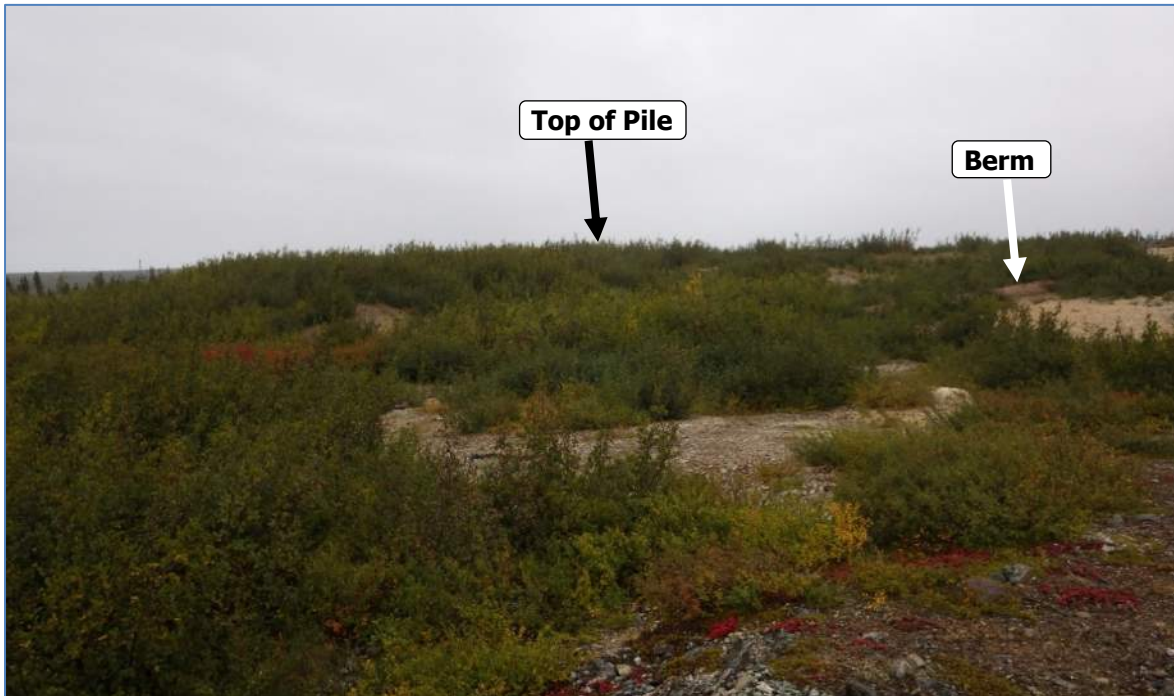
The Shear Lake waste rock pile was inspected on September 1, 2022. The Shear Lake waste rock pile is located on the east side of Shear Lake some 4.5 km north of the former mill site (at the TP1). The pile was reportedly capped with local, compacted glacial till to promote runoff and reduce infiltration. Some erosion control on the till cap was performed in 2005. A berm approximately 0.5 m high is surrounding the pile near the bottom reaching to the pile top on the south and west sides. The berm near the top of the pile on the west side is shown in Photo 17. Photo 18 (A) shows an aerial view of the Shear Lake waste rock pile in 2022.

Photo 17: West side of the Shear Lake waste rock pile (looking east).

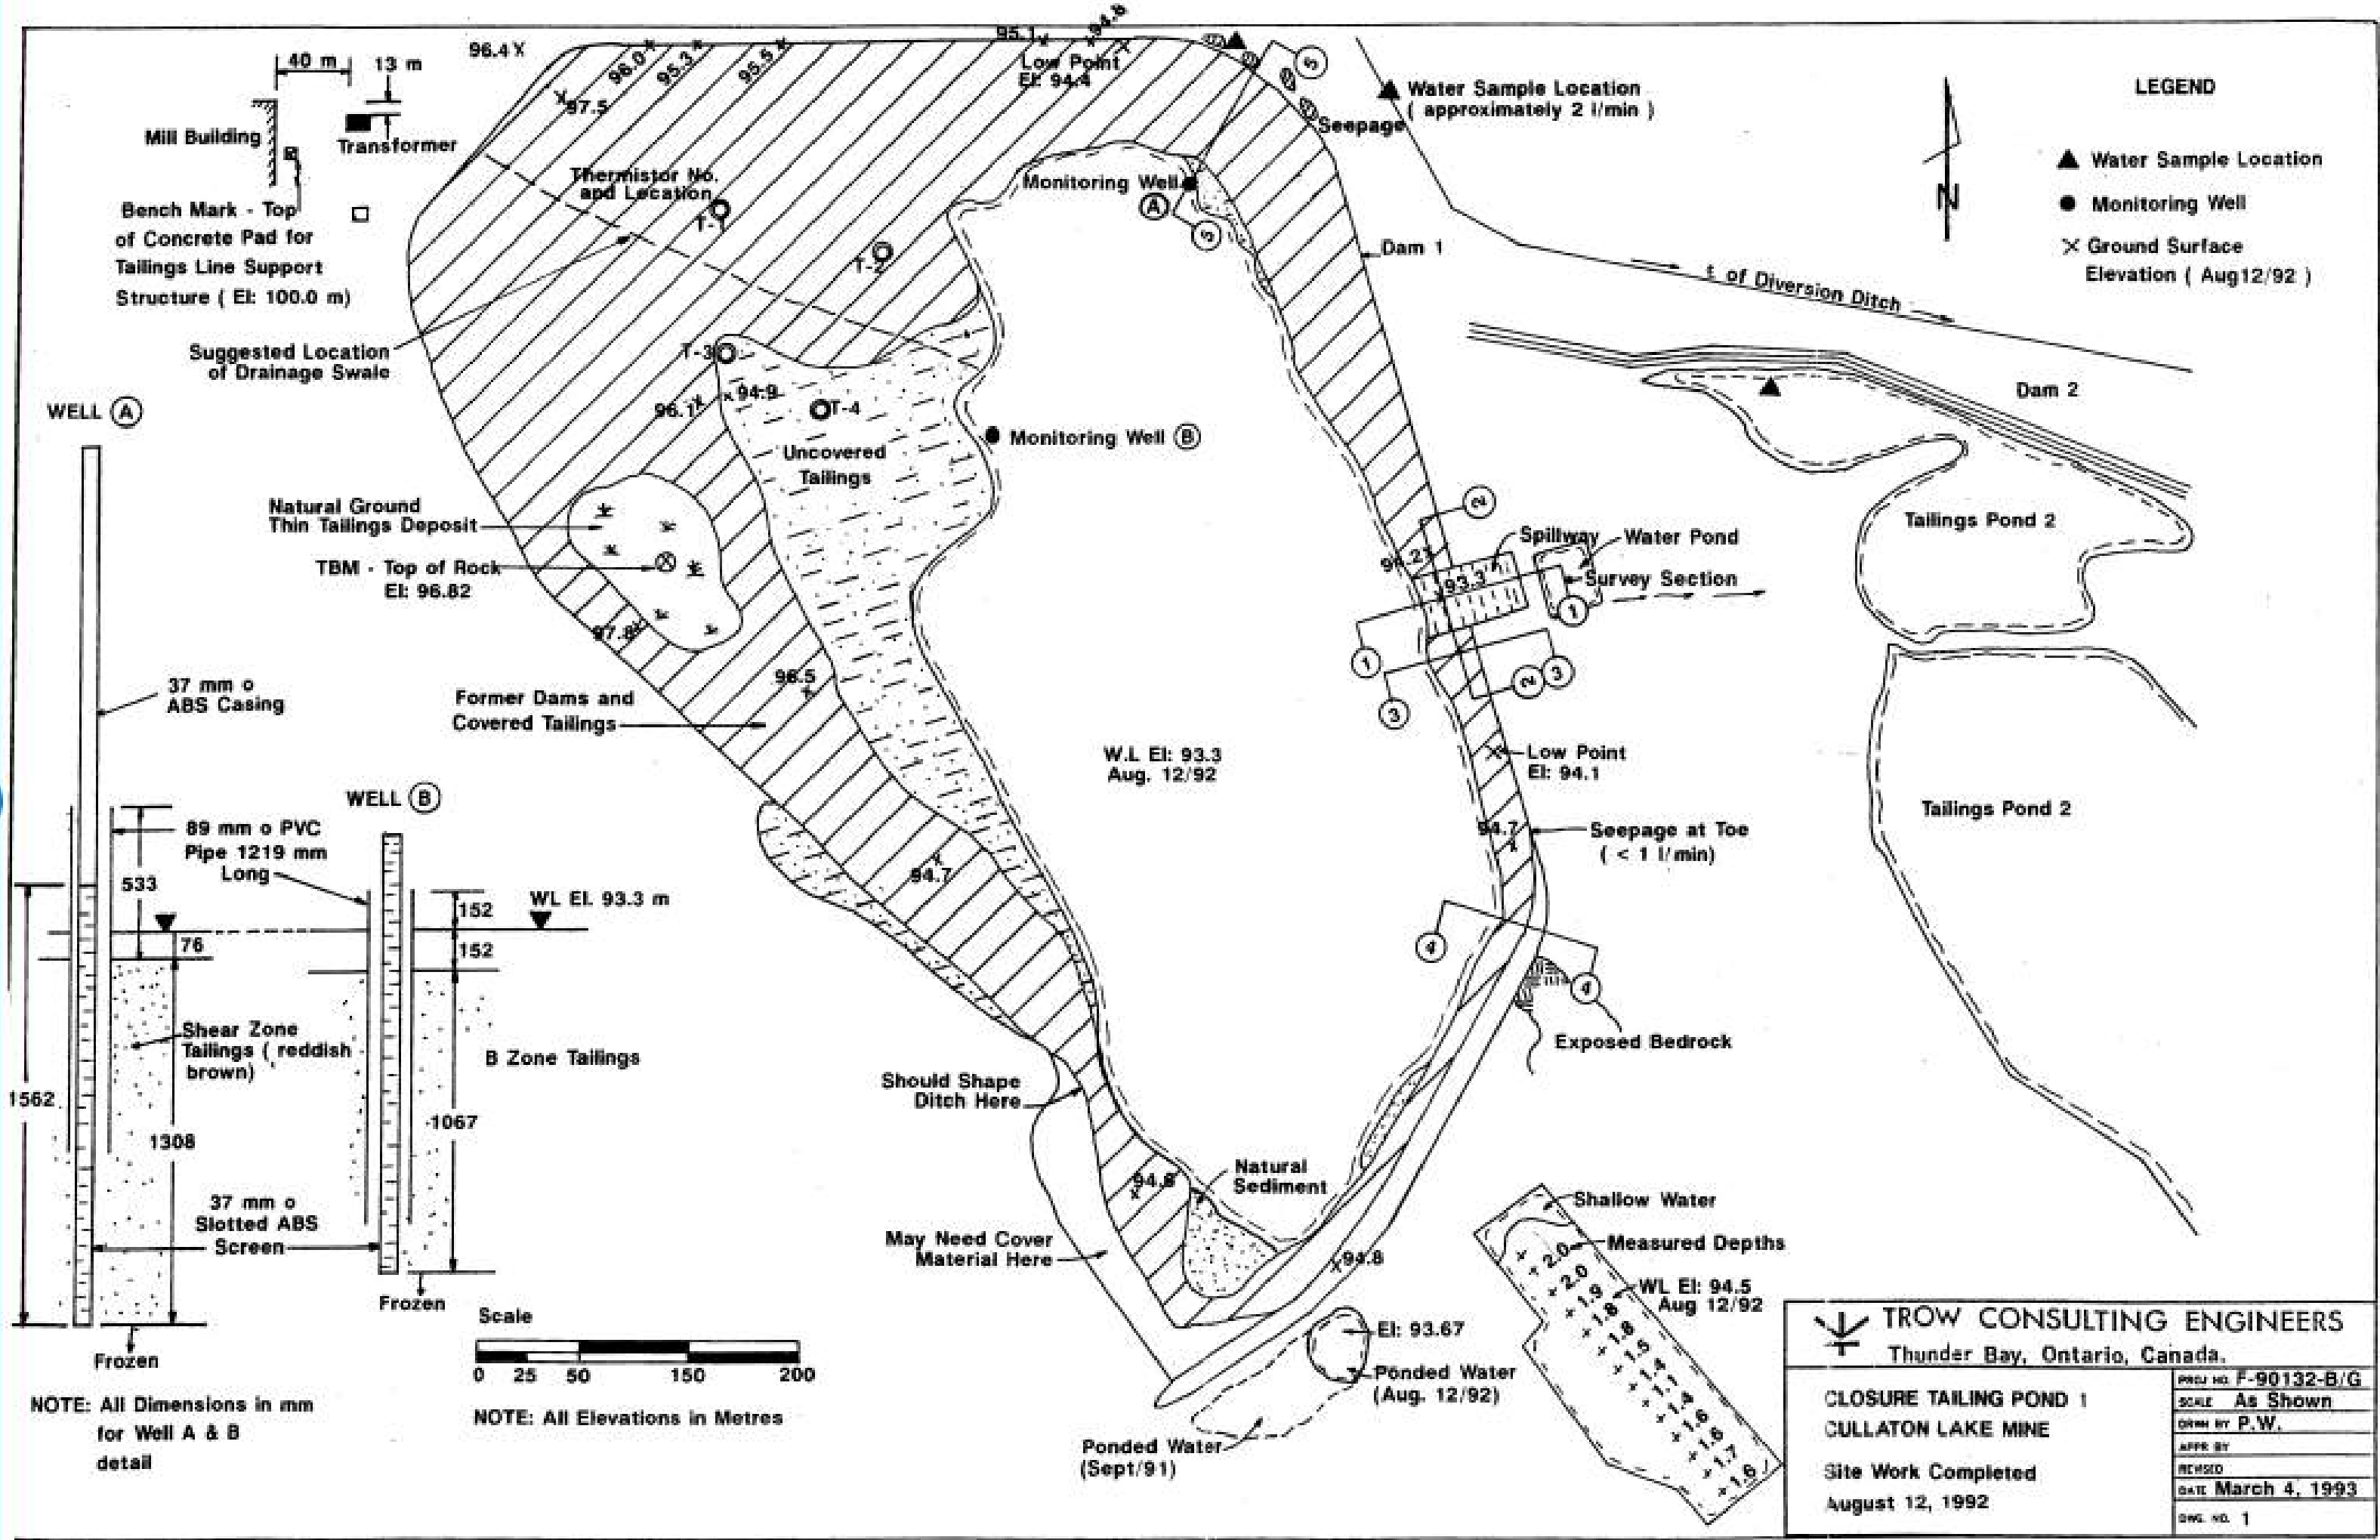
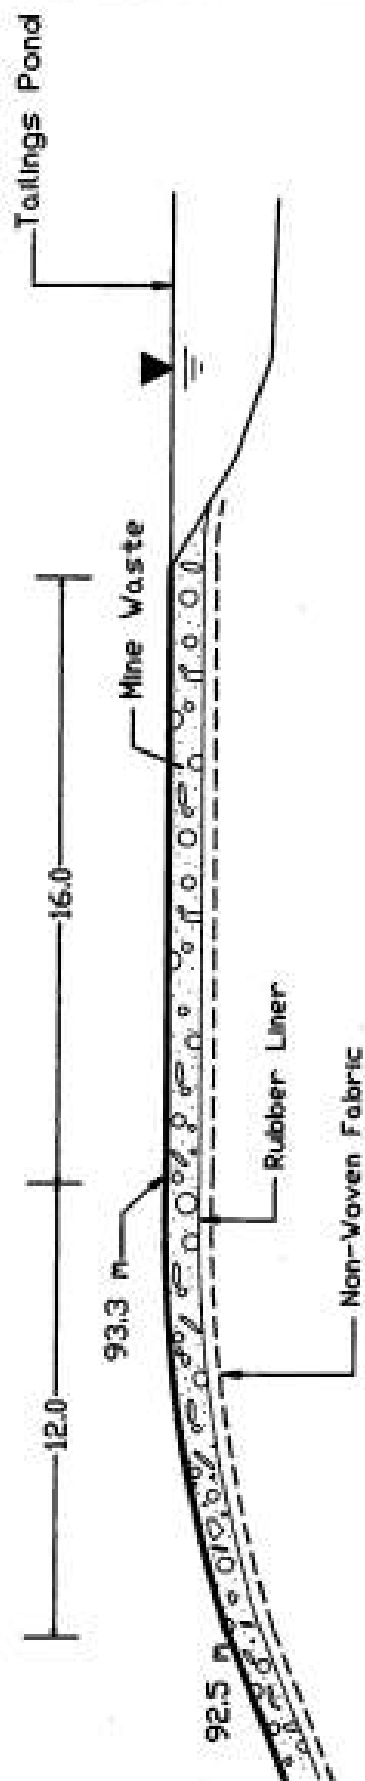
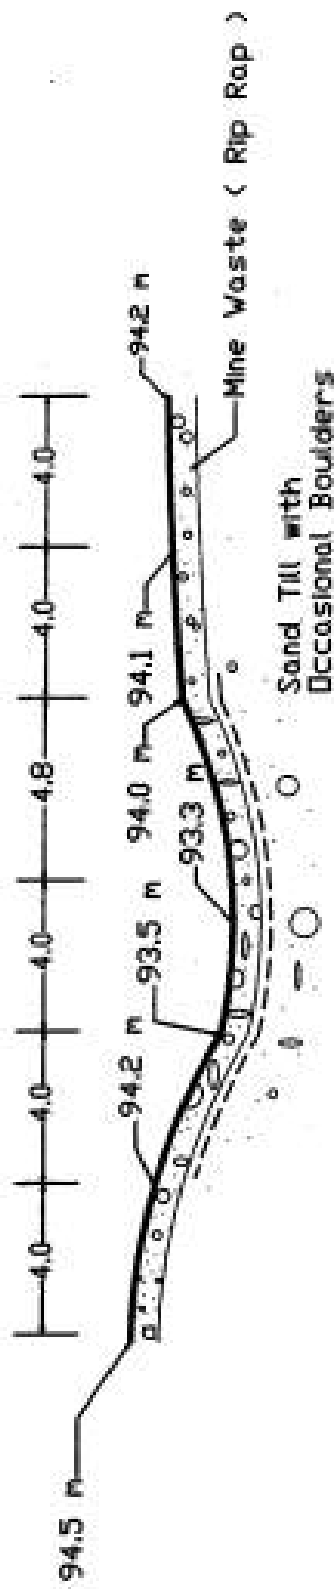
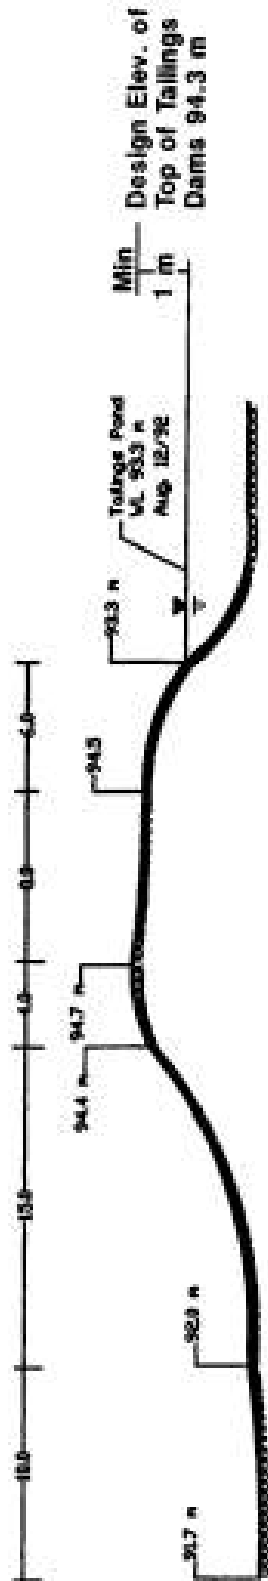
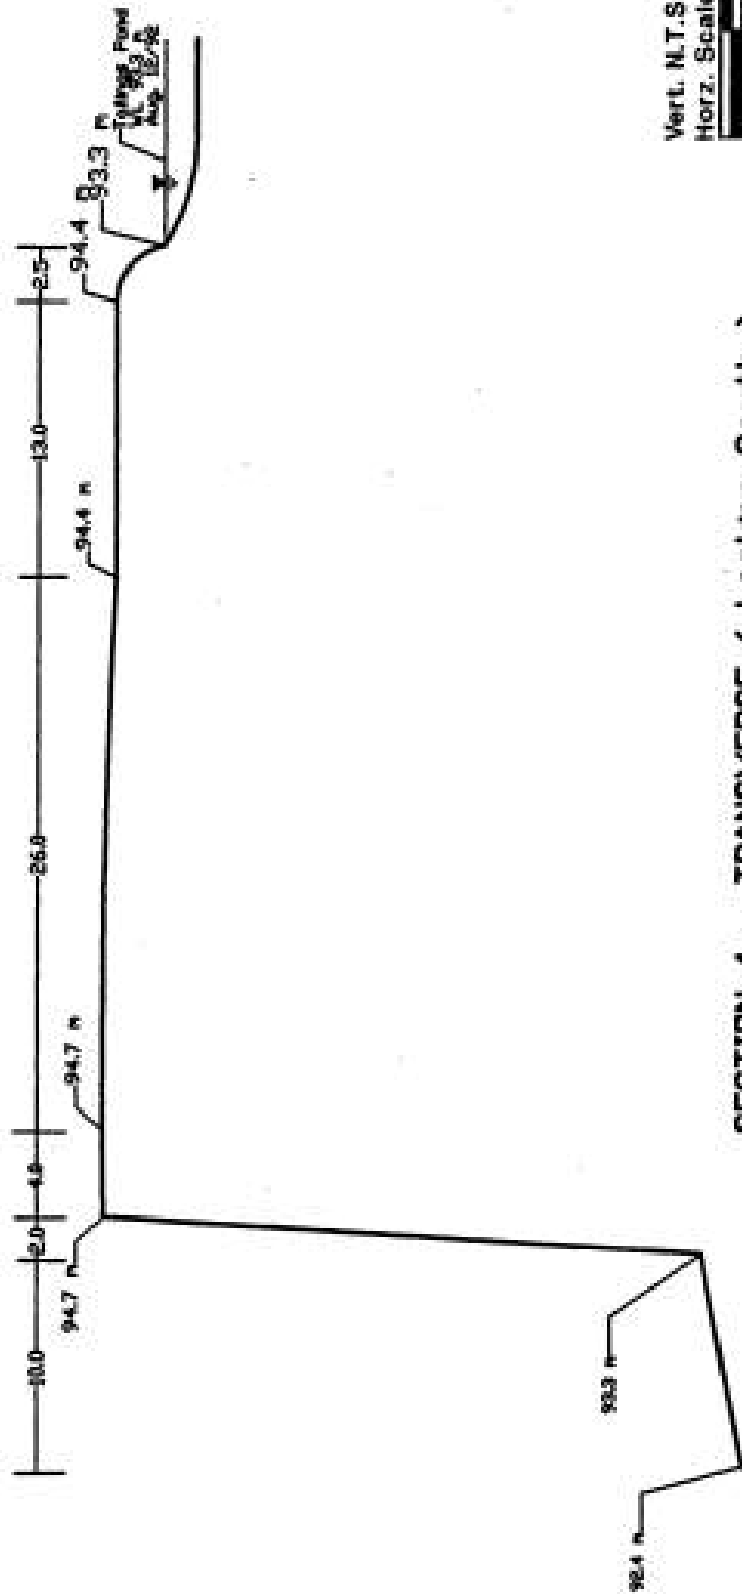
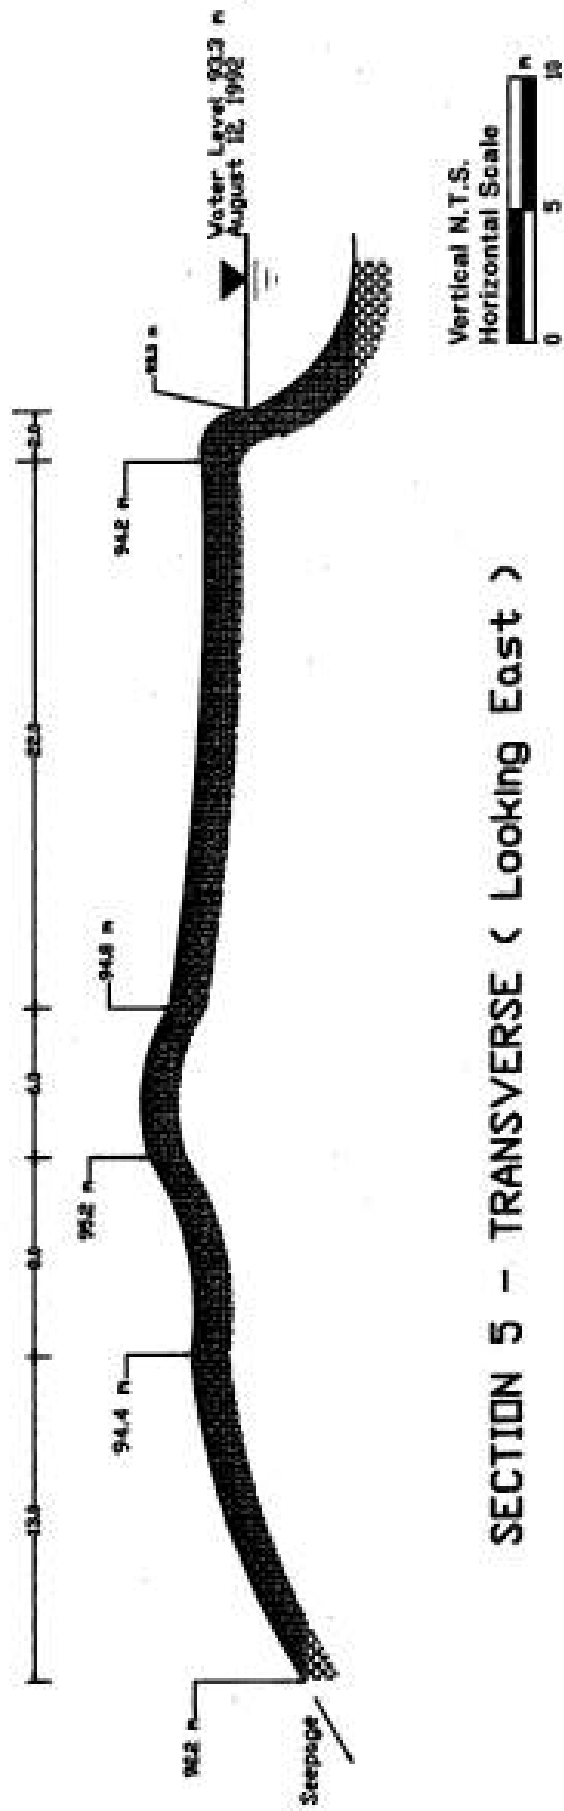
**CLOSURE TAILING POND 1
CULLATON LAKE MINE**

The attached Drawings No. 1 to 4 (Appendix B), are reproduced from the 1992 inspection report and serve to illustrate the conditions at the time. Observations with respect to the tailings impoundment included:

- the Pond No. 1 spillway exceeds the design requirements (wider channel and flatter slopes) given in the Closure Plan and was constructed with non-woven filter fabric on the cohesionless subgrade soil and covered with a rubber liner and about a 300 mm thick layer of graded waste rock;
- a few minor seeps were observed on the downstream side of Dam No. 1;
- no recommendations were made other than to conduct a detailed site survey.
