October 3, 2005

Reference: F-90132

***2005 Tailings Dam Examination  
Cullaton Lake Gold Mine, Nunavut  
Licence NWB1CUL020***

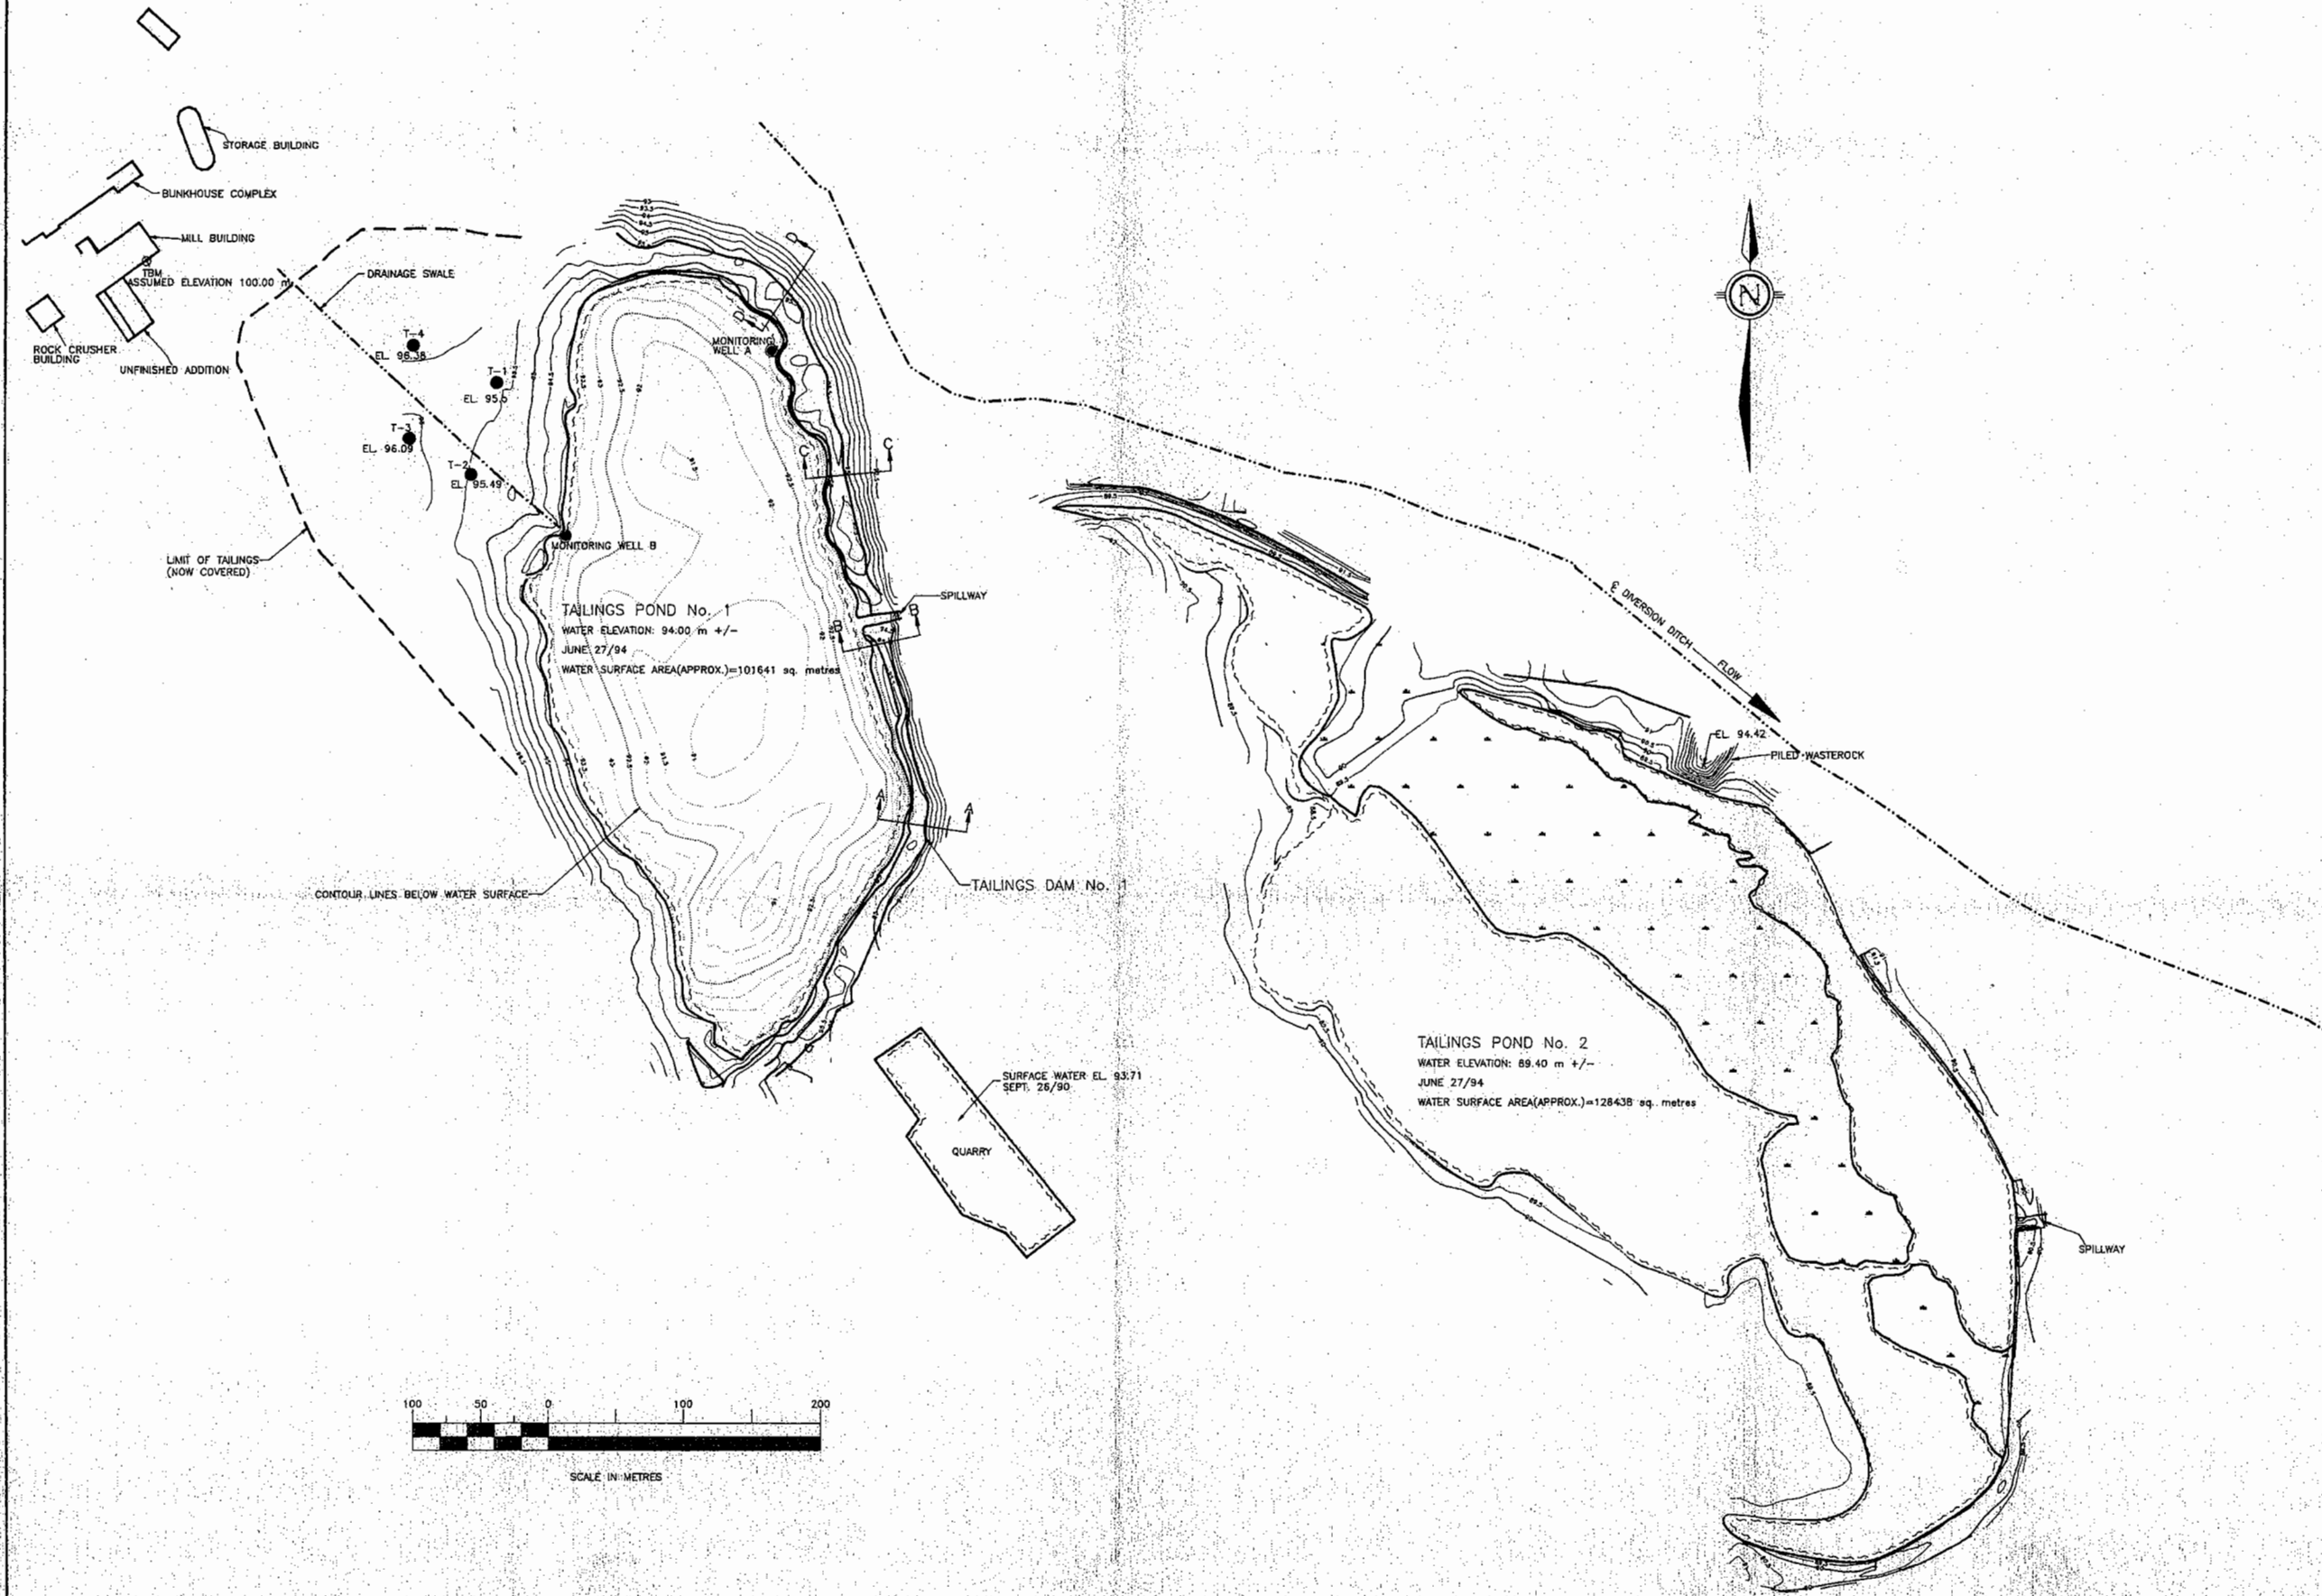
Further to your authorization, we have carried out a visual examination of the tailings impoundment facility at the above noted site. The attached Dwg. No. 1 in Appendix A, (January 30, 1995) illustrates the general layout of the facility.
