February 28, 2011

Reference: THB-000090132-A0

***2010 Tailings Dam Examination  
Cullaton Lake Gold Mine, Nunavut  
Licence NWB1CUL0207***

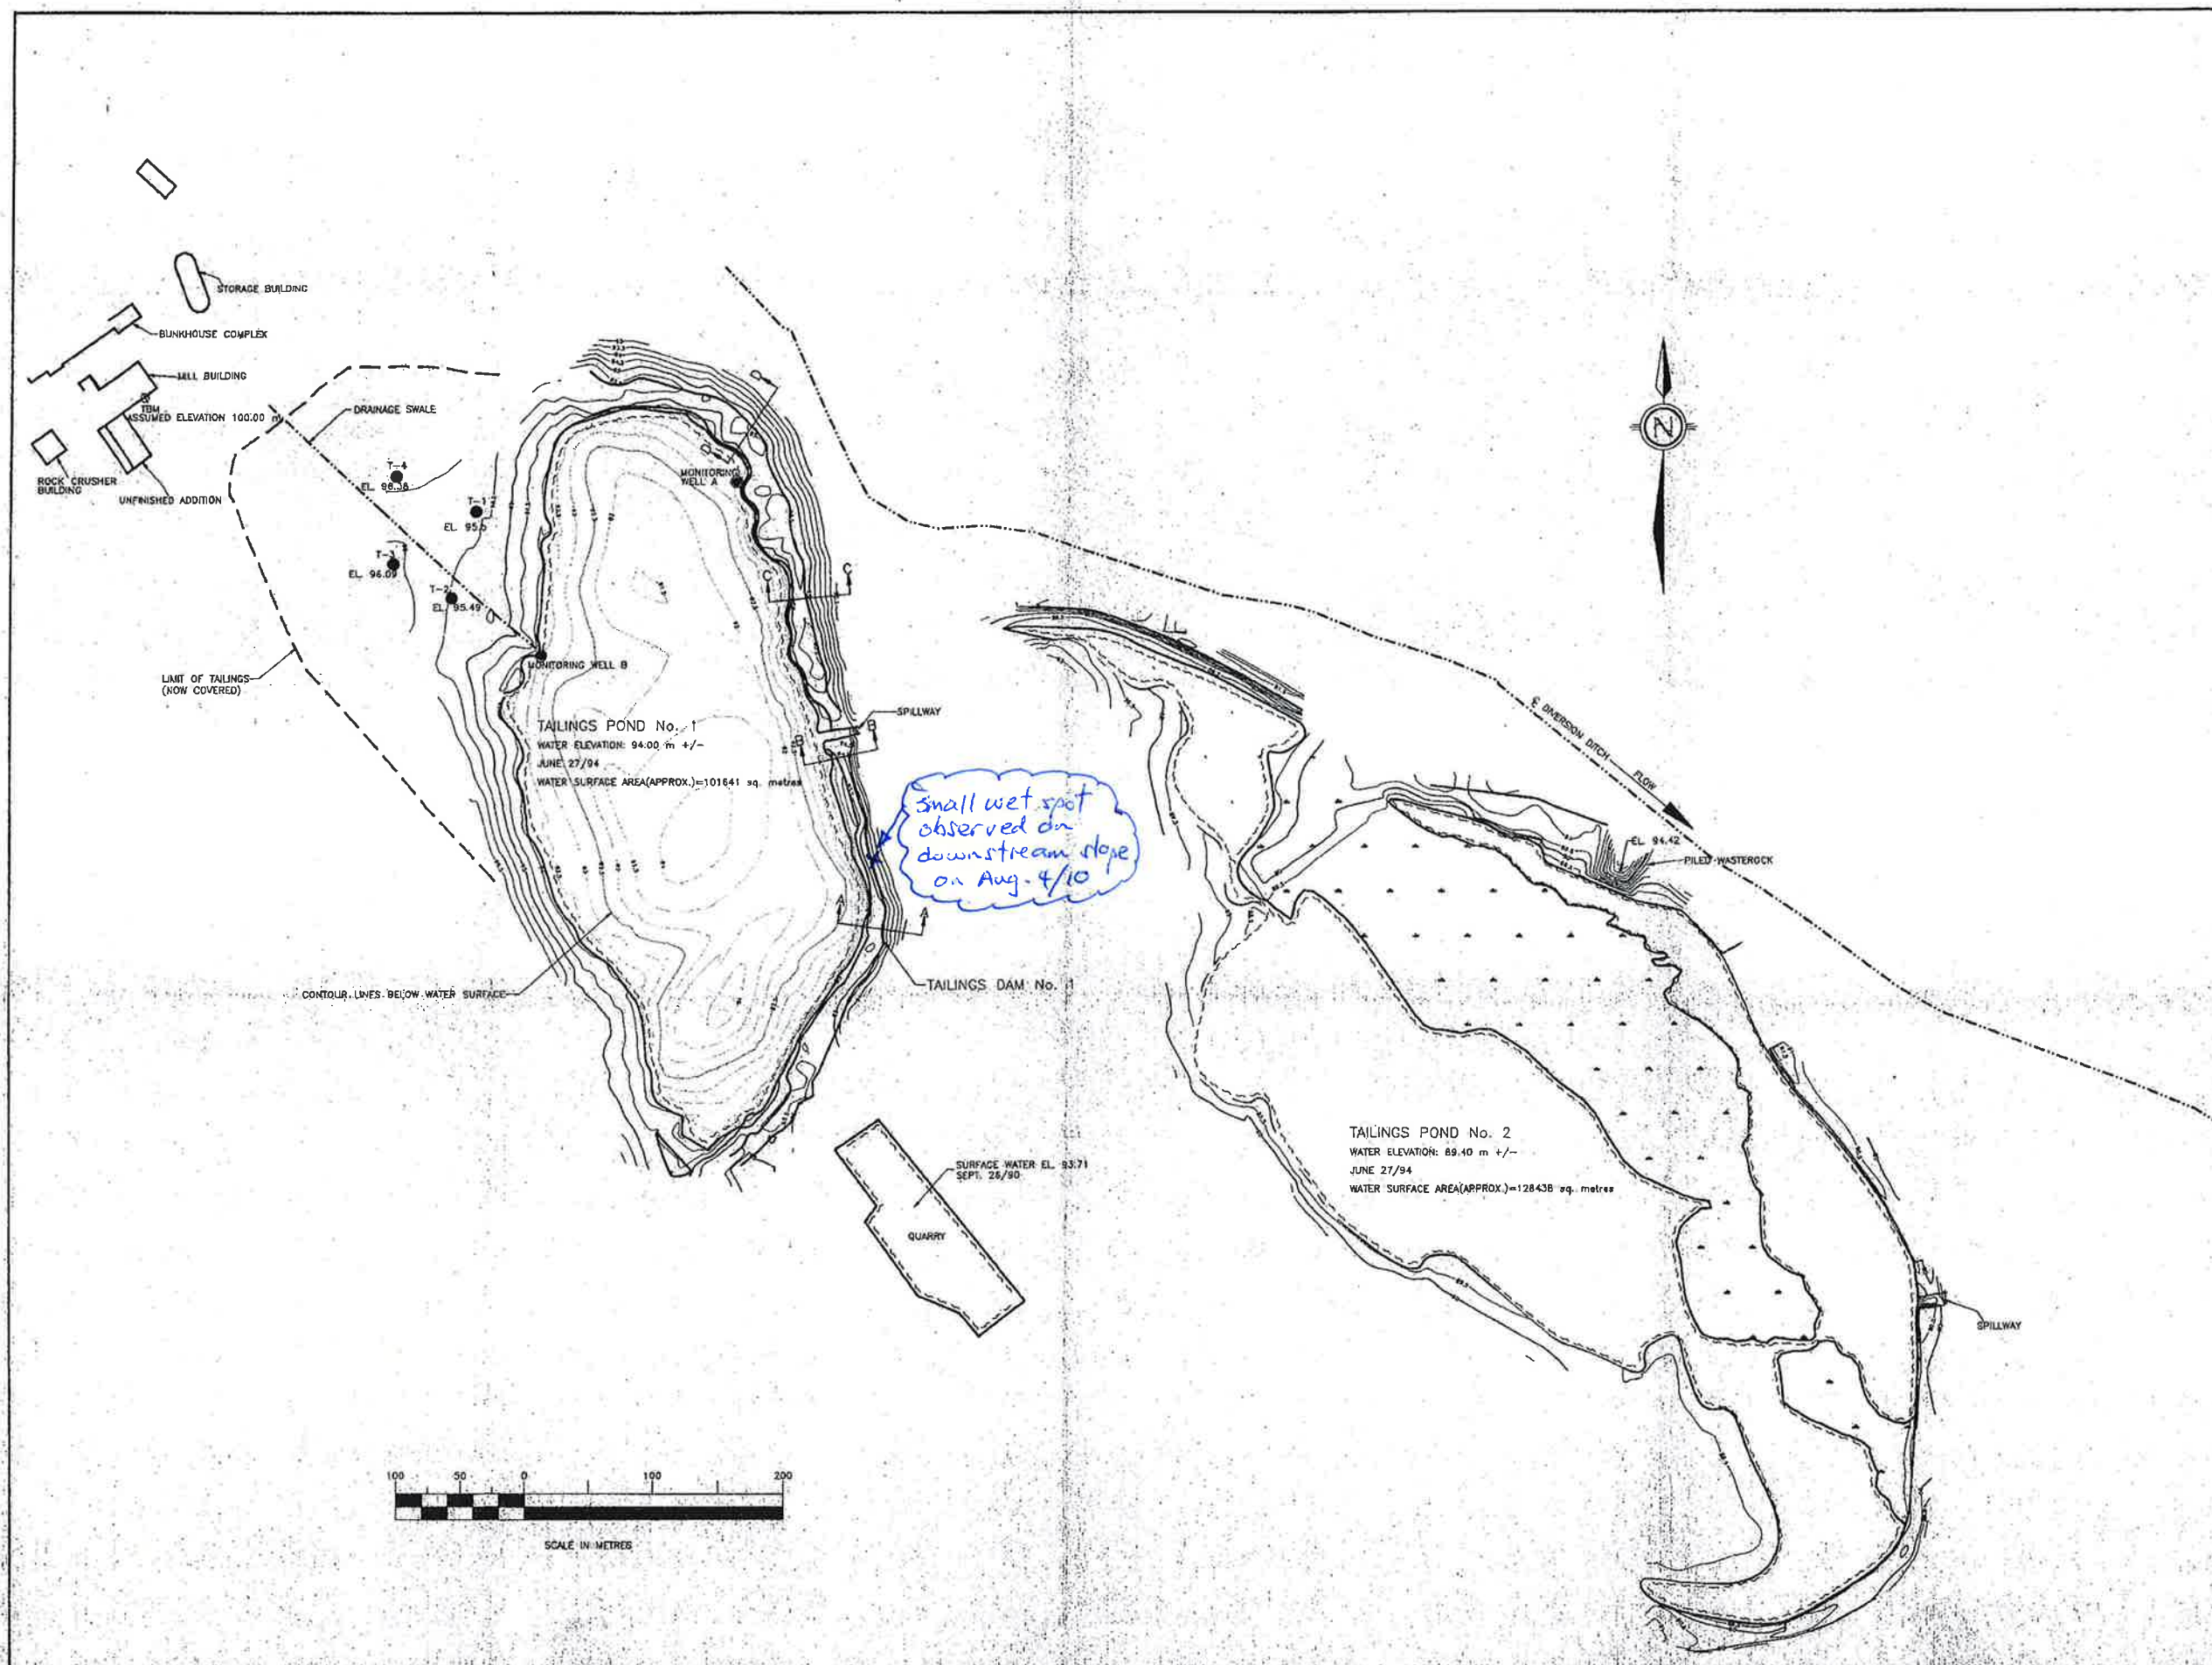
No seepages were observed on the day of inspection. However, a wet spot was observed about halfway down the downstream slope of the dam (see Photo 5), south of the spillway, at the approximate location shown on Figure 1 in Appendix A. As no flow was visible, it was not possible to determine if this was, in fact, a seep, or the result of recent precipitation that had pooled and not evaporated. Based on a hand level measurement, the base of the wet spot was about 150 mm to 300 mm below the Pond No. 1 water level on the date of site visit. For monitoring purposes, this location should be staked/marked in the field during the next site visit for ease of locating it in the future.

It is recommended that the condition of the Dam No. 1 spillway channel continue to be monitored for erosion and if any is apparent, remedial measures, such as the addition of additional rockfill, be implemented. In addition, the wet spot noted on the downstream side of Dam No. 1, south of the spillway, should be marked in the field and monitored during each subsequent visit.
