**CULLATON LAKE MINE
DAM SAFETY REVIEW**

**Report
to
Barrick Gold Corporation**

Date: July 20, 2016
File: 19-7004-0

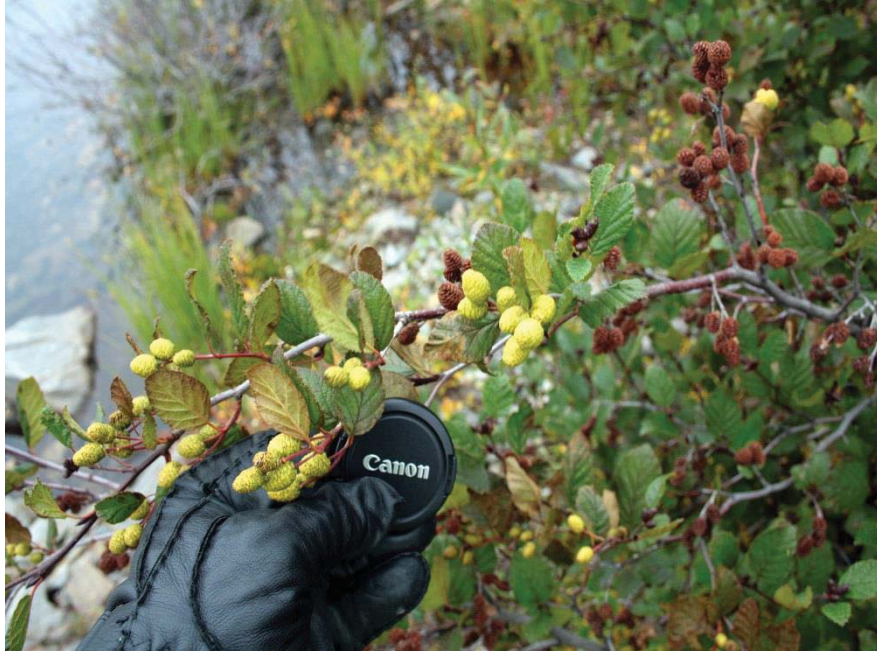
- Photo 5 shows a branch of the typical pioneer bush species which has made a substantial contribution to the revegetation of exposed surfaces at the site.

Photo 5. Pioneer species of bush which has rapidly accelerated in growth this summer over all exposed areas.

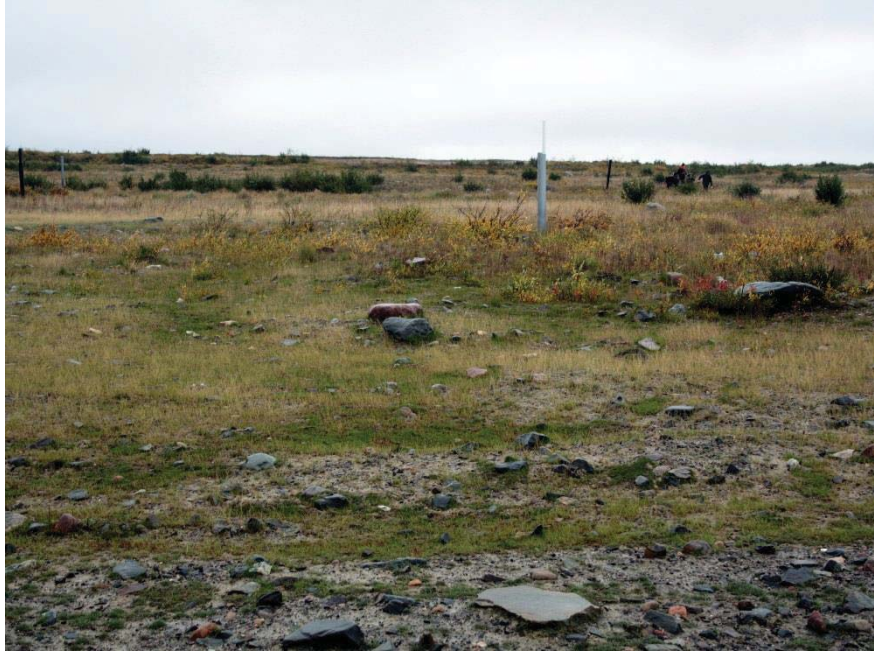
- Photo 15 is a duplicate photo, showing the extent to which the natural regrowth of vegetation is progressively covering the tailings dry cover. This becomes apparent when comparing this photo to earlier inspection records by EXP (2014b).

The locations of old thermistors are shown in Photo 15. They have fallen into disrepair after over fifteen years of life and are no longer relied upon.

Photo 15. (same as previous) Note area where till is now being gradually covered with natural regrowth of vegetation.

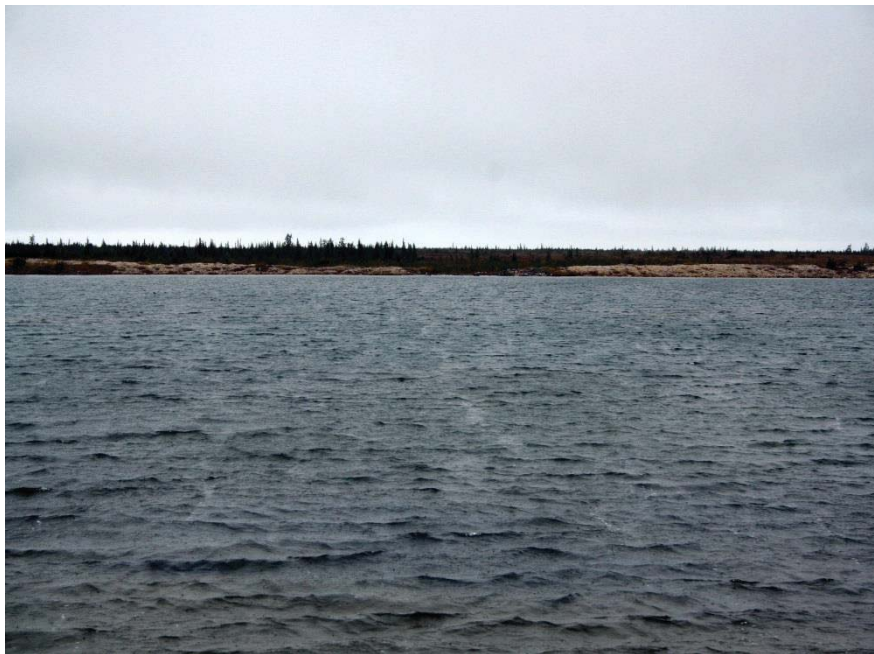
- Photo 18 is an east facing view of the surface of TP1, looking towards the main embankment, from the water's edge.
- Photo 19 is a west facing view showing the difference in vegetation between natural ground (in the distance) and revegetated tailings cover (in the foreground). While the natural ground is richer in biodiversity, it is clear that nature is progressively restoring, over time.

Photo 18. East facing view of the main embankment of TP1.

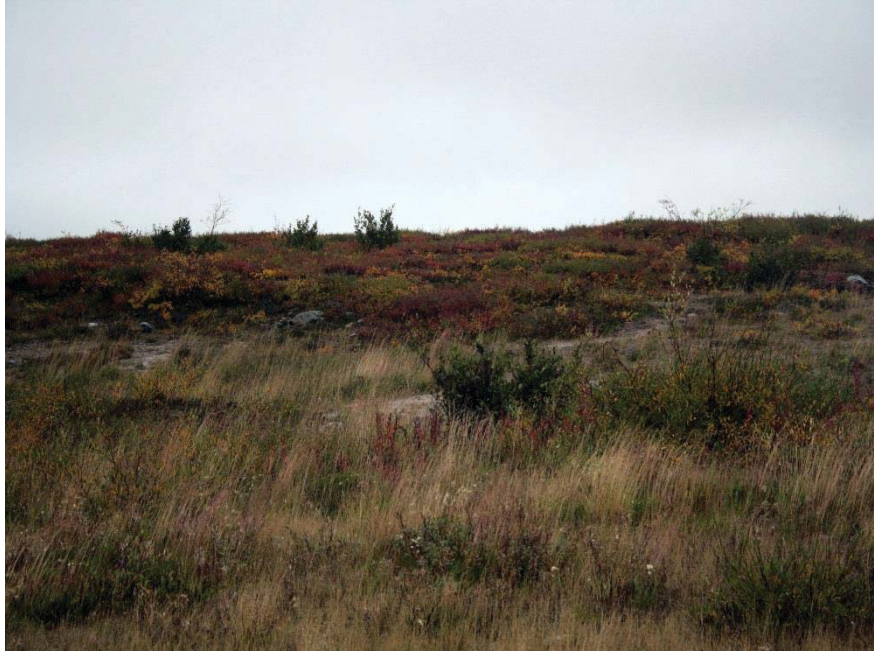
Photo 19. View westwards from TP1 showing natural vegetation in distance, reclaimed tailings in foreground.

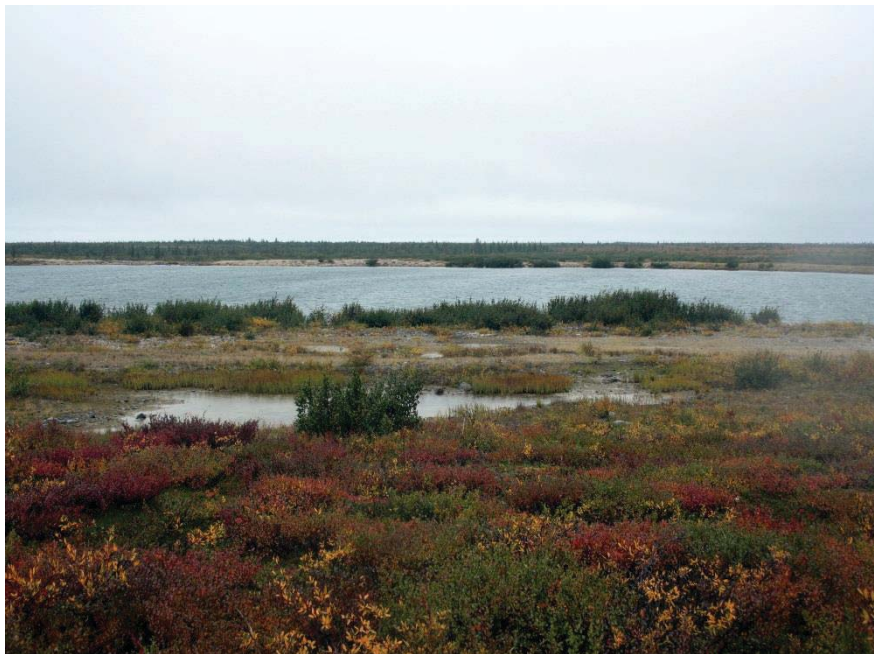
- Photo 20 is a shot in the reverse direction where three environments are clearly visible - natural habitat (in the foreground), revegetated tailings cover in mid-picture, and the water surface of TP1 in the distance.

Photo 20. E facing view from W of TP1 showing progression in revegetation.

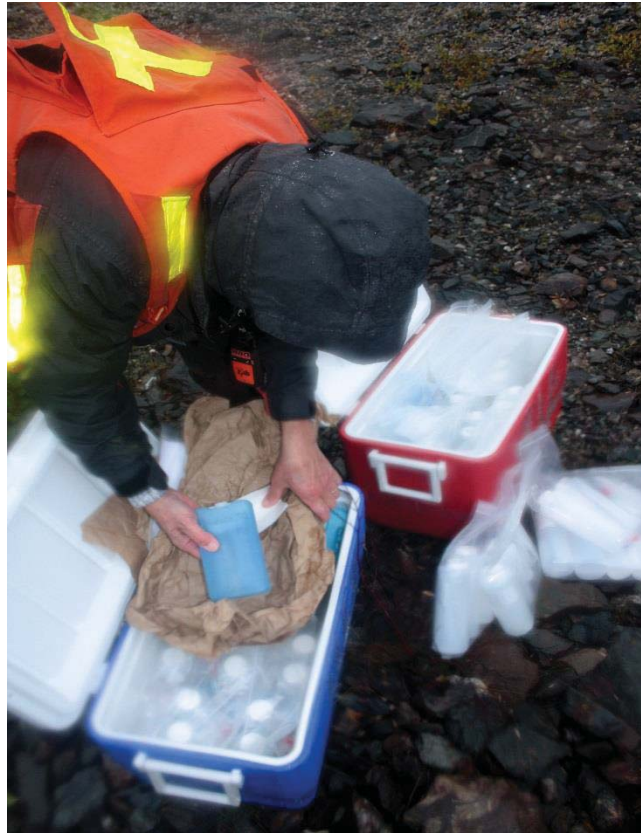
Photo 23. Extensive Water Sampling Program.

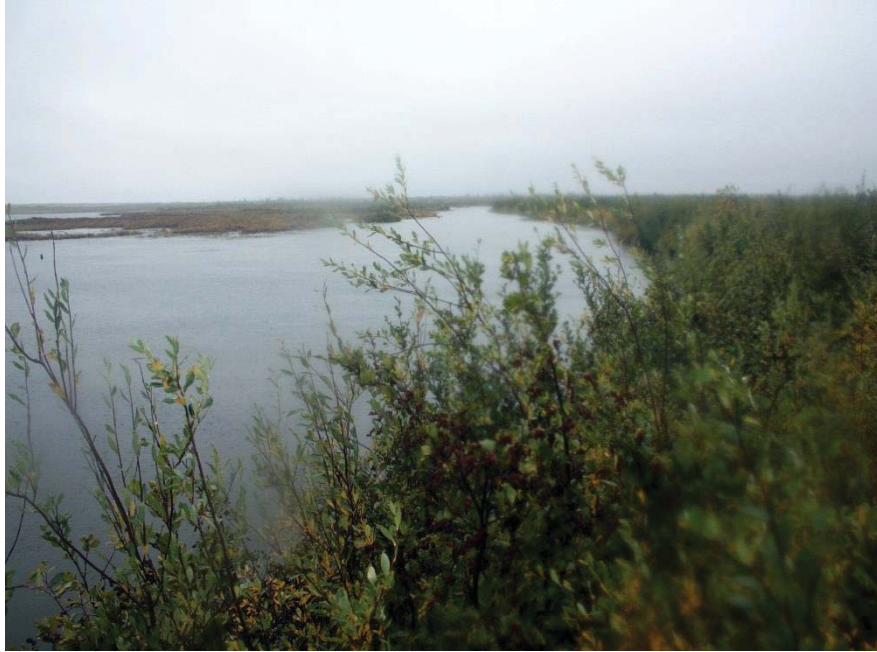
- Photo 25 shows the surface of the contents of TP2, looking north-west towards TP1 (not visible in the photo).

Photo 25. View looking NW from no. 2 spillway towards TP1.

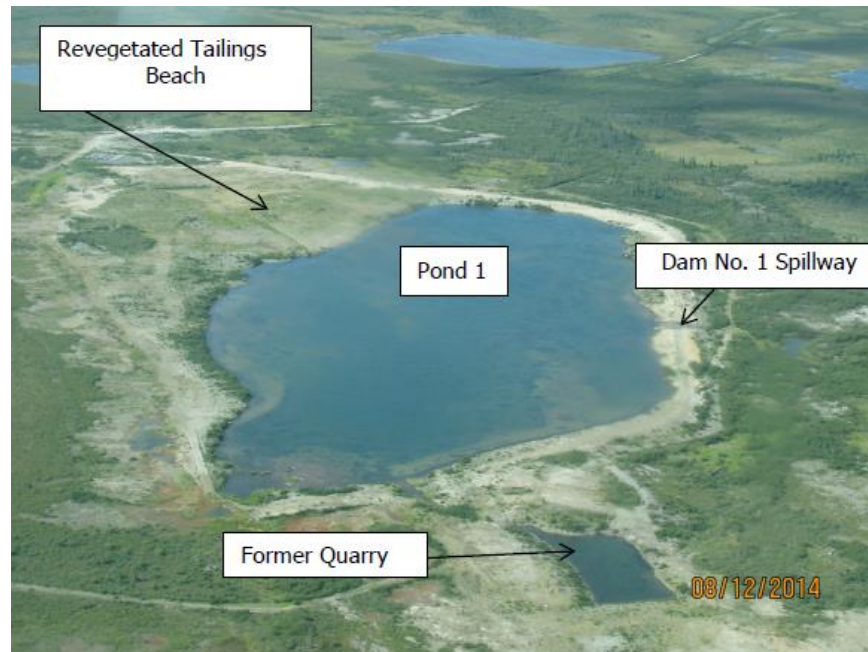
Photo 26. Tailings facility looking north [Reference: EXP 2014 annual geotechnical inspection report]

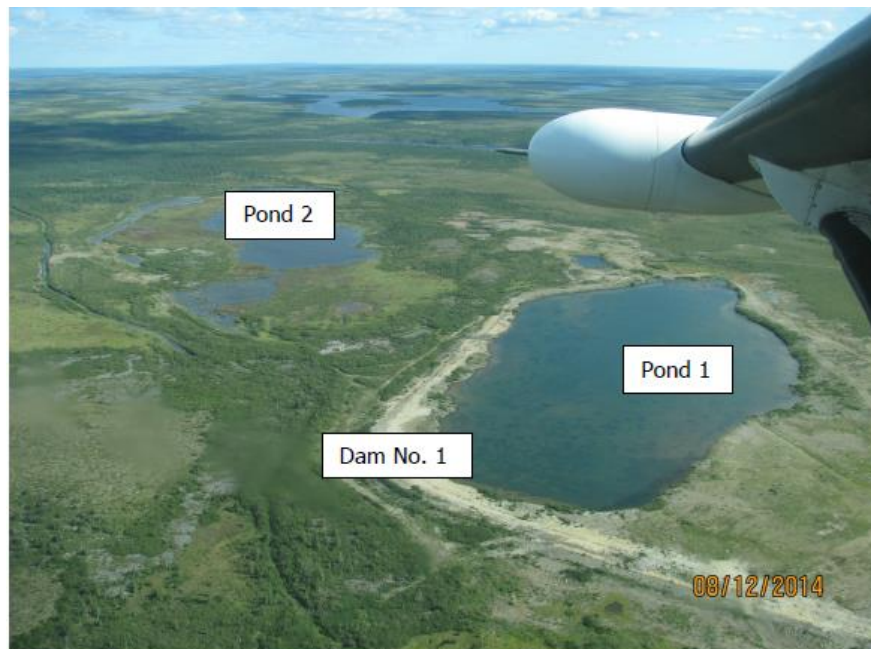
Photo 17. Tailings facility looking southeast [Reference: EXP 2014 annual geotechnical inspection report]

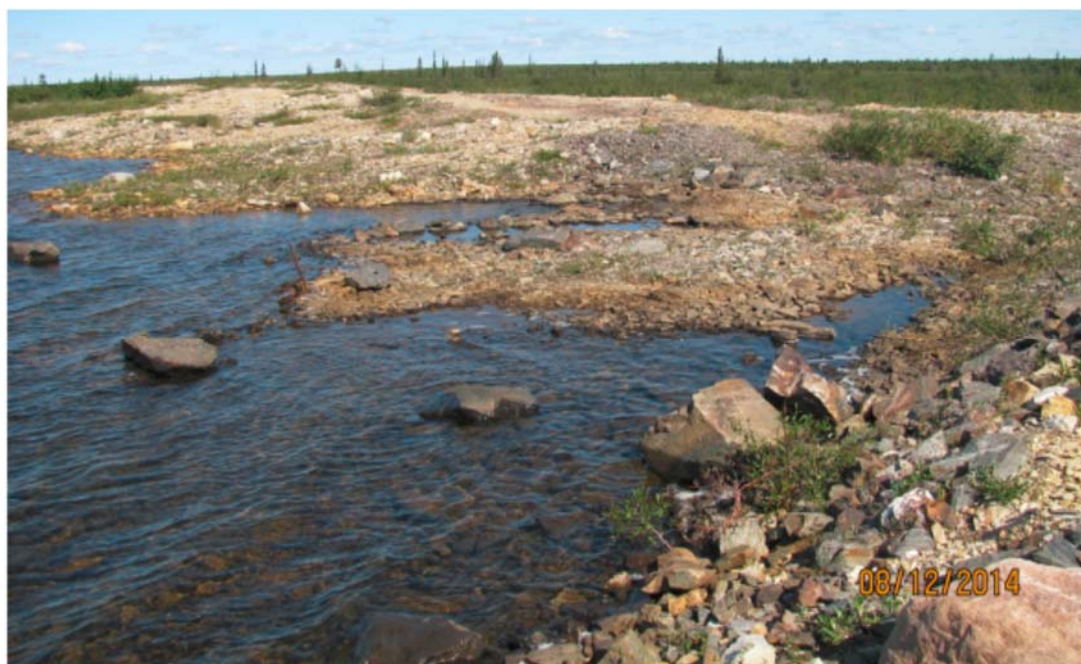
Hydrotechnical routing was conducted for the IDF as determined by the Regional Analysis (1.01 m³/s) and the Rational Method (2.58 m³/s). The one dimensional (1D) U.S. Army Corps of Engineers HEC-RAS hydraulic model was utilized to route flow through Spillway 1. In addition, Photos 3-1 and 3-2 contained in the 2014 Tailings Dam Examination (EXP, 2014b) were reviewed when assessing roughness coefficients to be applied for the spillway.

Photo 3-1 – TP1, Spillway 1 Inlet and Crest (Photo 6 of EXP, 2014)

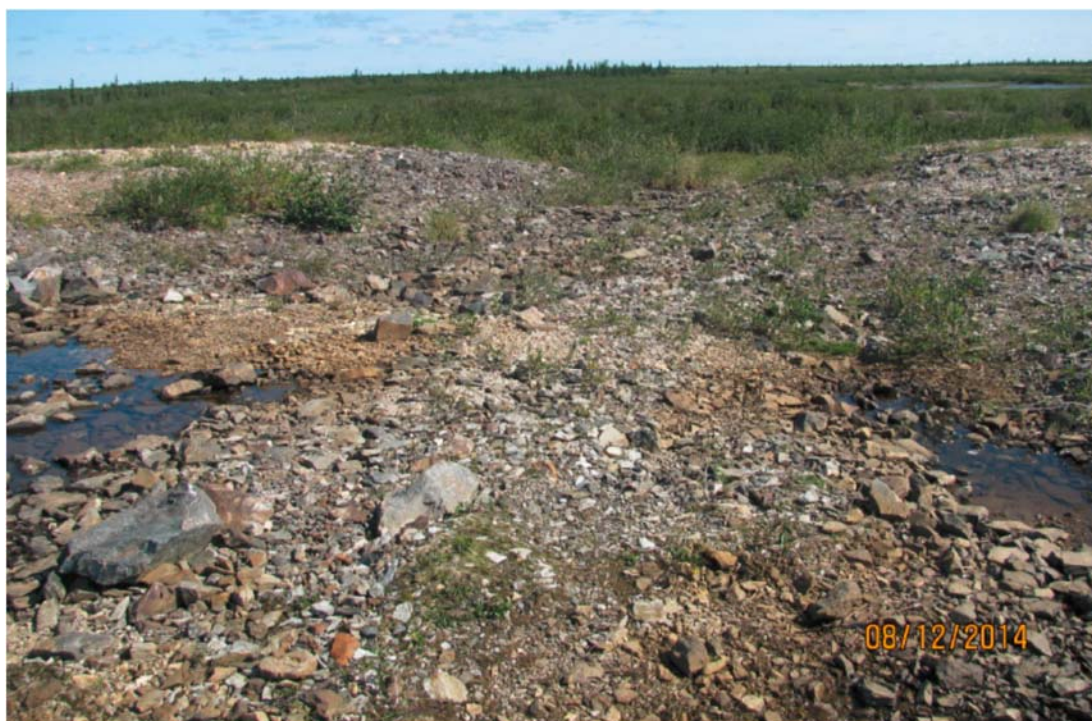
Photo 3-2 – TP1, Spillway 1 Downstream Channel (Photo 7 of EXP, 2014)

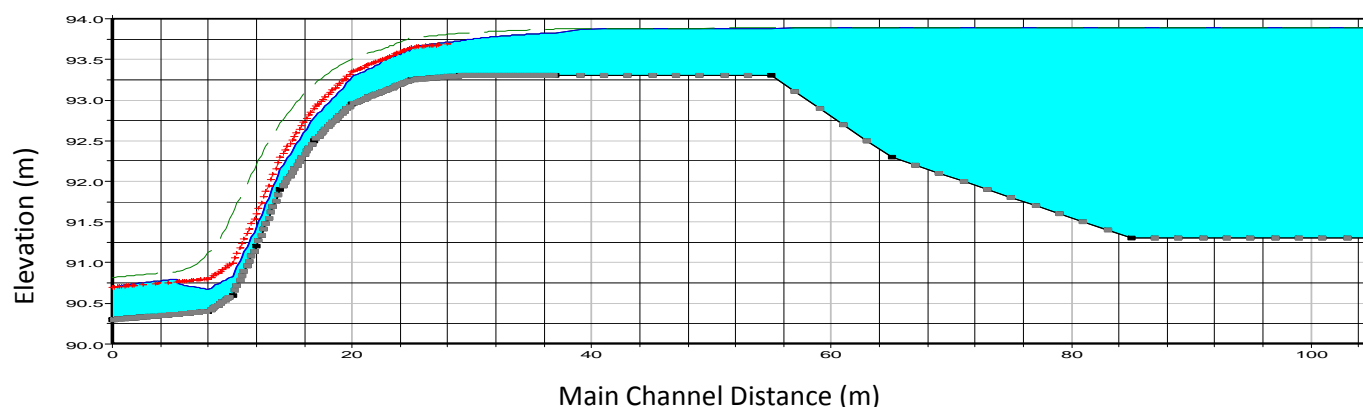
Figure 3-1 in Appendix D shows a section view of the routing of IDF flow over Spillway 1, as extracted from the HEC-RAS model.

Figure 3-1 – Section View Showing the Routing of the IDF through Spillway 1
