September 25, 2018

Re: **Project No. THB-00090132-HG**  
**2018 Tailings Facility Examination**  
**Cullaton Lake Gold Mine, Nunavut**  
**Licence 1BR-CUL1118**

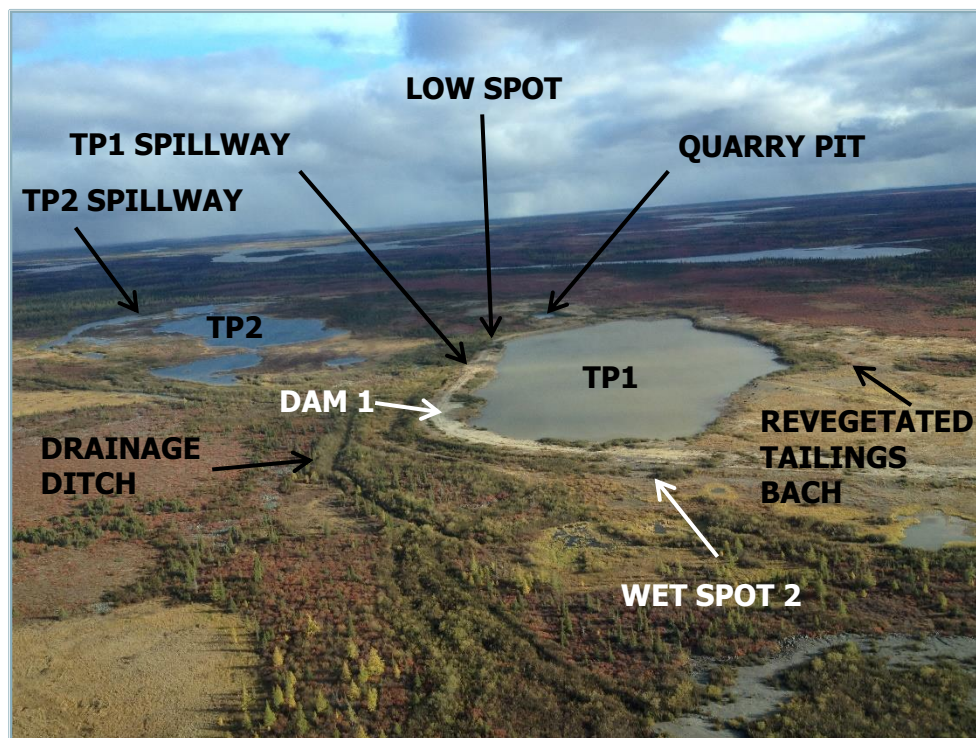
Photo 1 shows an aerial view of TP1 and its location relative to TP2. Photo 2 shows TP1, the revegetated tailings beach and Dam 1 with the spillway, the low point south of the spillway, and the access road. The tailings beach adjacent to the northwest edge of the pond had been previously covered with local till as reported in Trow's/EXP's previous inspection reports.

Two wet spots that were wet were observed in 2018. Wet Spot 1 was observed in the area of the low point, about 20 m north of the low point and 15 m downstream of the dam toe. Wet Spot 2 was observed on the north side of the dam near the water sampling point 940-22, about 15 m downstream of the dam toe. Wet Spot 1 had a trace of standing water near a rock surface that appeared to be bedrock, as shown in Photo 7. Wet Spot 2 had a trace of standing water by a cluster of boulders, as shown in Photo 8. The elevation of both spots appeared to be below the water level of the pond. The location of both spots is shown on the survey plan in Appendix A and in Photo 1 (Wet Spot 2) and Photo 2 (Wet Spot 1). The area of Wet Spot 1 is marked with pink flagging.

Vegetation on the till covered tailings is small and sparse, as shown in Photos 1 and 2 . However, the density of the vegetation is increasing gradually based on the comparative visual observations of previous years.

*Photo 1: Aerial view of TP1 and TP2 (looking south).*

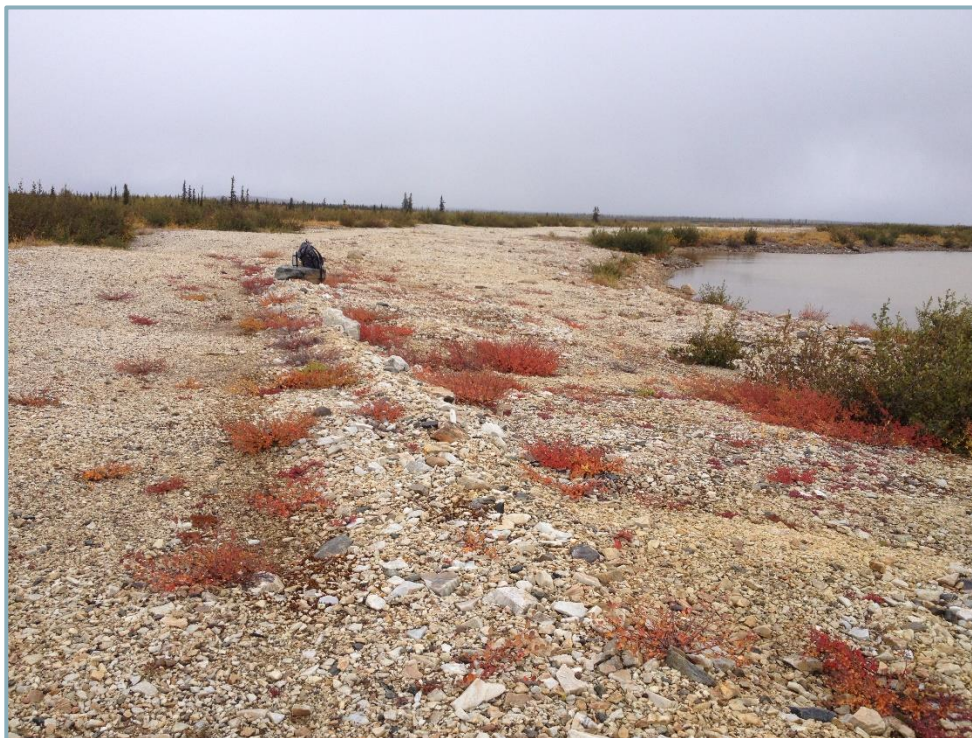
Photos 9 and 10 show views of the upstream face and crest of Dam 1. Typically, the embankment, which is constructed principally with local cohesionless till, is irregular in section and surface grade.

*Photo 9: Dam 1 upstream face and crest north of TP1 spillway (looking southeast).*

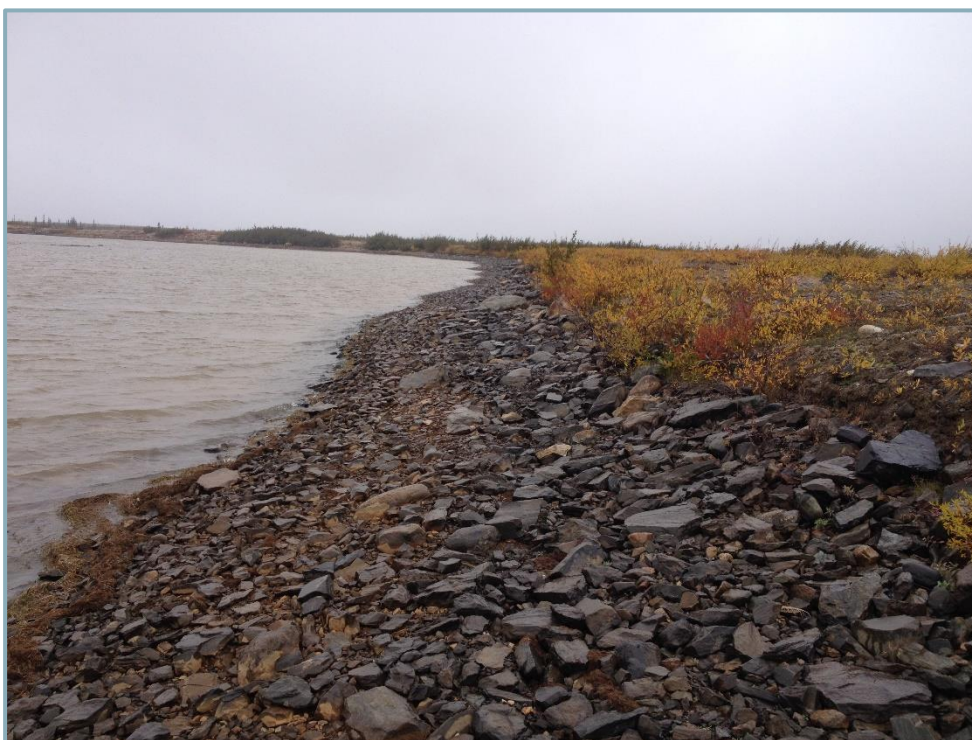
*Photo 10: Dam 1 upstream face south of TP1 spillway (looking north).*

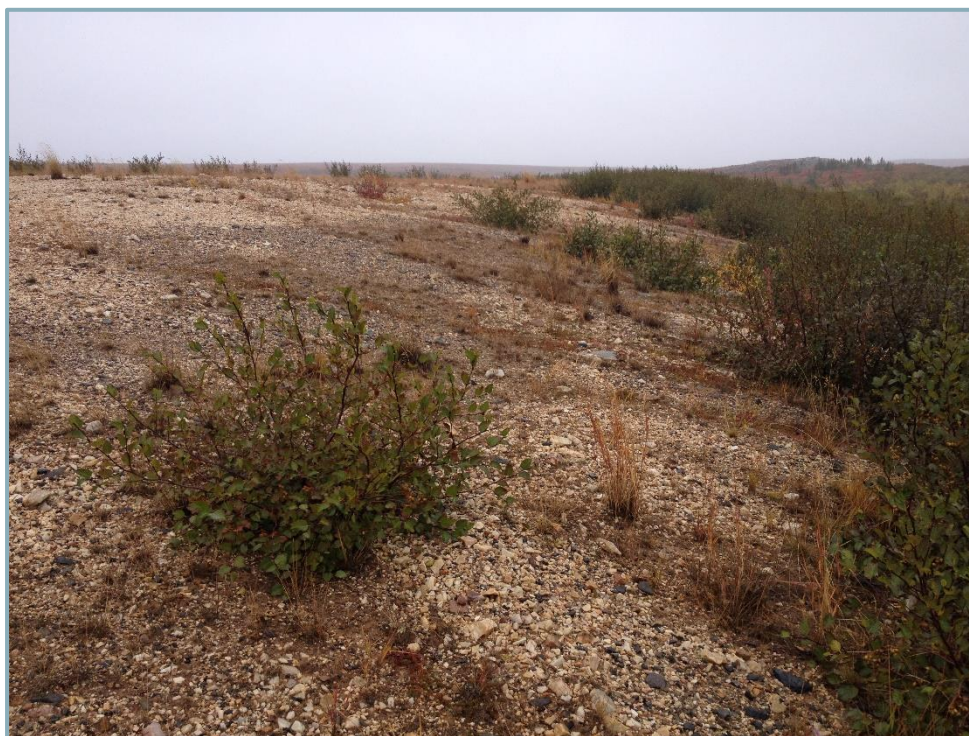
It would be key to note that the efforts by Barrick staff in 2005 to reseed the waste rock cap, especially the side slopes, as erosion control measure improved vegetation in most areas. The aerial view in Photo 17 and the ground view in Photo 21 show that vegetation growth is still sparse on the top of the pile.

Consistent with previous inspection findings, very few small erosion gulleys/channels (20 mm to 30 mm deep/wide) were noted on the side slopes. These generally are short and do not extend the full length of the slope. Most of these had been filled to some extent with small granular material in 2005, to minimize further erosion.

*Photo 21: Top of Shear Lake Waste Rock Pile (looking north).*

Subsequent inspections should be made to verify the efficacy of the vegetation/till cover system. Any erosion gullies that form should be repaired with fine rock/gravel. It is expected that it will take several more years for the vegetation to establish itself fully.
