Cullaton Lake Mine

Closure and Reclamation Plan

PECG Project #
14054

August 10, 2018

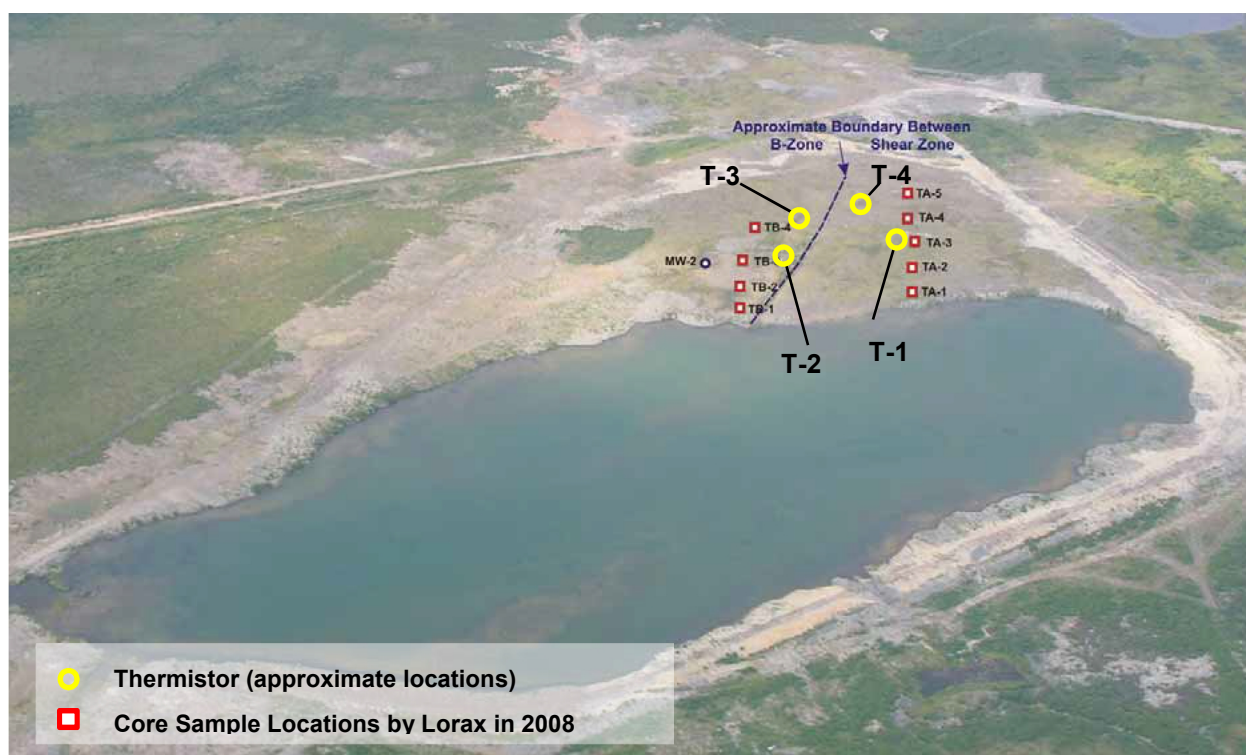
Figure 3-2. Permafrost Monitoring Locations in the Tailings Area

It is worth noting that the depth to permafrost is deeper in early September than in August, because the active layer has had longer to develop, and freezing conditions have not resumed yet for the winter. The most recent data indicate a much smaller active layer thickness in September (in 2015 and 2016) than in 2008. The depth to frost on September 6, 2017 was 1.3 m (exp 2017).

While some of the near-surface tailings have thus been observed to be unfrozen during the summer months, the depth to permafrost has been notably shallower than the earlier measurements made immediately following cover placement in the mid-1990's which observed frozen conditions at approximately 2.3 m depth. In addition, the manual test pits have shown that the layer of unfrozen tailings has been saturated, with the exception of a 0.9 m thick unsaturated zone measured in 2008.

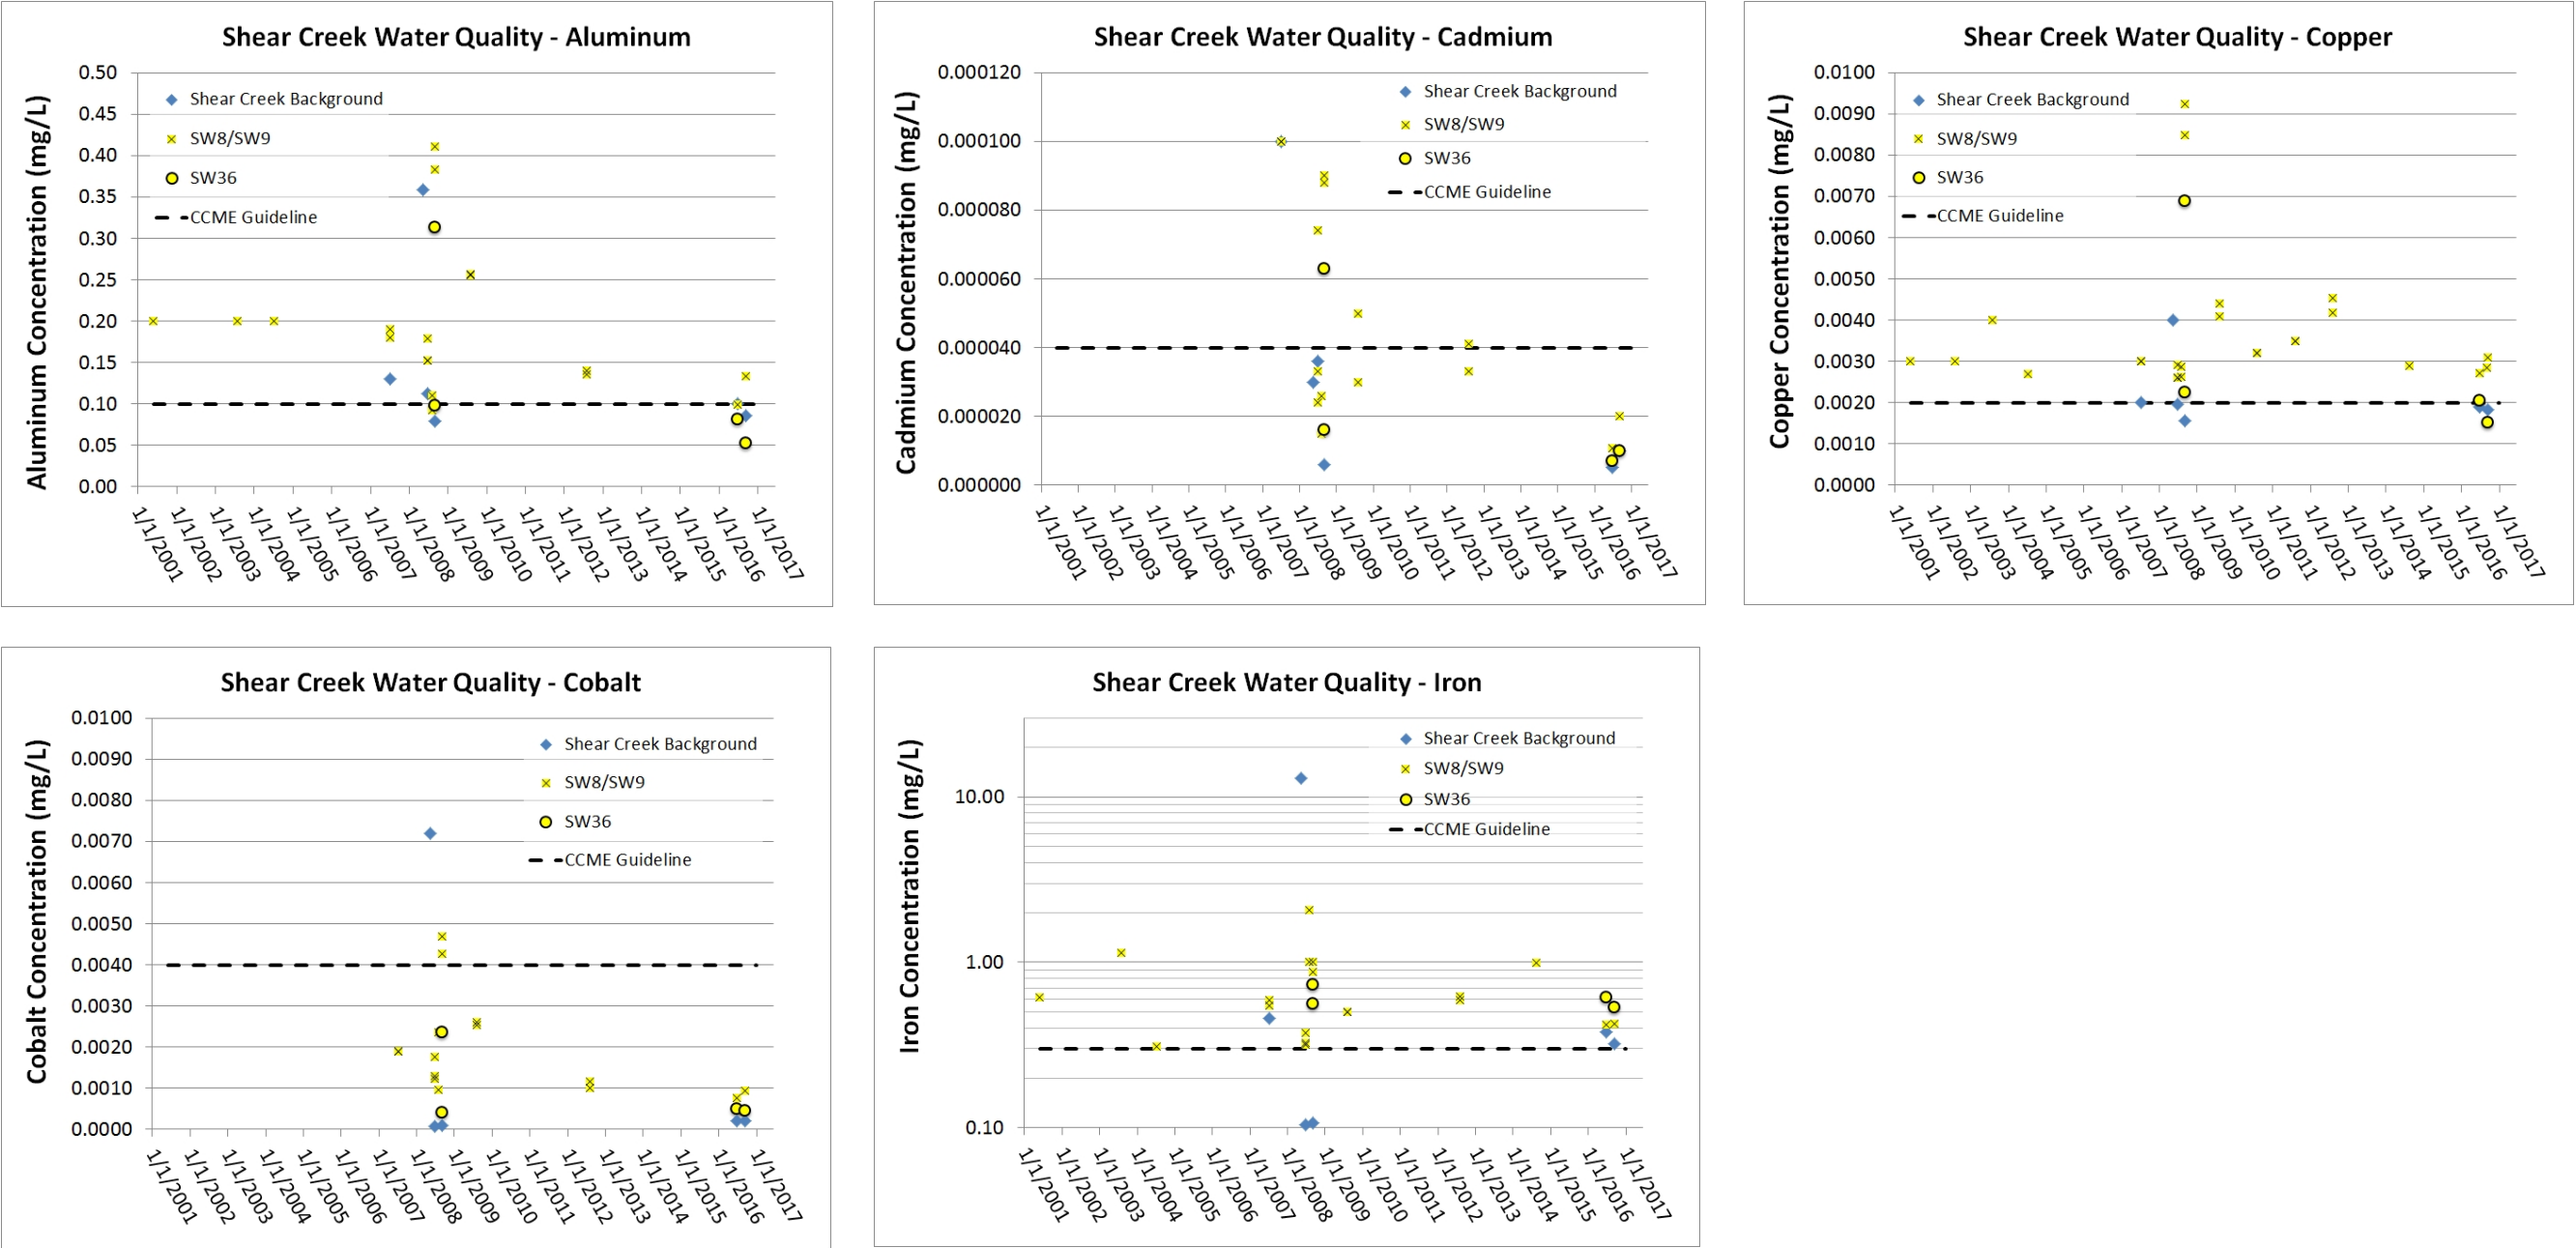
Figure 3-4. Water Quality in Shear Creek for Parameters of Interest

CCME exceedances have been observed in Shear Creek for Al, Cd, Co, Cu, and Fe. Time series plots for those parameters (Figure 3-4) indicated that water quality in Shear Creek does not appear to be deteriorating over time. At monitoring station SW36, 2016 concentrations were generally below CCME guidelines and close to background concentrations. Concentrations at SW36 for Al, Cu, and Fe were observed to be slightly higher than CCME guidelines in some 2016 samples. However, for those parameters, the background concentrations were typically near CCME guideline levels as well. Site-specific water quality guidelines may be appropriate for those parameters.

the sulphide in the rock becomes exhausted. Water quality monitoring (Figure 3-4) showed that between 2001 and 2016, the water quality in Shear Creek (i.e., downstream from the waste rock), has not degraded.

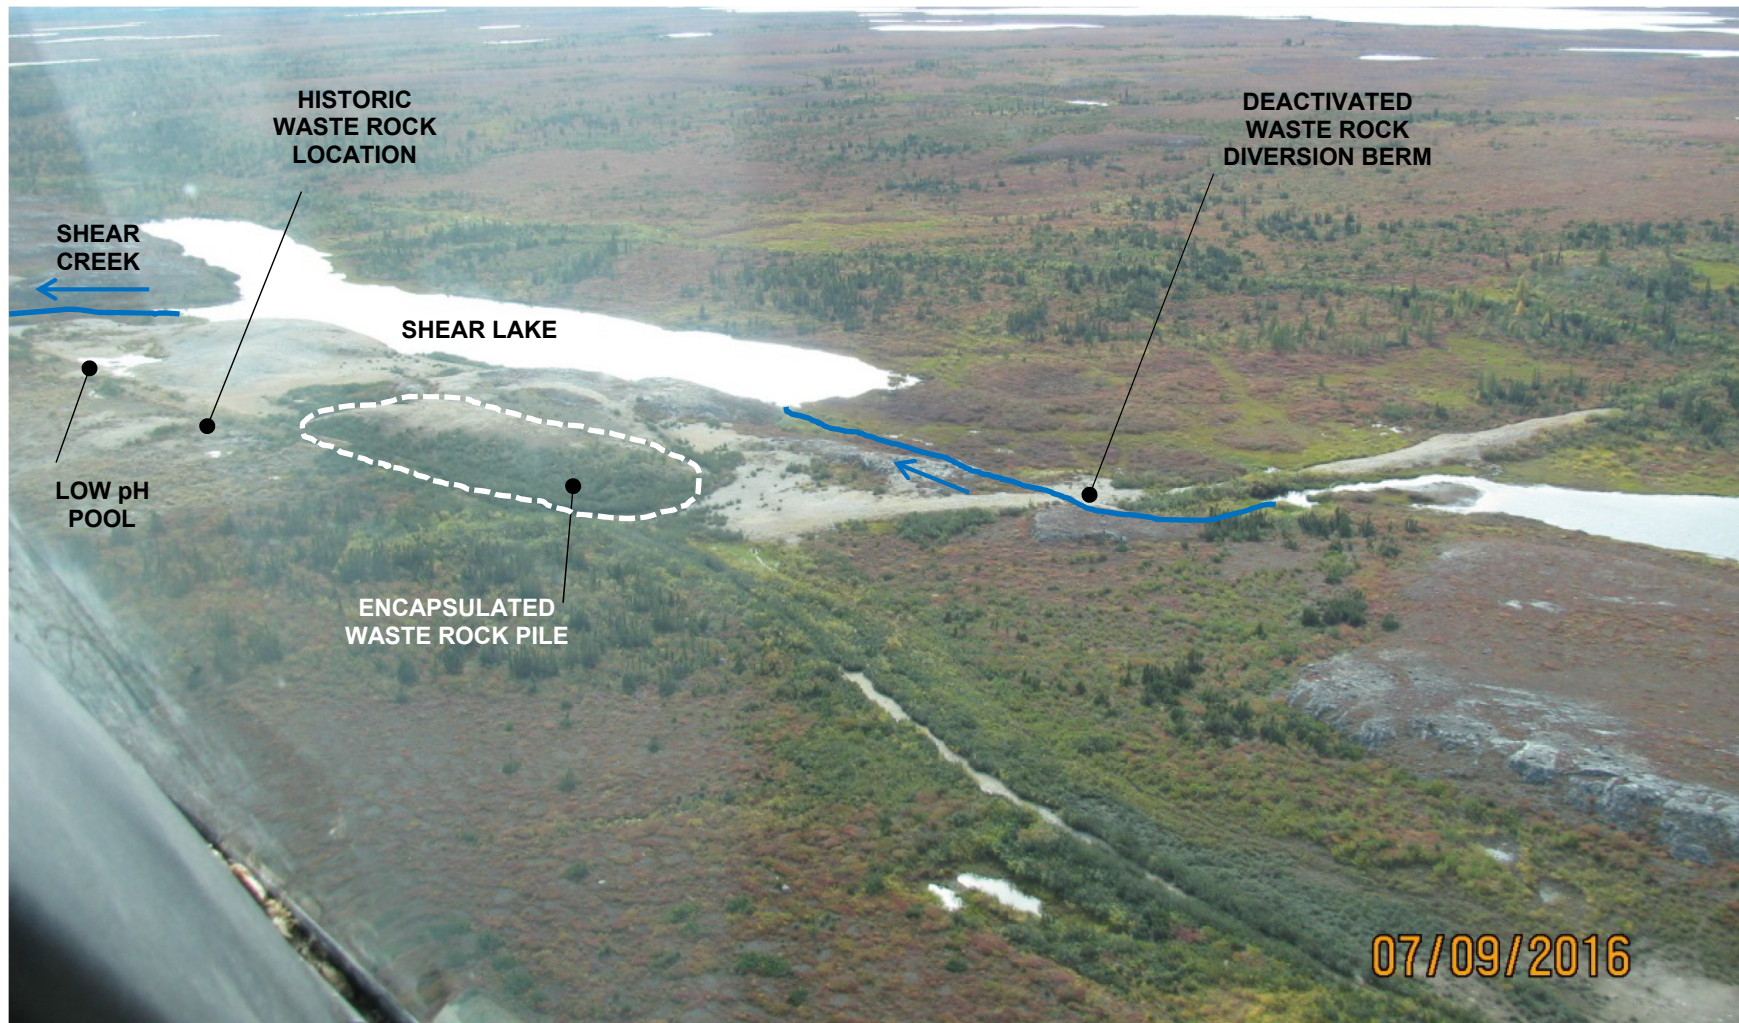
Photograph 5-4. Shear Lake and Waste Rock Pile Area (looking west)

The time series plots are consistent with Lorax's work in the ERA (AECOM, 2009) where they concluded that because of the absence of remaining sulphides in the residual waste rock, the water quality of the waste rock drainage is unlikely to get any worse over time.

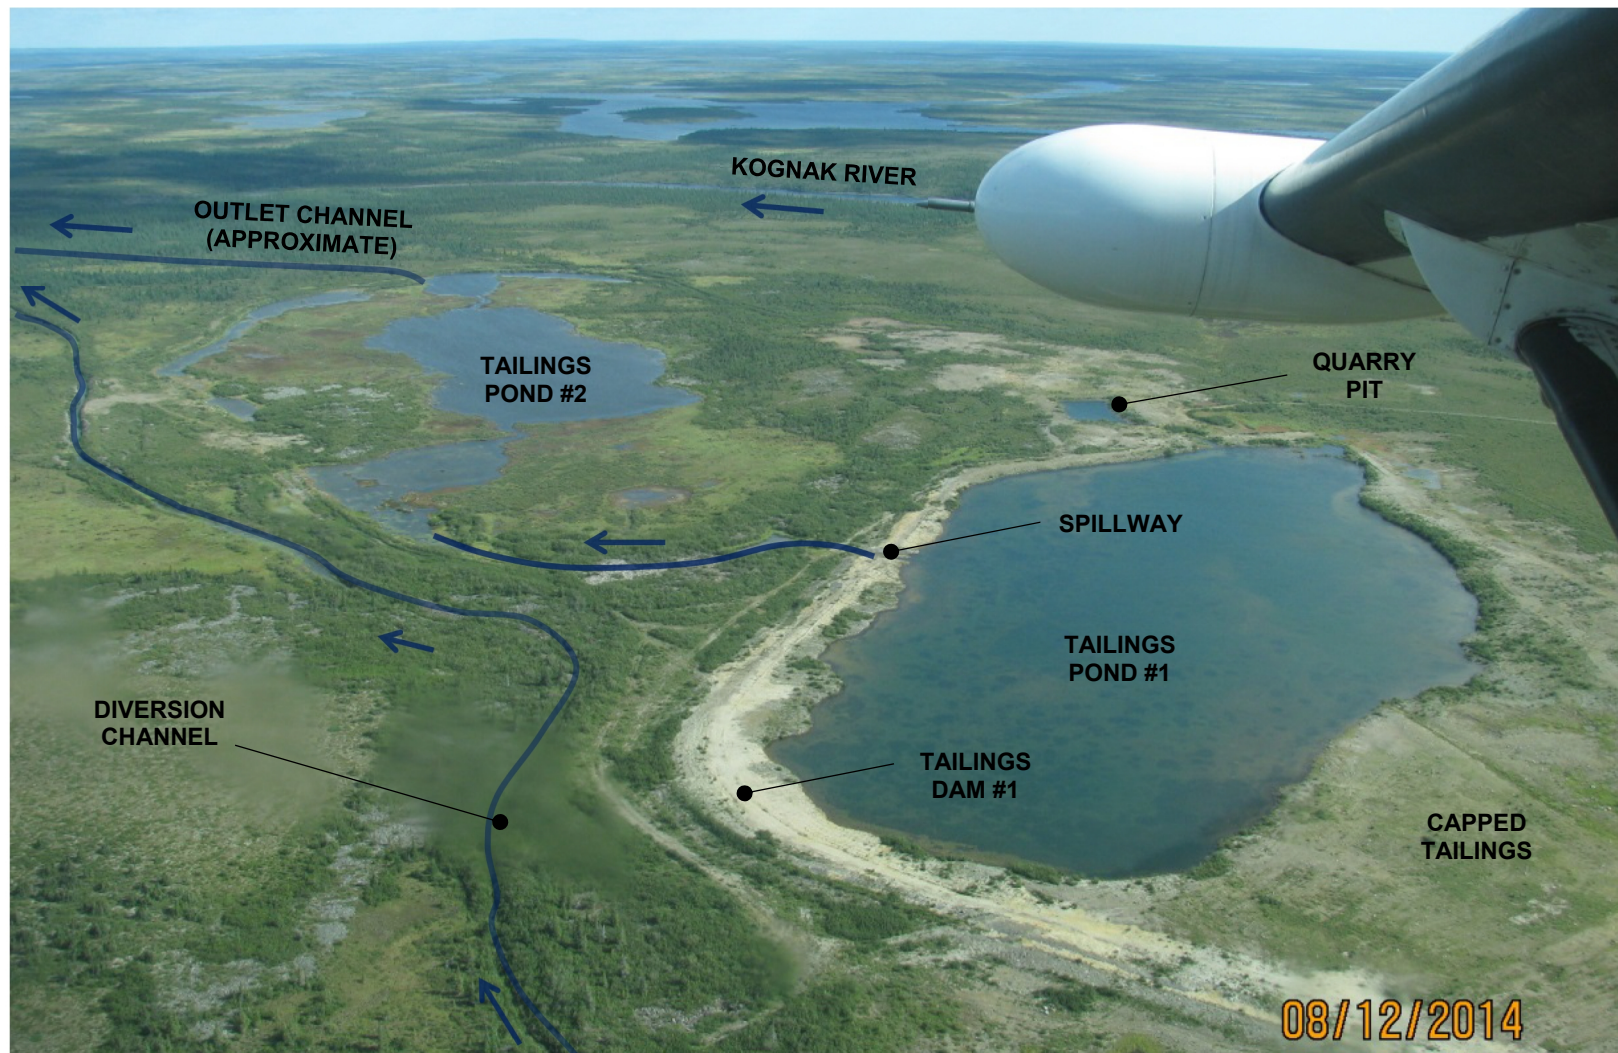
Photograph 5-8. Tailings Area Looking Southeast

Tailings Pond #1 is upstream of Tailings Pond #2 (approximately 300 m from the Tailings Pond #1 spillway to Tailings Pond #2) and they are connected by a small un-named stream. Tailings Pond #2 discharges to the Kognak River approximately 1.3 km downstream via a series of wetlands and boulder fields. An abandoned quarry pit is located within this area and is partly flooded. There is no evidence that the quarry pit drains into Tailings Pond #1. The headwaters of the tailings management area are re-routed around the north side of the tailings area via a diversion channel. The diversion channel terminates in a wetland downstream of Tailings Pond #2 outlet (Photograph 5-8 and Figure 5-5).

A diversion channel runs along the north side of the tailings impoundment area, from the B-Zone portal area to near the east end of Tailings Pond #2. The channel terminates in a wetland downstream from the outlet of Tailings Pond #2 (Photograph 5-8). The purpose of the channel was to collect runoff and divert it around the mine complex and tailings area to prevent fresh water from coming in contact with mine contact water.

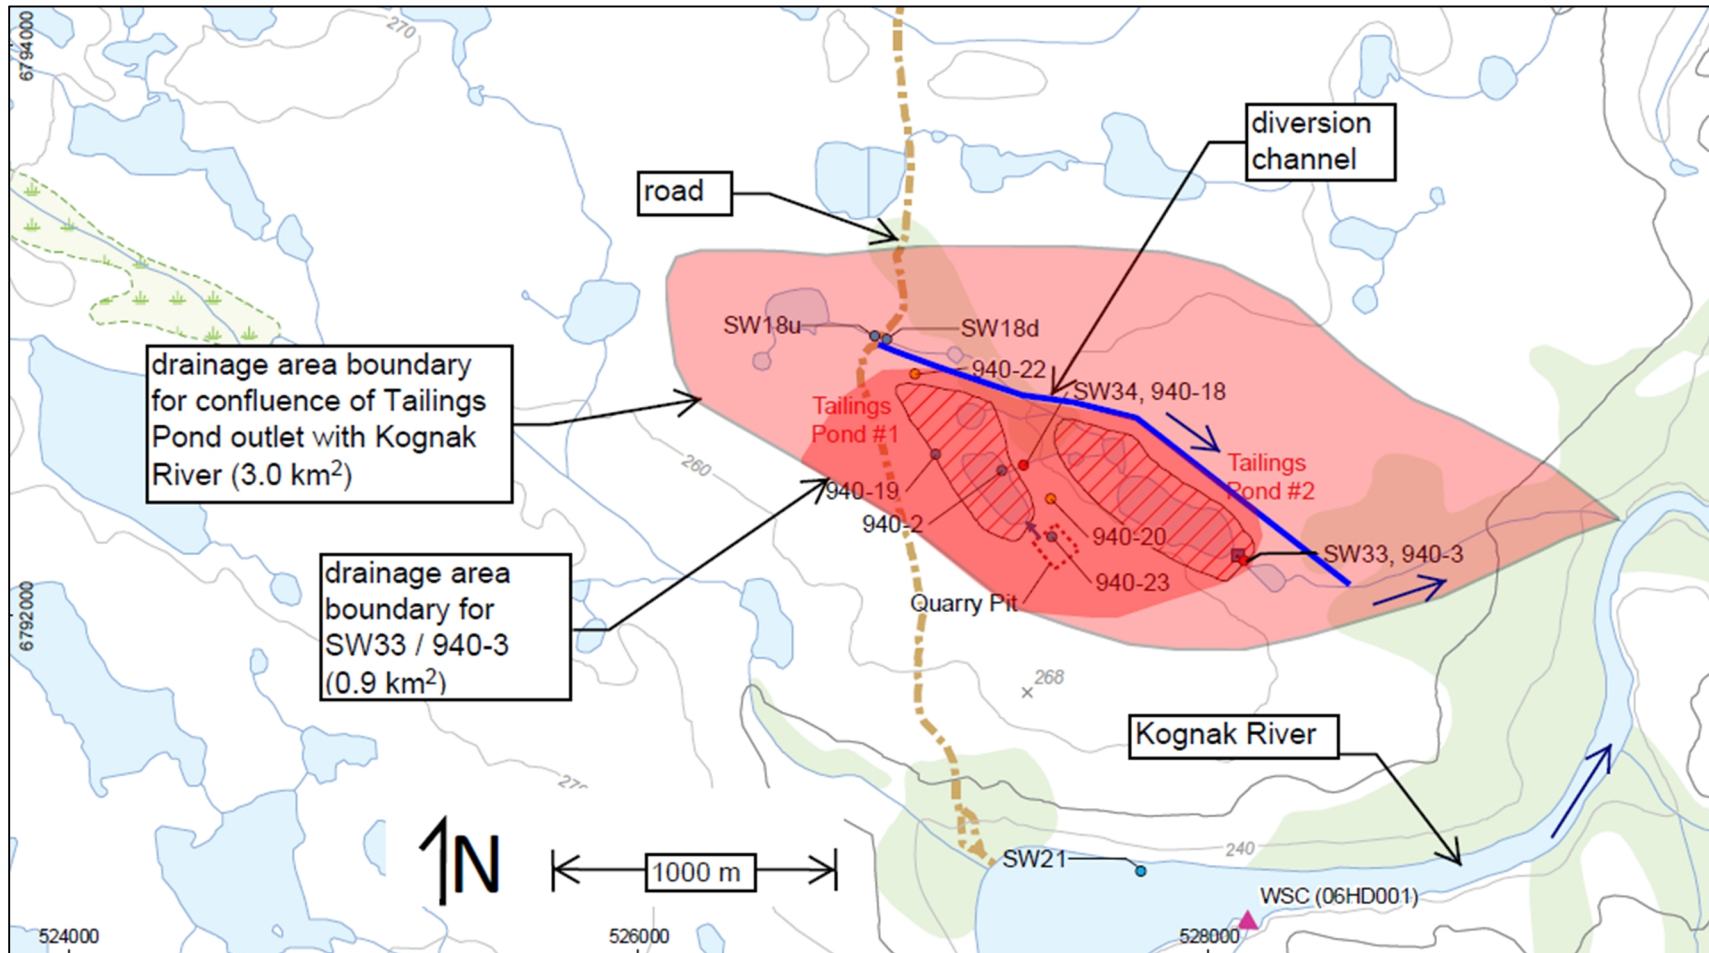
Figure 5-5. Drainage Basin Areas of the Tailings Ponds

Dilution calculations (MEA, 2016) indicated that CCME for those parameters would likely be met in the creek downstream from Tailings Pond #2, prior to its confluence with the Kognak River. Tailings drainage basin areas are presented on Figure 5-5 (MEA, 2016).

site indicate that the drainage channel diverts flow around Tailings Pond #2 and does not reduce the drainage area of Tailings Pond #1, compared to pre-mining conditions (Figure 5-5). Therefore, failure of the diversion channel could result in an increase in surface water inflow to Tailings Pond #2 (compared to existing conditions), but Tailings Pond #1 would remain unaffected. Because Pond #2 has been decommissioned, an increase in flow rate through that pond would not have a consequence on tailings dam stability or water quality in the receiving environment.

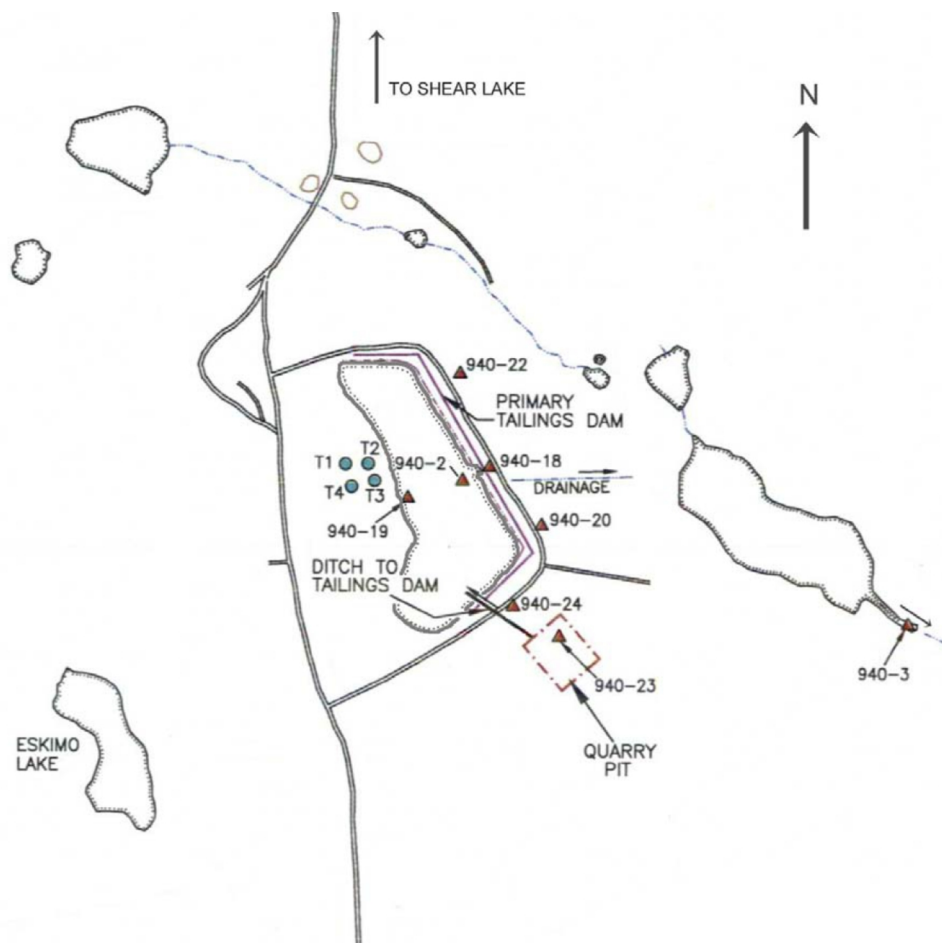
Figure 5-6. Location of Quarry Pit (map not to scale), thermistor (T circles) and water sampling (940-X triangles) stations.

The open portion of the quarry is filled with water, presumably from collected runoff and seepage. A ditch connects the quarry to Pond #1 to drain water from the pit to Pond #1. However this ditch has

remained dry since the equipment was buried in the pit in 2001. Annual water license reports indicate that all inert waste material was placed in the Quarry Pit.

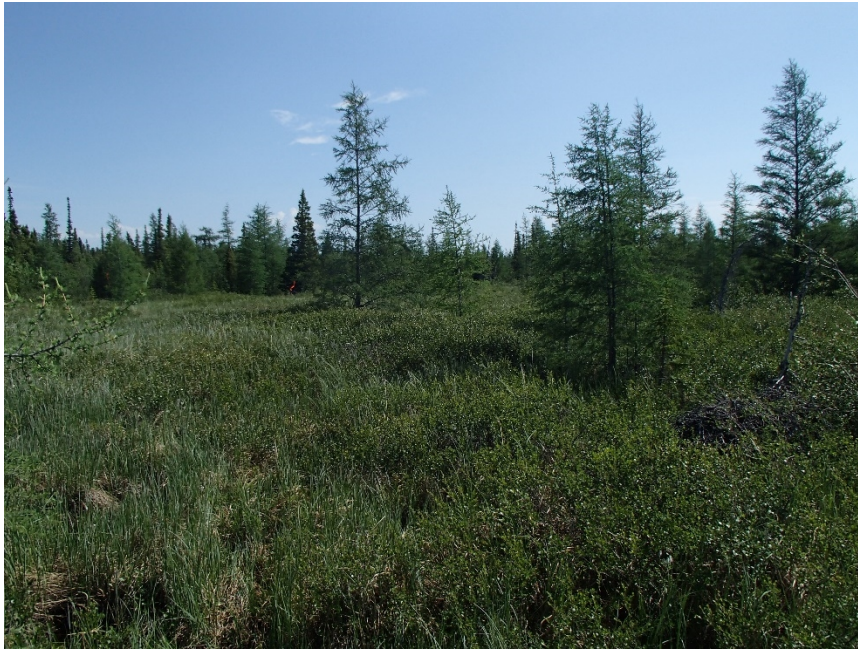
Figure 3. Meadow/wetland downstream of Tailings Pond #2 outflow creek looking downstream (towards Kognak River). Photo taken on July 11, 2018.

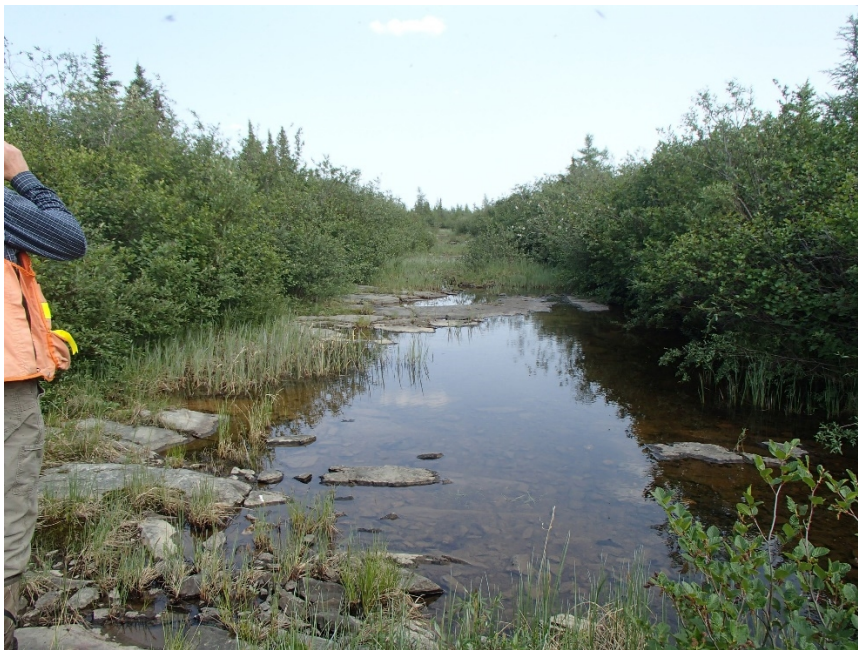
Figure 4. Diversion channel looking downstream. Photo taken on July 10, 2018.

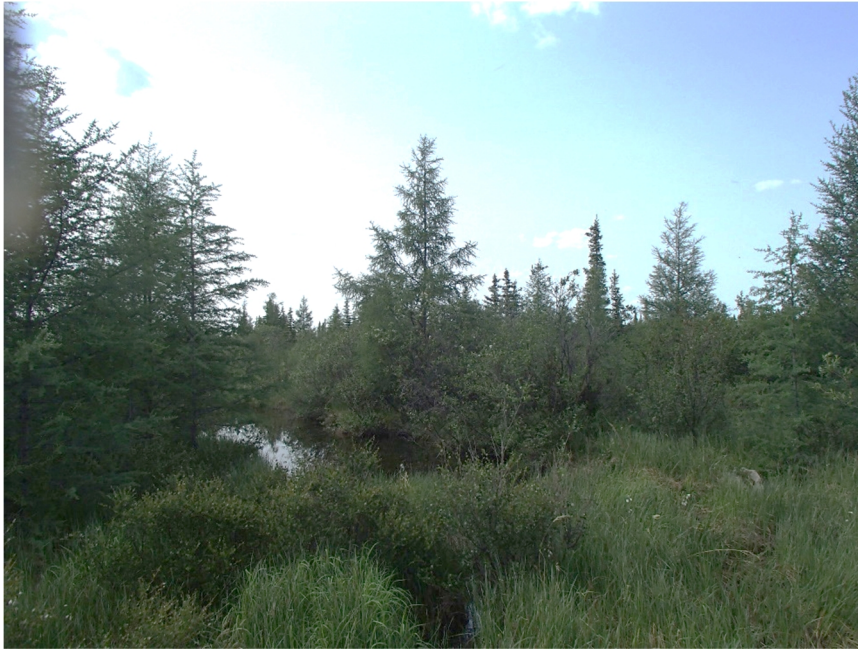
Figure 5. Diversion channel terminus at wetland/meadow looking upstream. Photo taken on July 10, 2018.

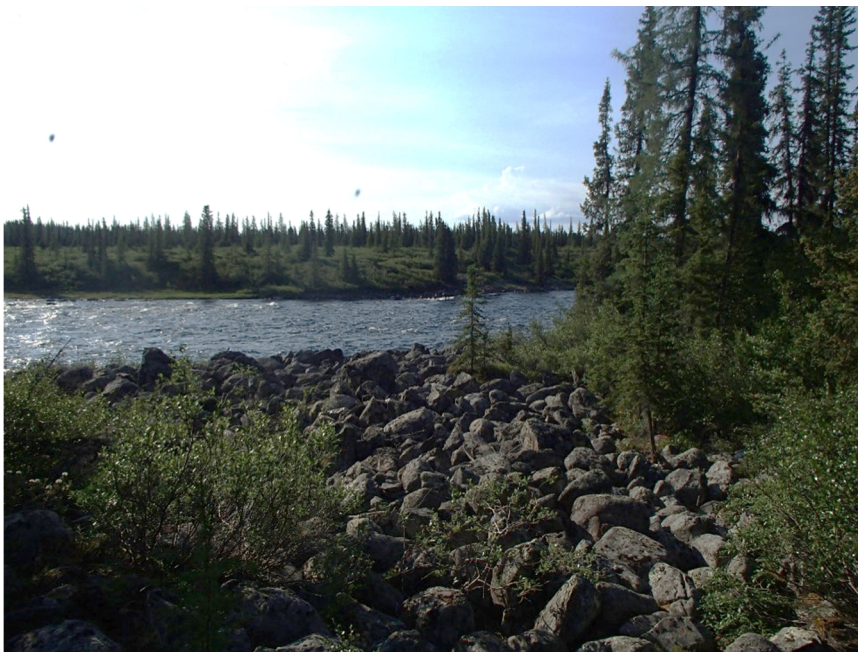
Figure 6. Boulder field at the Kognak River. Photo taken on July 11, 2018.

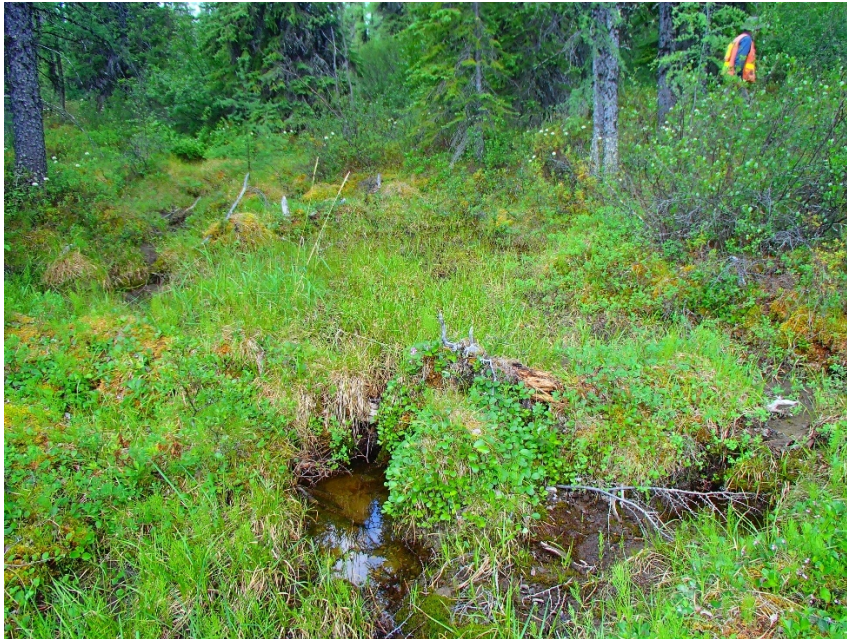
Figure 7. Water flowing from hillside upstream of boulder field at Kognak River. Photo taken on July 11, 2018.

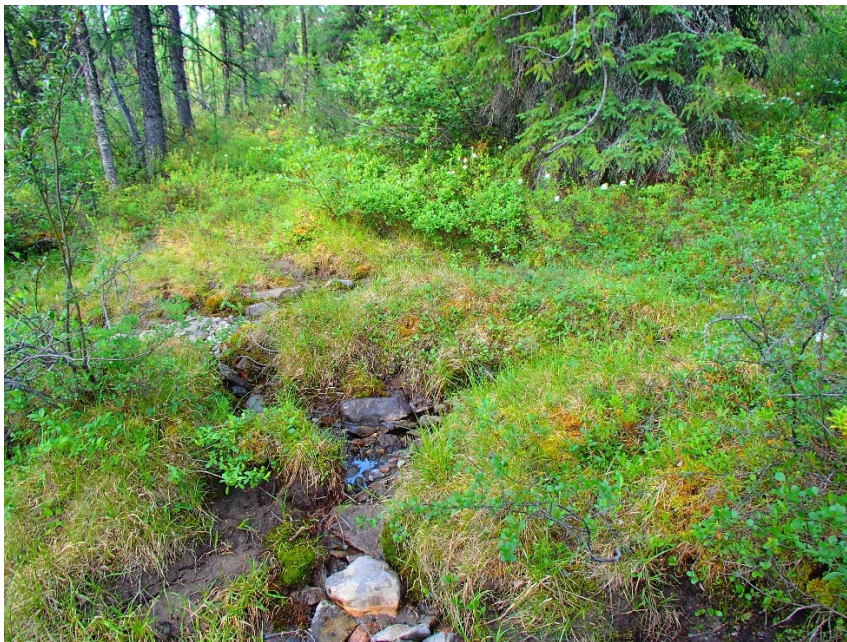
Figure 8. Water flowing from hillside upstream of boulder field at Kognak River. Photo taken on July 11, 2018.

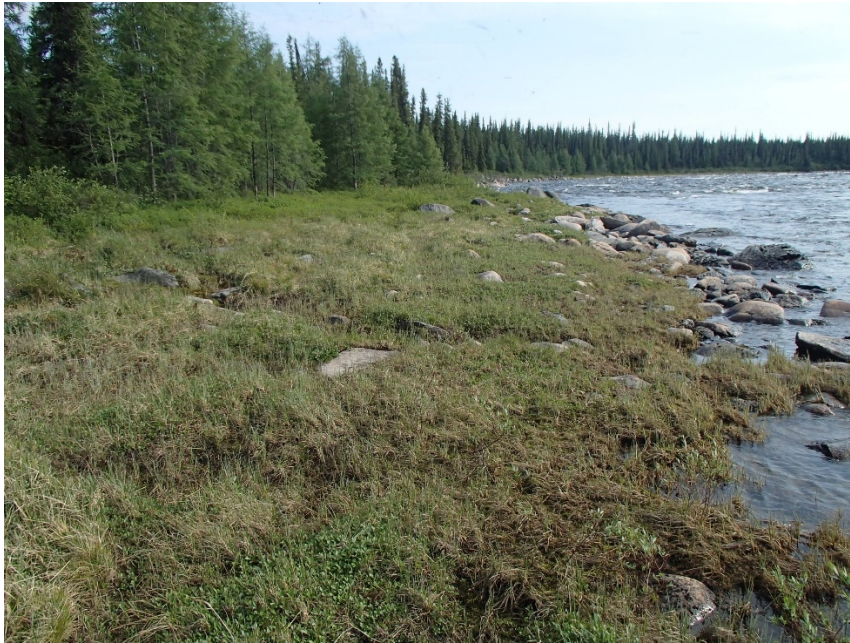
***Figure 9. Area with potential creeks at confluence with the Kognak River, looking downstream.
Photo taken July 11, 2018.***

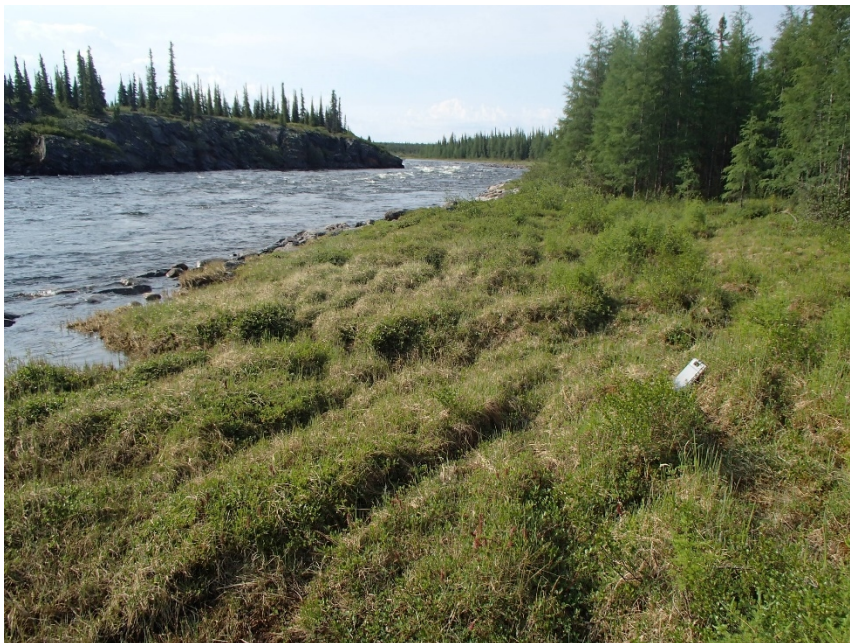
***Figure 10. Area with potential creeks at confluence with the Kognak River, looking upstream.
Photo taken July 11, 2018.***
