Long Term Monitoring, 2009 FOX-C, Ekalugad Fjord, Nunavut

FINAL REPORT

Project No. 1697-0902
November 27, 2009

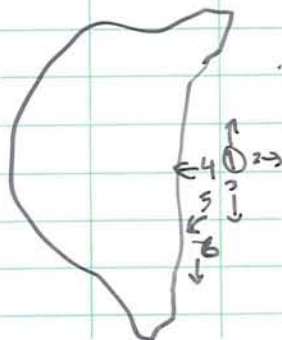
LAKE PICS

NOTE: PICS 100-0494, 95 OF STAINED
AREA IN BORROW 5/6 AREA (POSSIBLY
IN SITU TREATMENT AREA). DISTINCT
PHC - LIKE SMELL
