## **Long Term Monitoring, 2011 FOX-C, Ekalugad Fjord, Nunavut**

### **FINAL REPORT**

Franz Environmental Inc.  
329 Churchill Avenue, Suite 200  
Ottawa, Ontario  
K1Z 5B8  
Tel. (613) 721-0555  
Fax: (613) 721-0029

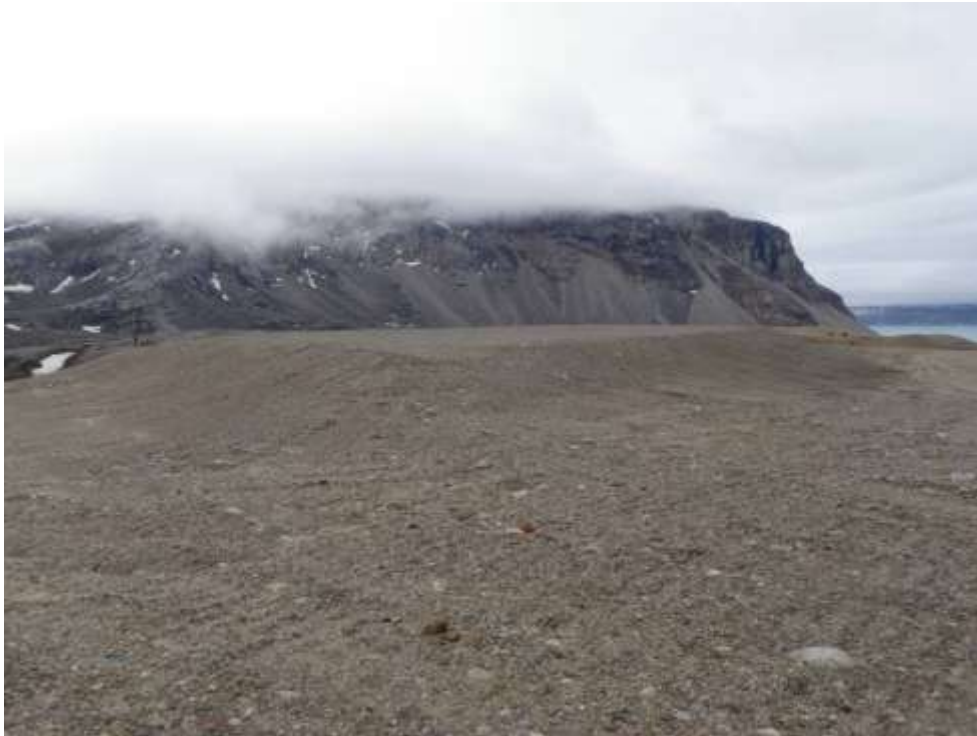
East corner of the NHL. Viewpoint 2 (Figure A-1; Appendix A). Photograph reference 2 (CD-ROM). Direction photo taken: NW

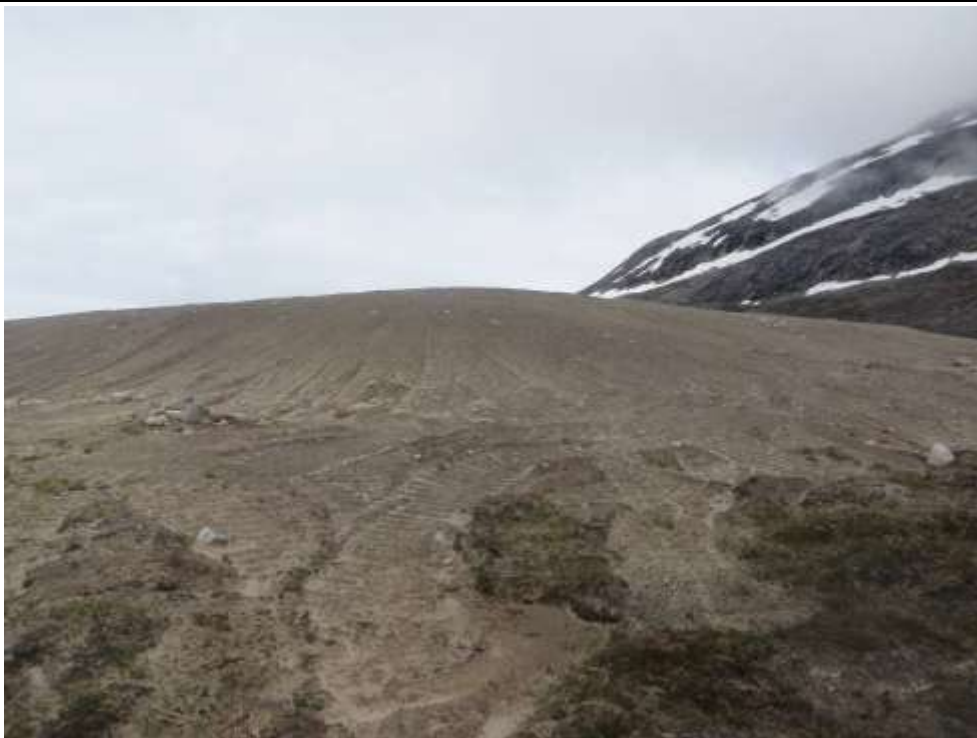
South corner of the NHWL. Viewpoint 27 (Figure A-1; Appendix A). Photograph reference 27 (CD-ROM). Direction photo taken: NW

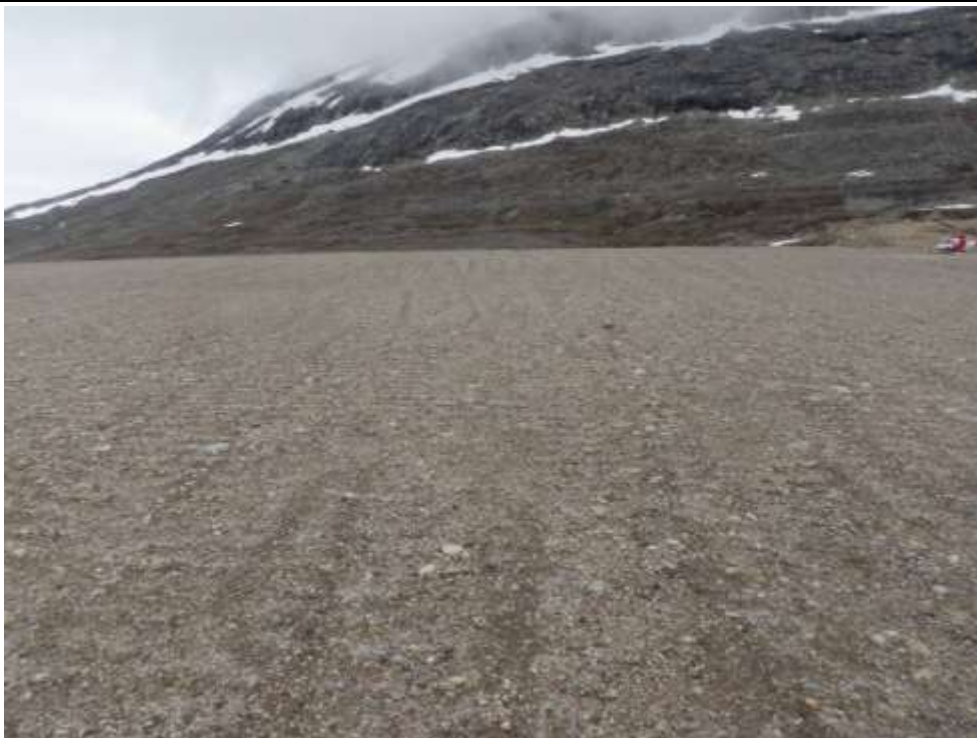
Top of the landfill. Viewpoint 43 (Figure A-1; Appendix A). Photograph reference 43 (CD-ROM). Direction photo taken: NW

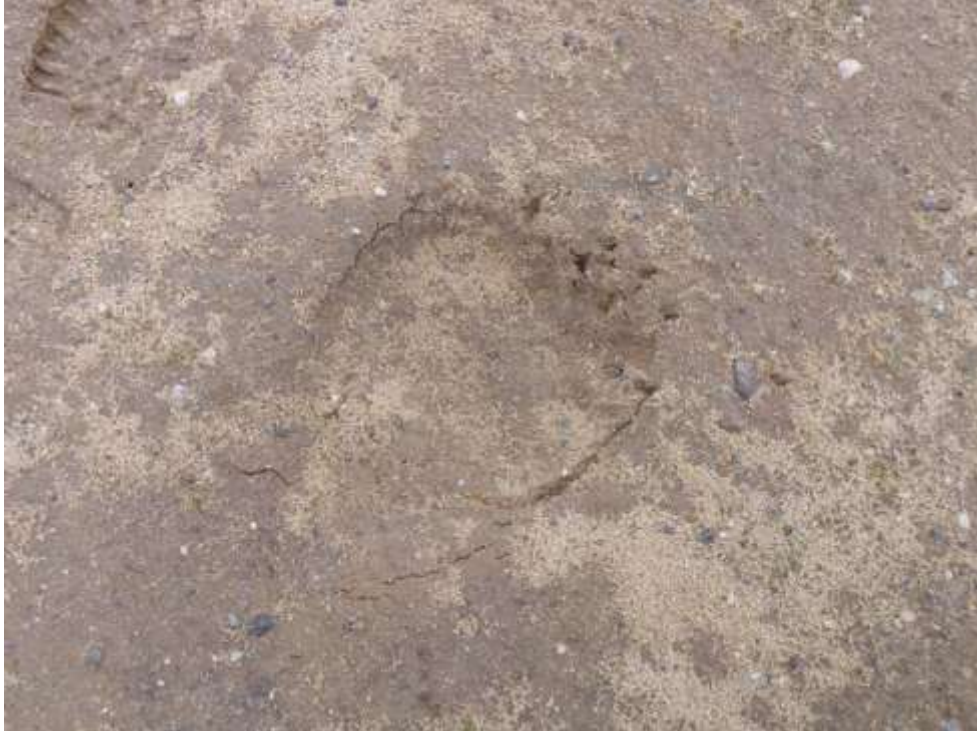
During the site visit, the FRANZ field assessors observed evidence (e.g. scat, tracks or visual observation) that Canada geese, polar bears and ducks are present on the site.

Polar Bear Track. Size 10 boot print as reference. Viewpoint N/A. Photograph reference 81 (CD-ROM). Direction photo taken: N/A
