Long Term Monitoring, 2013 FOX-C, Ekalugad Fjord, Nunavut

FINAL REPORT

Franz Environmental Inc.
329 Churchill Avenue, Suite 200
Ottawa, Ontario
K1Z 5B8
Tel. (613) 721-0555
Fax: (613) 721-0029

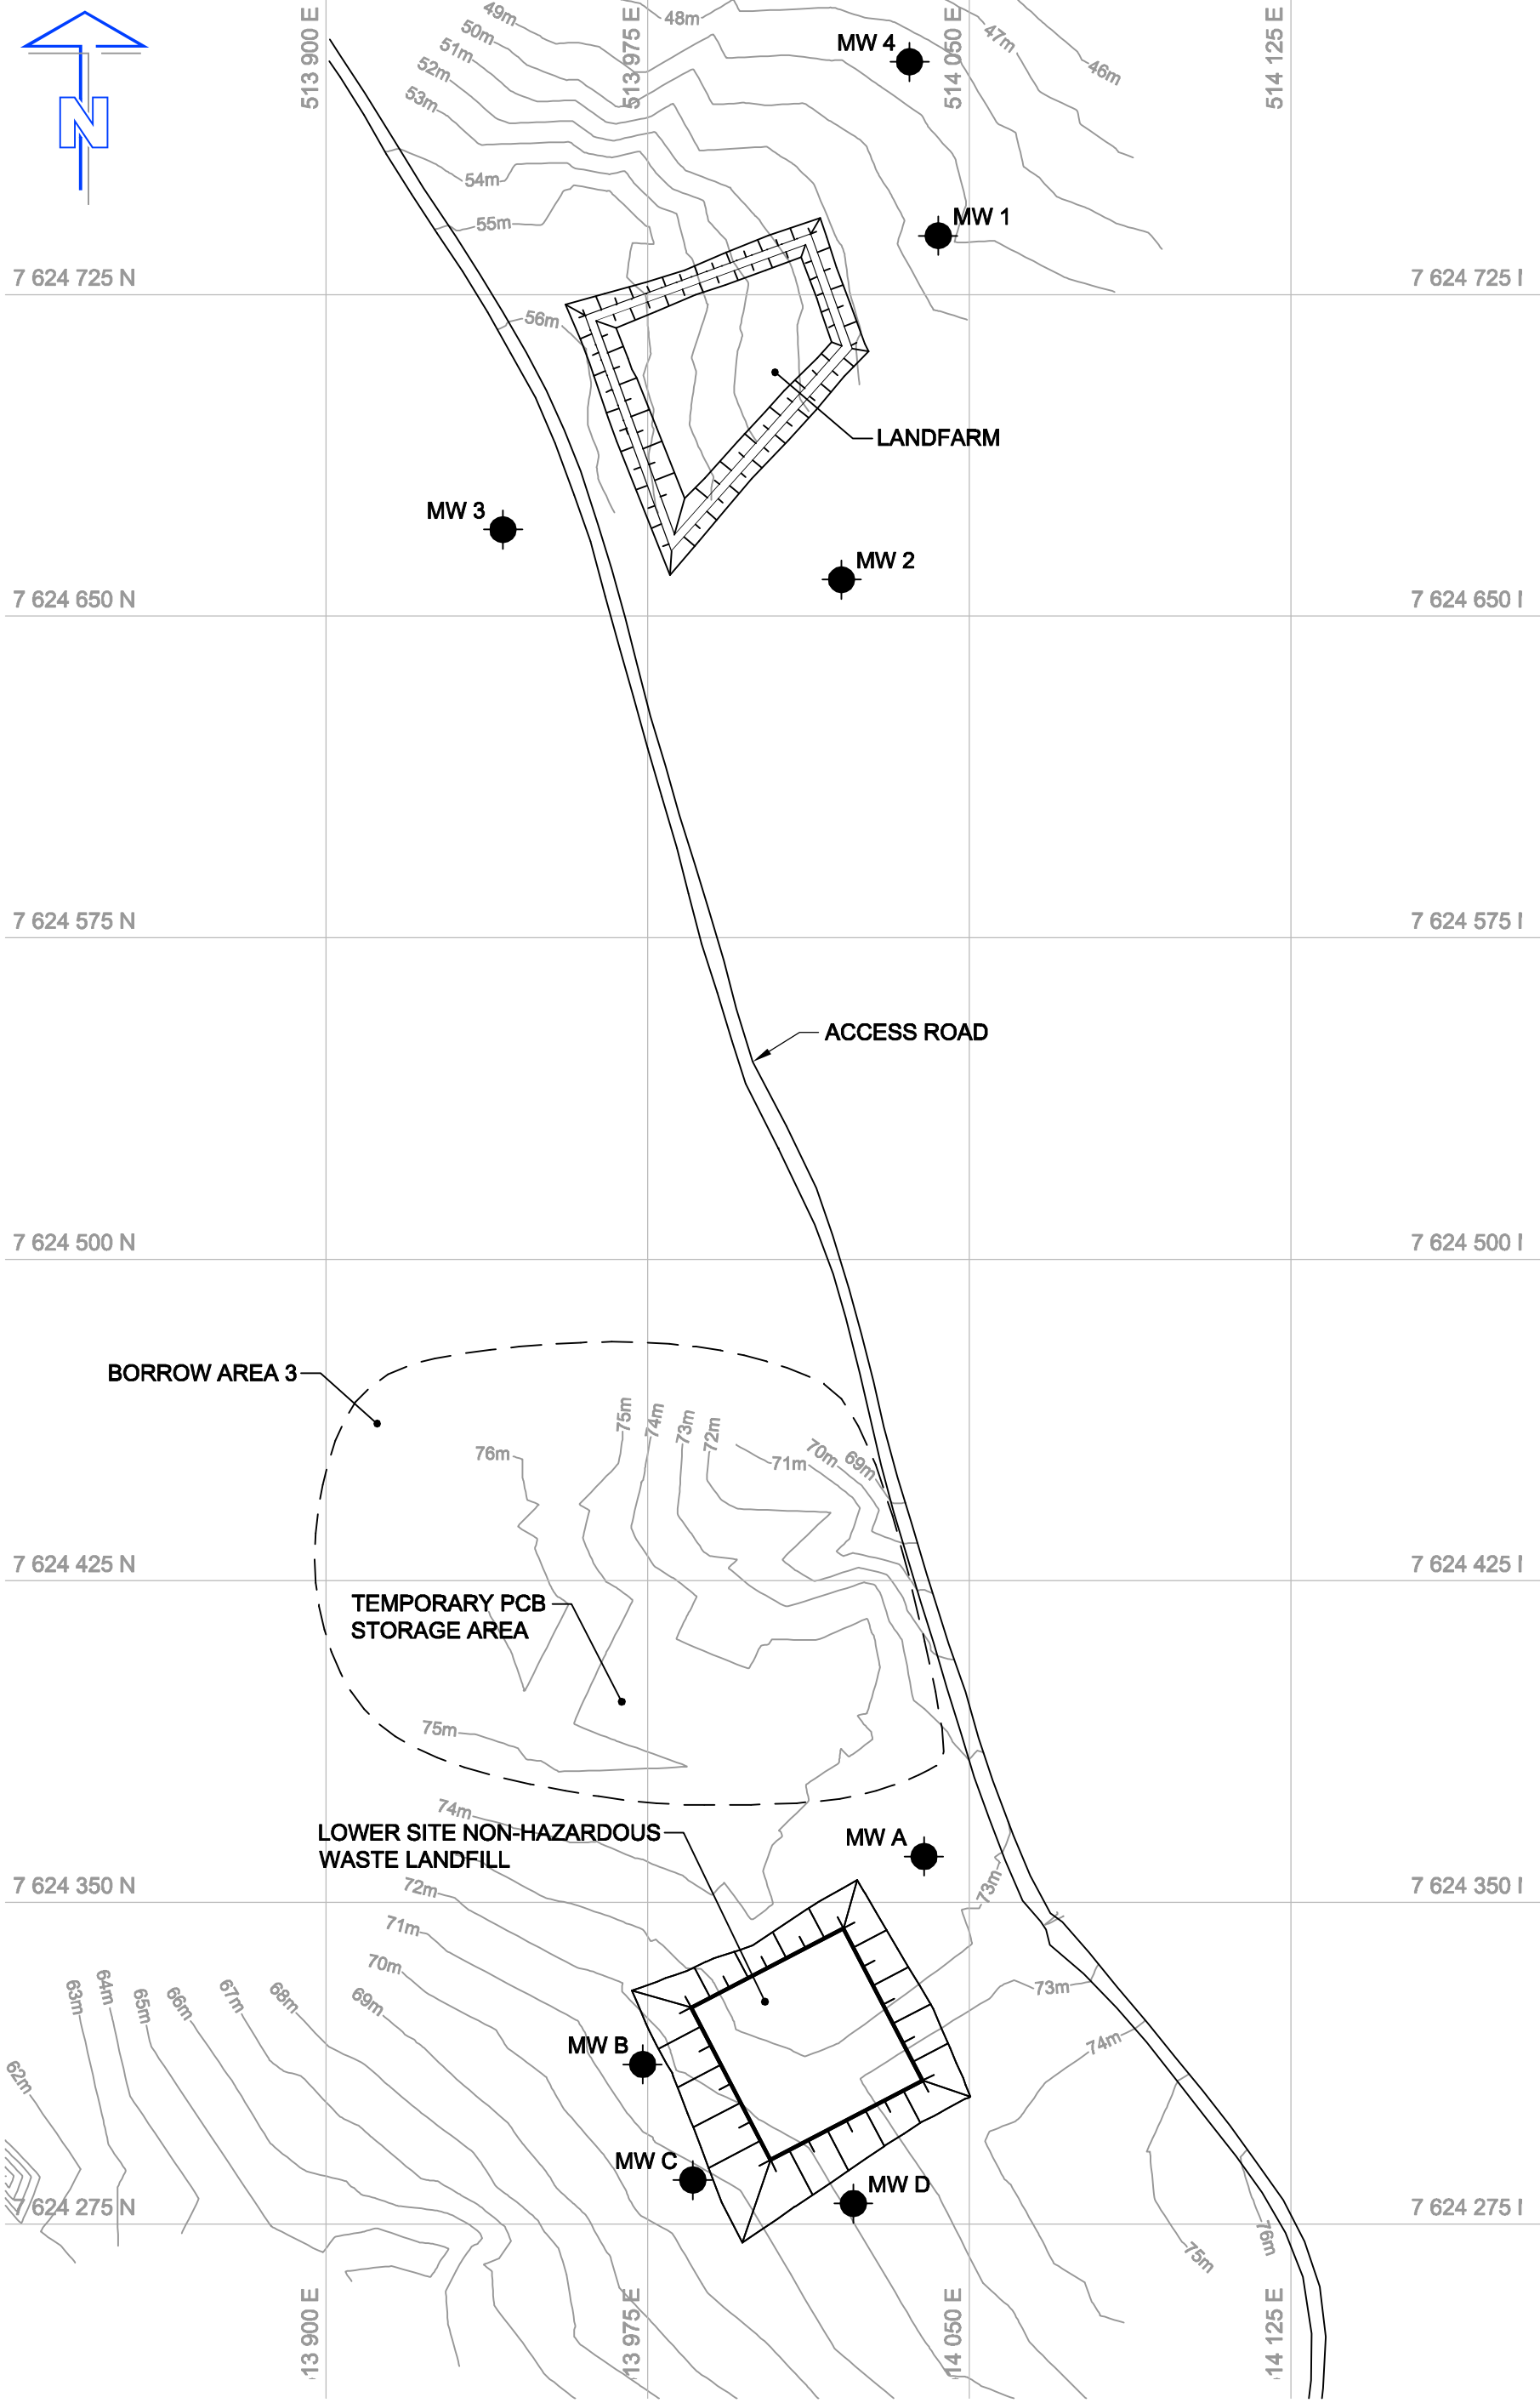
Title: Non-Hazardous Waste Landfill	
  FRANZ ENVIRONMENTAL INC. CONSULTING • ENGINEERING • TECHNOLOGIES	Project: FOX-C Ekalugad Fiord 1697-1301
Date: December 2013	Client: Aboriginal Affairs and Northern Development Canada
Scale as shown	Figure A-1

A noticeable depression of approximately 390 m² was observed adjacent to the northwest berm between monitoring well MW-North and the beach access road. This depression was dry during the 2013 site visit; however, it likely contains ponded water at times of high rainfall and spring melt as evident by the dry cracking soil conditions and moss growth. Four small (< 0.02 m³) potholes were observed along the sides of the landfill that are likely the result of erosion. Some larger particles (cobbles) are exposed at the top of the berms on the southwest and south sides of the NHWL and one area at the toe of the berm on the northwest side. No evidence of burrowing animals, vegetation re-establishment, staining, seepage points or exposed debris was observed.
