ENNADAI LAKE  
REMEDATION PROJECT

## REMEDIAL ACTION PLAN FORMER WEATHER STATION ENNADAI LAKE, NUNAVUT

NOVEMBER 2012  
ISSUED FOR REVIEW  
EBA FILE: Y22101286.0012

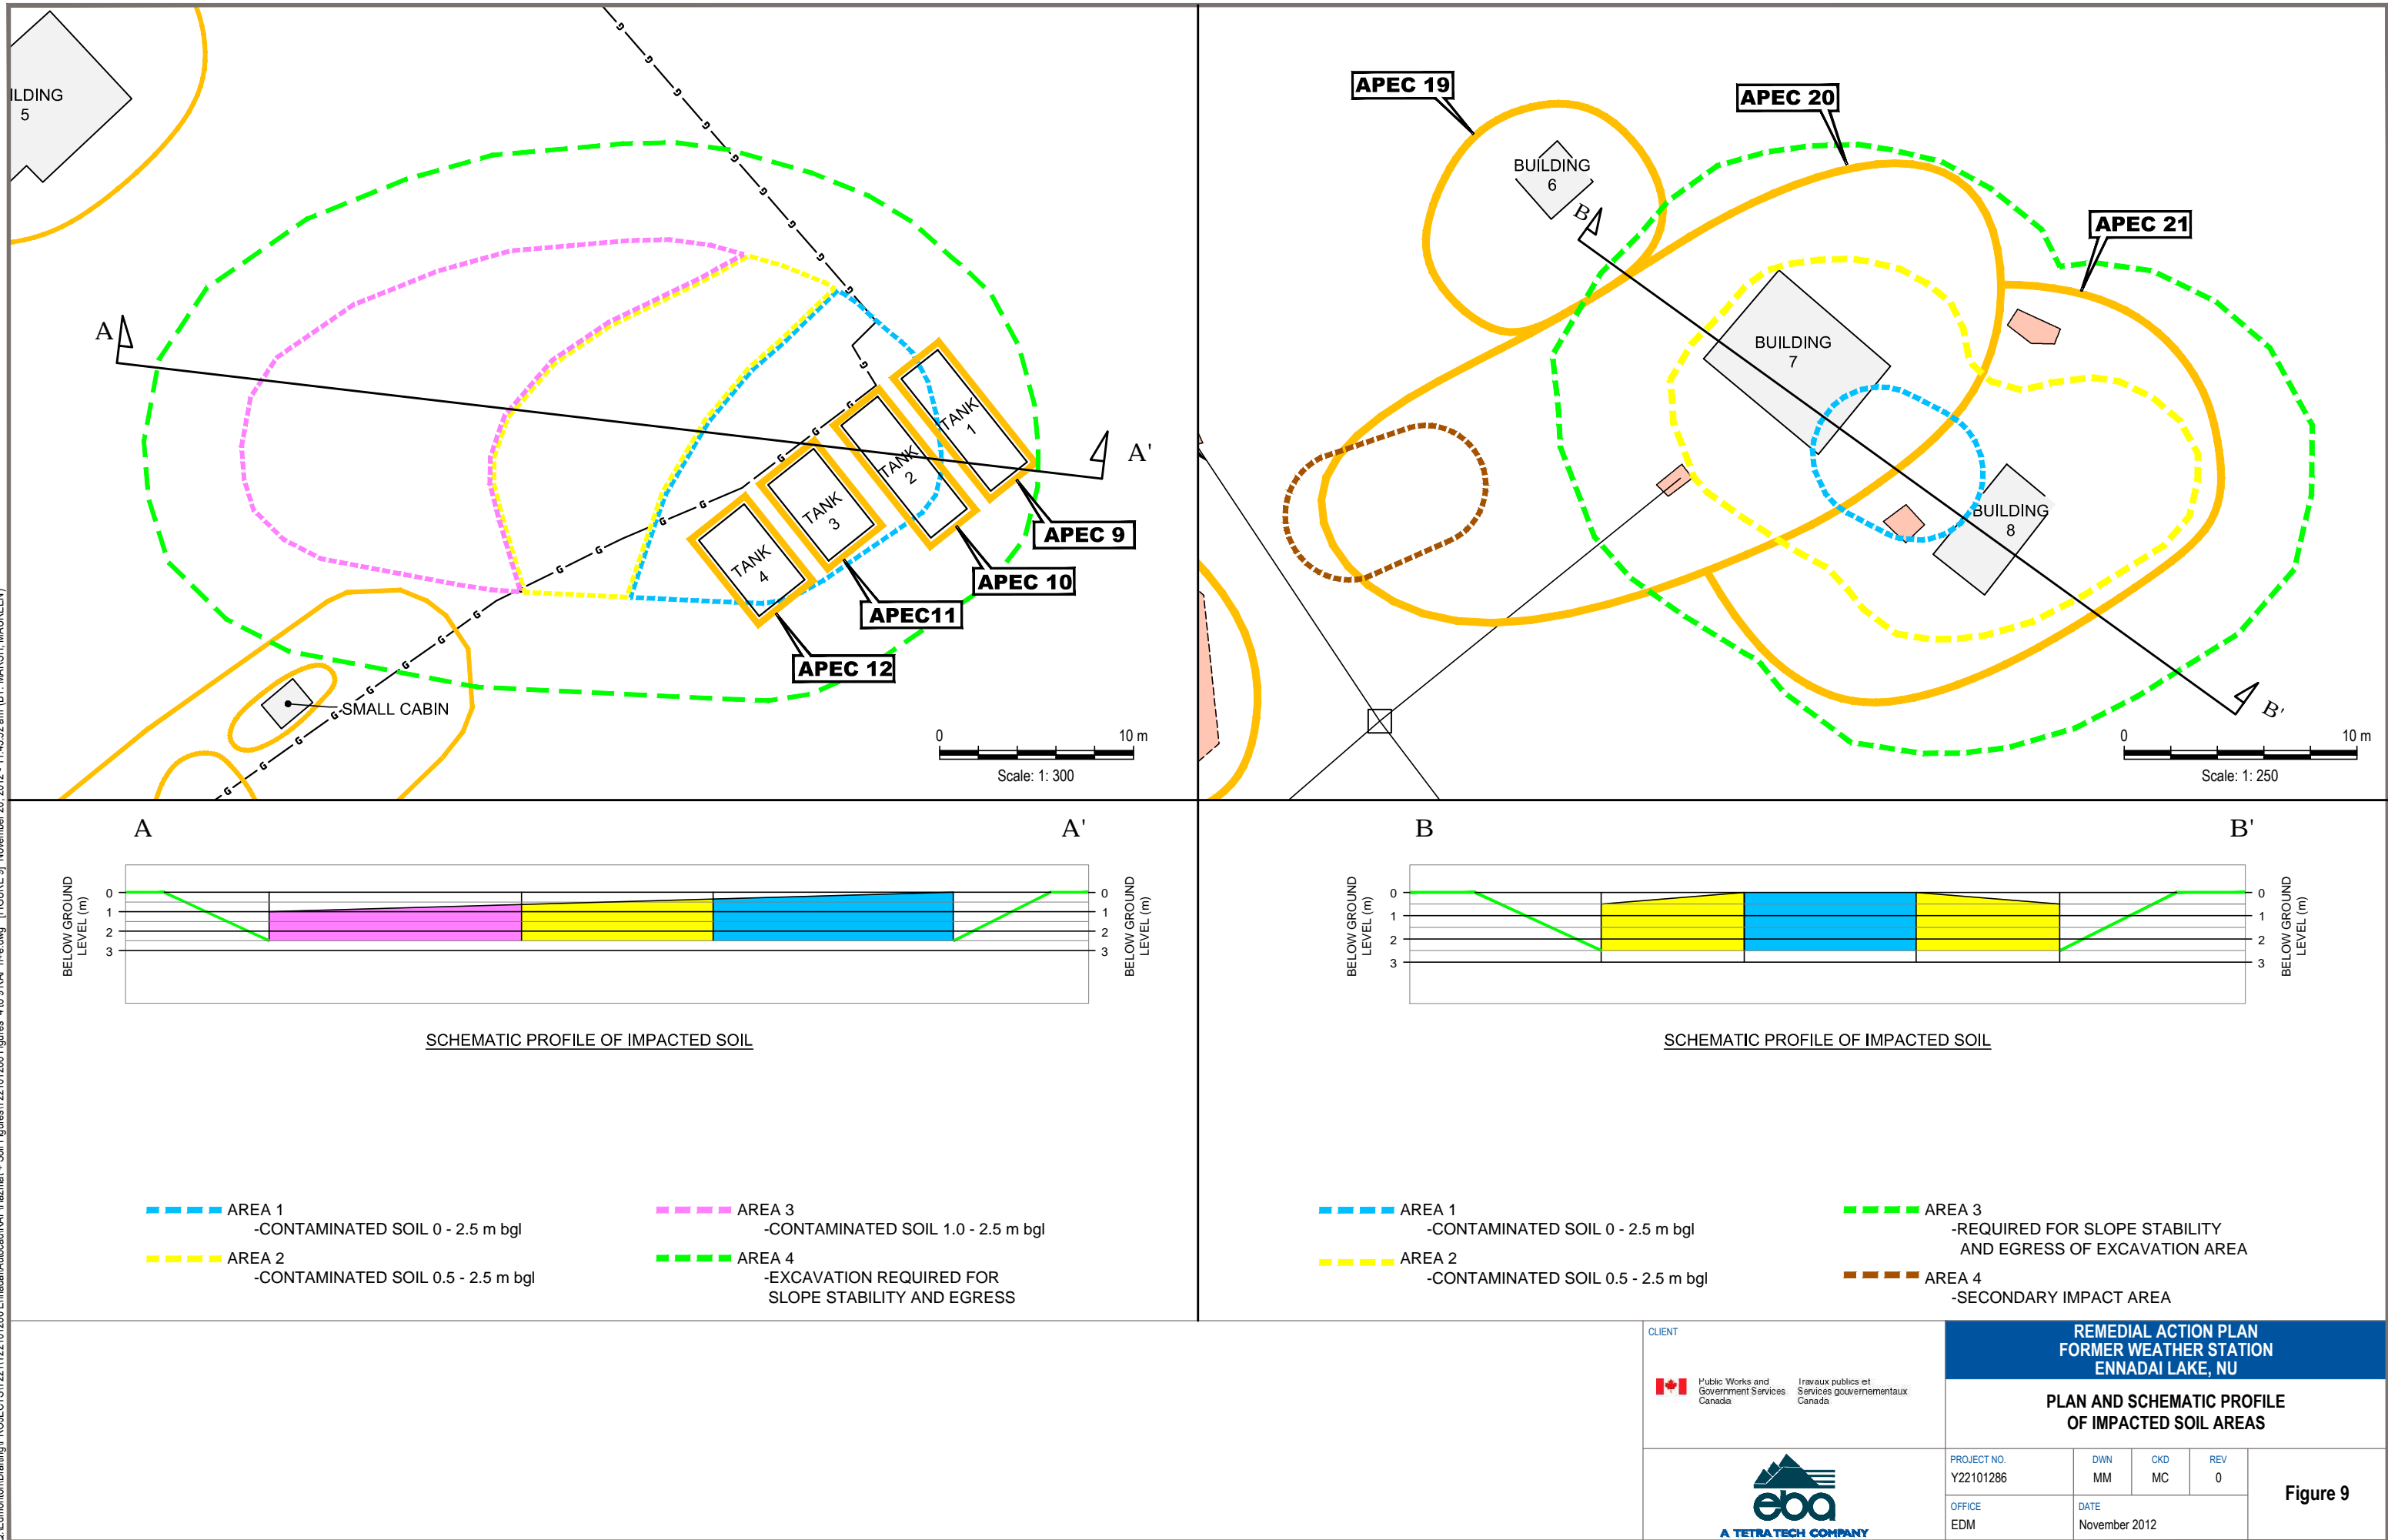
Q:\Edmonton\Drafting\PROJECTS\Y221\Y22101286 Ennadai\Aube\RAP\Hazmat - Soil Figures\Y22101286 Figures 4 to 9 RAP f-h.e.dwg [FIGURE 9] November 26, 2012 - 11:45:52 am (BY: MARSH, MAUREEN)

There is a significant amount of clean overburden within APEC 12 and APEC 20 that will need to be stockpiled on-site. In addition to the clean overburden, clean soil will need to be excavated to ensure safe access into the excavations (estimated to be 2.5 m deep). Demarcation of the overburden amounts, as well as the area needed for ingress and egress are shown on Figure 9. Estimated volumes of clean material are provided in Table 12 below.

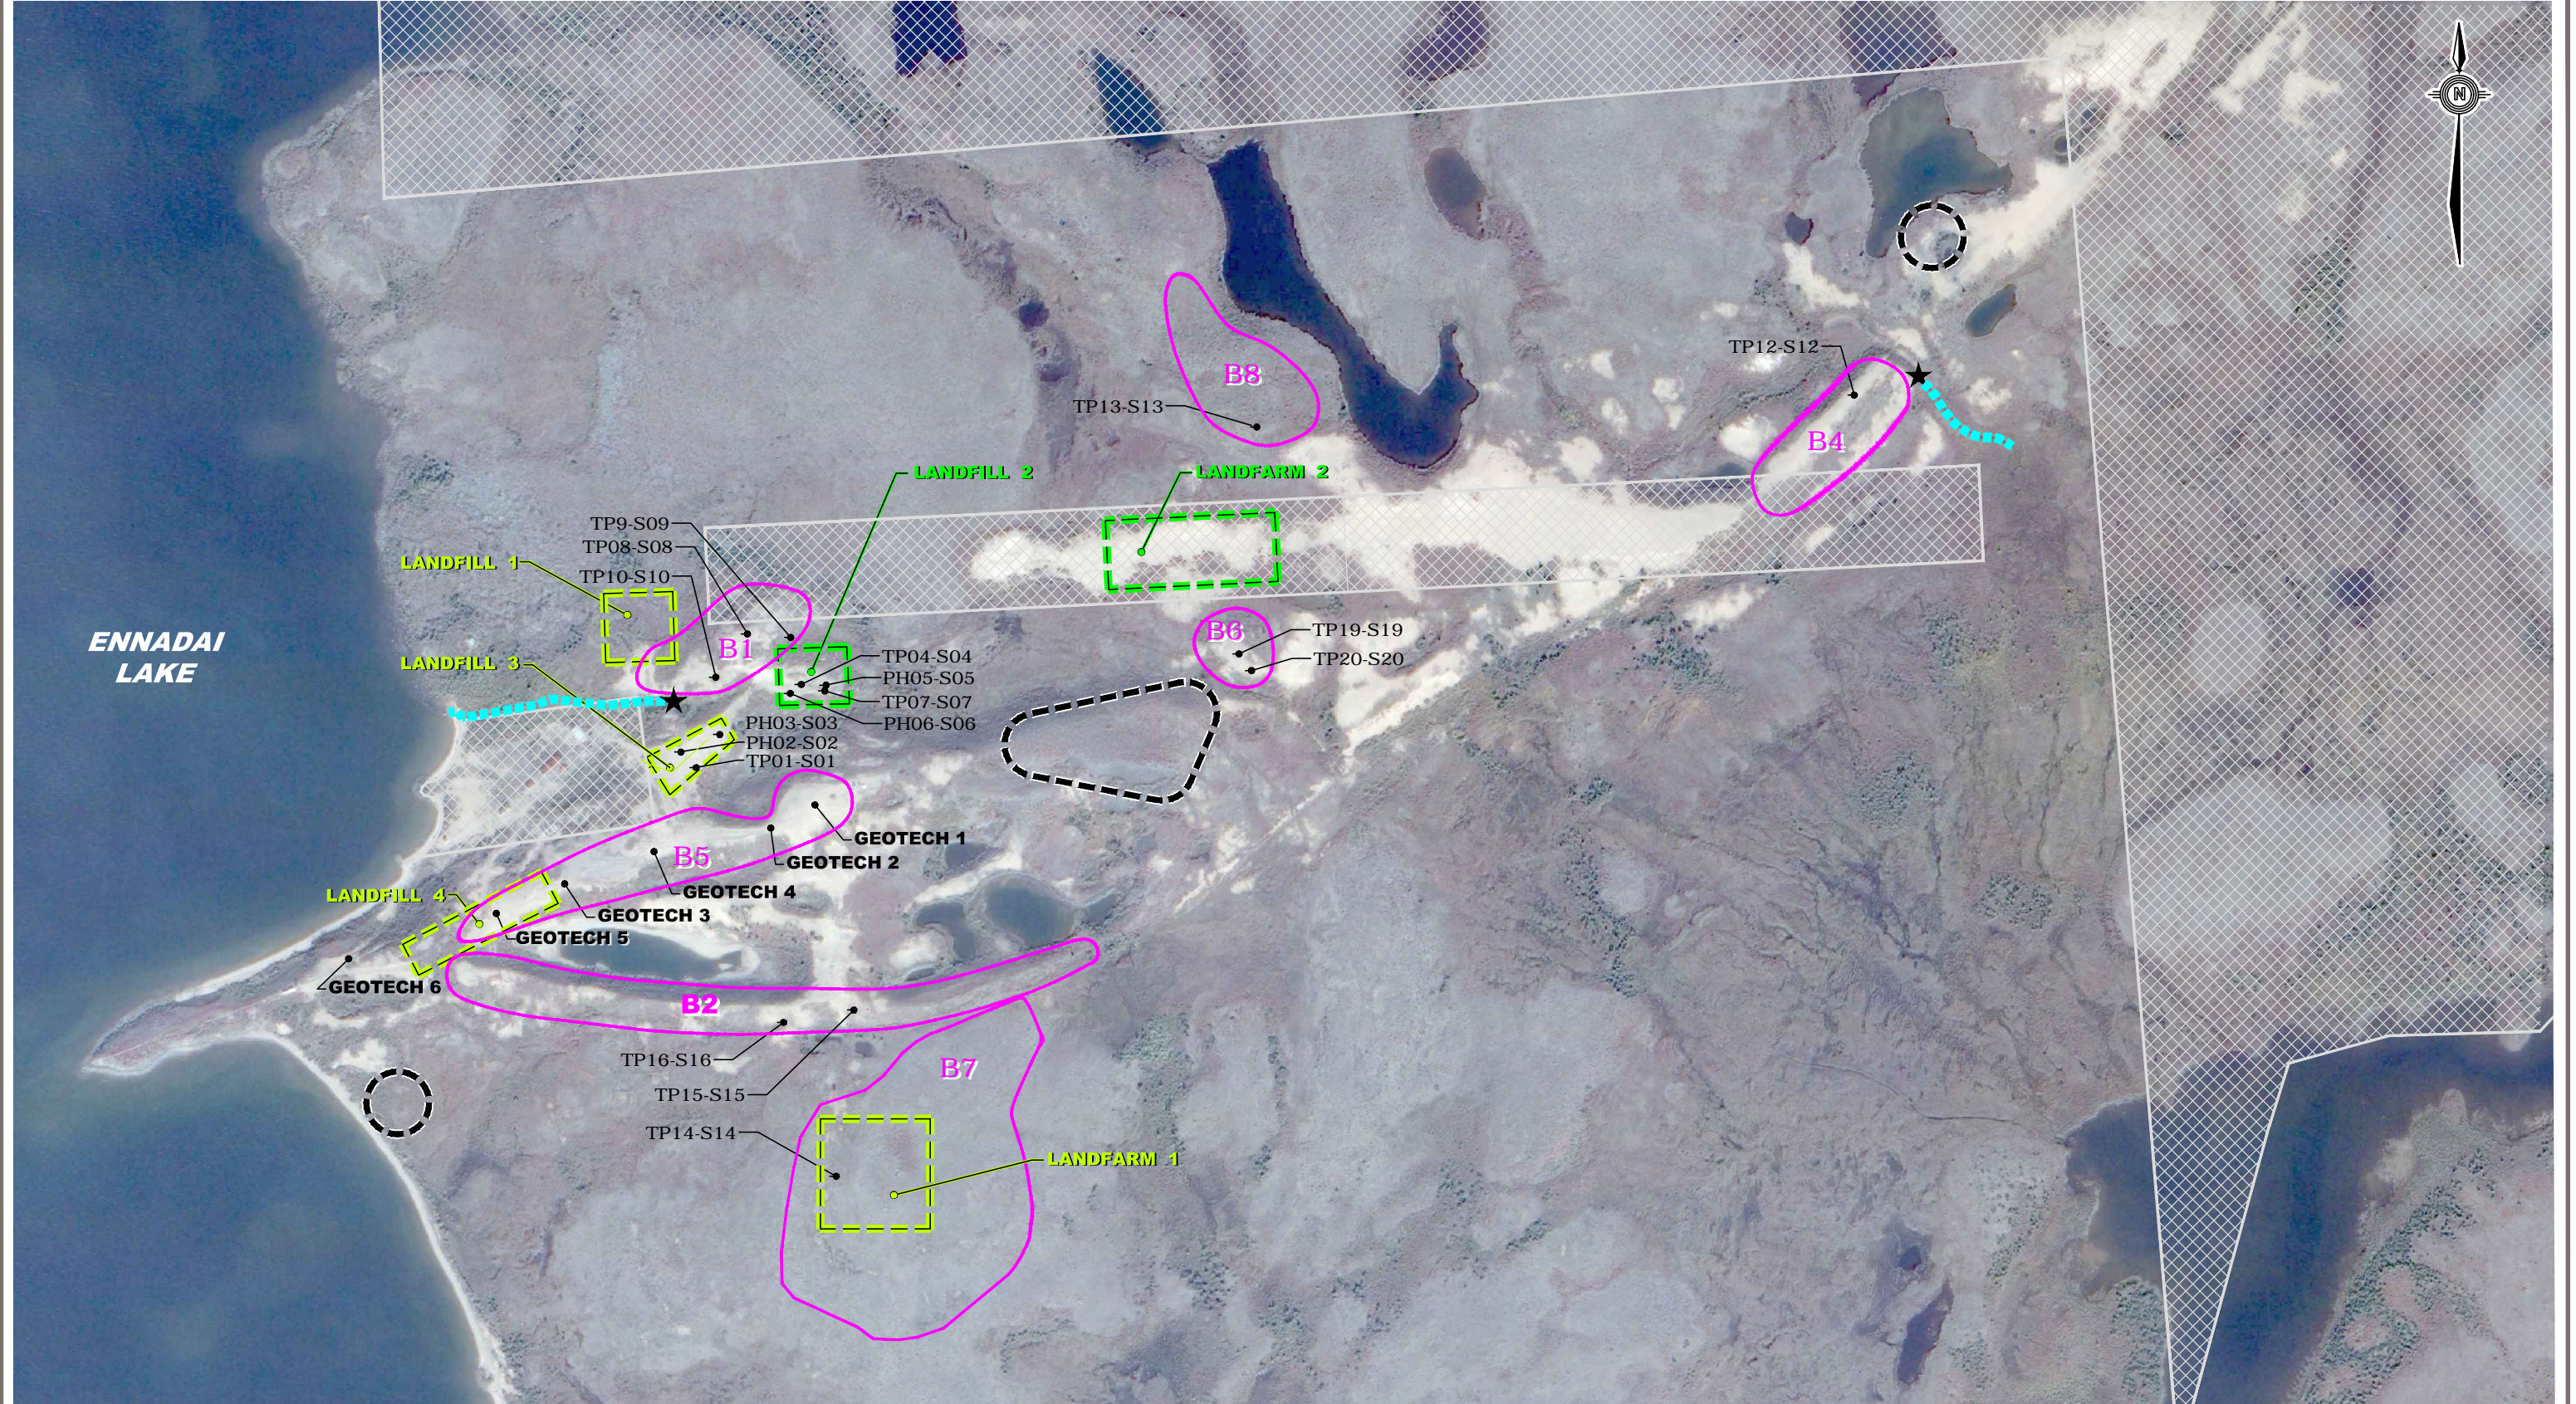
PROJECT NO. Y22101286	DWN MM	CKD KK	REV 0	Figure 10
OFFICE EDM	DATE November 2012

Eight potential borrow sources (B1 to B8) were investigated during the field program. A detailed description of the eight borrow sources is presented in the Phase ESA III (EBA 2012). For the RAP, Borrow B3 was eliminated and the extent of Borrow B4 was reduced because of nearby archaeologically restricted areas. Only the available borrow sources are presented in the RAP, and these are shown on Figure 10.

Two sites were assessed for potential landfarm locations as shown in Figure 10, and summarized in Table G-2 in Appendix D. A detailed description of the potential landfarm locations is presented in the Phase III ESA (EBA 2012). The areas identified are approximately 11,000 m<sup>2</sup> (105 x 105 m) for Landfarm 1 and 10,700 m<sup>2</sup> (60 x 180 m) for Landfarm 2 (Photos G40 to G44). Landfarms 1 and 2 are 450 and 550 m from the site respectively. Landfarm 1 is vegetated and mostly undisturbed, and is 30% covered with boulders typically between 0.3 and 1.5 m diameter. Landfarm 2 lies on IOL, and is relatively level, well-drained and slopes gently to the west with exposed sand and some gravel, occasional cobbles and small boulders at the surface. Roads will need to be constructed for both sites to allow access for heavy equipment.

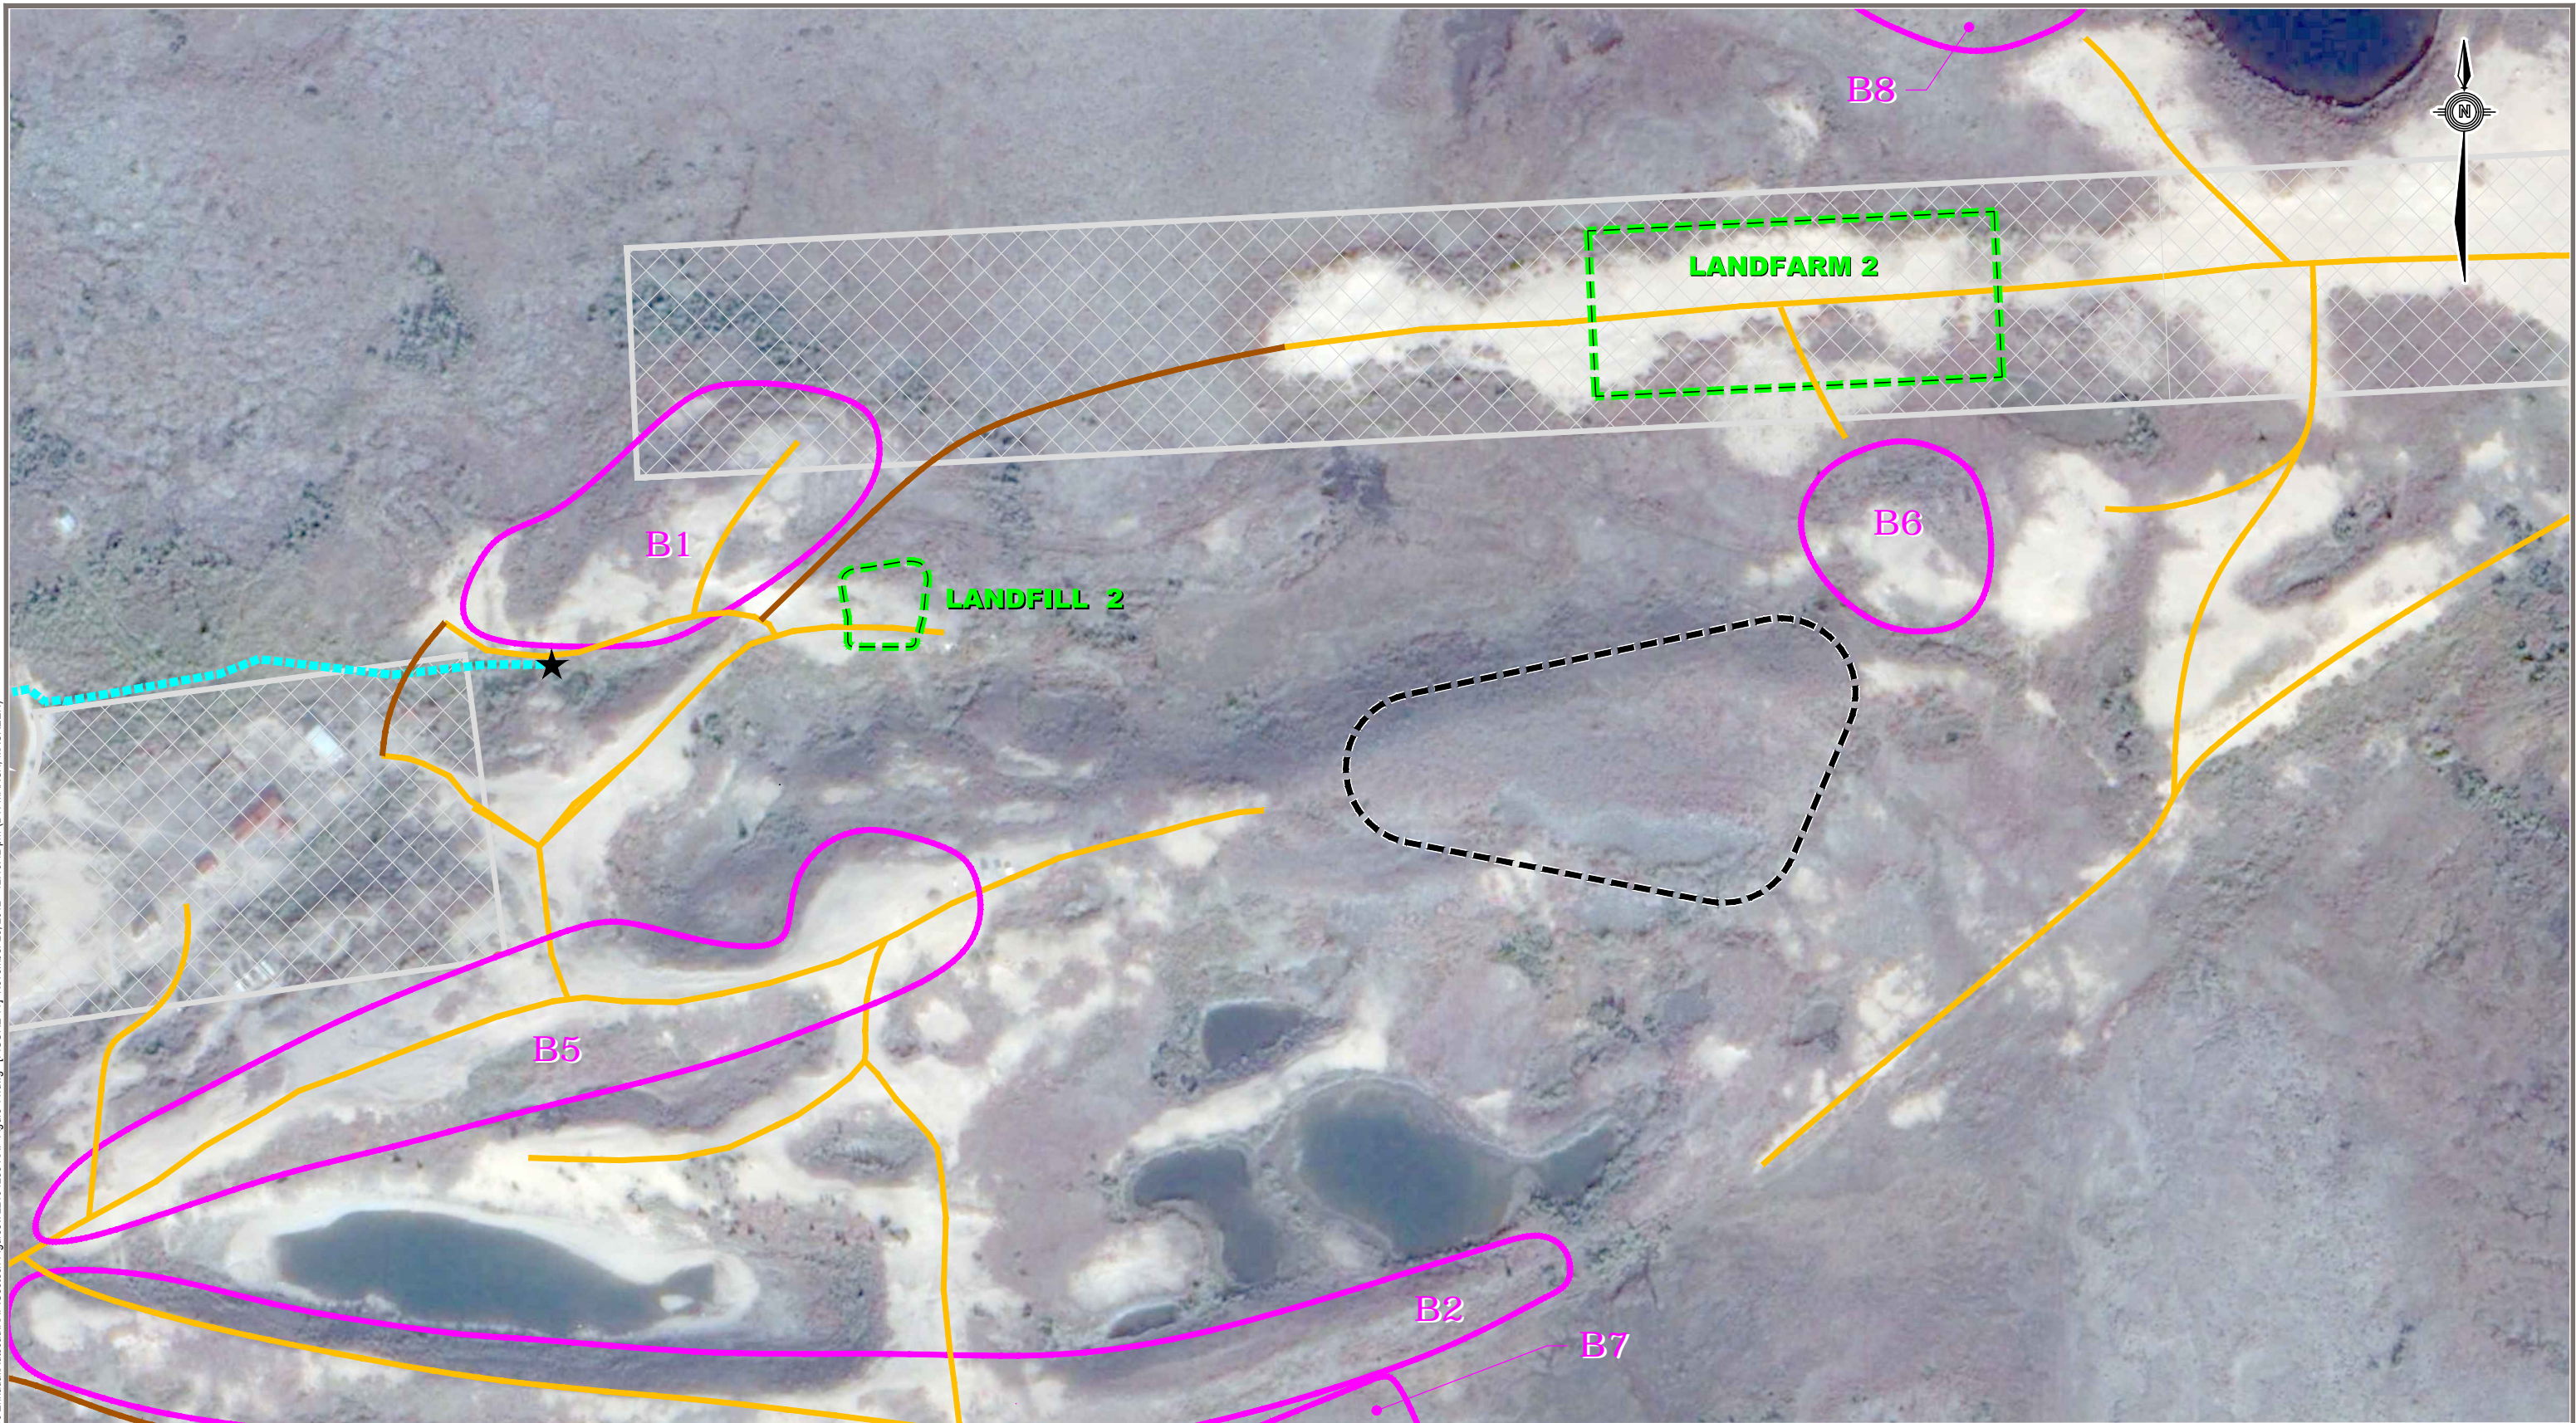
Figure 11

location and is presented on Figure 11. Landfarm 2 is on disturbed sandy terrain that could be easily graded.

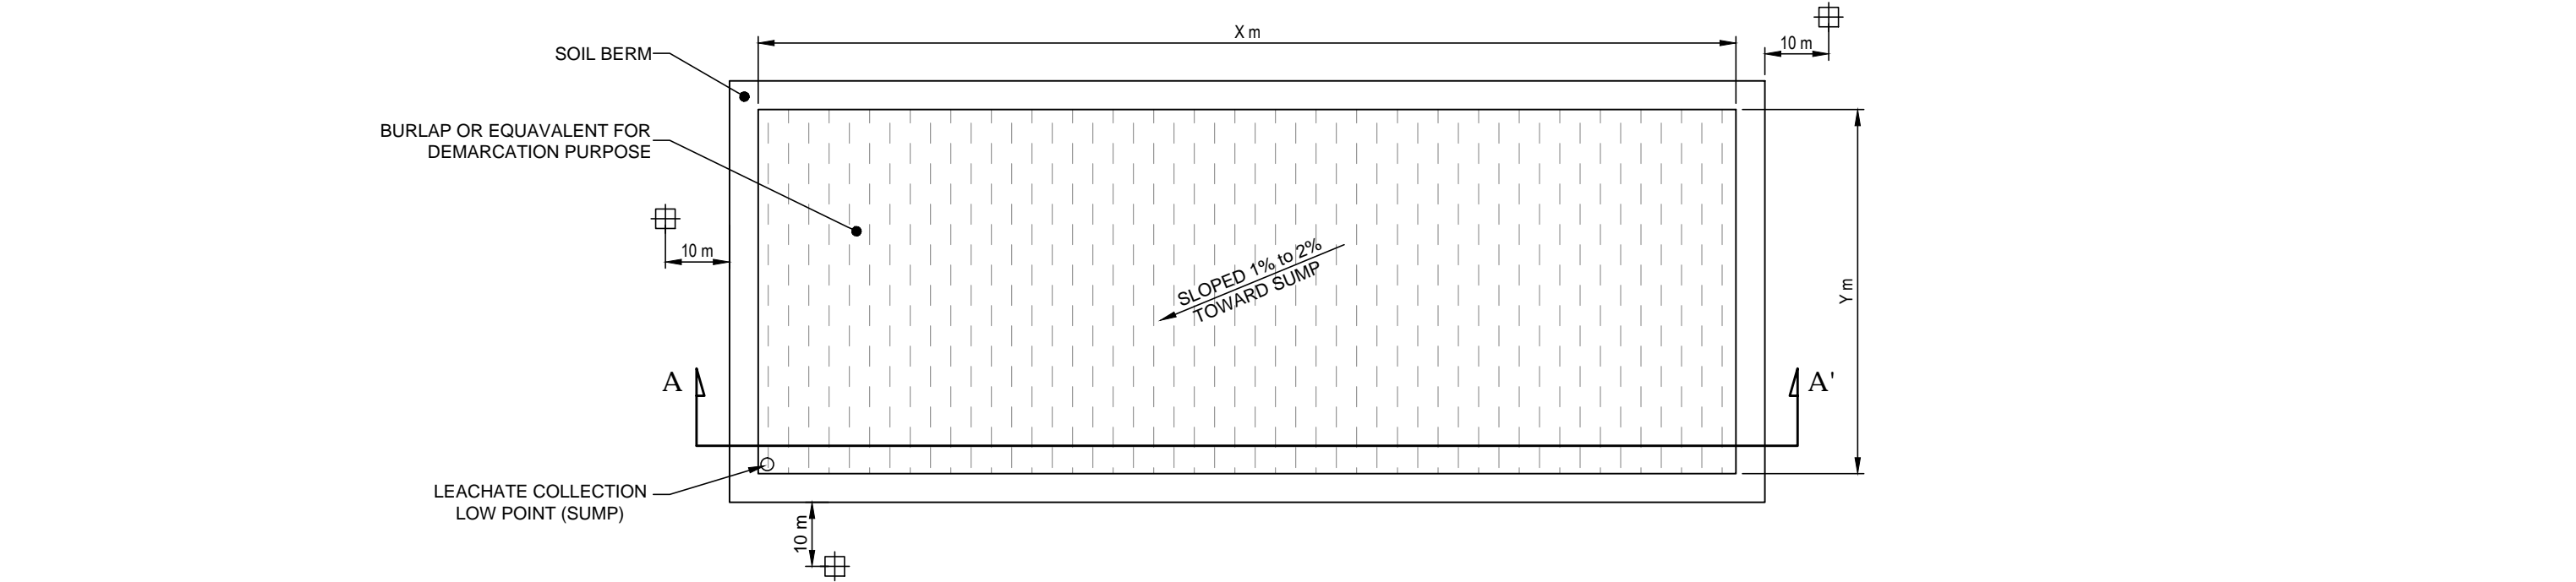
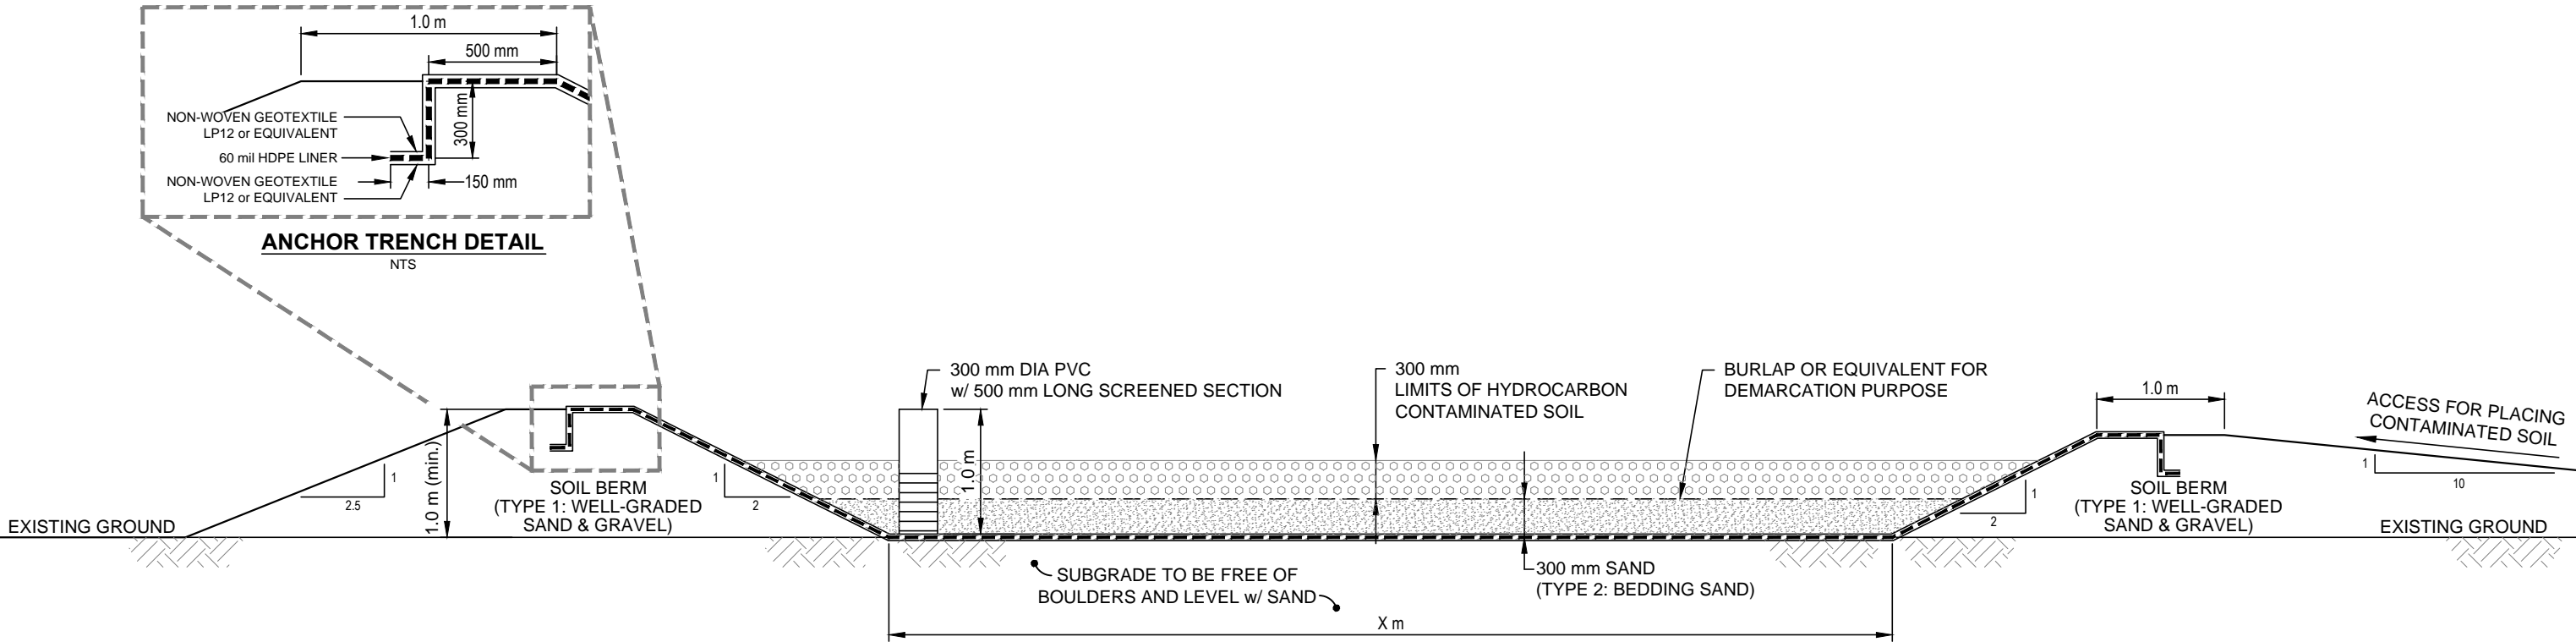
A TETRA TECH COMPANY		PROJECT NO. Y22101286	DWN MM	CKD CC/EG	REV 0	Figure 13
		OFFICE EDM	DATE November 2012

As discussed in Section 9.4.3, Type 1 granular fill material consisting of well-graded sand and gravel with trace to some silt can be used for the construction of landfarm berms. The Landfarm will be a lined facility using a 60 mil HDPE geomembrane protected on either side with a non-woven geotextile, as presented on Figure 13. After the 60 mil HDPE and non-woven geotextile is installed within, then Type 2 granular fill material (bedding sand) should be placed ovetop to protect the liner system from tilling or turning events during nutrient application. It is recommended that a layer of burlap or equivalent material be placed over the sand bedding to provide demarcation between the contaminated soil and bedding material.

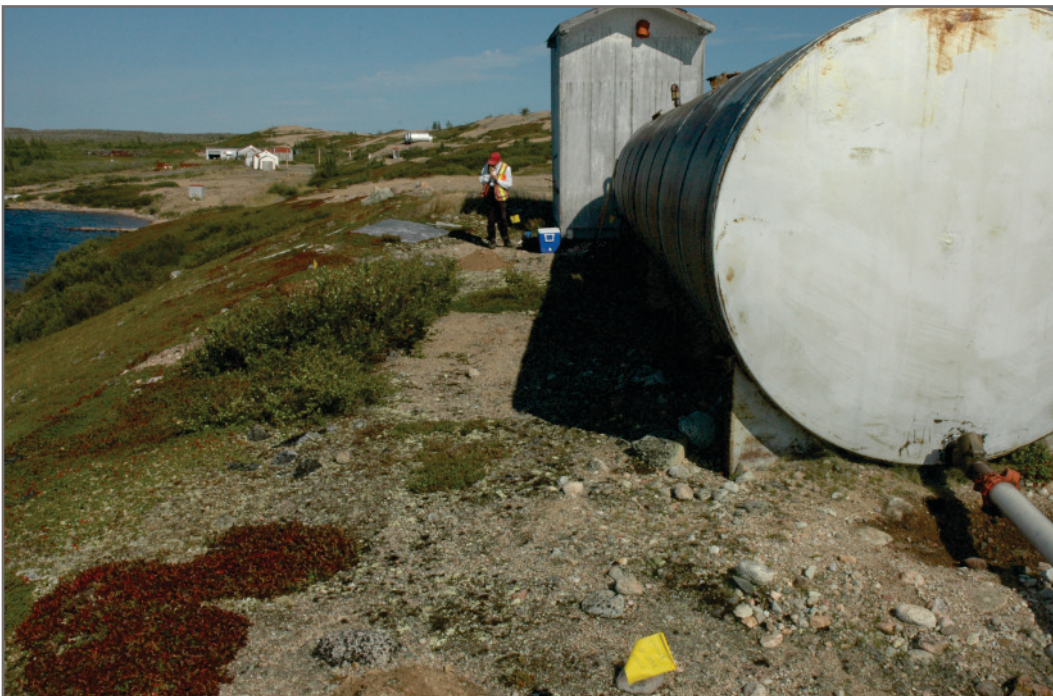
**Photo E-6:** APEC 4b - Tank 5 - Delineation of tanks; staining can be seen at the valve

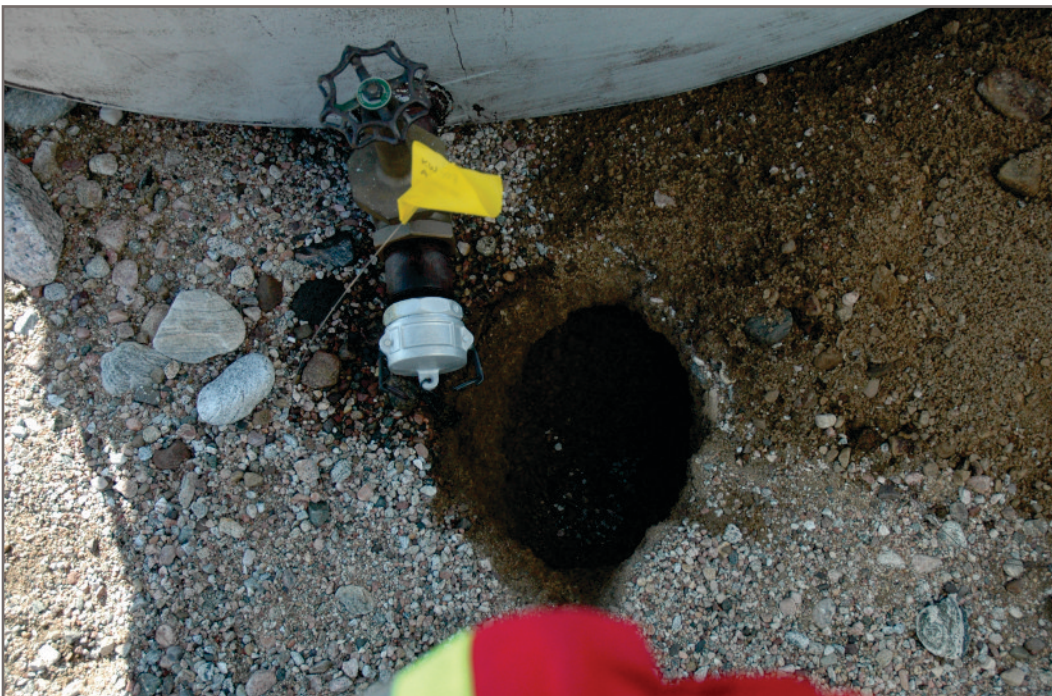
**Photo E-8:** APEC 4a - Tank 5 - Flag locations for soil samples APEC 4a- SS001, staining was noted at the valve of the AST

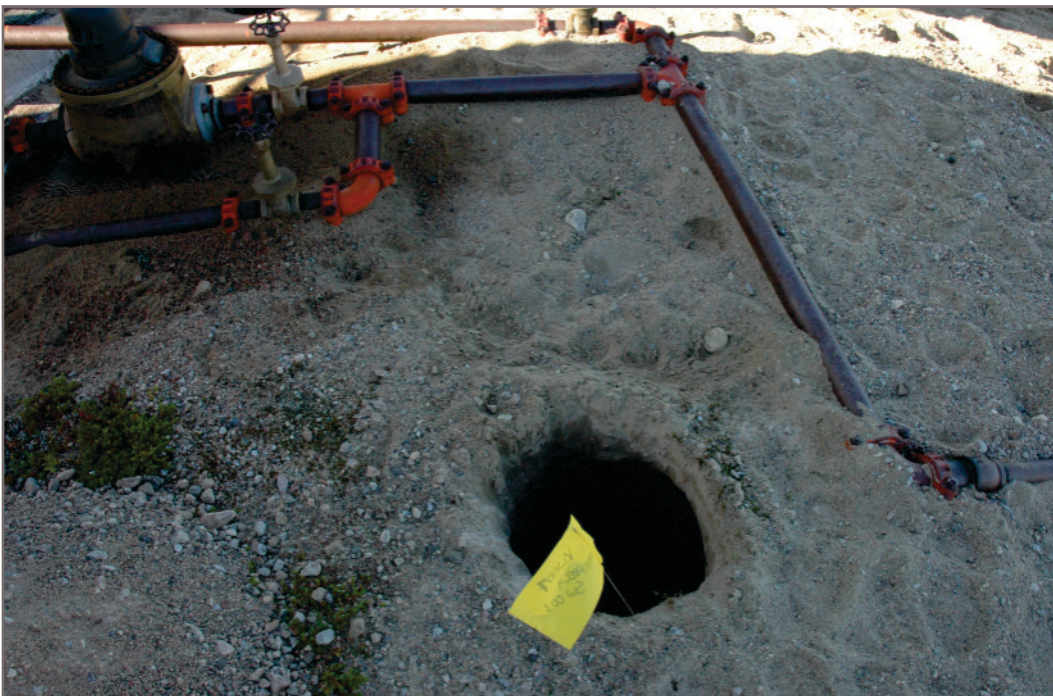
**Photo E-12:** APEC 9 - Tank 1- Soil sample location APEC 9- SS001; the soil sample was taken down-gradient of the fuel distribution lines; significant hydrocarbon odour and staining around the valves was noted

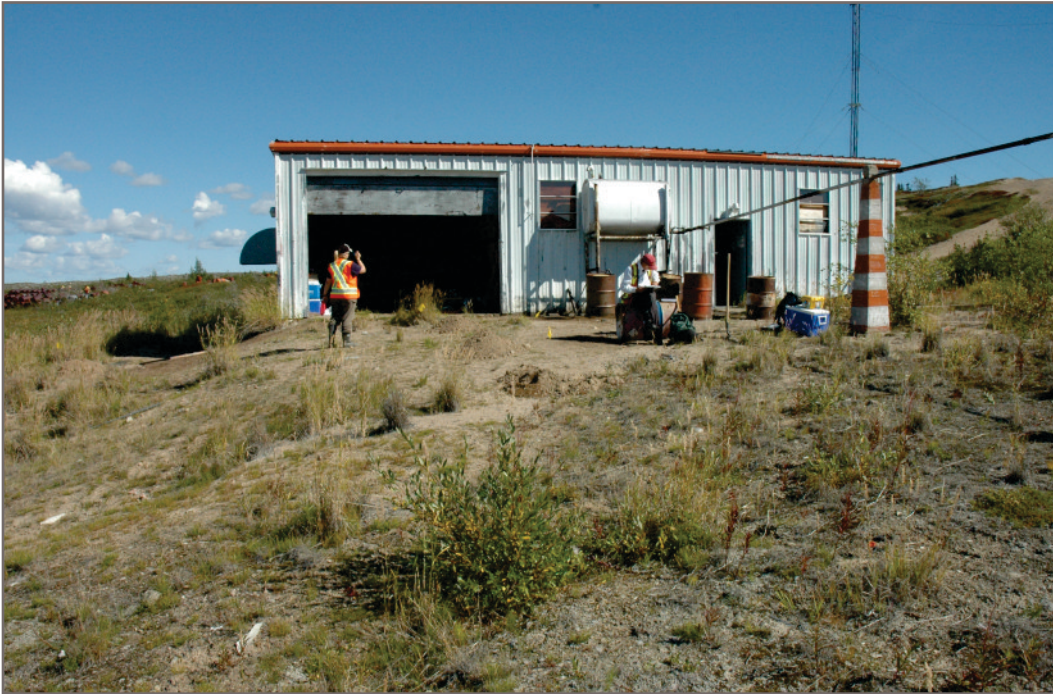
The Phase III ESA identified a single area of metal impacted soil (antimony and lead) in APEC 15, Figure 7 that is a result of battery disposal. The APEC is shown in Photos E16 to E18. The total volume of impacted material is 0.5 m<sup>3</sup>. This volume was identified in the Phase III ESA (EBA 2012).

**Photo E-17:** APEC 15 - Building 2 - Delineation soil sample locations APEC 15-SS002 to SS005 shown; the picture was taken facing north

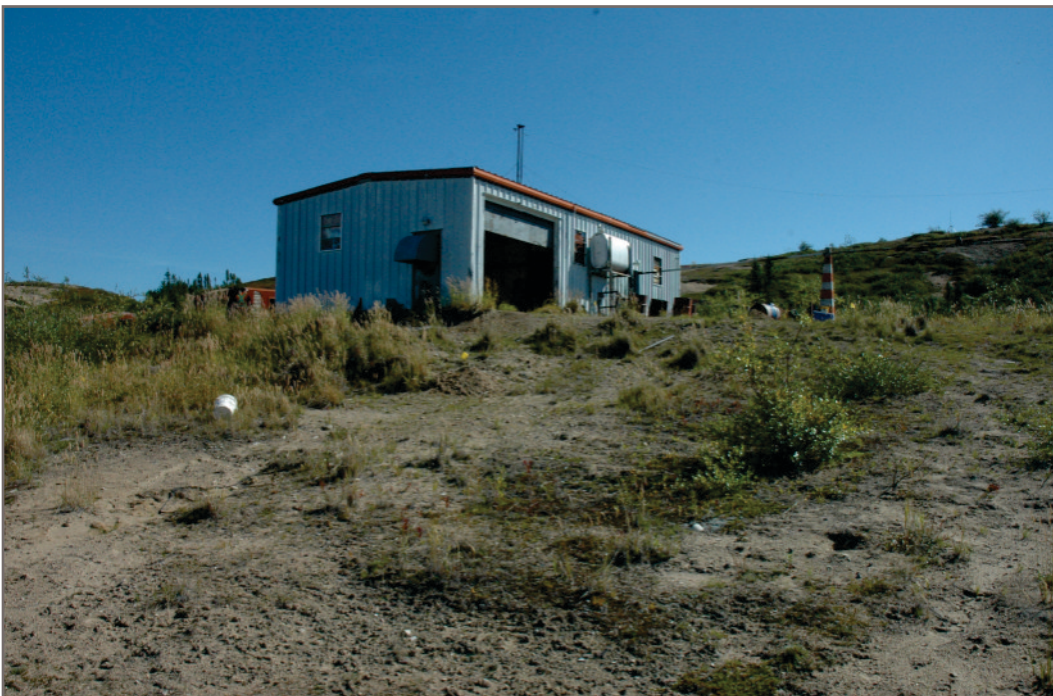
**Photo E-18:** APEC 15 - Building 2 - Delineation soil sample locations APEC 15-SS005, SS006 and SS008; the picture was taken facing northeast

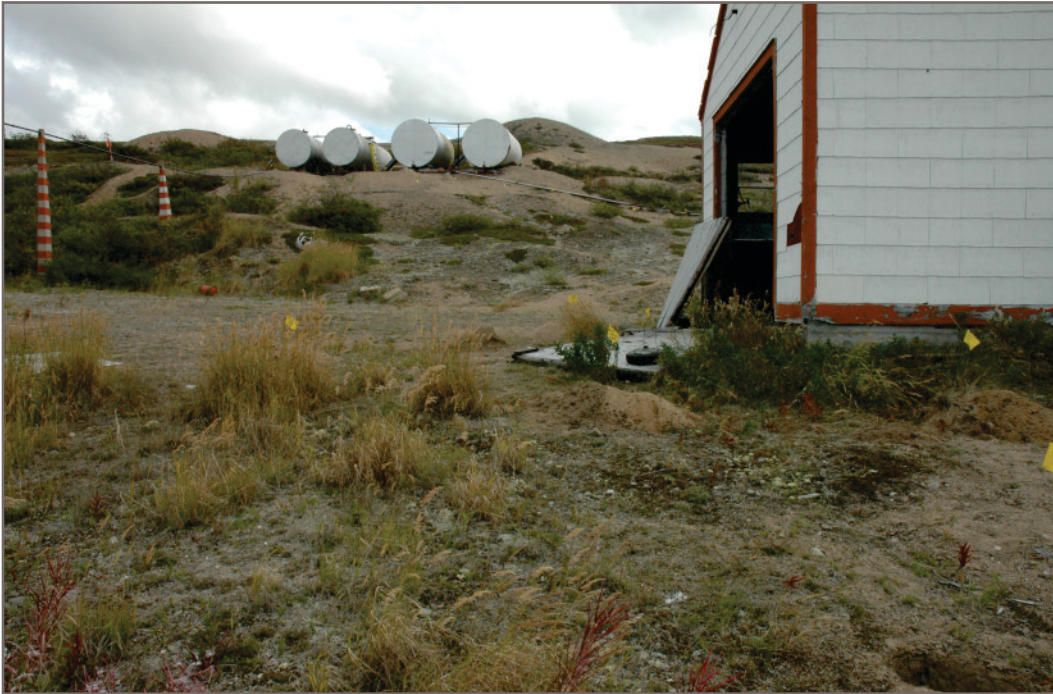
**Photo E-19:** APEC 18 - Building 5 - Delineation soil sampling locations APEC 18-SS001 to SS006; a concrete pad and excavator were present in the building

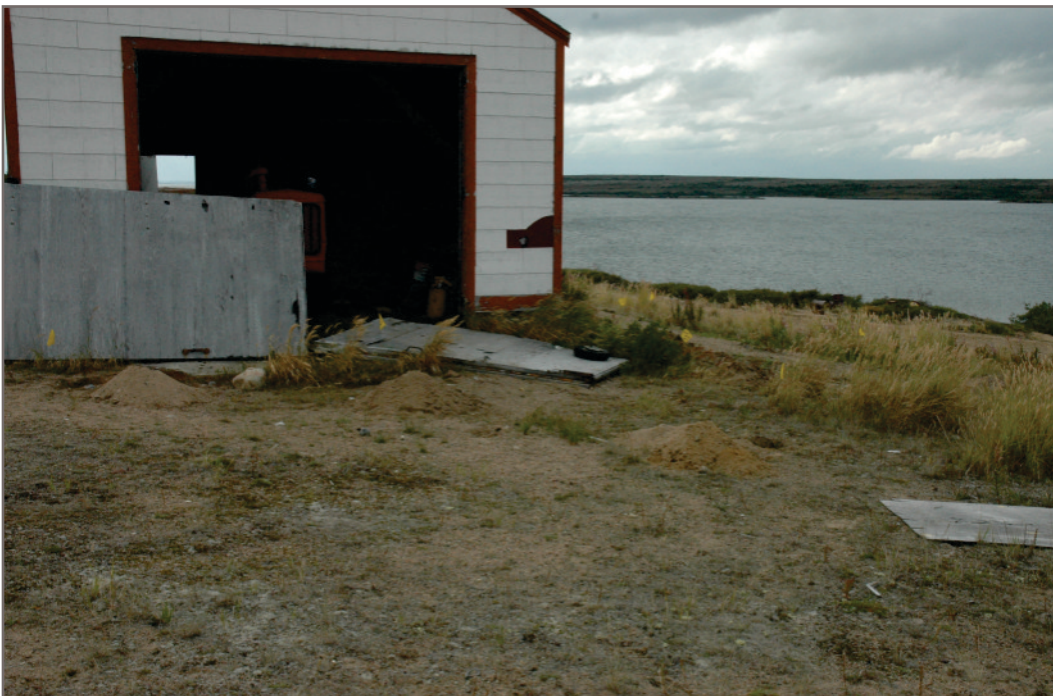
**Photo E-20:** APEC 18 - Building 5 - Delineation soil sampling locations APEC 18-SS001 to SS006; the photo was taken facing south toward the building

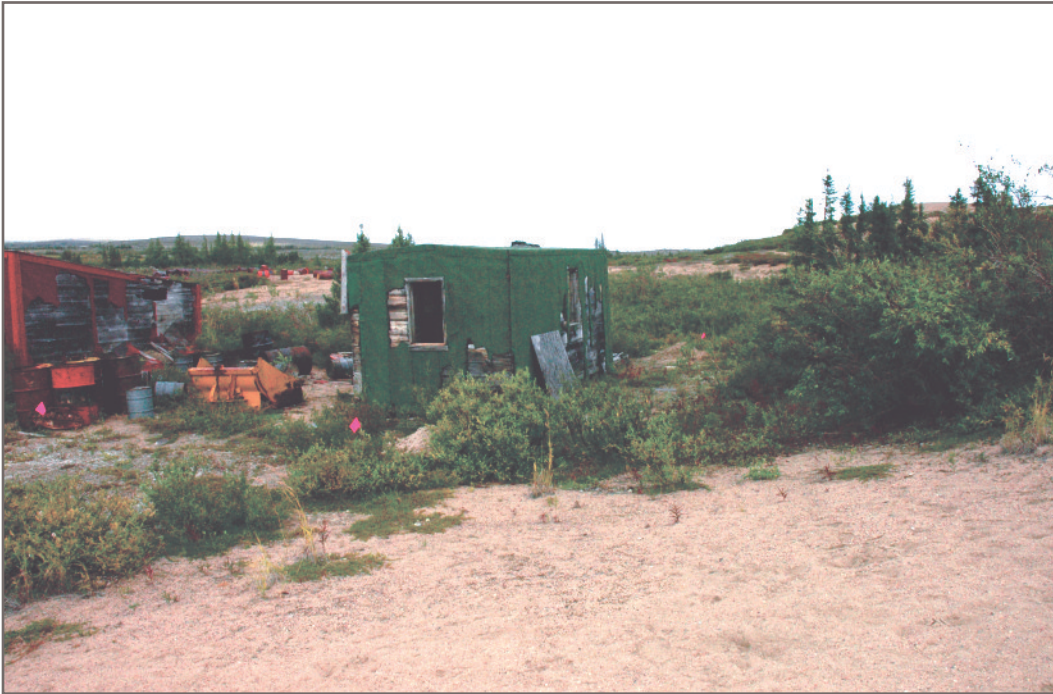
**Photo E-21:** APEC 19 and APEC 20 - Buildings 7 and 8 - Hydrocarbon contamination was identified between the buildings

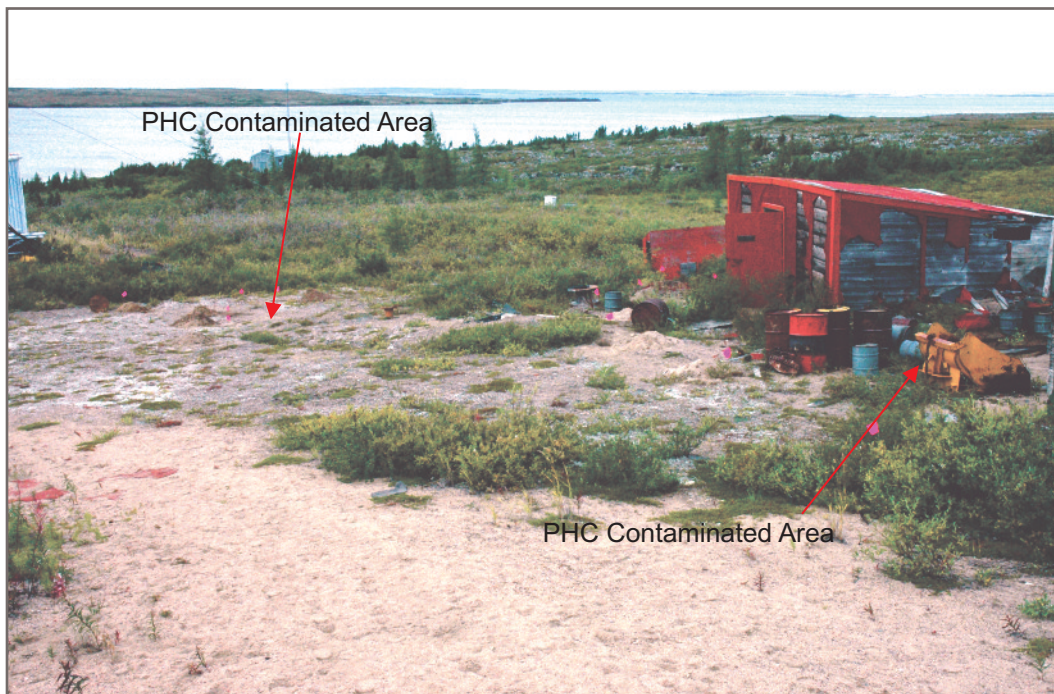
**Photo E-22:** APEC 19 and 20 - Buildings 7 and 8 - Two areas of hydrocarbon contamination were identified. The approximate locations of the areas are shown.

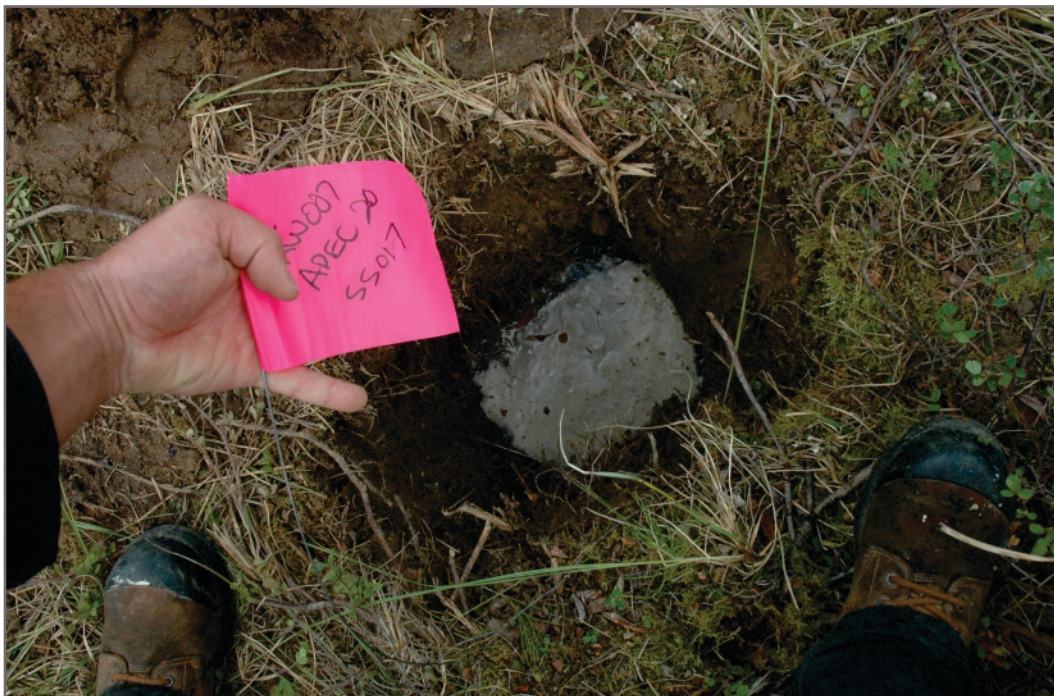
**Photo E-24:** APEC 20 - Building 8 - Soil sample APEC 20-SS017 is shown; water was encountered upon the completion of the test pit
