ENNADAI LAKE  
REMEDATION PROJECT

## REMEDIAL ACTION PLAN FORMER WEATHER STATION ENNADAI LAKE, NUNAVUT

NOVEMBER 2012  
ISSUED FOR REVIEW  
EBA FILE: Y22101286.0012

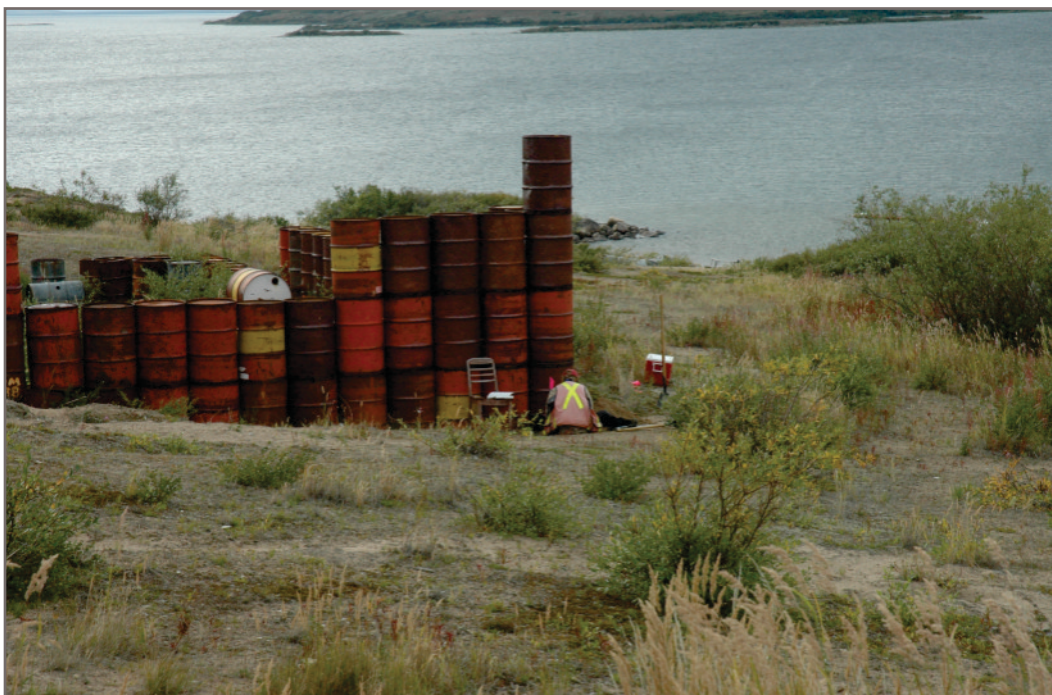
**Photo E-25:** APEC 23 - Drum Cache 1/Wind Break- Delineation soil samples APEC 23-SS001, SS003 and SS005 are shown; a historic fuel cache was formerly located south of APEC 23 toward Ennadai Lake

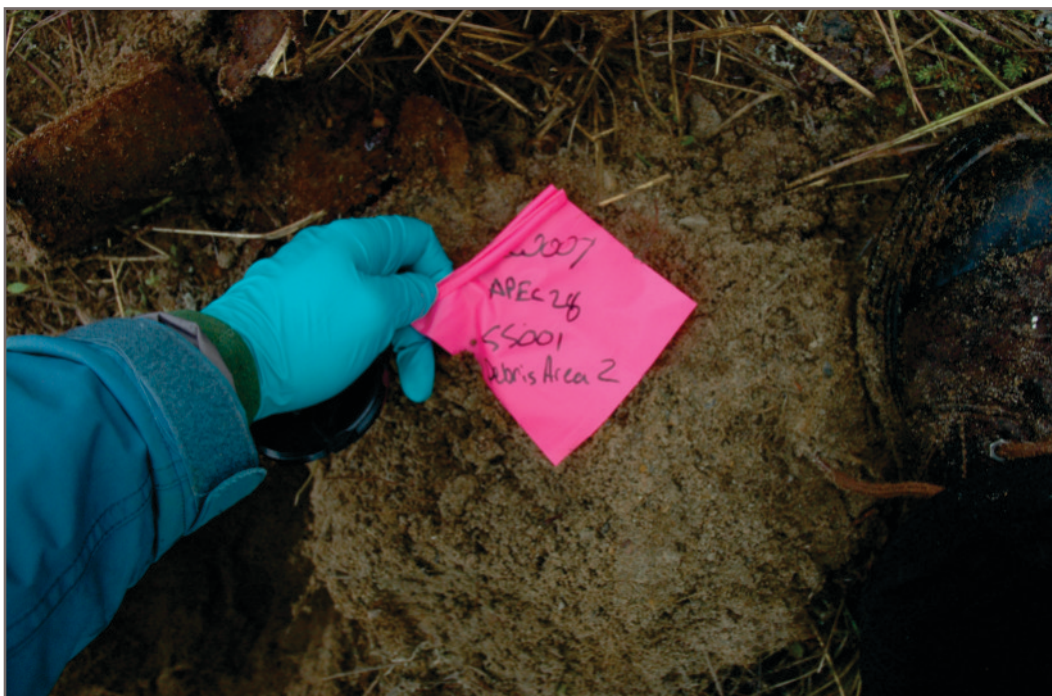
- Photo E-26: APEC 28 - Debris Area, organic soil/matter was encountered overlaying sand, multiple layers of waste were discovered during test pitting
- Photo E-27: APEC 29 - Shoreline - Various empty barrels were found around the Site; there was no staining or odour noted

**Photo E-26:** APEC 28 - Debris Area, organic soil/matter was encountered overlaying sand, multiple layers of waste were discovered during test pitting

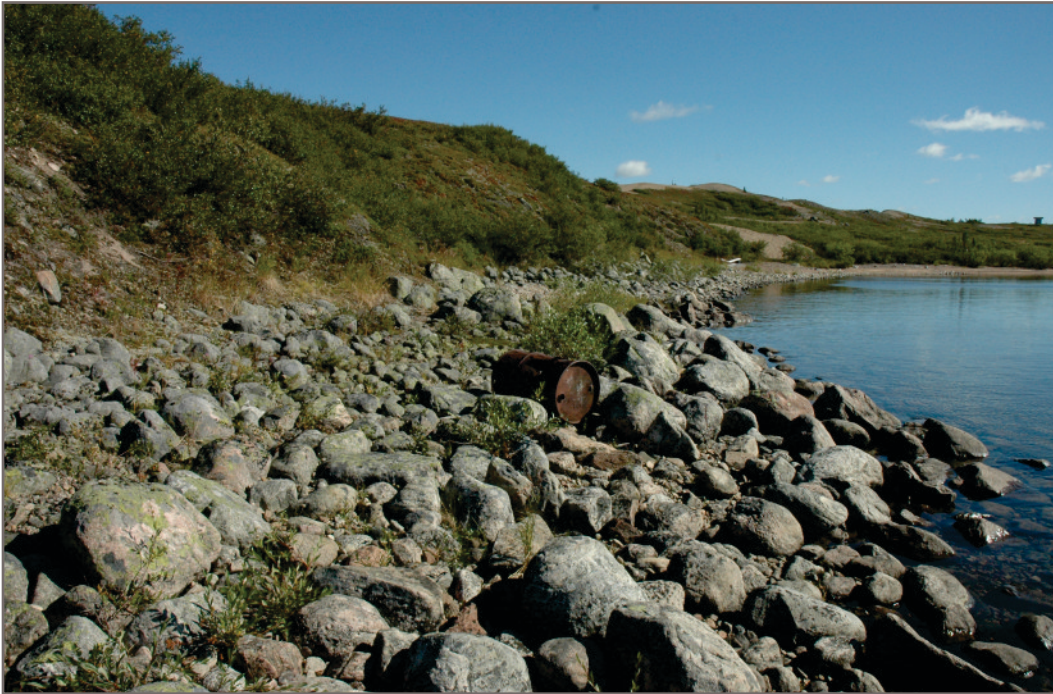
**Photo E-27:** APEC 29 - Shoreline - Various empty barrels were found around the Site; there was no staining or odour noted

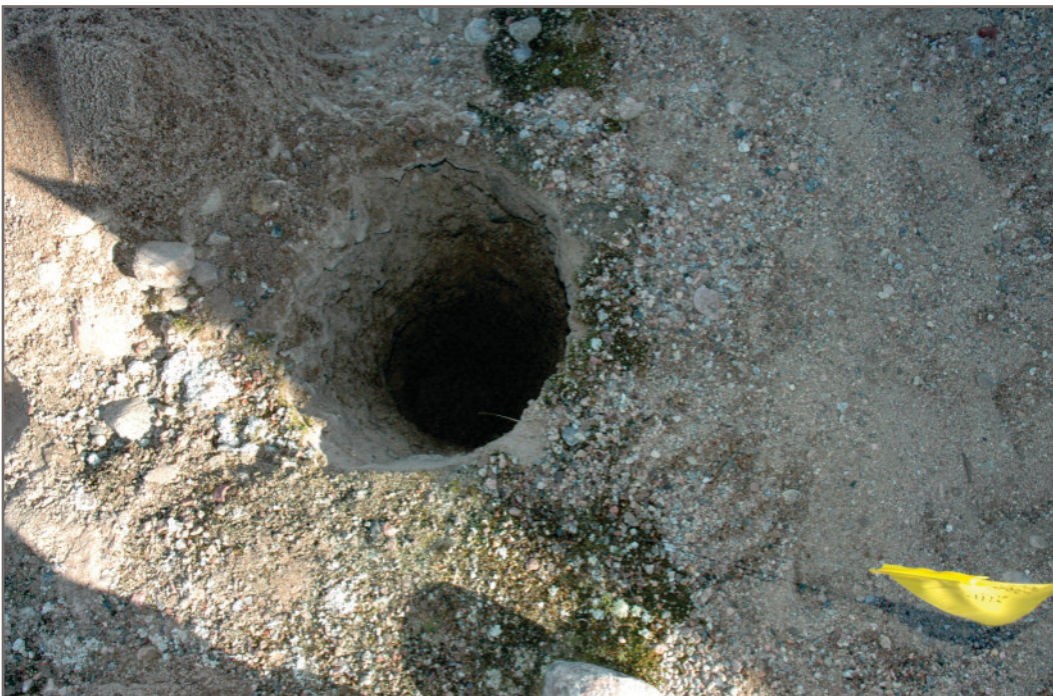
- Photo E-28: General Soil Condition taken at APEC 12 - Sand with an estimated 5 – 10 % cobbles, located at the toe of APEC 12
- Photo E-29: General Soil Condition at APEC 3 - Sand with an estimated 10 - 20 % cobbles and gravel at terminal extent of pipeline near Stain 3

**Photo E-28:** General Soil Condition taken at APEC 12 - Sand with an estimated 5 - 10% cobbles, located at the toe of APEC 12

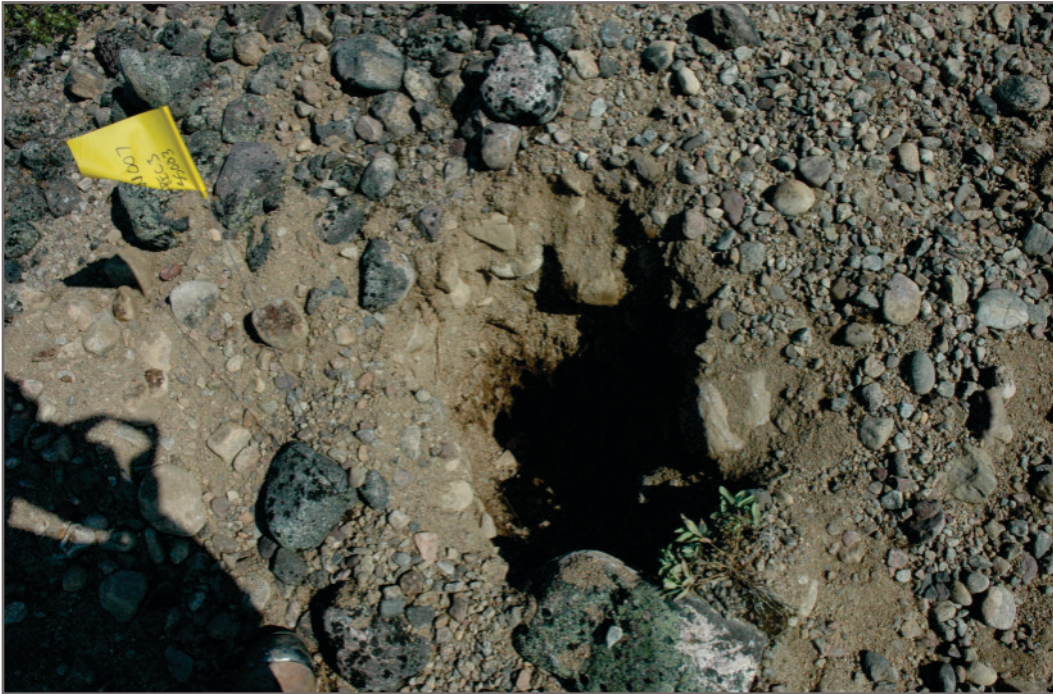
**Photo E-29:** General Soil Condition at APEC 3 - Sand with an estimated 10 - 20 % cobbles and gravel at terminal extent of pipeline near Stain 3

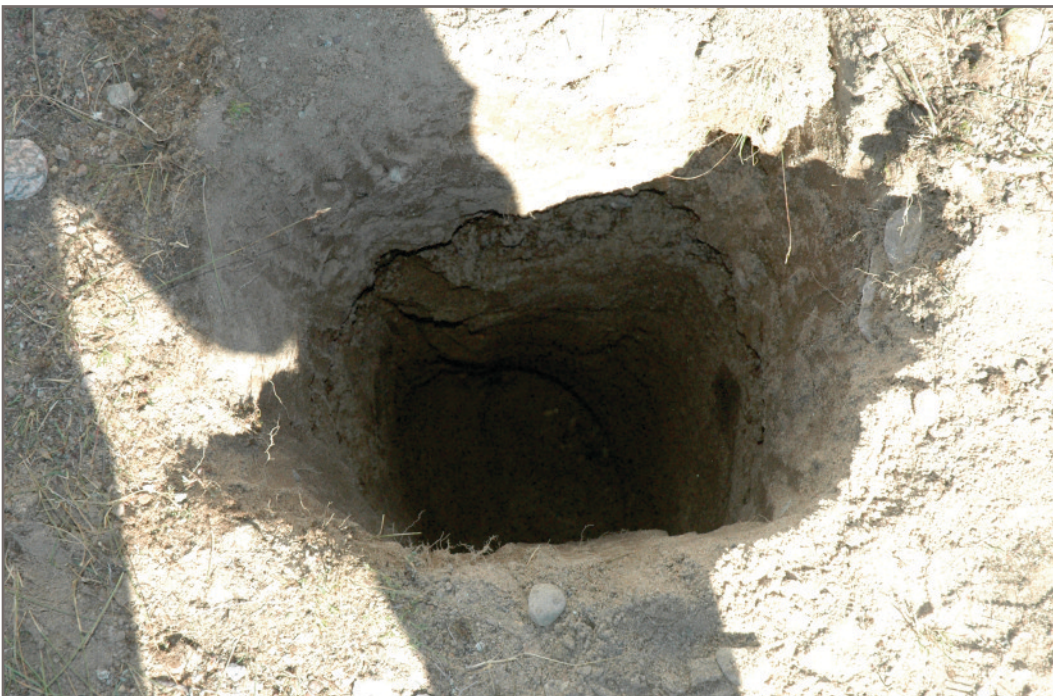
- Photo E-30: General Soil Condition at APEC 13 (Central Buildings) - Well sorted sand with some gravel

**Photo E-30:** General Soil Condition at APEC 13 (Central Buildings) - Well sorted sand with some gravel

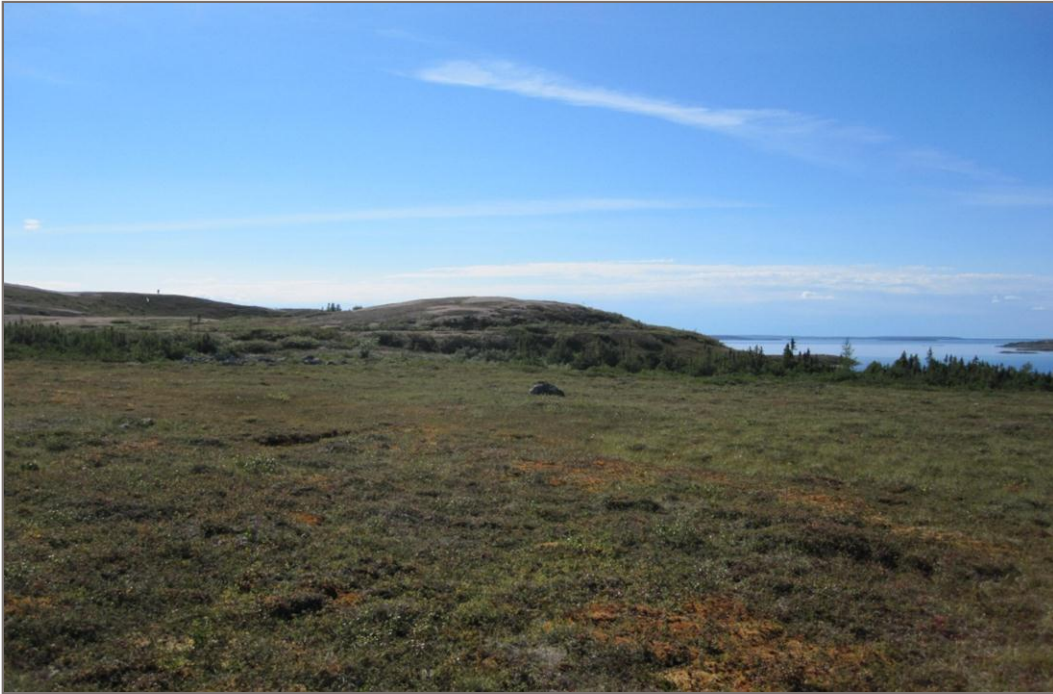
**Photo G12:** Borrow 1 in the background, with debris in Landfill 2 in the foreground, looking north northwest.

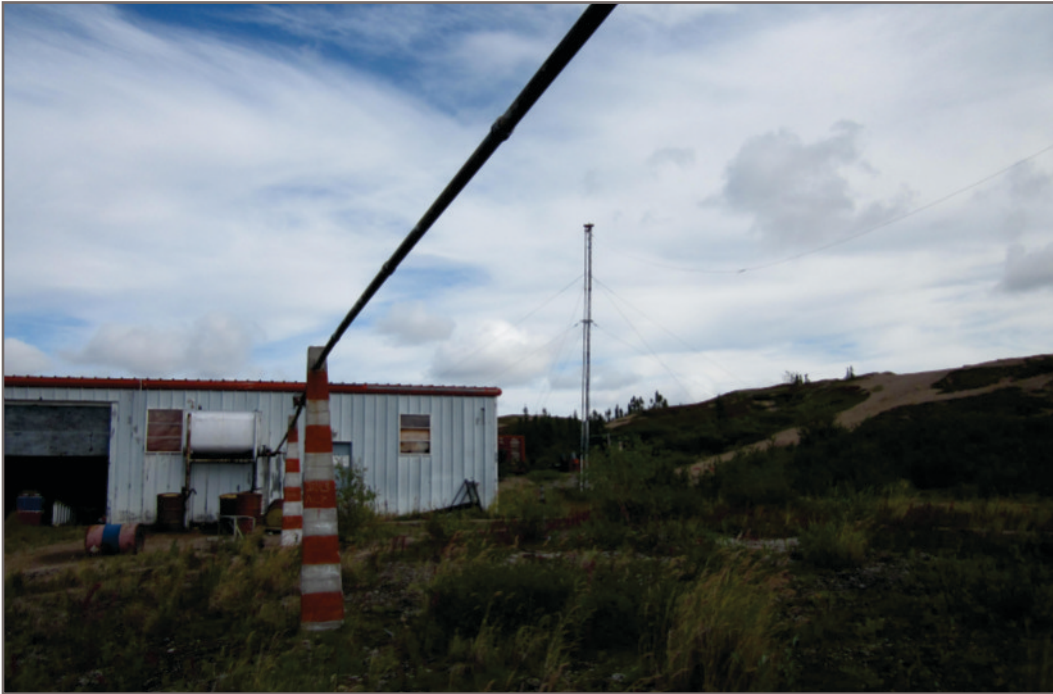
**Photo H-10:** APEC 13 - Overhead piping from tanks to Buildings - View of overhead piping towards Building 3; total and leachable lead painted concrete and organic content in pipeline

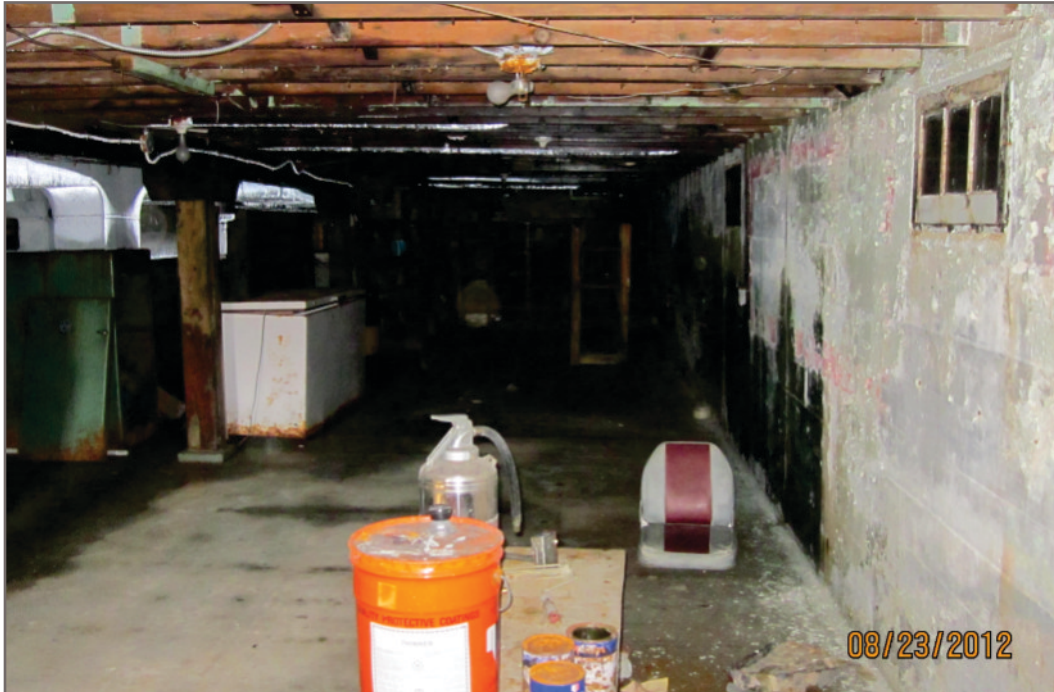
**Photo H-12:** APEC 14 - Building 1 - Asbestos black felt, asbestos window caulking, total and leachable lead painted wood

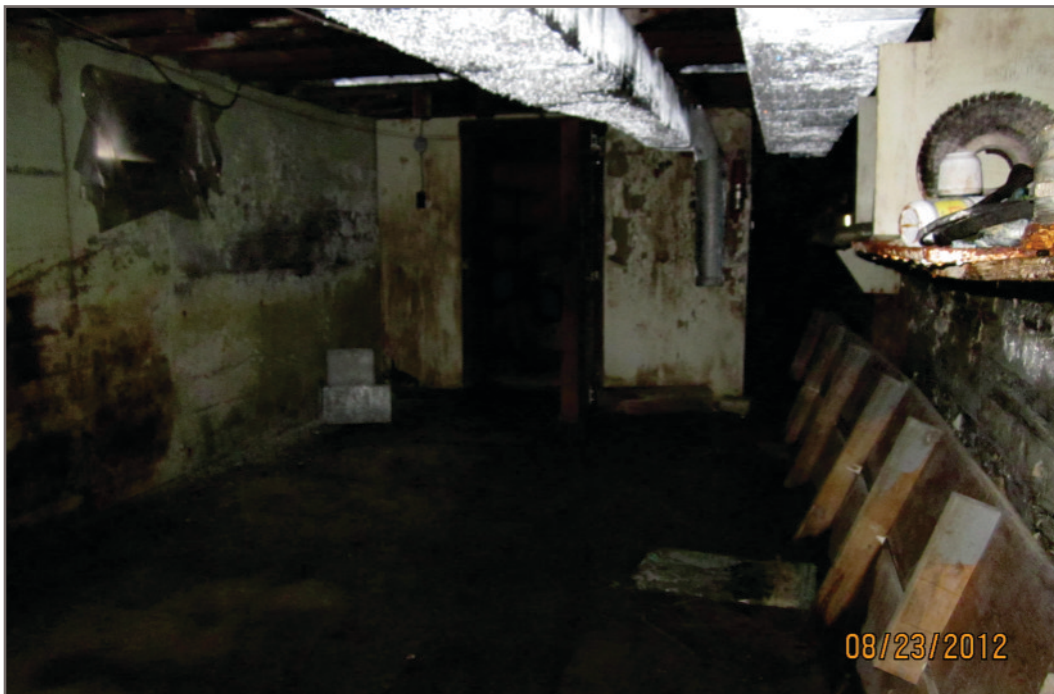
**Photo H-13:** APEC 14 - Building 1 - Basement total lead and leachable lead painted concrete walls, miscellaneous chemicals, ODS in freezer, mould on wood beams and concrete

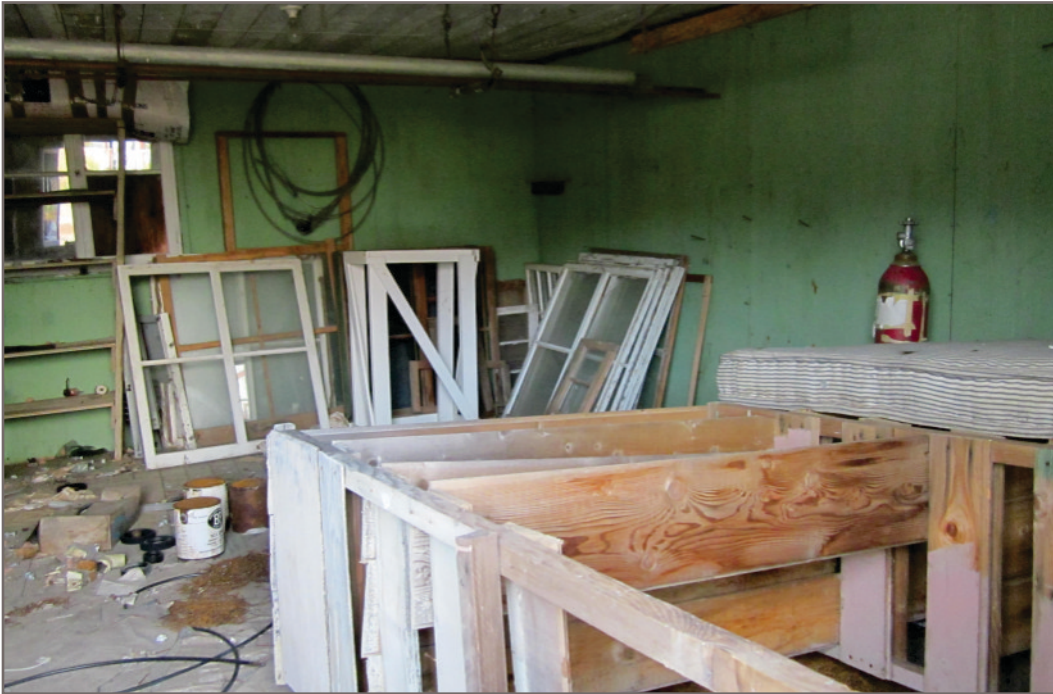
**Photo H-28:** APEC 16 - Building 3 - Asbestos black felt, attic insulation, window caulking and total lead and leachable lead painted wood

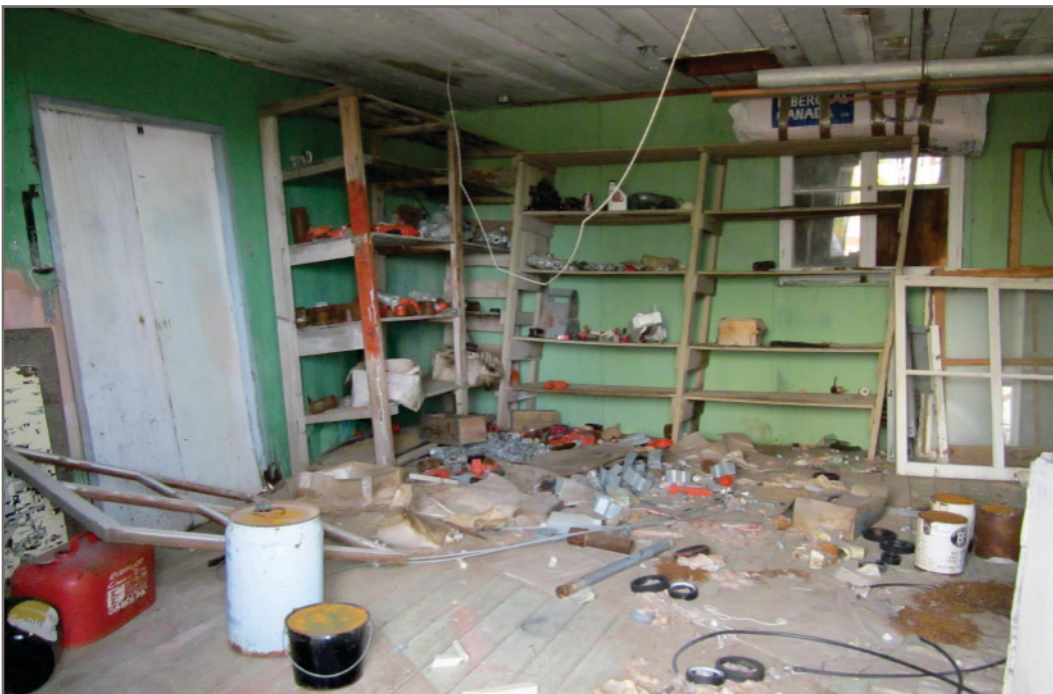
**Photo H-29:** APEC 16 - Building 3 - Total lead and leachable lead painted wood and compressed gas cylinder

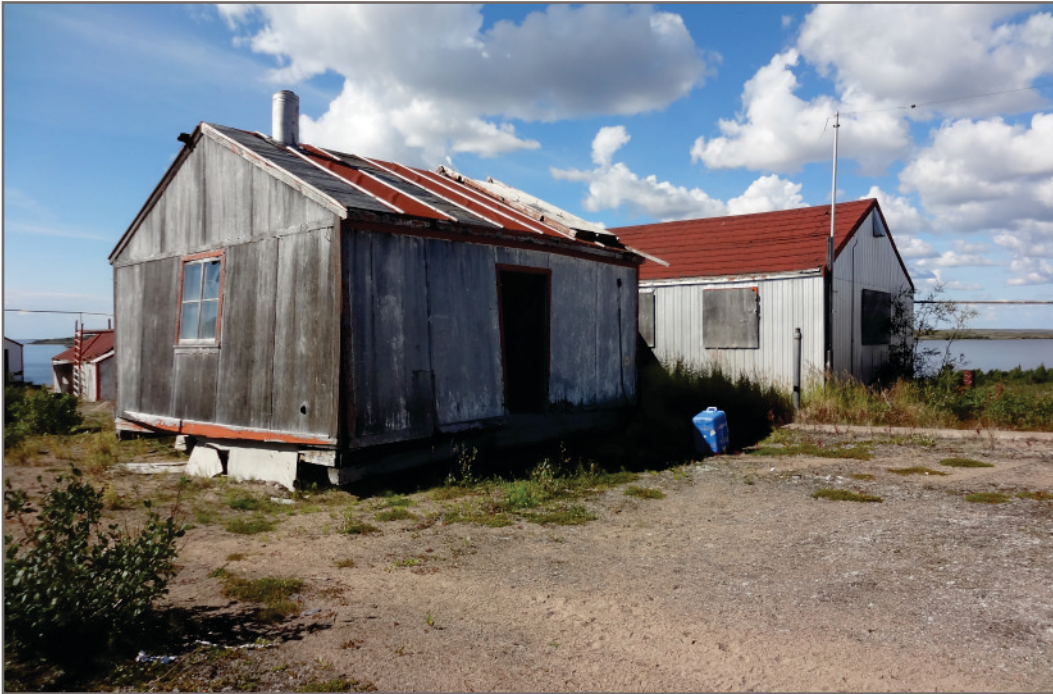
**Photo H-31:** APEC 17 - Building 4 - Asbestos black felt, attic insulation, window caulking, walls panels and total lead and leachable lead painted wood

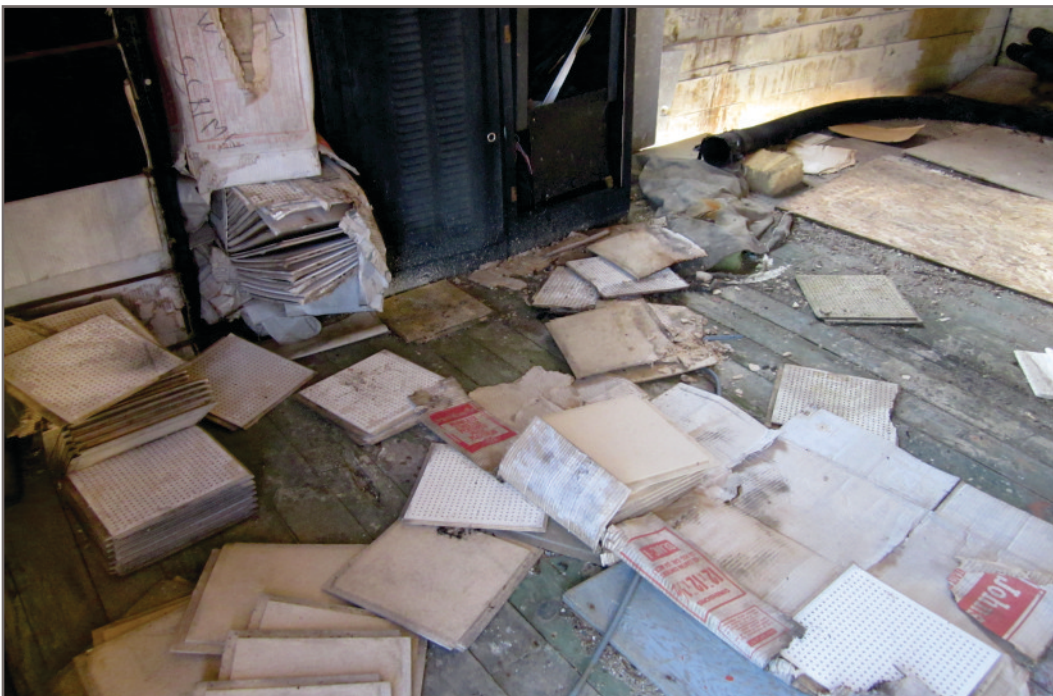
**Photo H-32:** APEC 17 - Building 4 - Asbestos chimney tile and ceiling tile, and total lead and leachable lead painted wood

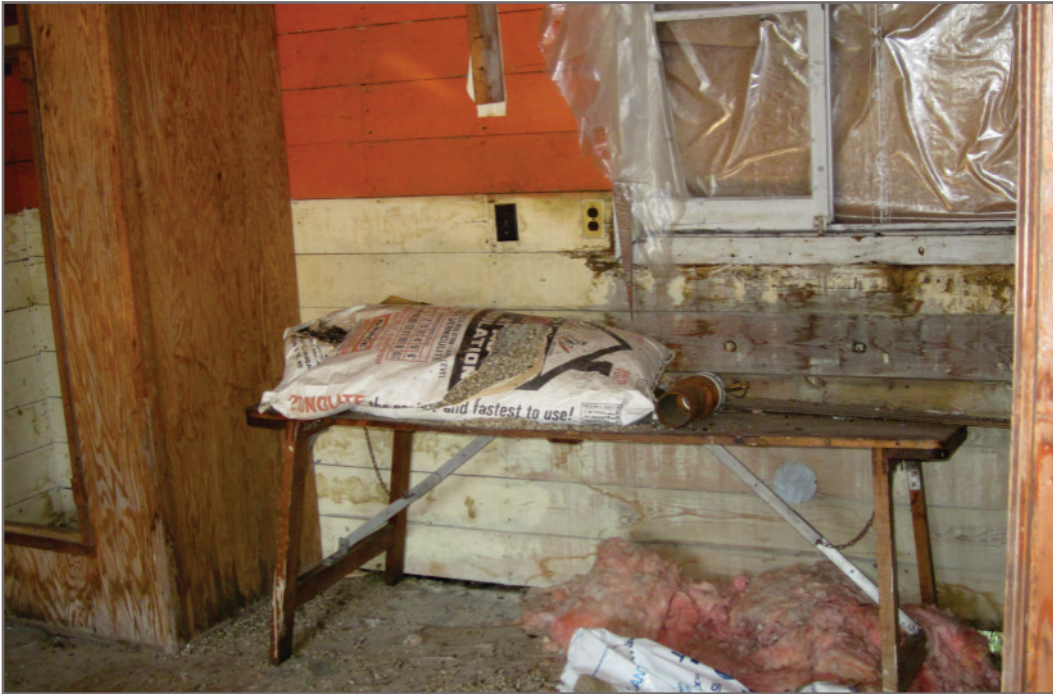
**Photo H-33:** APEC 17 - Building 4 - Asbestos insulation, and total lead and leachable lead painted wood

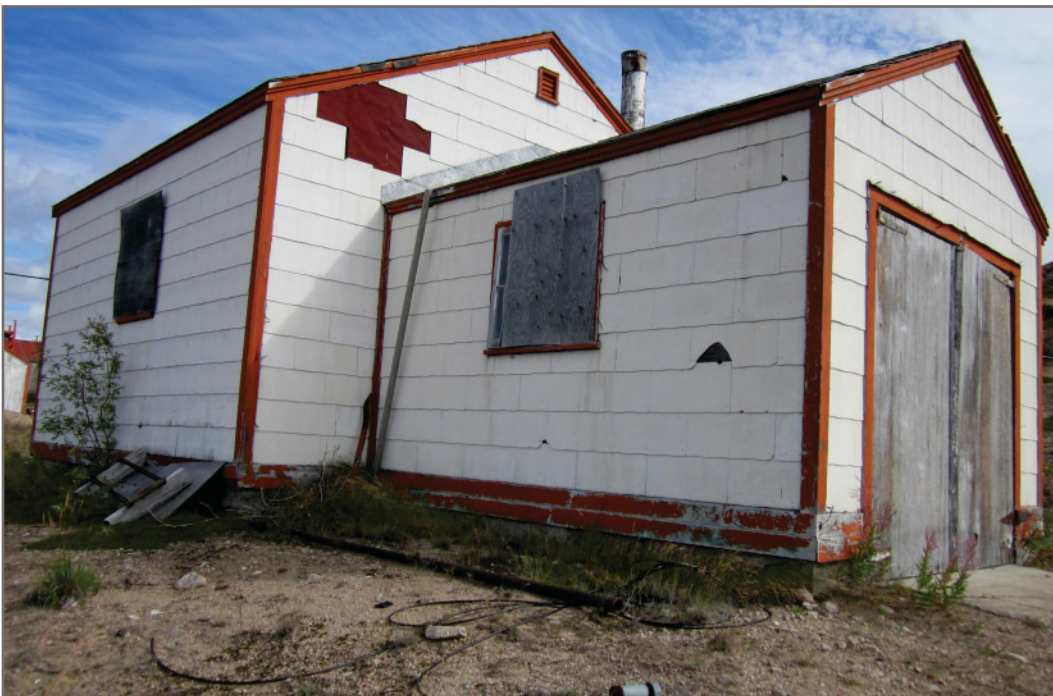
**Photo H-34:** APEC 18 - Building 5 - Asbestos exterior panels, black felt, attic insulation, window caulking, and total lead and leachable lead painted wood

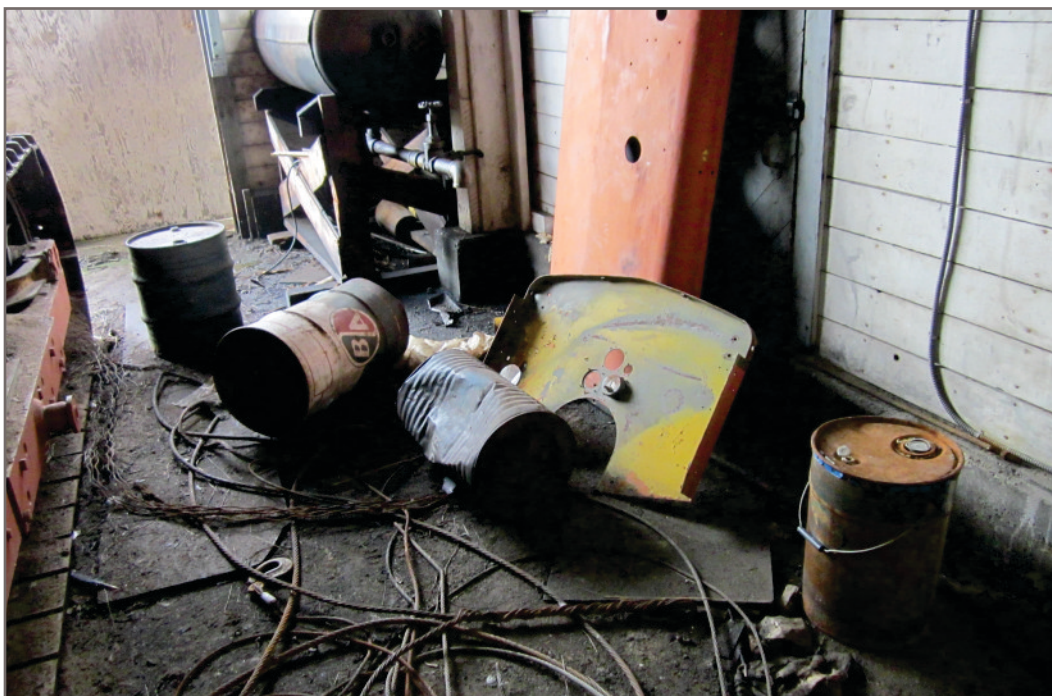
**Photo H-36:** APEC 18 - Building 5 - Total lead and leachable lead painted wood, AST organic contents and miscellaneous containers of oil/lubricants

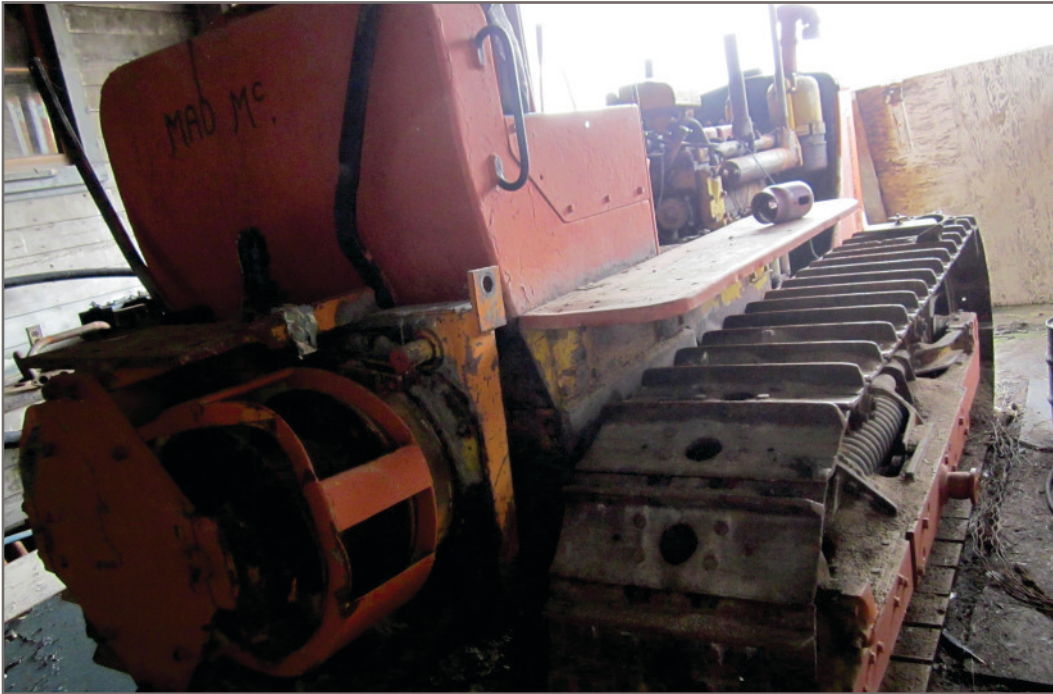
**Photo H-37:** APEC 18 - Building 5 - Total lead and leachable lead painted caterpillar

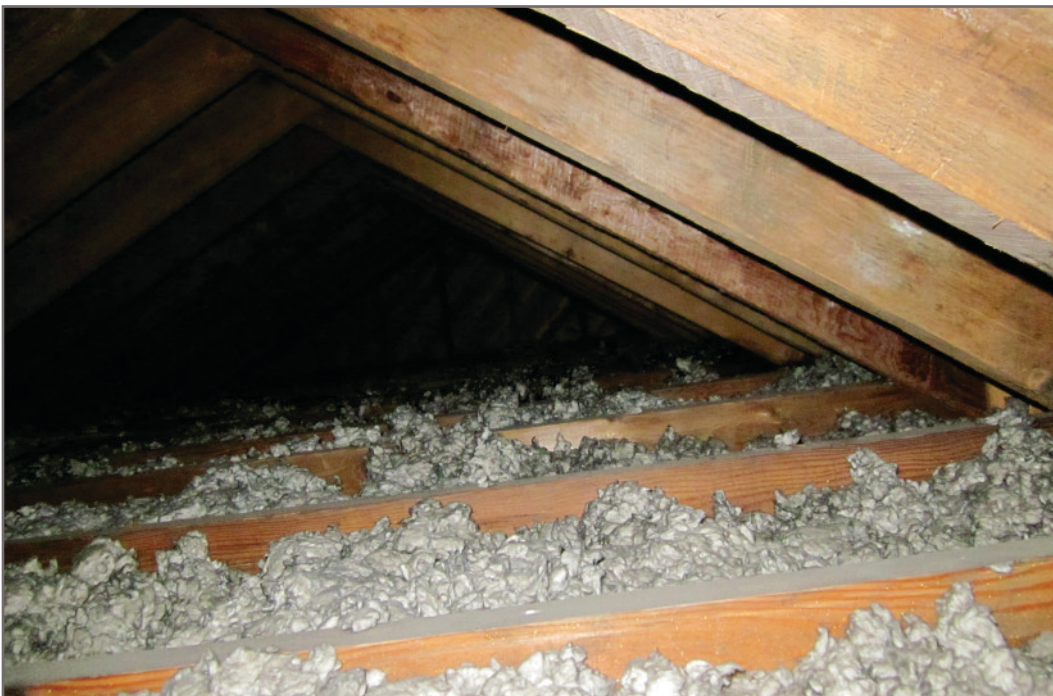
**Photo H-38:** APEC 18 - Building 5 - Fibre glass insulation (not containing asbestos)

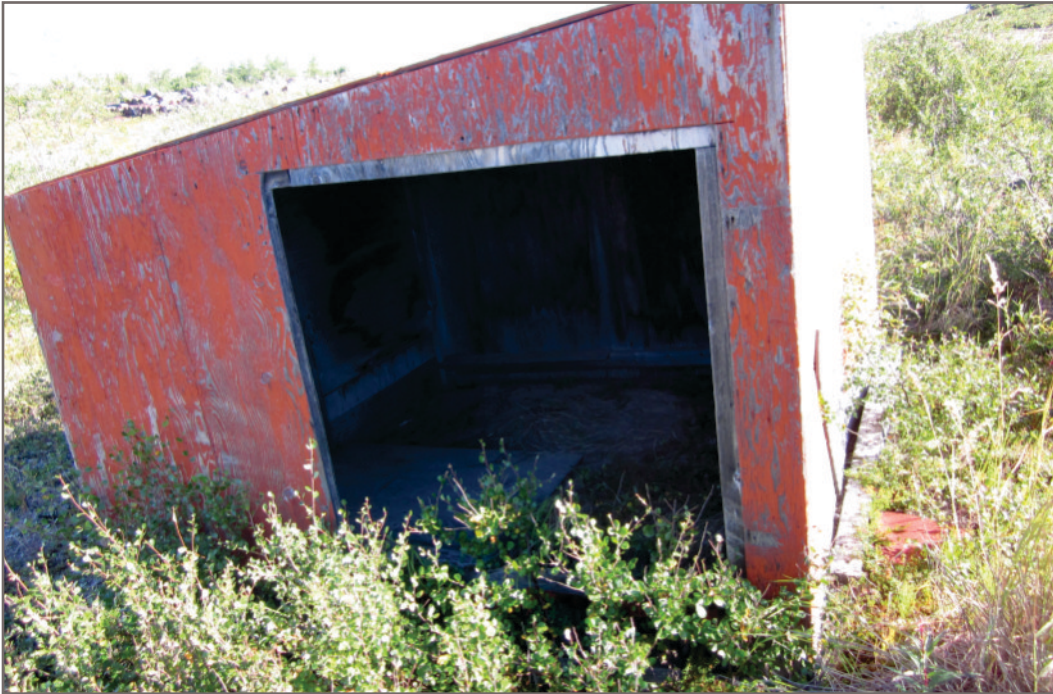
**Photo H-39:** APEC 19 - Building 6 - Total lead and leachable lead painted wood

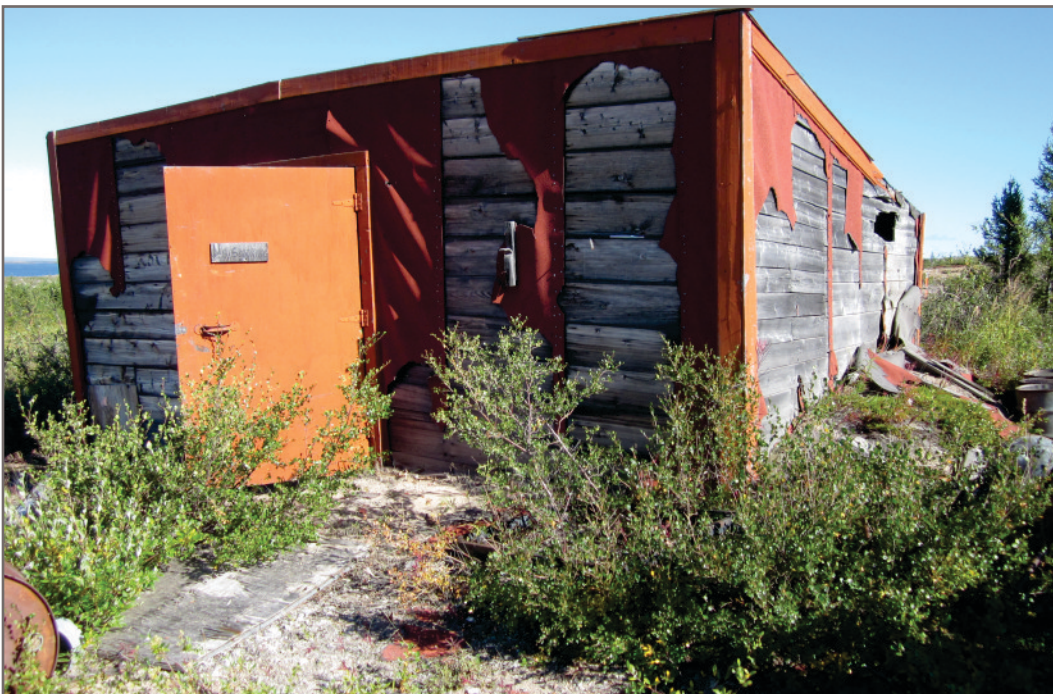
**Photo H-40:** APEC 20 - Building 7 - Asbestos exterior asphalt shingles and total lead and leachable lead painted wood

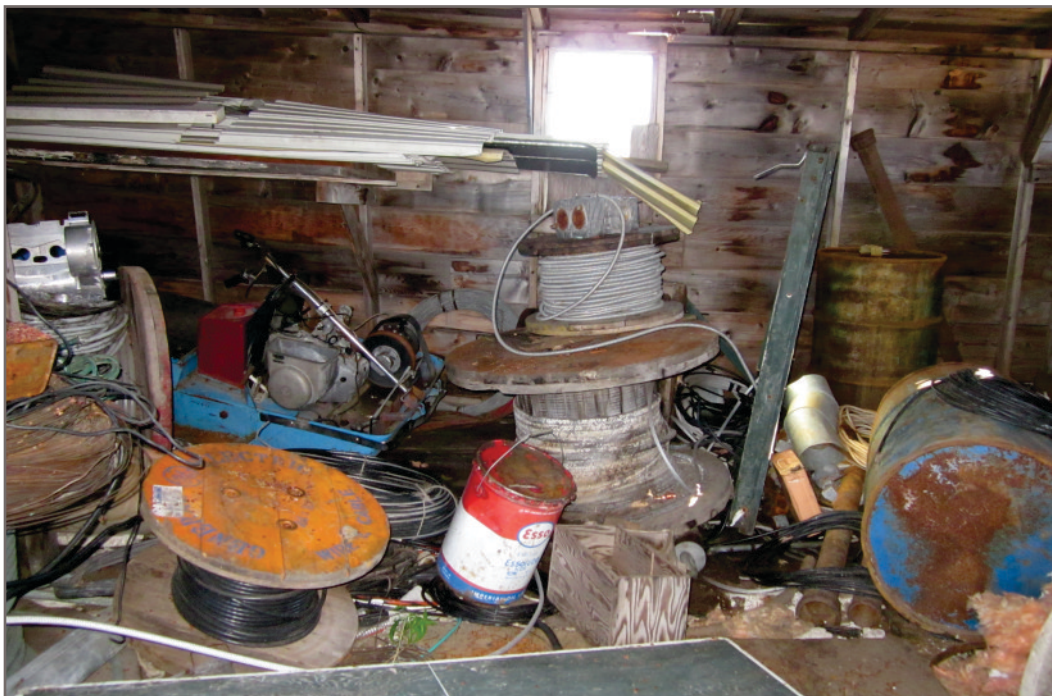
**Photo H-41:** APEC 20 - Building 7 - Asbestos flooring, asbestos white piping, asbestos black felt, total and leachable lead painted wood and metal, miscellaneous containers of oil/lubricants, drum content (clear, flammable) and PCBs in light ballasts and electrical equipment

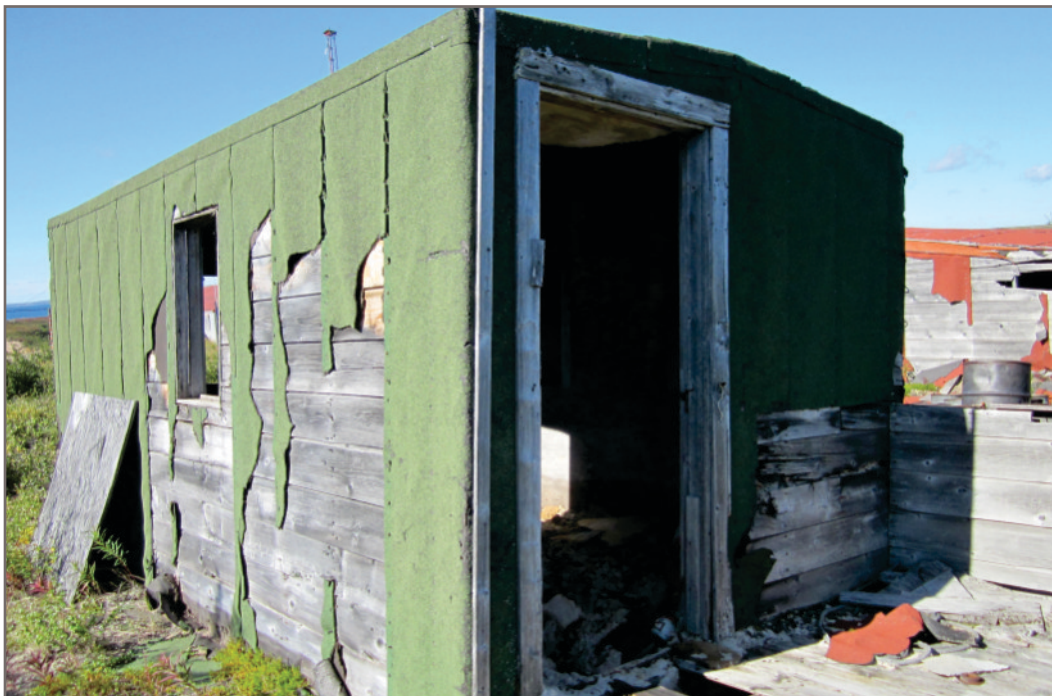
**Photo H-42:** APEC 21 - Building 8 - Asbestos exterior asphalt shingles and black felt

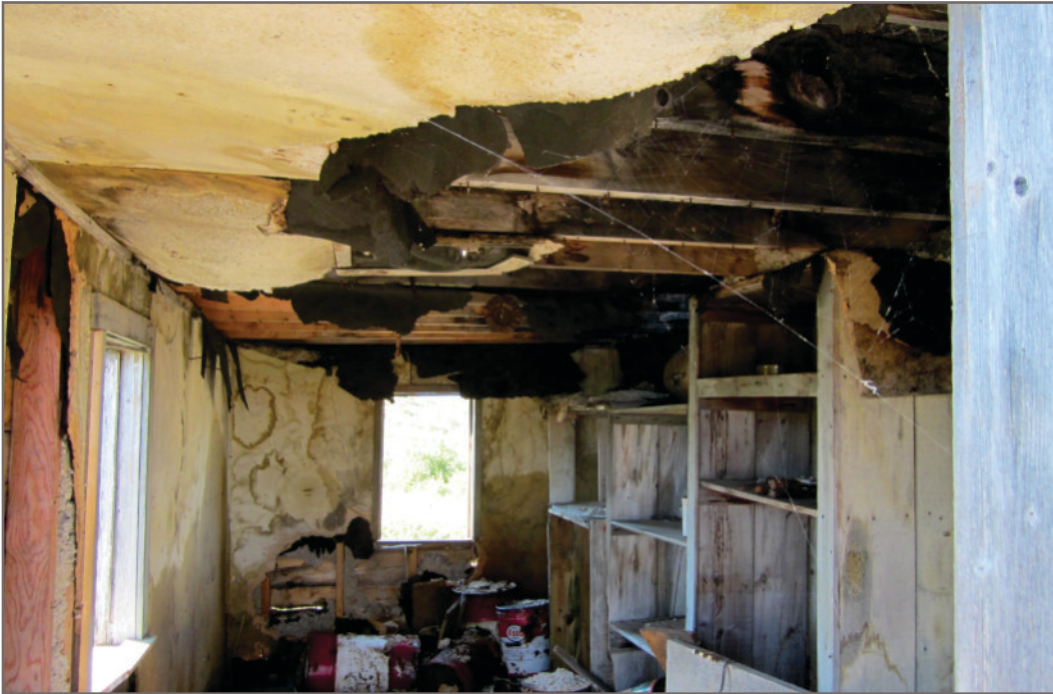
**Photo H-43:** APEC 21 - Building 8 - Miscellaneous containers of oil/lubricants

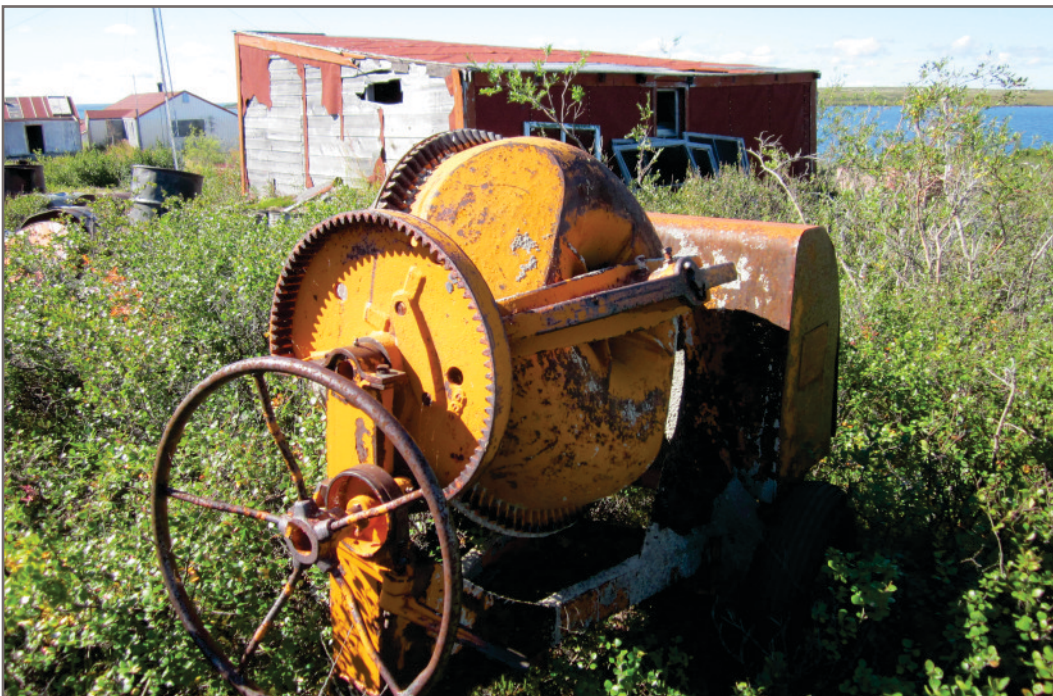
**Photo H-44:** APEC 21 - Cement mixer, painted with total lead and leachable lead paint

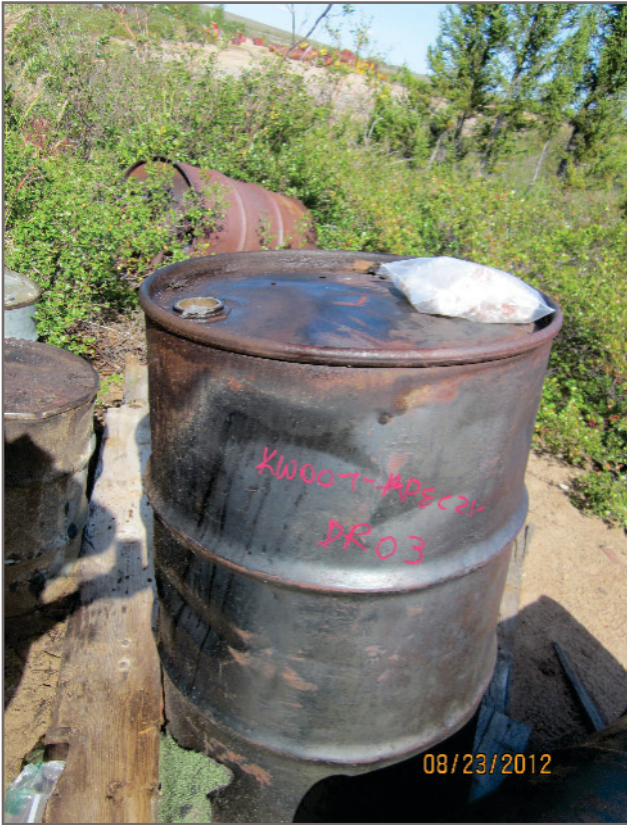
**Photo H-45:** APEC 21 - Organic content in 205L and 20L drums between Building 7 and Building 8

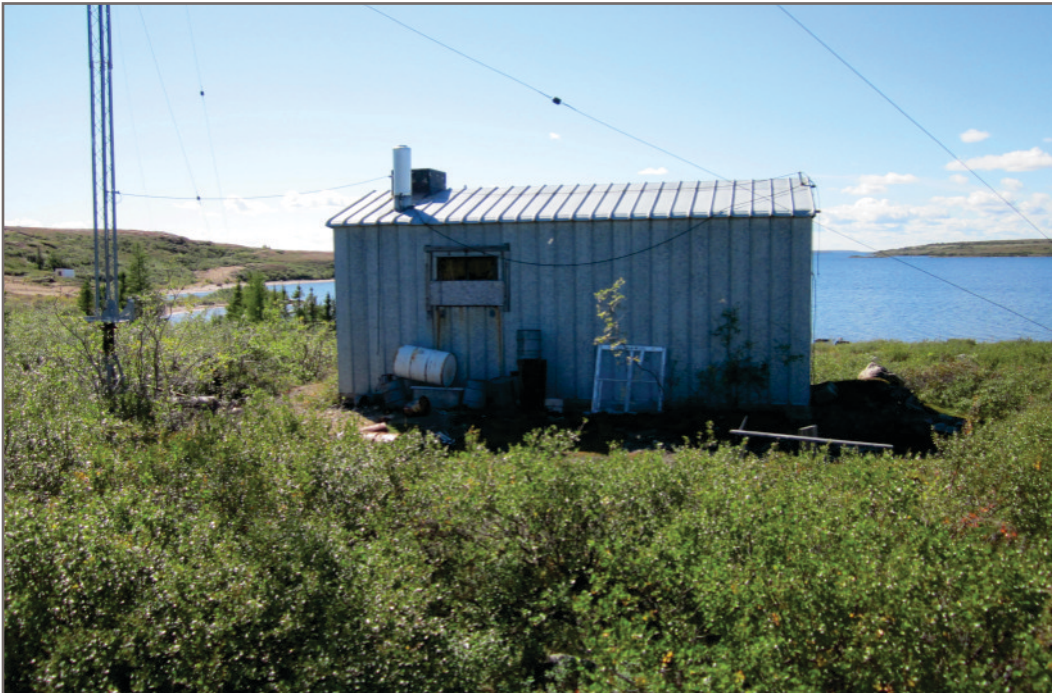
**Photo H-46:** APEC 22 - Building 9 - Metal exterior and total lead and leachable lead painted metal tower and drums, and drum content (organic)

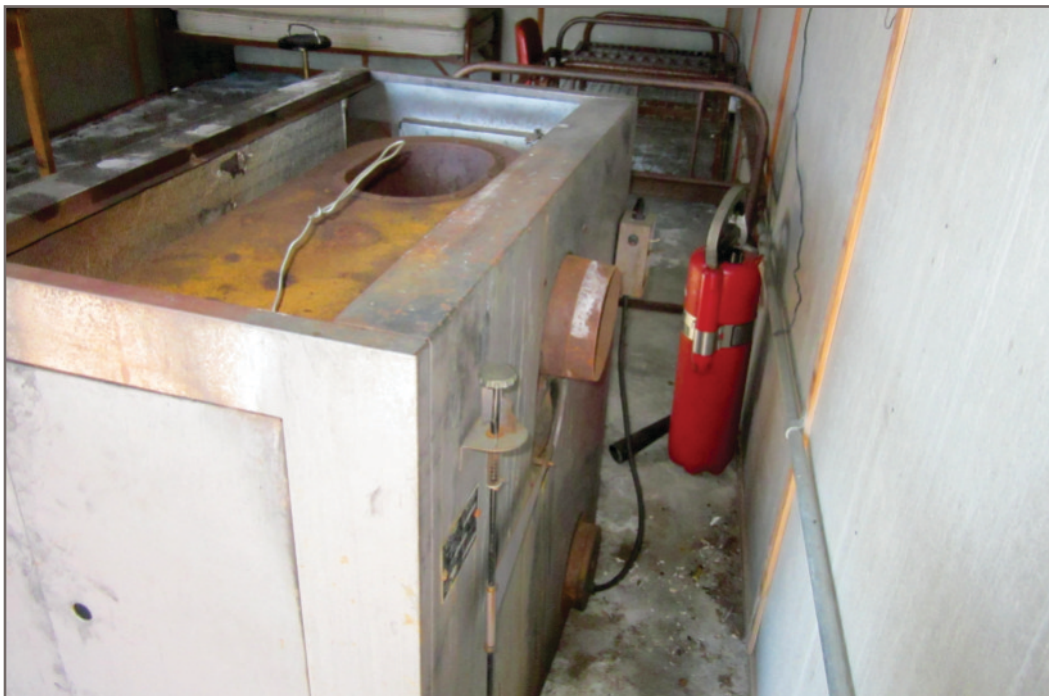
**Photo H-47:** APEC 22 - Building 9 - Interior asbestos panels and fire extinguisher

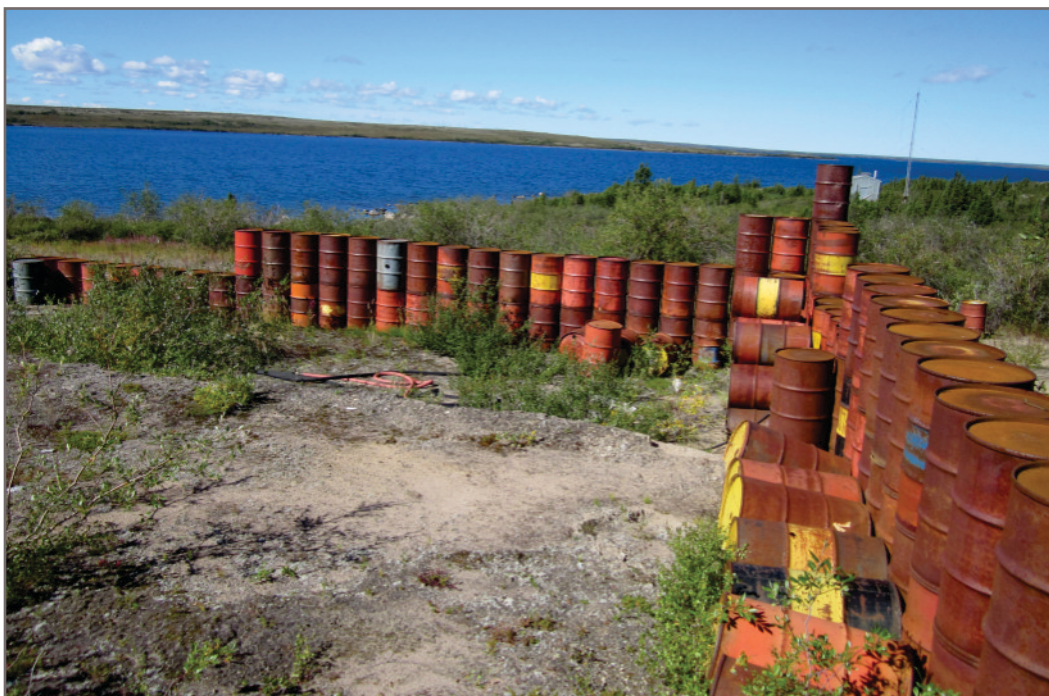
**Photo H-48:** APEC 23 - Drum Cache 1 - Total lead and leachable lead painted drums welded together and drum content (organic)

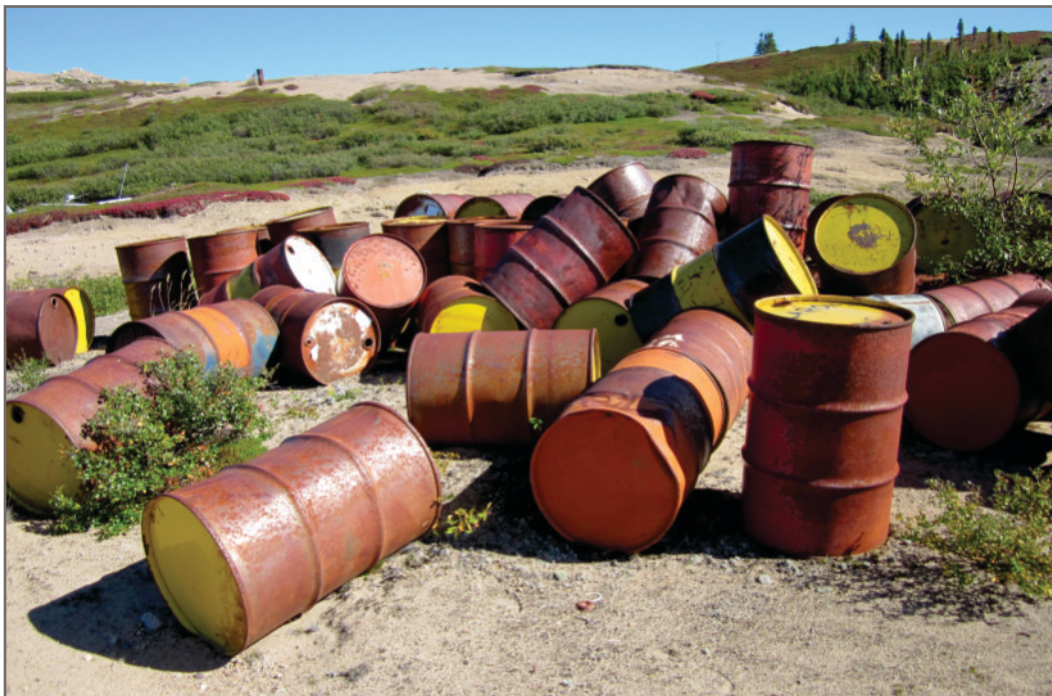
**Photo H-49:** APEC 24 – Drum Cache 2 - Total lead and leachable lead painted drums and drum content (organic)
