ENNADAI LAKE  
REMEDATION PROJECT

## REMEDIAL ACTION PLAN FORMER WEATHER STATION ENNADAI LAKE, NUNAVUT

NOVEMBER 2012  
ISSUED FOR REVIEW  
EBA FILE: Y22101286.0012

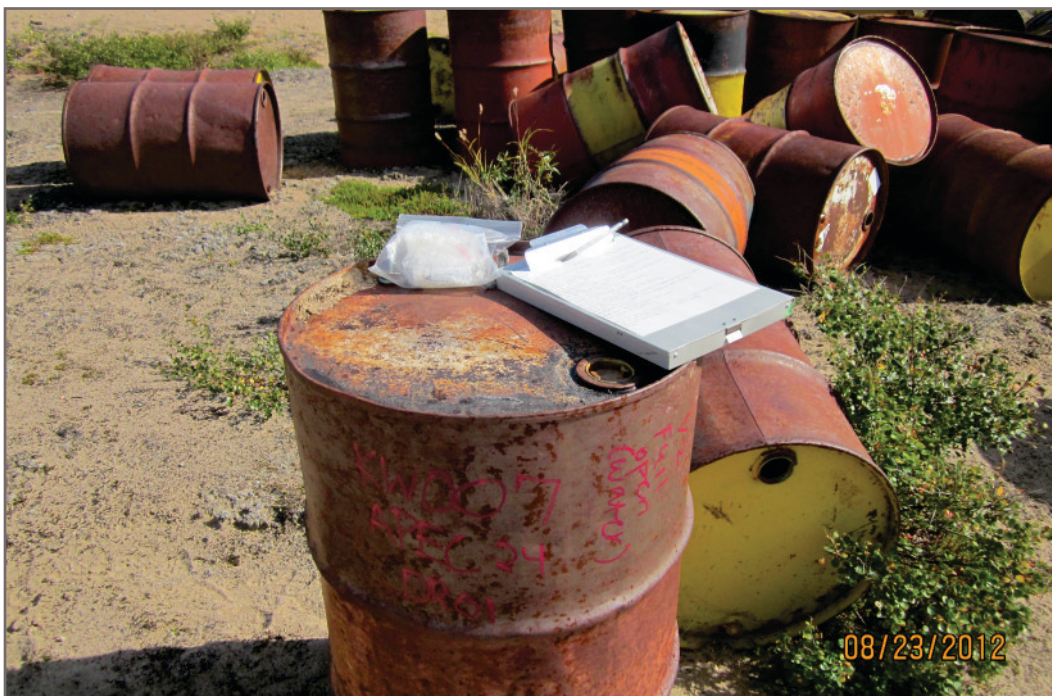
**Photo H-50:** APEC 24 – Drum Cache 2 - Total lead and leachable lead painted drum and some organic drum content

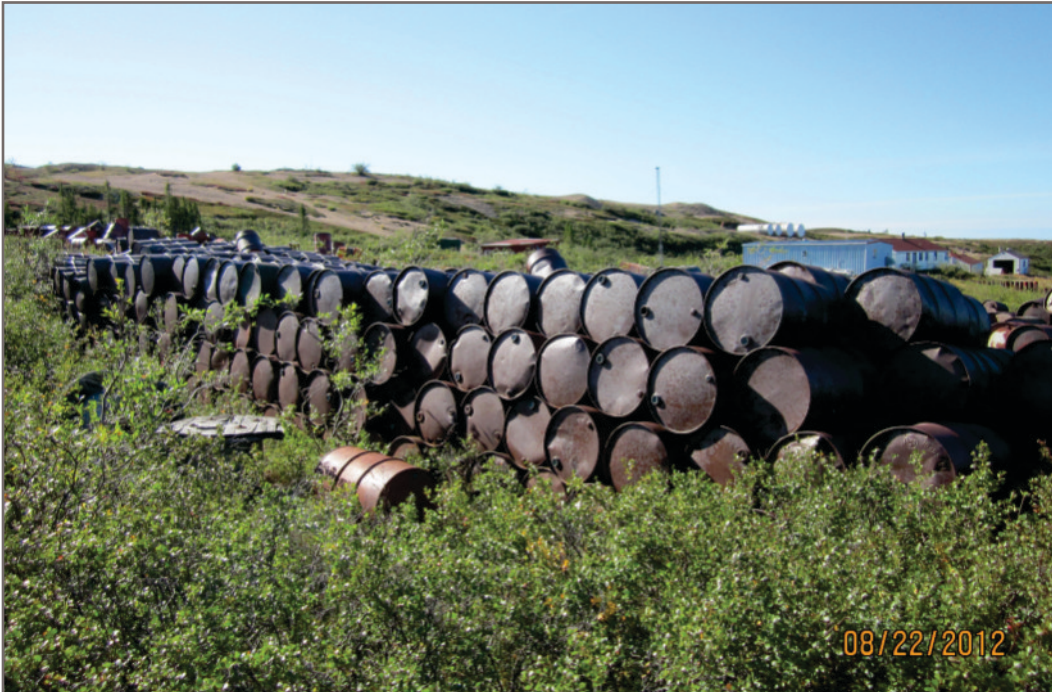
**Photo H-51:** APEC 25 - Drum Cache 3 - Total lead and leachable lead painted drums and drum content (organic)

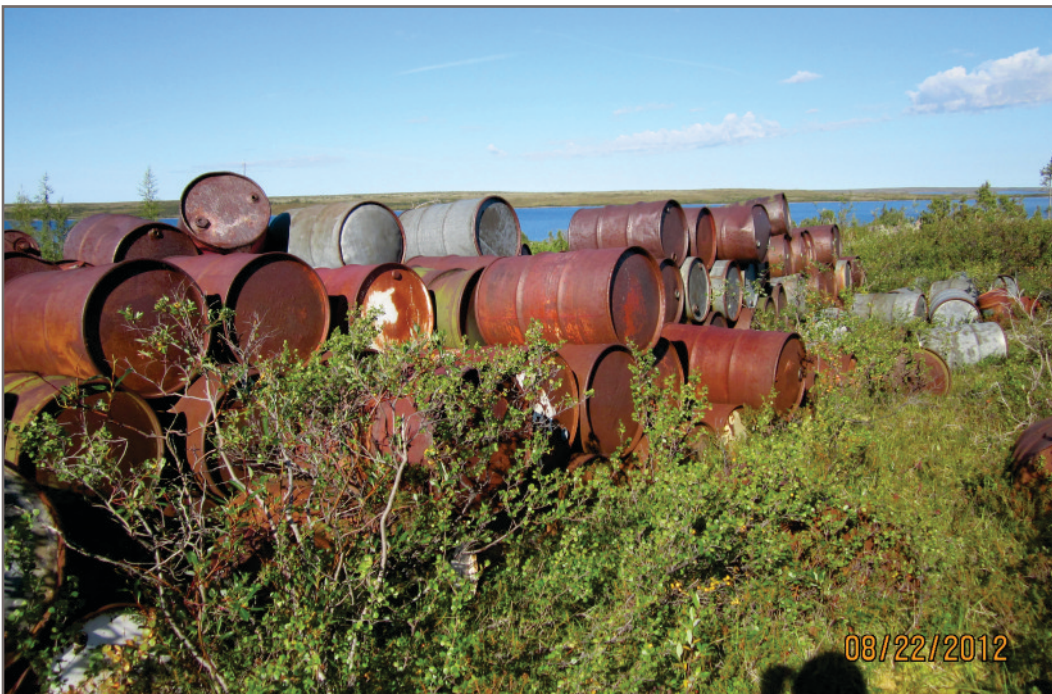
**Photo H-52:** APEC 26 - Drum Cache 4 - Total lead and leachable lead painted drums

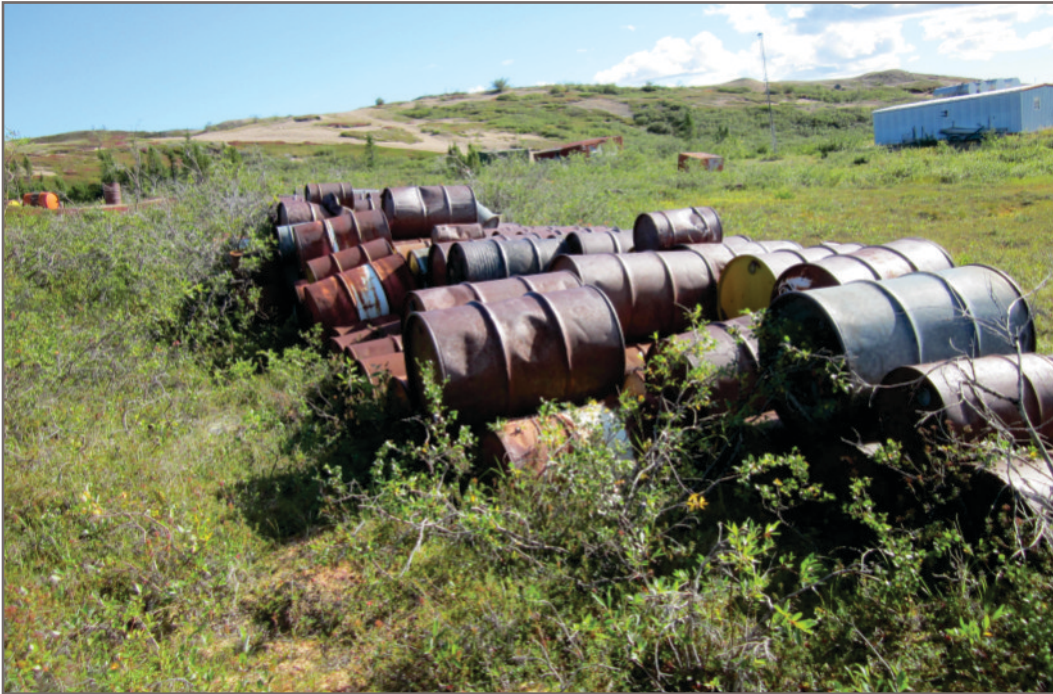
**Photo H-53:** APEC 27 - Drum Cache 5 - Total lead and leachable lead painted drums

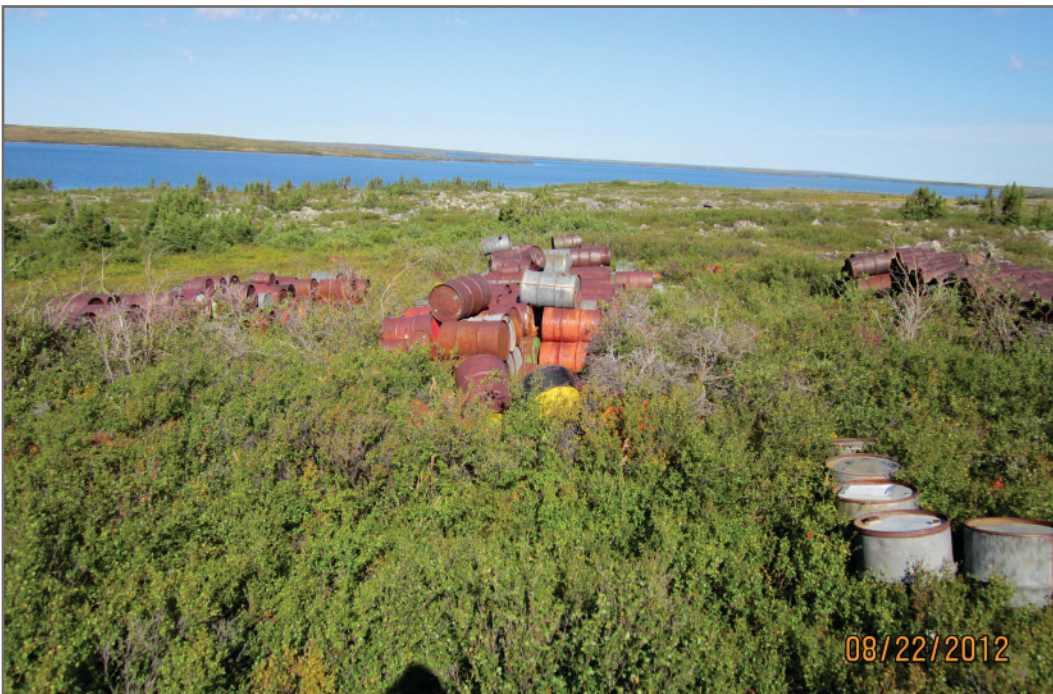
**Photo H-54:** APEC 25-27 - Drum Cache 3 on the right, Drum Cache 4 in the center and Drum Cache 5 on the left - Total lead and leachable lead painted drum and drum content (organic)

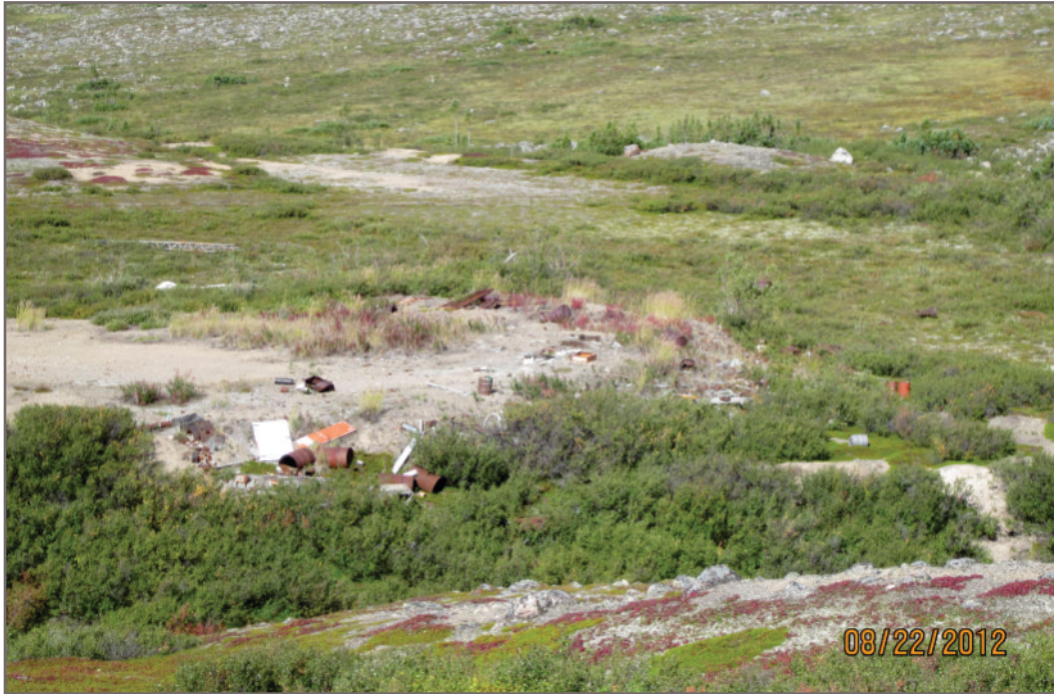
**Photo H-55:** APEC 28 - Main Debris Area - Metal debris

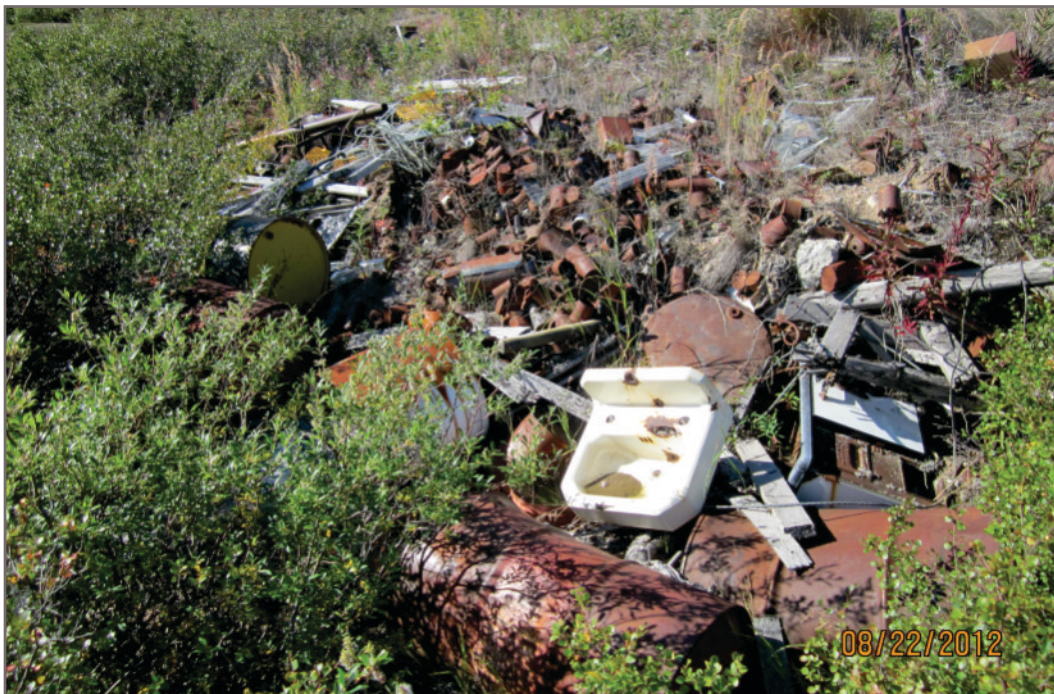
**Photo H-56:** APEC 28 - Main Debris Area - Partially buried total and leachable lead paint wood, metal and drums, electrical parts and lead acid batteries

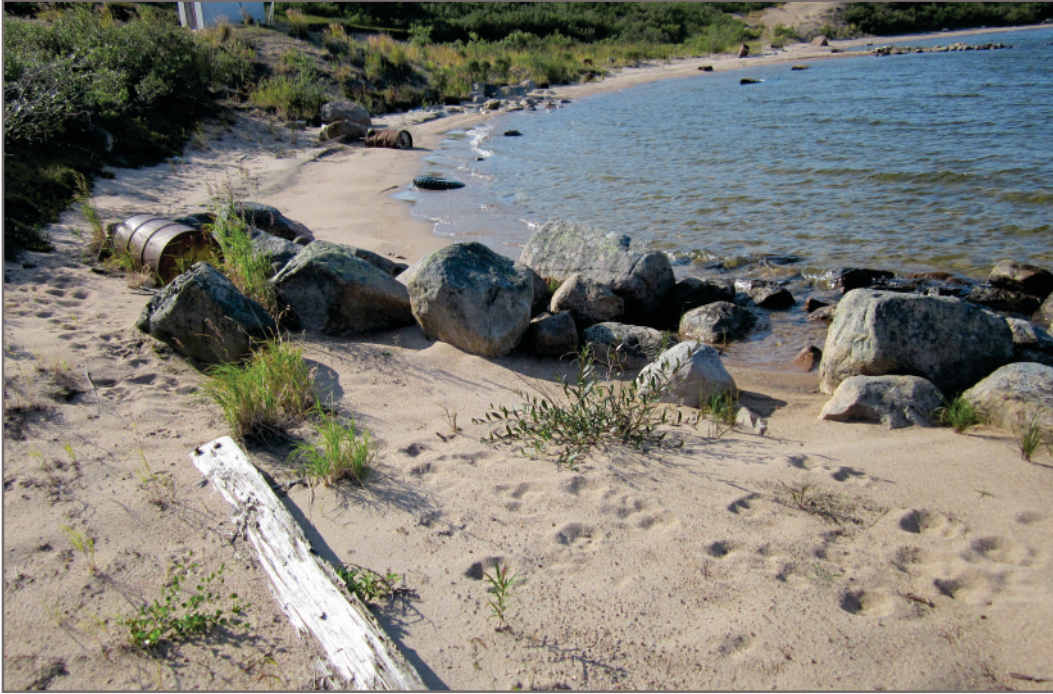
**Photo H-57:** APEC 29 - Shoreline Debris Area and Pumphouse (in background) - Various metal and wood debris

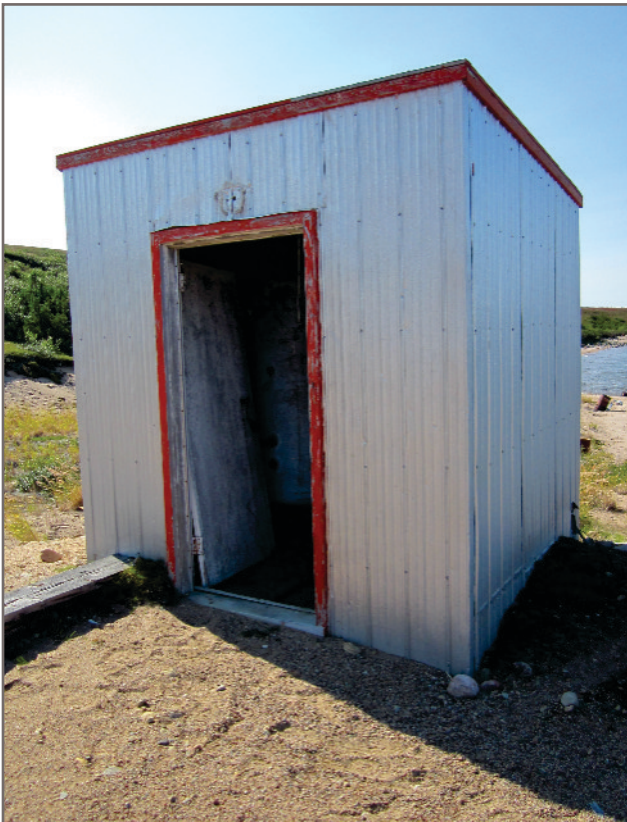
**Photo H-58:** APEC 29 - Pumphouse - Asbestos black felt, total lead and leachable lead painted equipment and wood

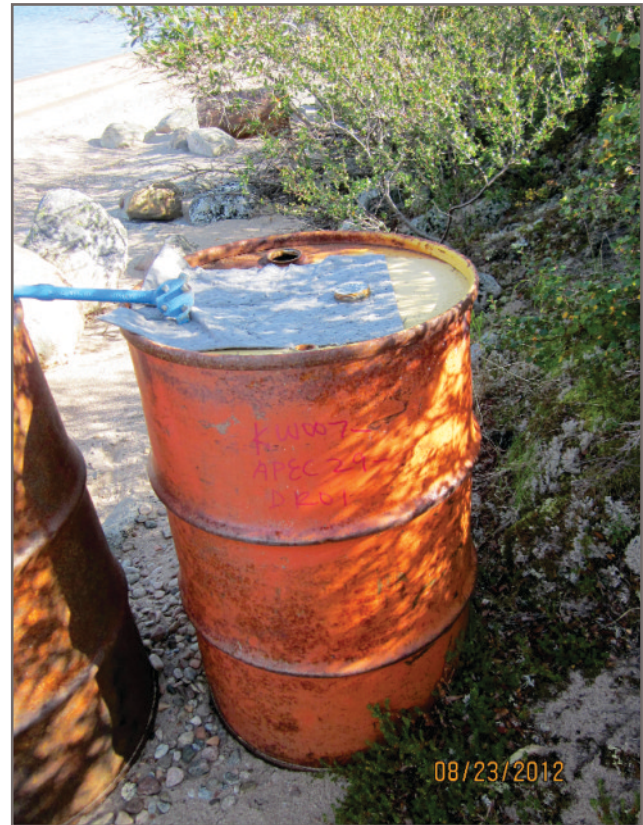
**Photo H-59:** APEC 29 - Total lead and leachable lead painted drum with blue, flammable content

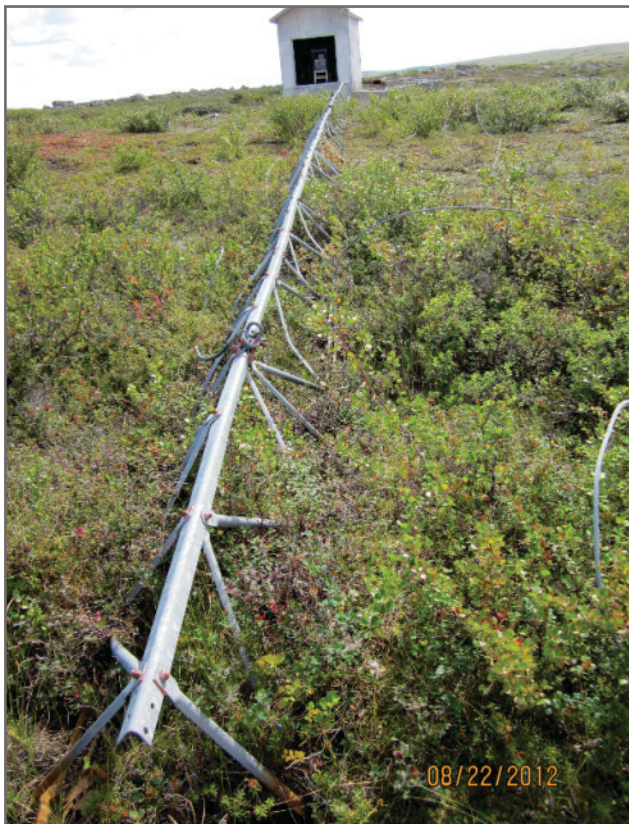
**Photo H-60:** APEC N/A - Building 10 - Total and leachable lead painted metal tower and Building 10 in background

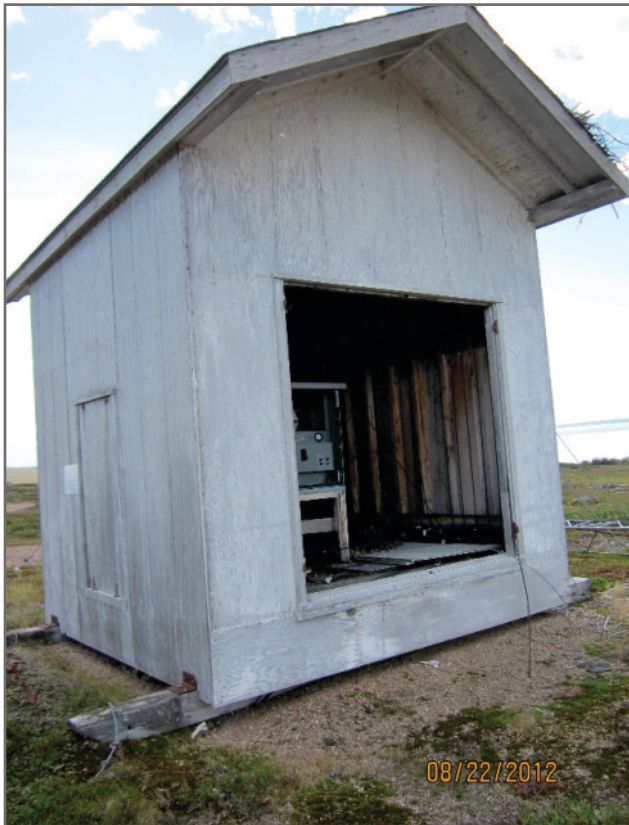
**Photo H-61:** APEC N/A - Building 10 -  
Antenna Tuning Unit Shelter,  
Total lead and leachable lead  
painted wood and asbestos  
panel

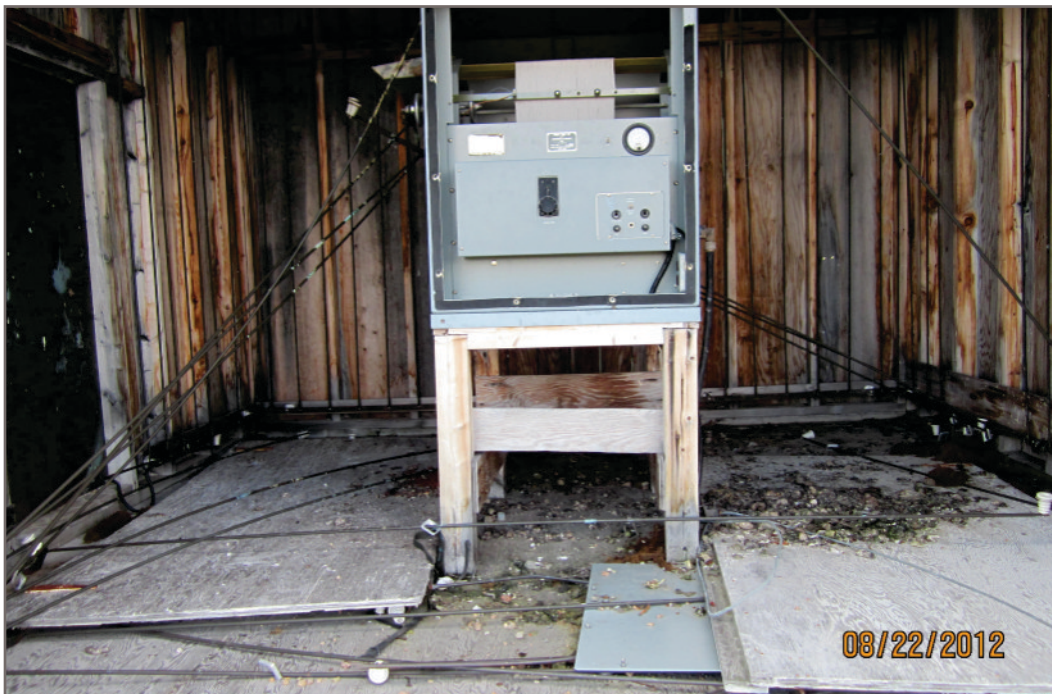
**Photo H-62:** APEC N/A - Building 10 - Antenna Tuning Unit Shelter interior

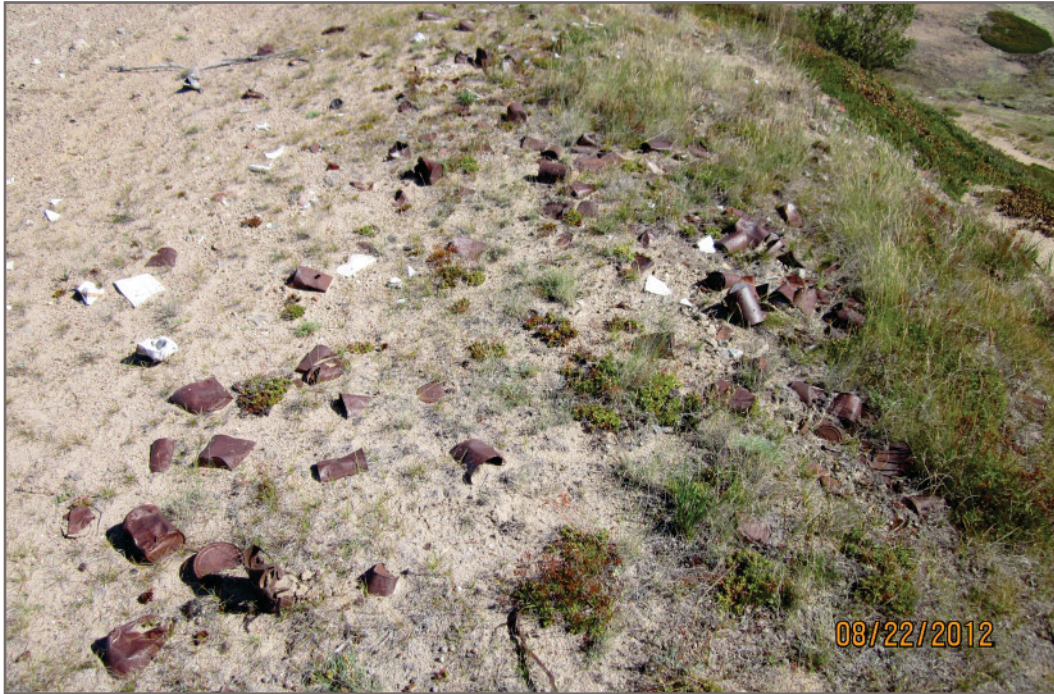
**Photo H-63:** APEC N/A - Scattered debris throughout and adjacent to the site - metal cans and debris west of the main building cluster on the hill

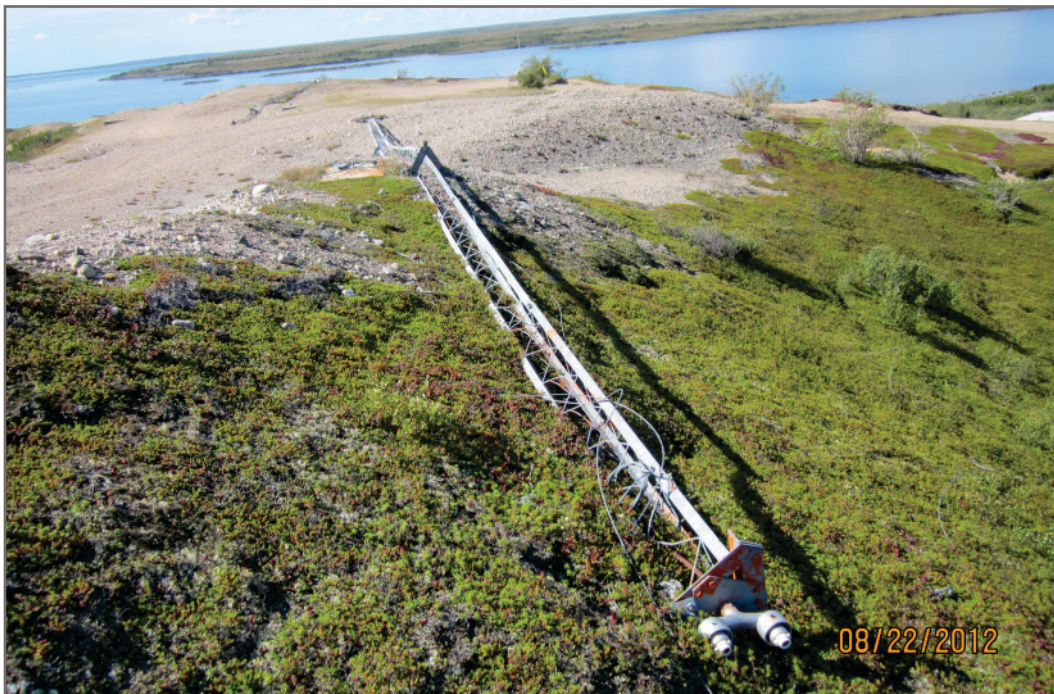
**Photo H-64:** APEC N/A - Scattered debris throughout and adjacent to the site - Two total lead and leachable lead painted metal towers west of the main building cluster, on the top of the hill

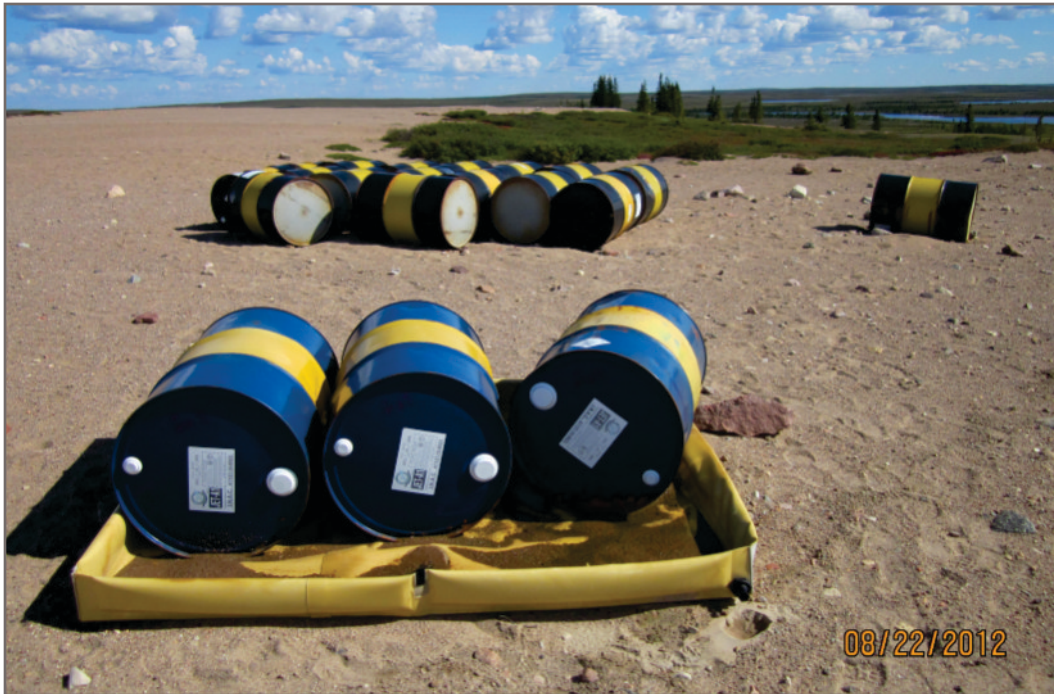
**Photo H-65:** APEC N/A - Scattered debris throughout and adjacent to the site; new drums and organic drum content by the airstrip
