**THE COLLECTION OF LANDFILL  
MONITORING DATA AT THE FORMER  
CAM-2 DEW LINE SITE**

Gladman Point, Nunavut

**FINAL REPORT – 2010**

**DEFENCE CONSTRUCTION CANADA**

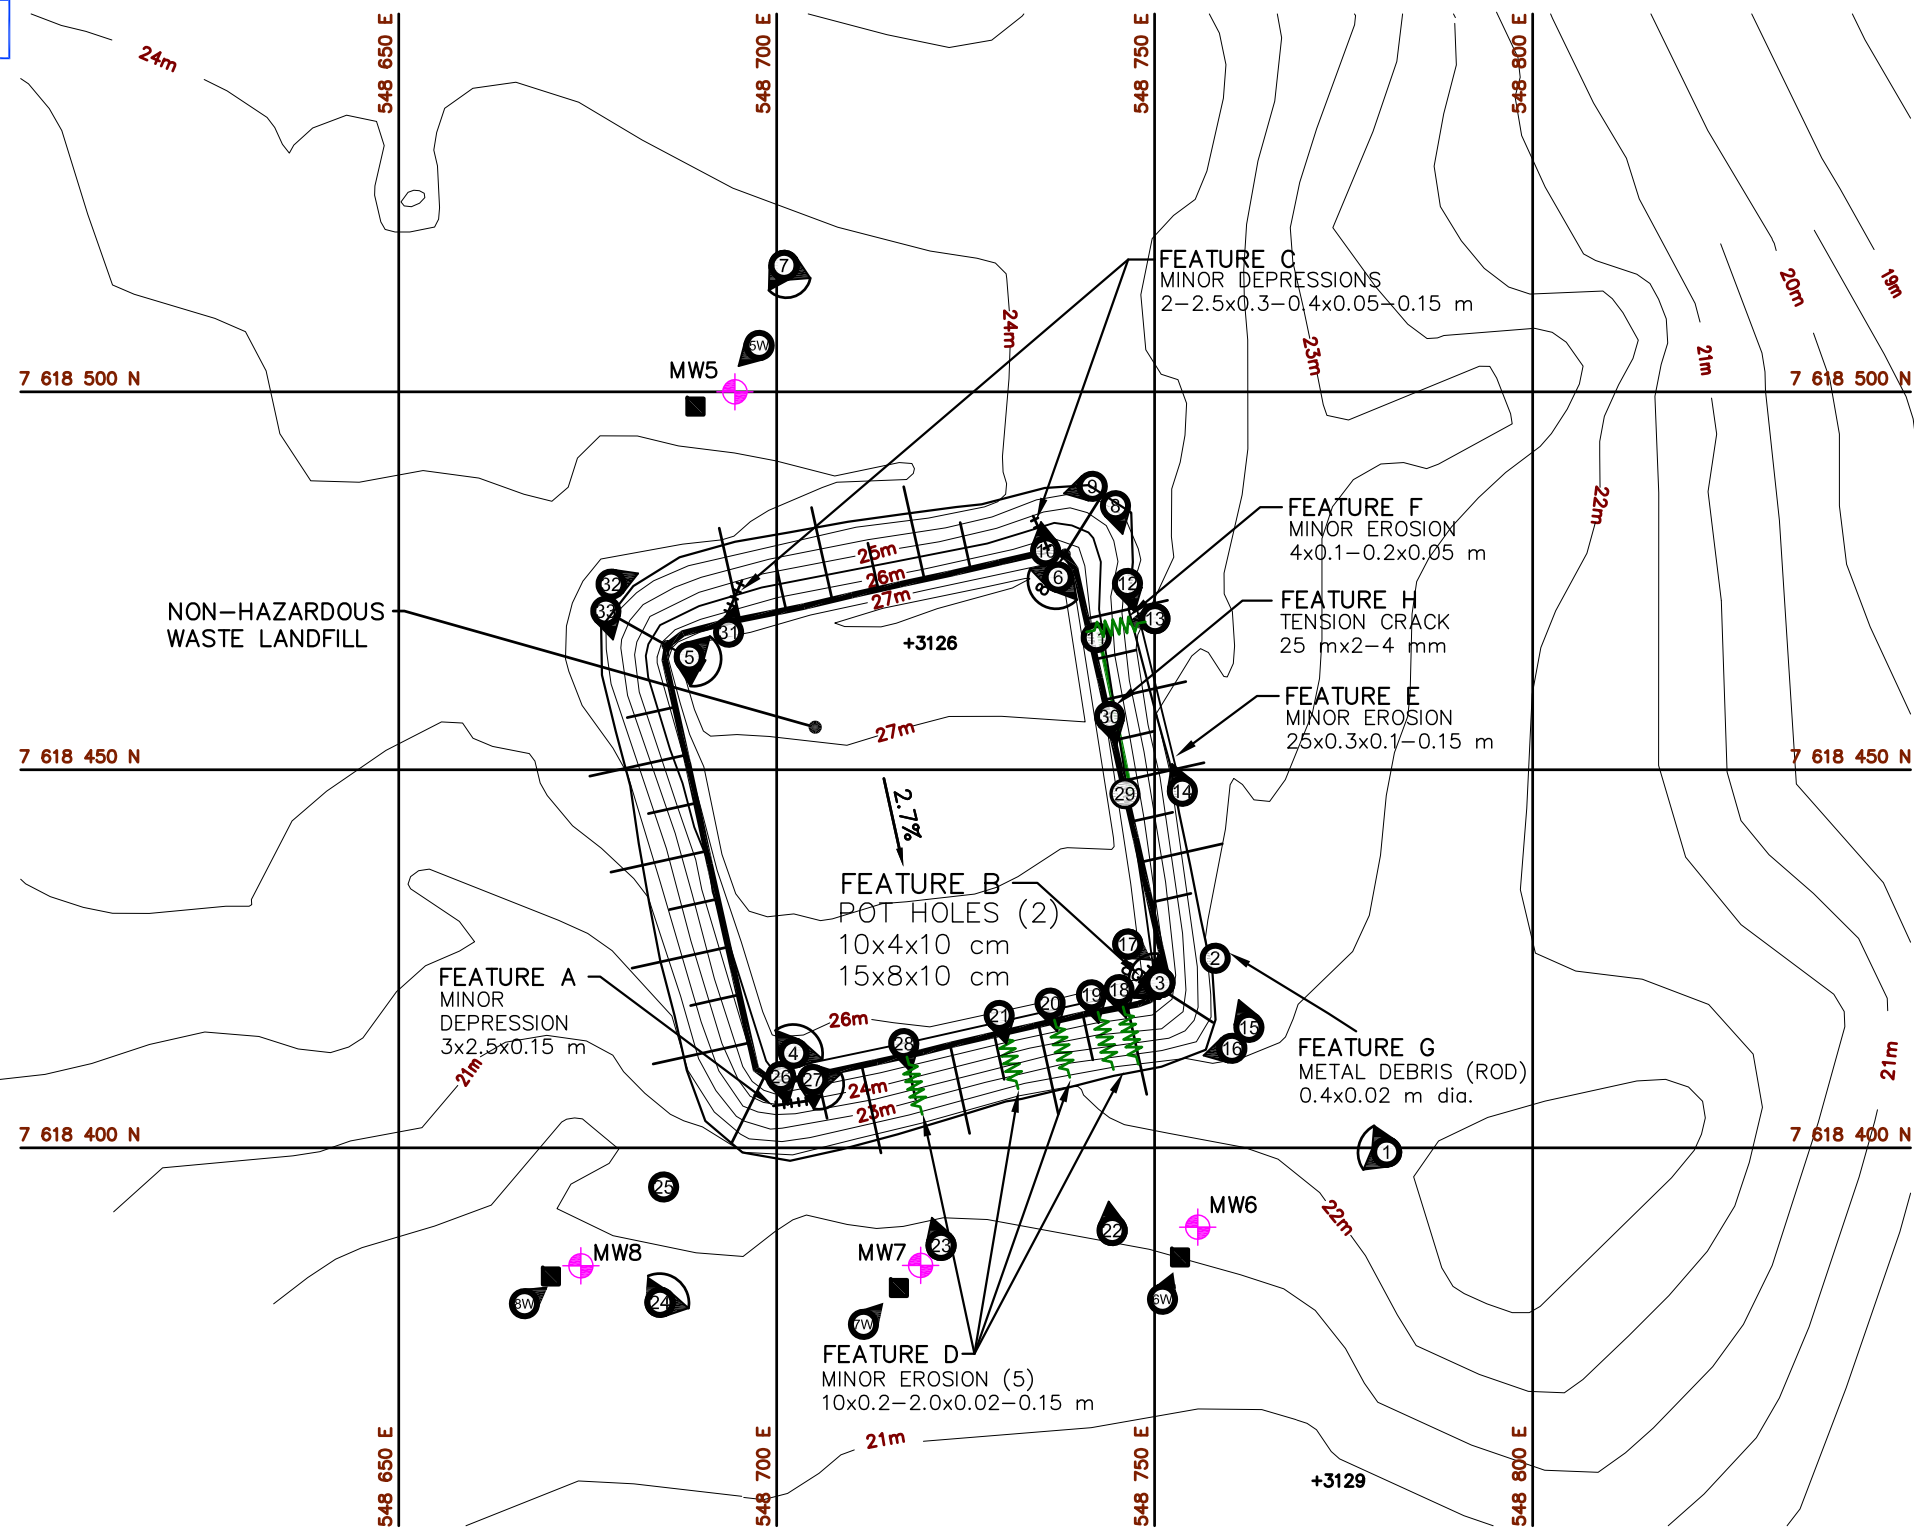
The Location Plan for the NHWLF has been completed as per the ToR and is included in the following page as Figure CAM-2.6 Gladman Point – NHWLF.
