# **The Collection of Landfill Monitoring Data at the CAM-2 Gladman Point – 2007 FINAL Report**

Prepared for  
**Defence Construction Canada**

Submitted by  
**Gartner Lee Limited**

**January, 2008**

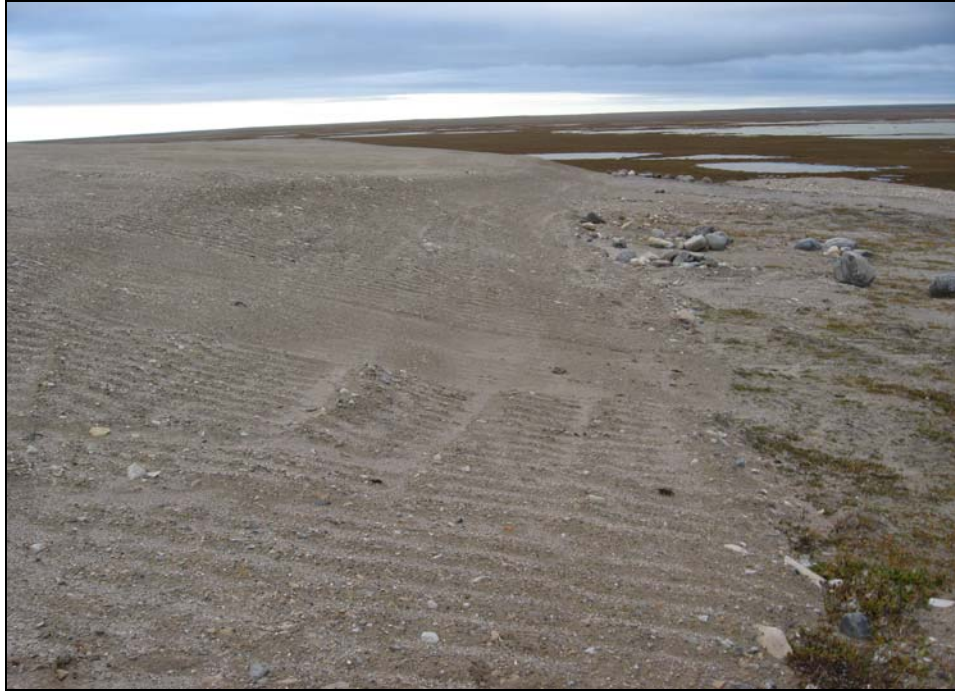
**Photograph 1. Station Landfill: Looking north along the east side of the landfill from the SE corner. Slope appears shallow and stable. No features of note. ↑**

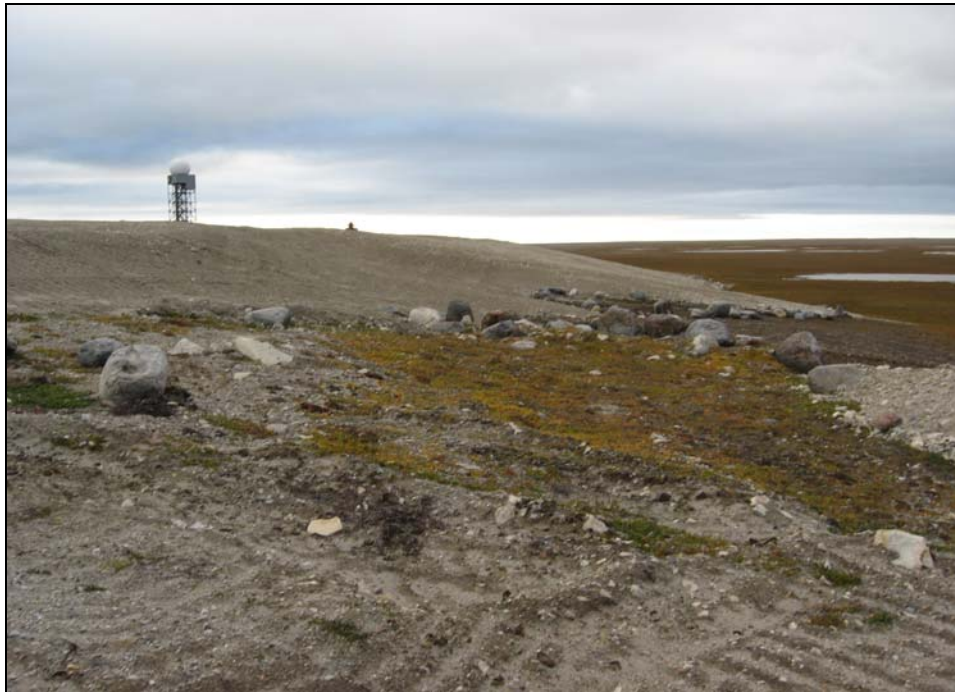
**Photograph 2. Station Landfill: Looking NNW along the west side of the landfill. No features of note.↑**

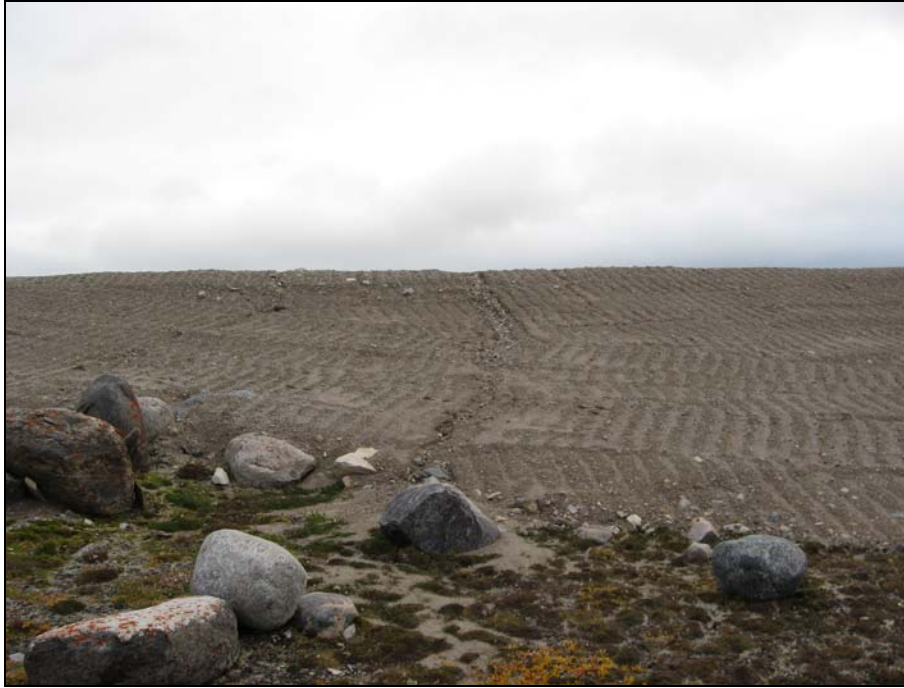
Minor surficial erosion, which appears to be associated with surface runoff, was noted at several locations along the eastern slope of the granular cover (refer to Photos 3 and 4). The granular cover in the areas of observed surficial erosion appears to be self armoured with limited potential for significant further degradation. None of the areas of observed surficial erosion appear to warrant remediation at this time.

**Photograph 3. Station Landfill: Looking upslope to an area of minor surficial erosion along the eastern slope of the landfill. Granular cover material appears to be self armoured and stable. ↑**

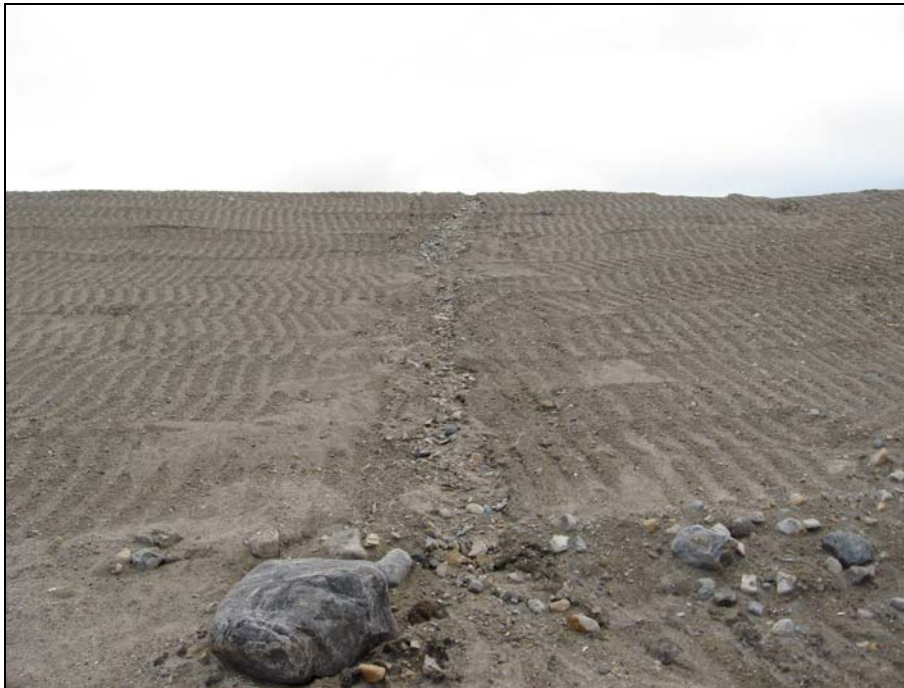
**Photograph 4. Station Landfill: Looking upslope (west) to minor surficial slope erosion. The granular cover material appears to be self armoured. ↑**

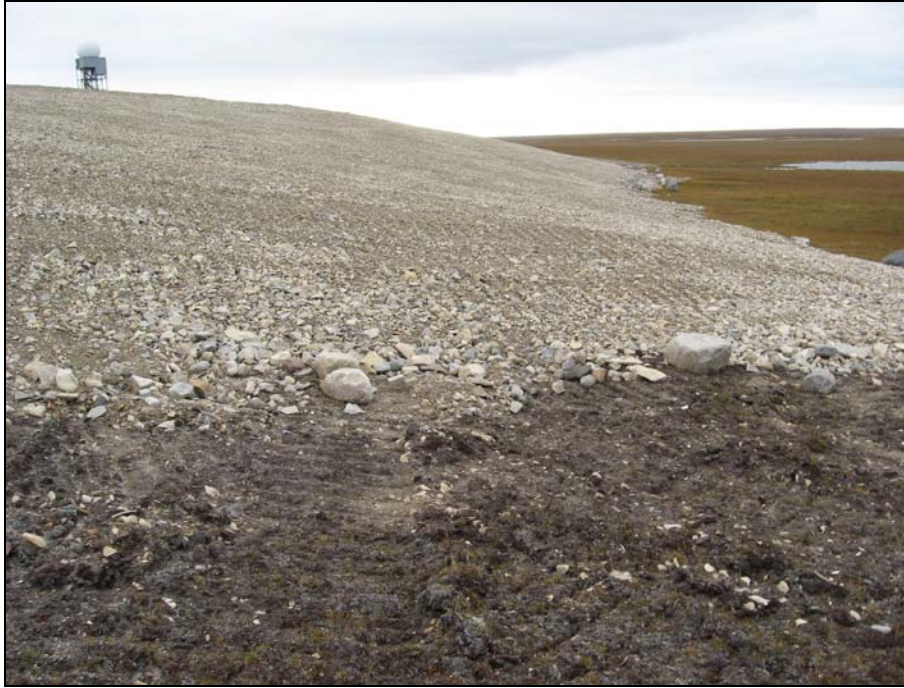
**Photograph 5. Station Landfill: Looking NNW along the eastern slope of the landfill towards the NE corner of the landfill. No features of note. ↑**

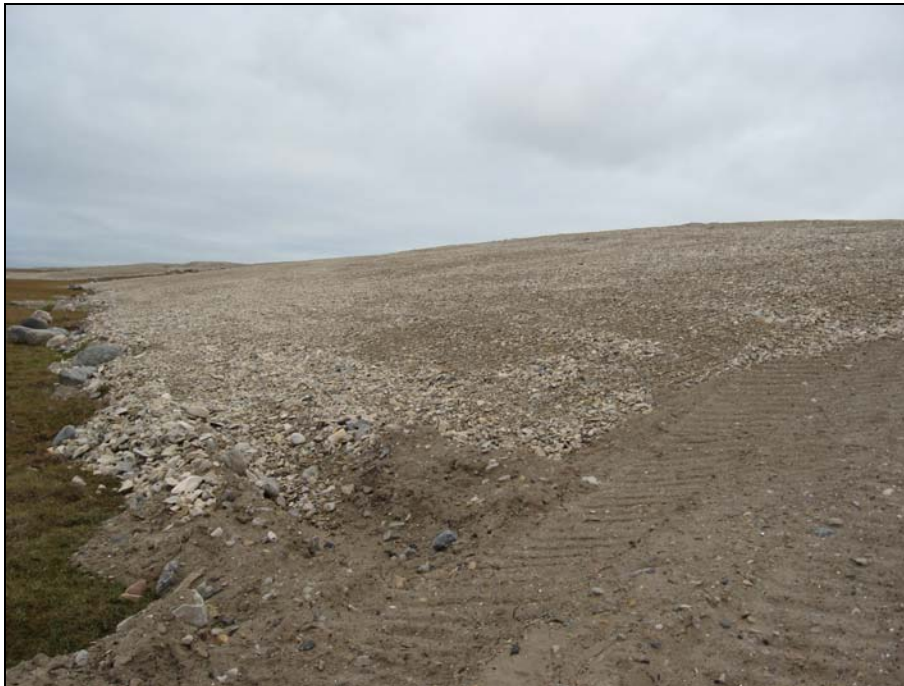
**Photograph 6. Station Landfill: Looking SSE along east side of Station LF from near NE corner. Coarse granular cover appears stable and has been contoured to a shallow slope.**

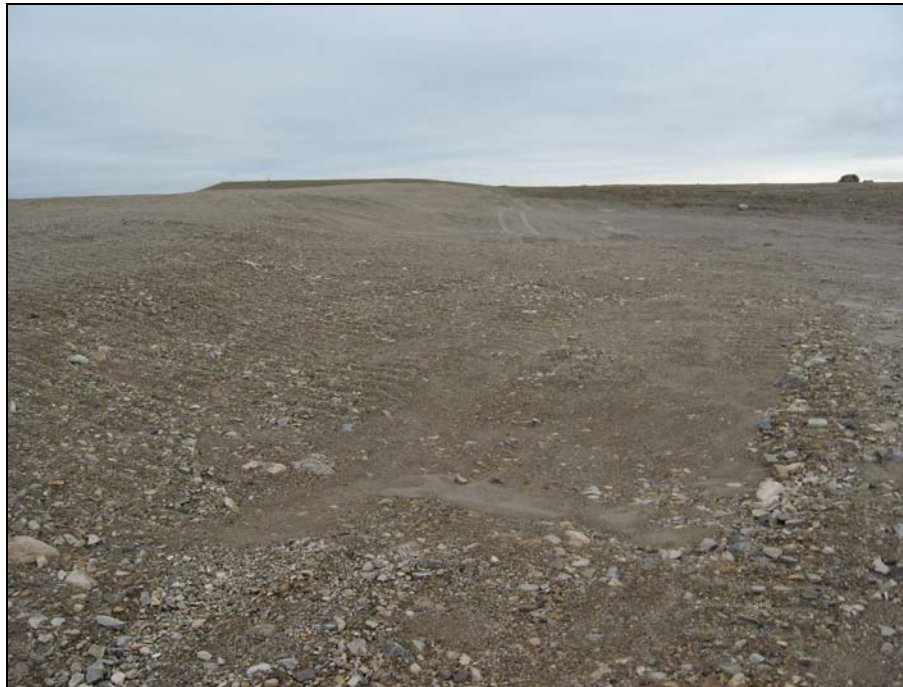
**Photograph 8. Station Landfill: Looking S along west side of Station Landfill from the north end of the landfill. The granular cover has minimal slope and appears to be very stable. Tier II LF visible in the background.↑**

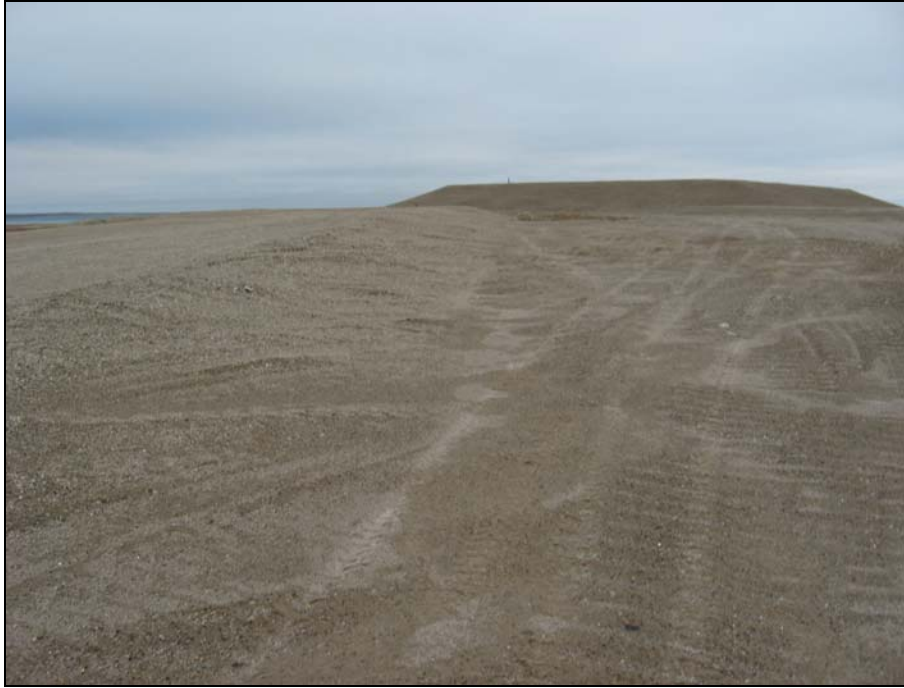
**Photograph 9. Station Landfill: Looking SSE along west side of Station LF to the SW corner. The NE corner of the Tier II landfill is visible in the background. No features of note. ↑**

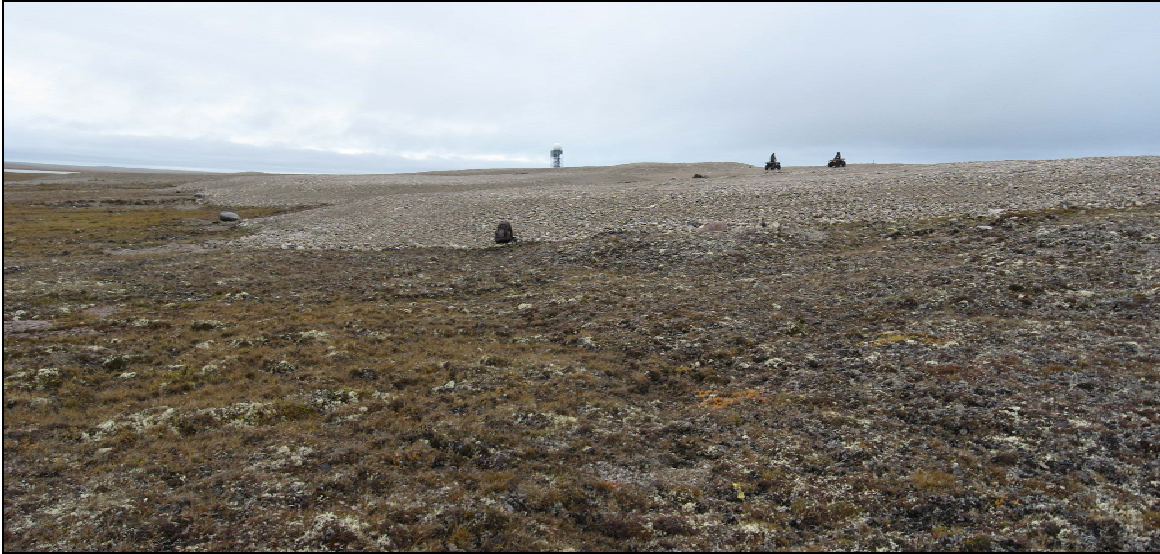
**Photograph 1. Panoramic looking SW to the NE corner of the two northernmost cells of the West Landfill North. No features of note. ↑**

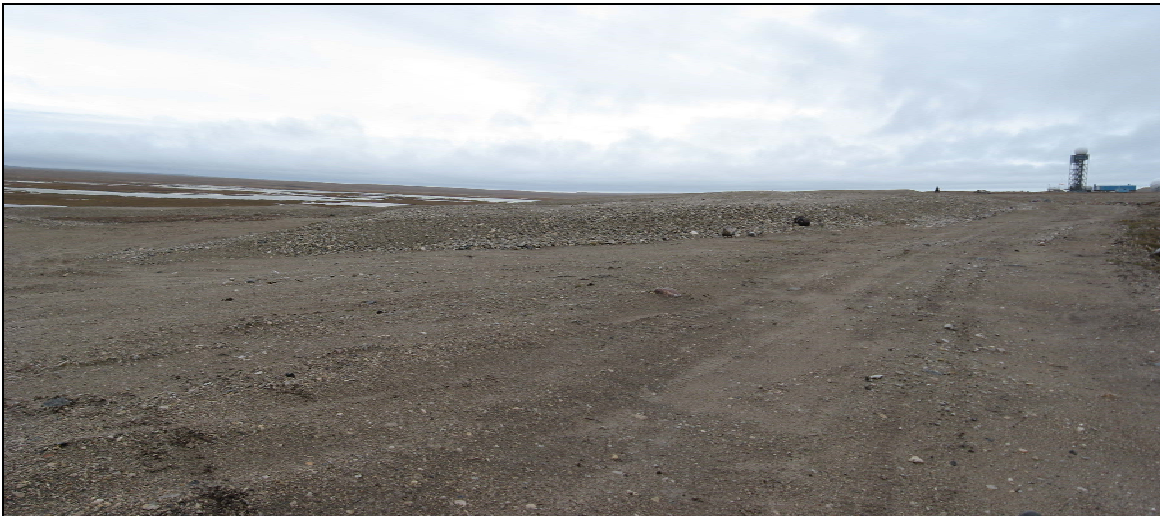
**Photograph 2. Looking SE to NW corner of 3rd cell from the north along the west side of the landfill. No features of note. Granular cover appears stable. ↑**

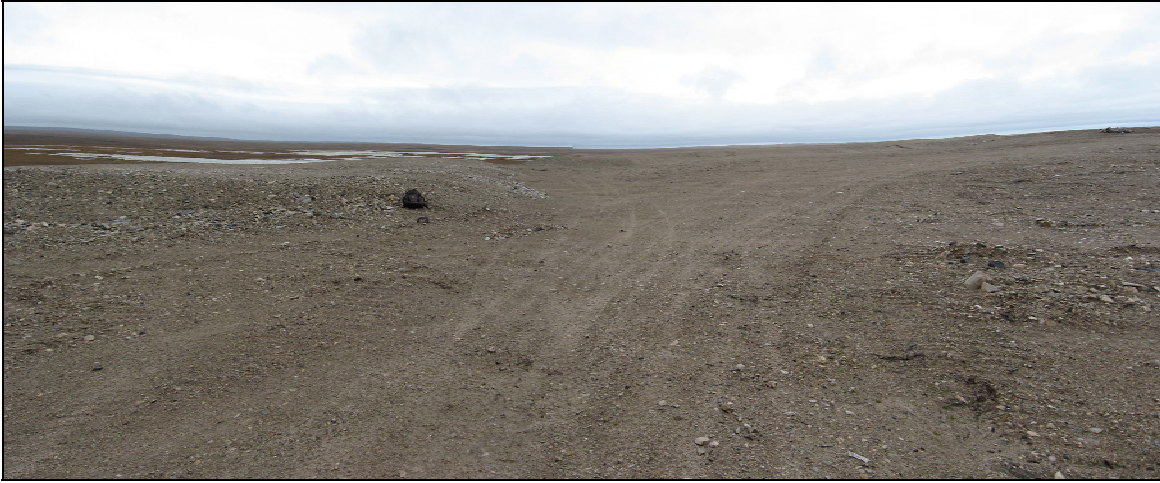
**Photograph 3. Looking E across the landfill from the west side. The backpack is on the SW corner of the 4th lobe from N end . The most southerly cell visible to the right. No features of note. ↑**

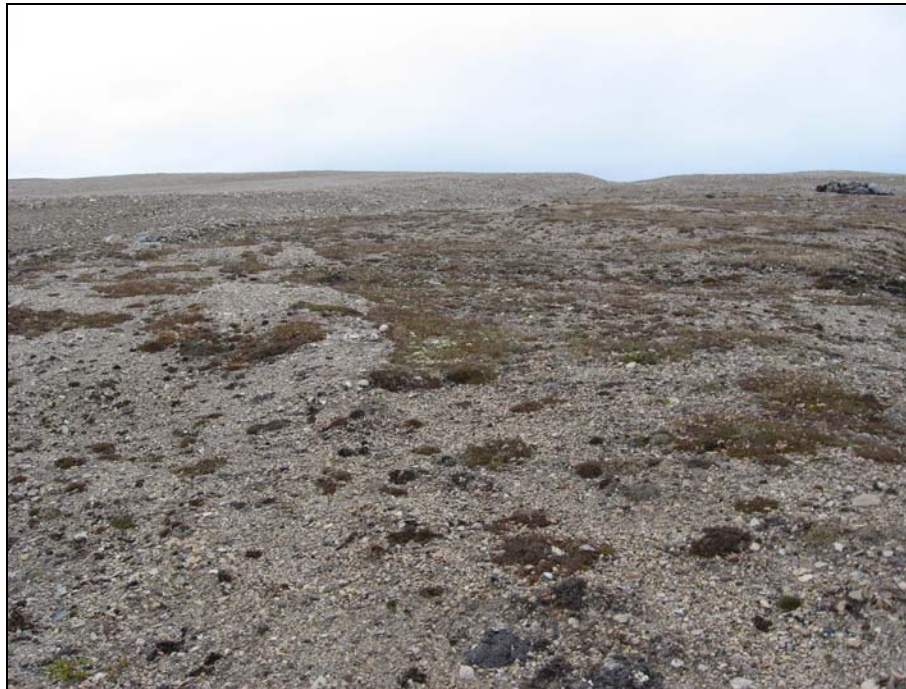
**Photograph 4. Looking south between the 3rd and 4th cells from the north of the landfill. No features of note. ↑**

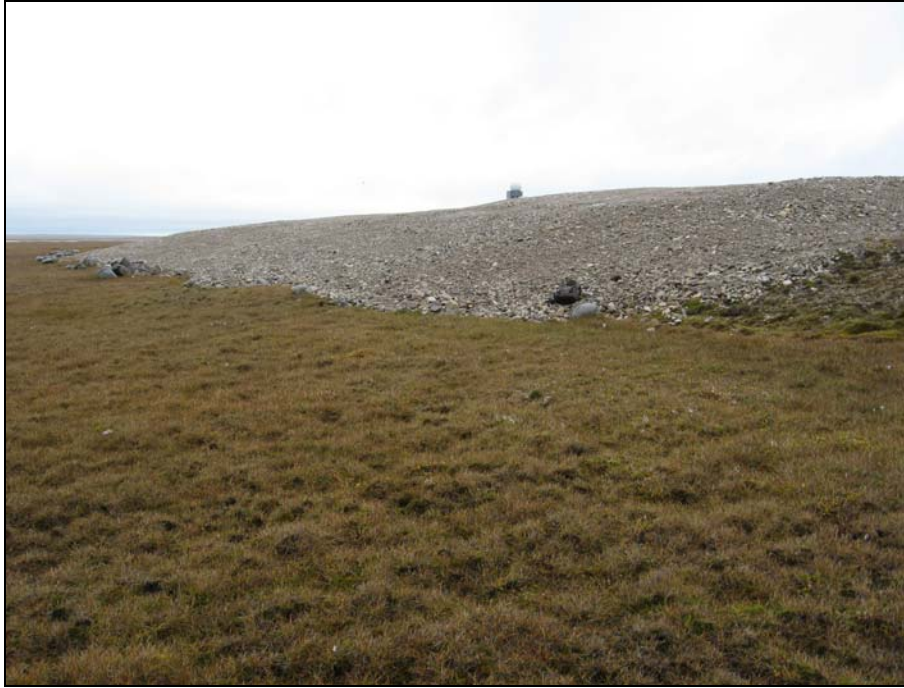
**Photograph 5. Looking SW to NE corner of the large central cell. Granular slope appears stable. No features of note. ↑**

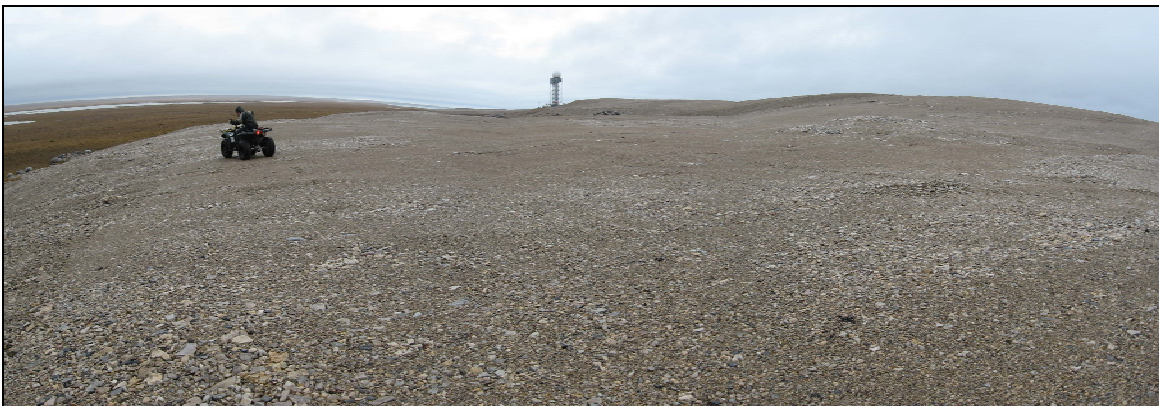
**Photograph 6. Panoramic of the upper landfill surface of the large central cell viewed from the NE corner. No features of note. Two other cells visible in distance along with radar ball tower. ↑**

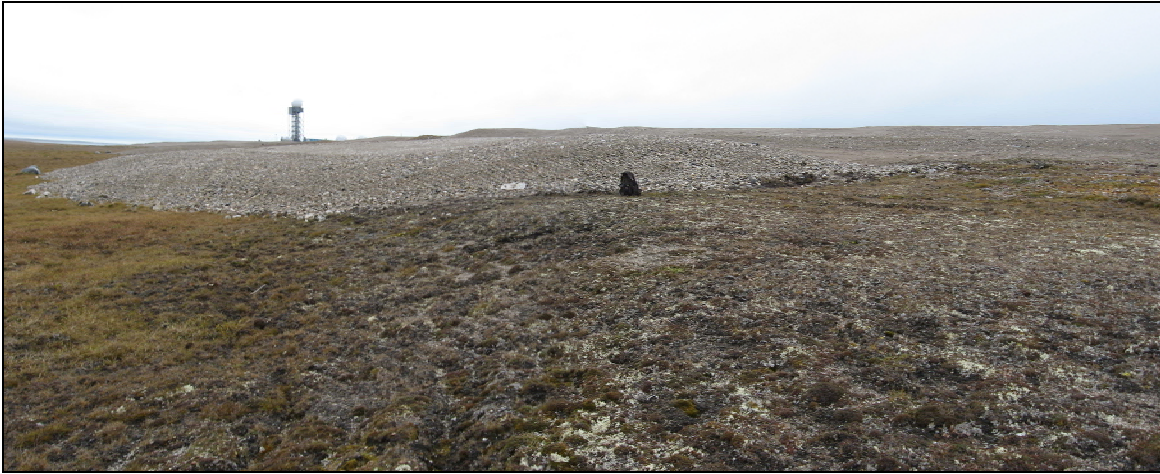
**Photograph 7. Panoramic looking SSW to SW towards the small central east lobe and large southern lobe. No features of note. ↑**

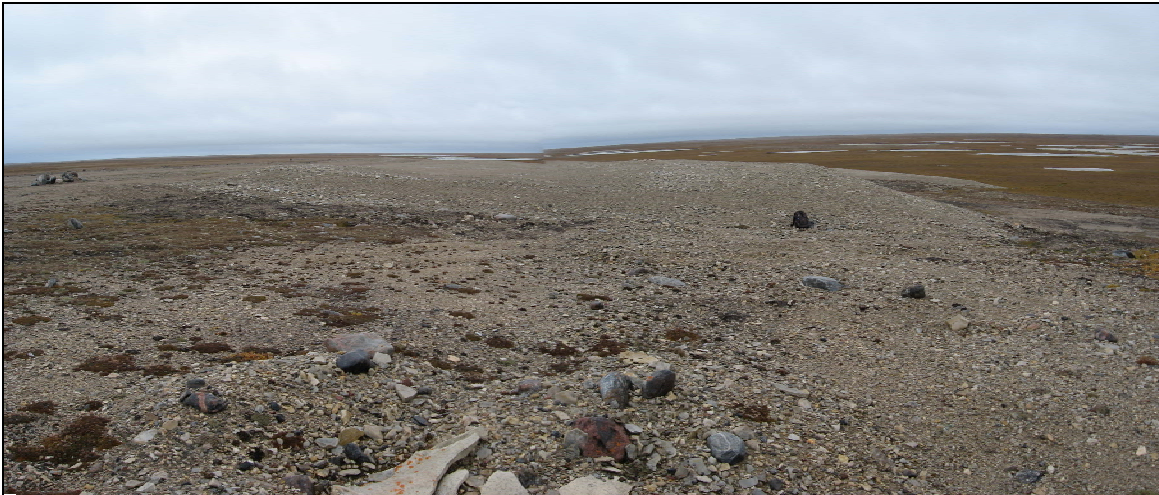
**Photograph 10. Looking N to south end of southern cell. No features of note. ↑**

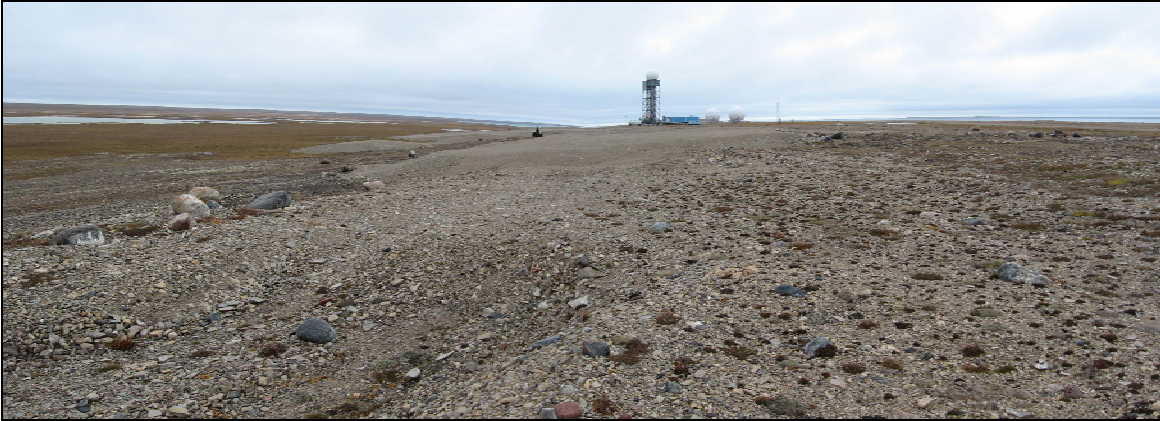
**Photograph 1. Looking east to north end of West Landfill South . No features of note. ↑**

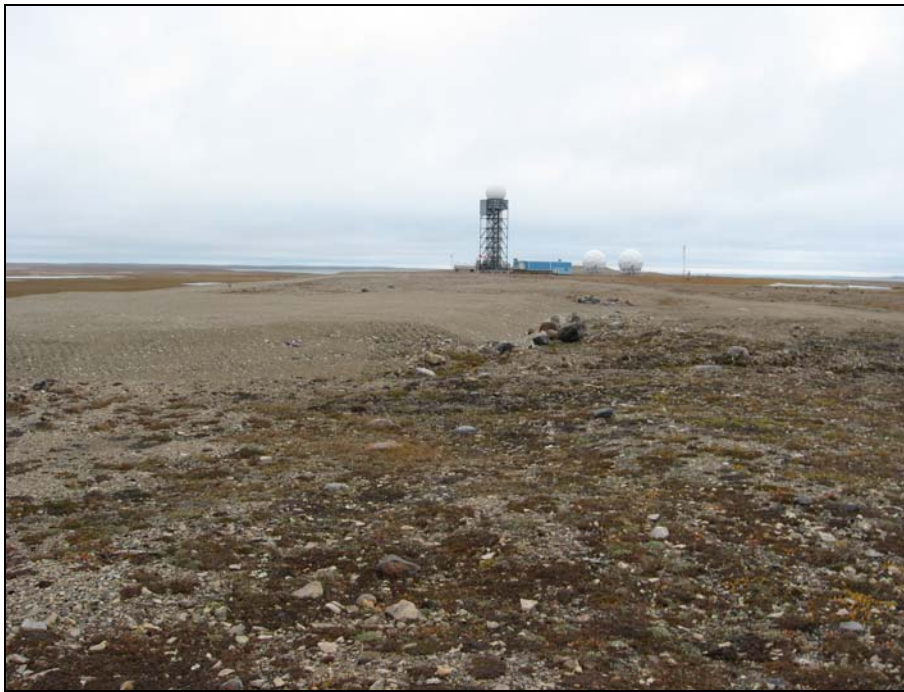
**Photograph 2. Looking S along west side of northern most cell. No features of note. ↑**

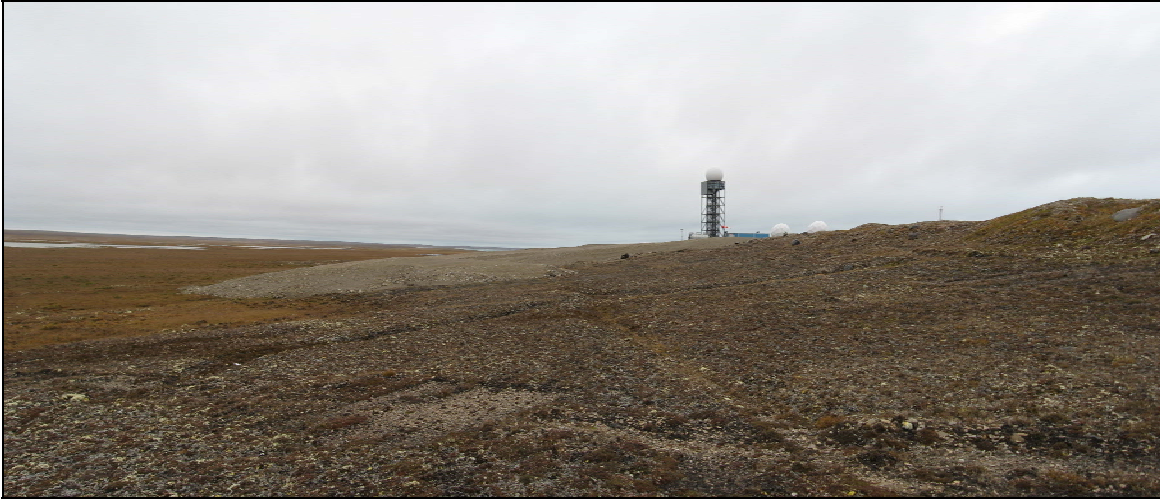
**Photograph 3. Panoramic looking SW from the east side of the northernmost cell. The small NE cell and larger central cell are both visible. No features of note. ↑**

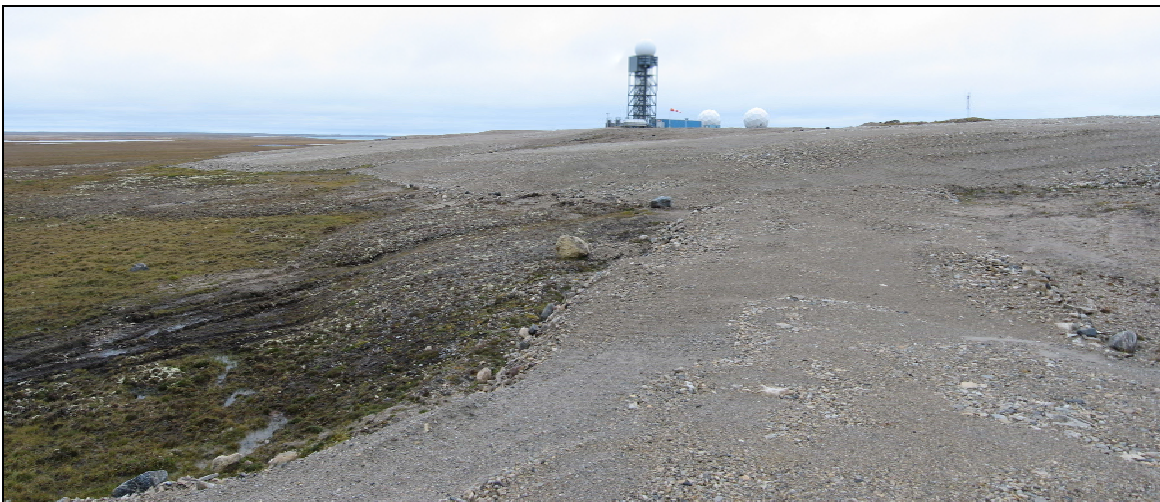
**Photograph 4. Looking S-SE from small eastern cell. The central cell is visible in the centre of the frame and the large souther cell is visible in the background to the left. No features of note. ↑**

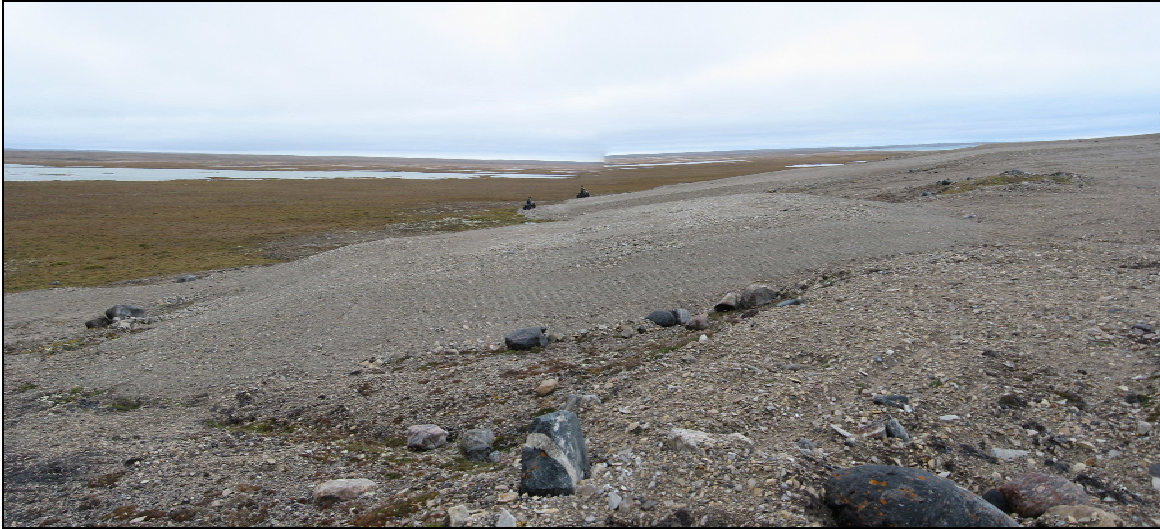
**Photograph 5. Looking SE from the NW corner of central landfill cell (2nd from the south).  
The granular cover appears stable. No features of note. ↑**

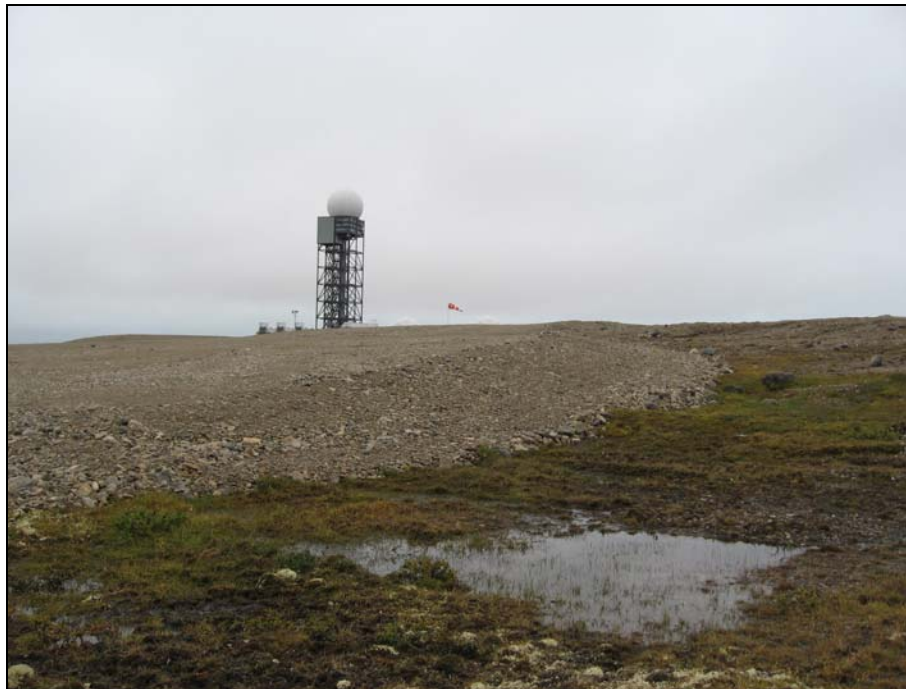
**Photograph 6. Looking SSW to the north end of the southern (largest) granular covered  
cell. Note ponded water. Slope appears stable. ↑**

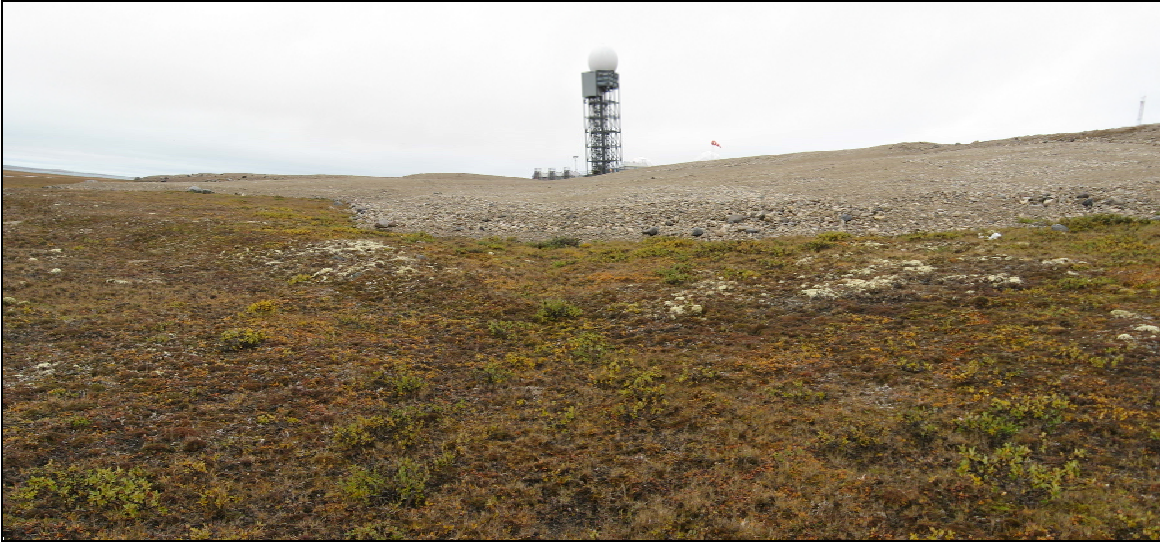
**Photograph 7. Looking roughly south to the NE corner and eastern side of the large southern cell. No features of note. ↑**

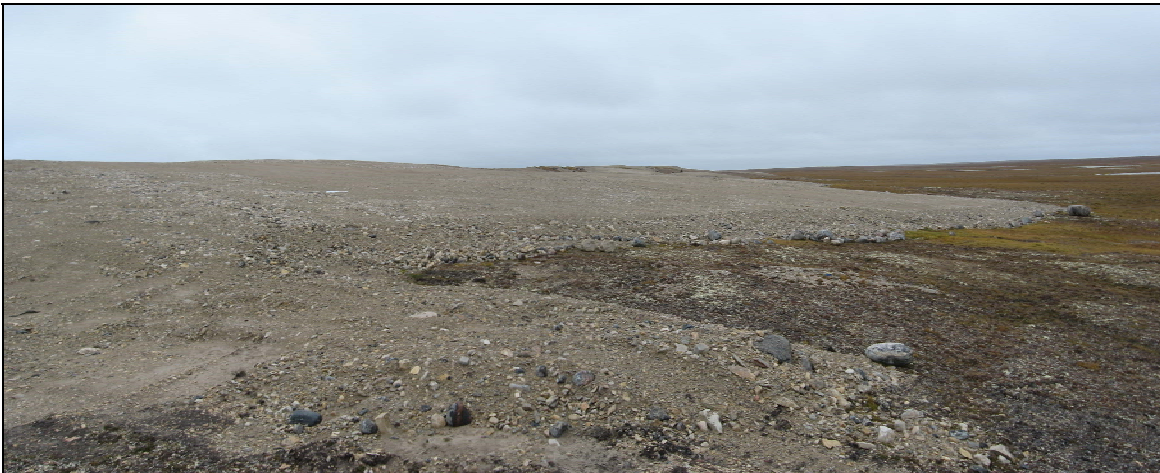
**Photograph 8. Looking N to NW towards the south end of the most southerly cell. Granular cover is stable and low profile. ↑**

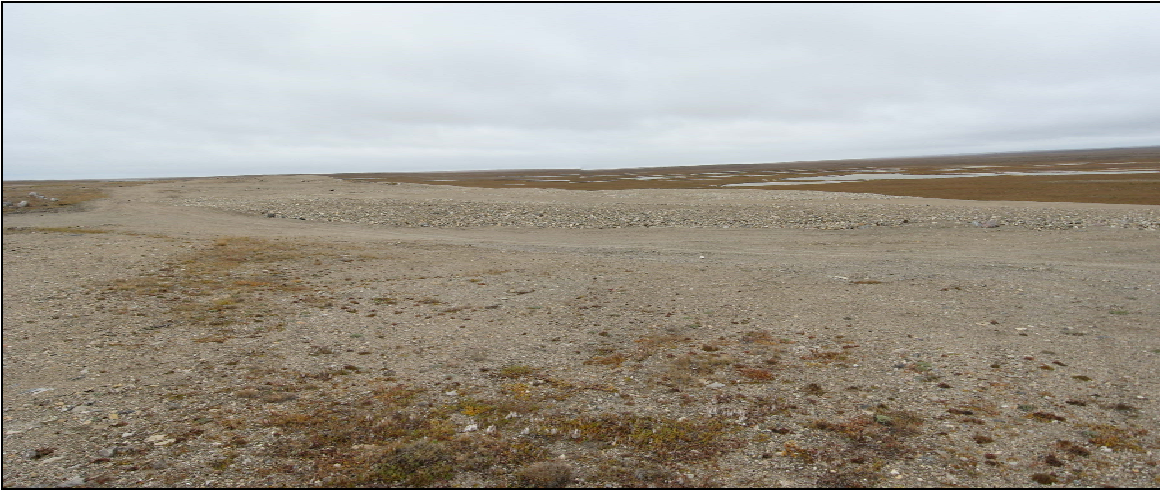
**Photograph 9. Looking N to NNE towards the SW corner of south cell. Granular cover appears stable. No features of note. ↑**

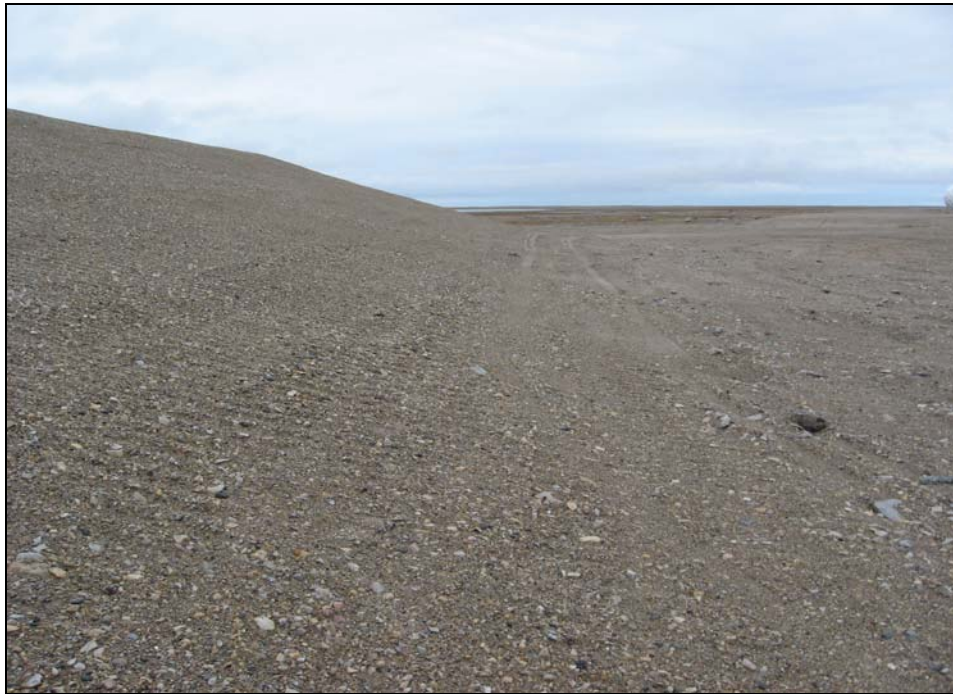
**Photograph 2. Looking WNW along northern toe of the landfill from the NE corner . Granular cover has even slope and level construction finish. ↑**

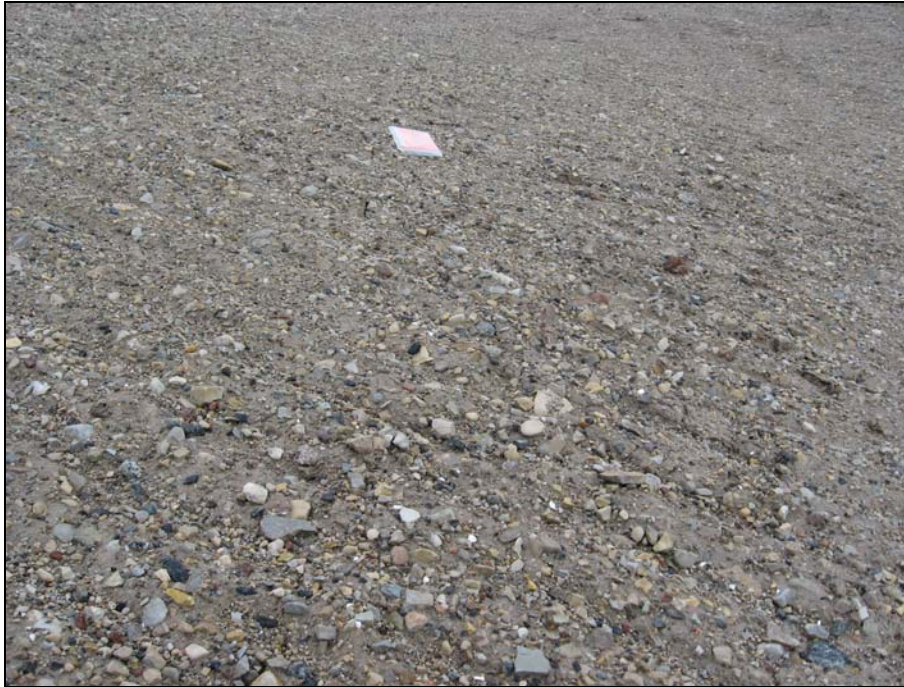
**Photograph 5.** Looking N following the lower fine tension crack noted above. The crack is obscured by fines that have washed in. ↑

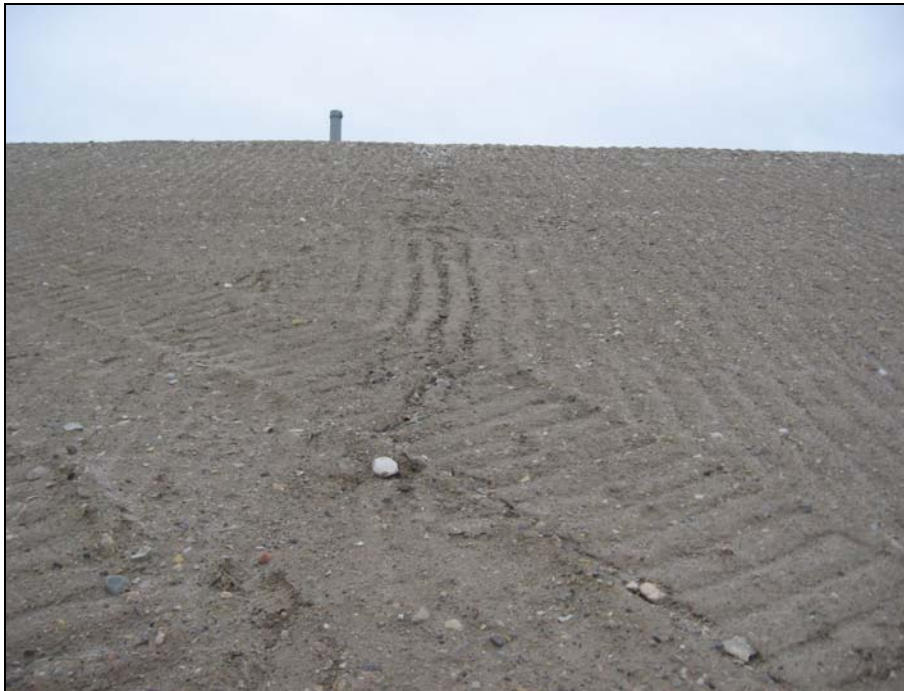
**Photograph 32. Minor surface erosion and gulying adjacent to VT-4 downslope to within 4m of toe of slope. Surface runoff appears to have been concentrated in equipment tracks. Granular cover appears to be self-armouring. ↑**

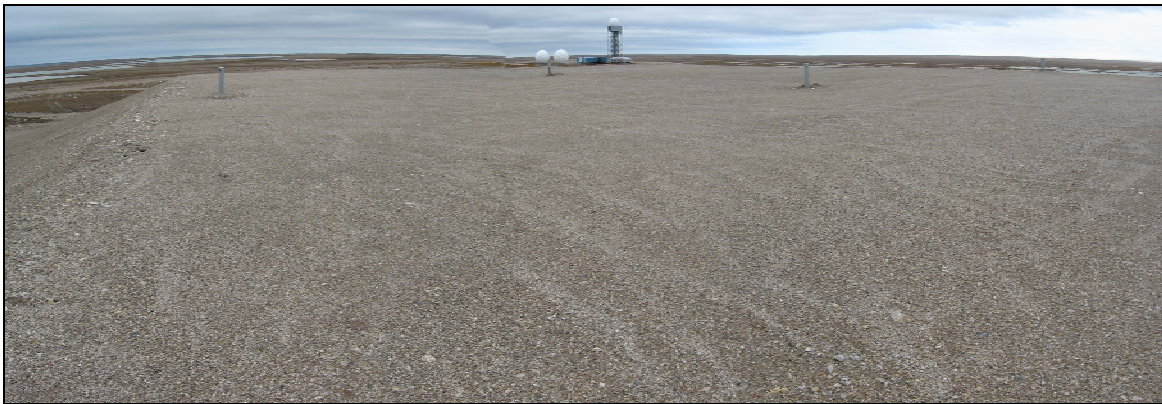
**Photograph 36. Upper surface of the landfill viewed from SE corner. No problematic conditions observed.↑**

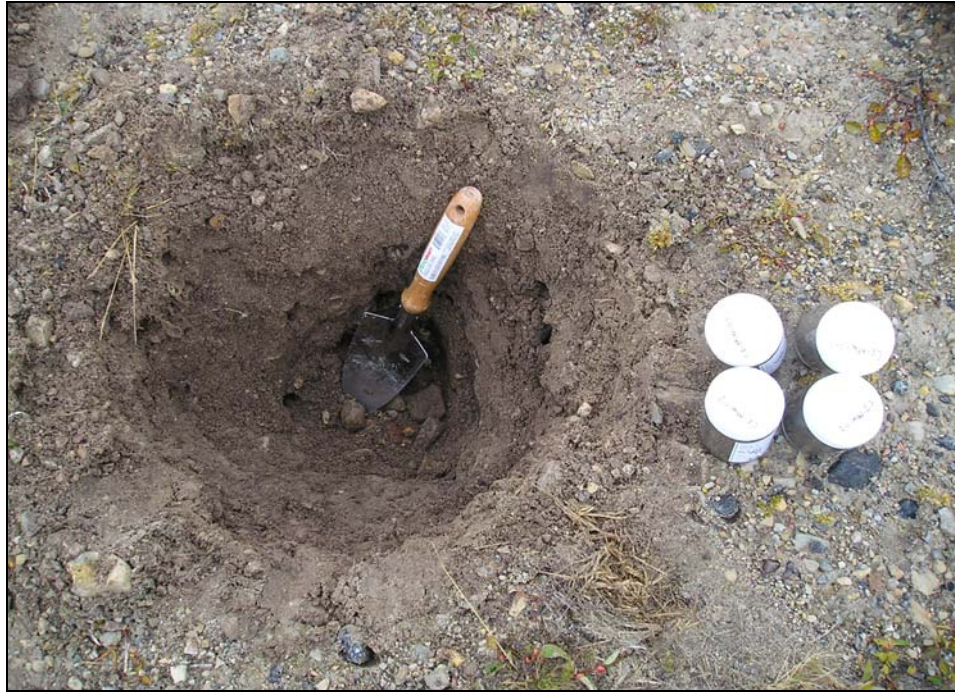
**Photograph 1. Test pit C2-MW-1 (Upgradient). Samples C2-MW-1-1 and C2-MW-1-2 collected. ↑**

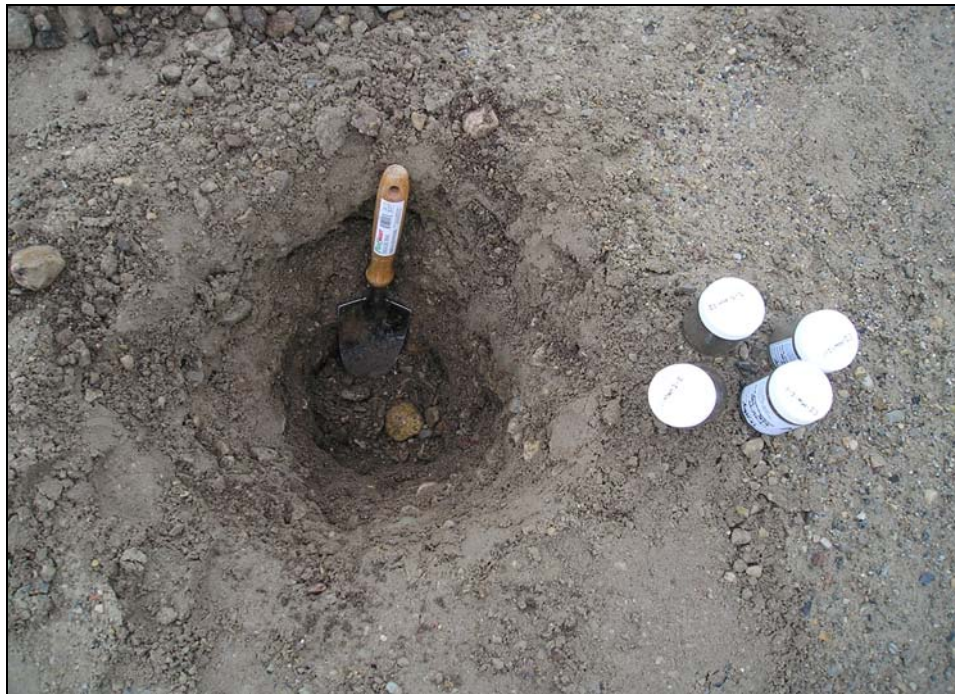
**Photograph 2. Test Pit C2-MW-2. Samples C2-MW-2-1 and C2-MW-2-2 collected. ↑**

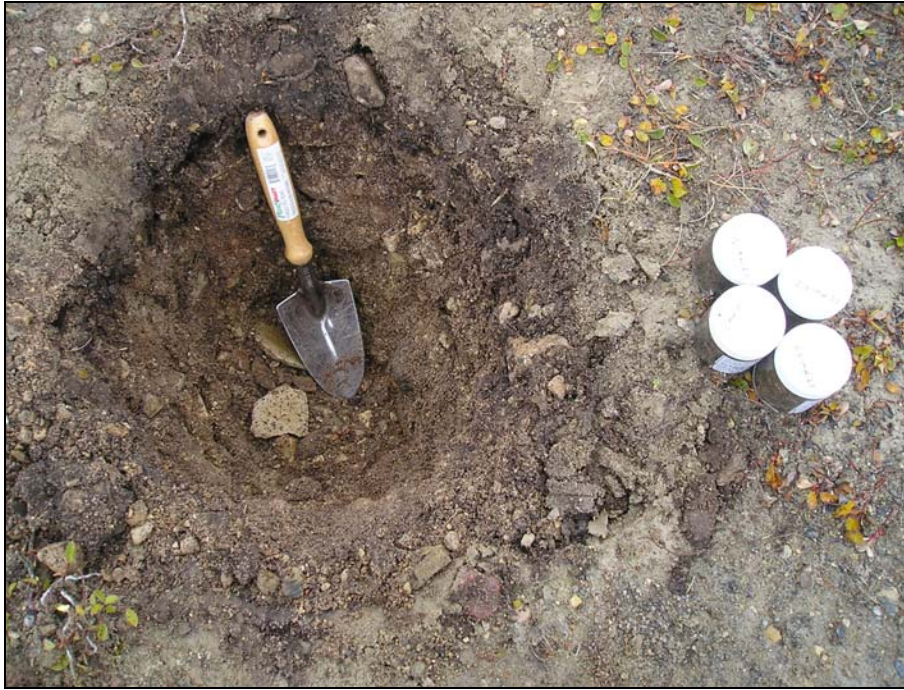
Photograph 3. Test Pit C2-MW-3. Samples C2-MW-3-1 and C2-MW-3-2 collected. ↑

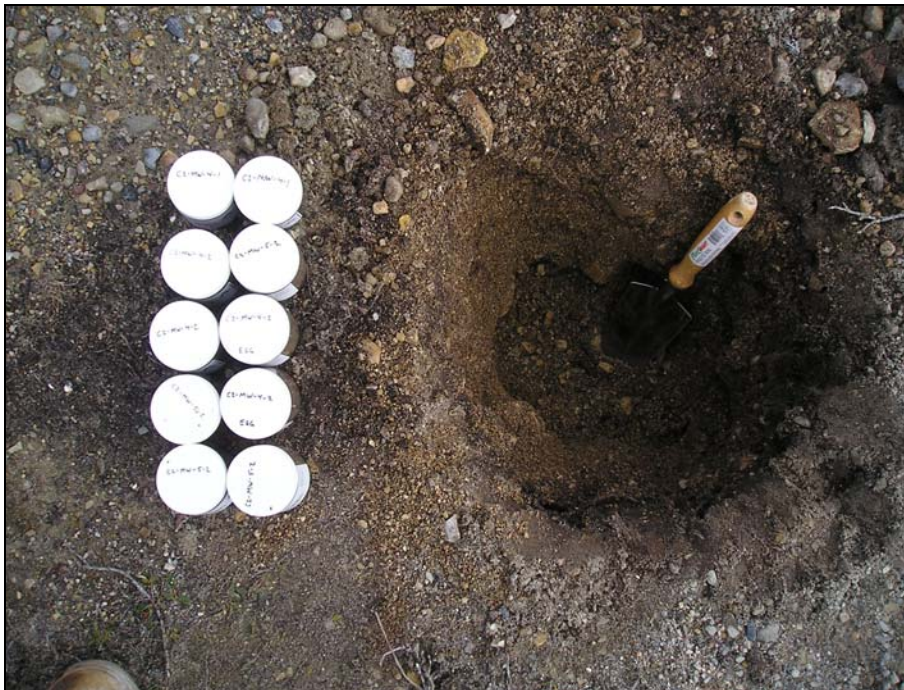
Photograph 4. Test Pit C2-MW-4. Samples C2-MW-4-1, C2-MW-4-2, and C2-MW-5-2  
(Duplicate of C2-MW-4-2) collected. ↑

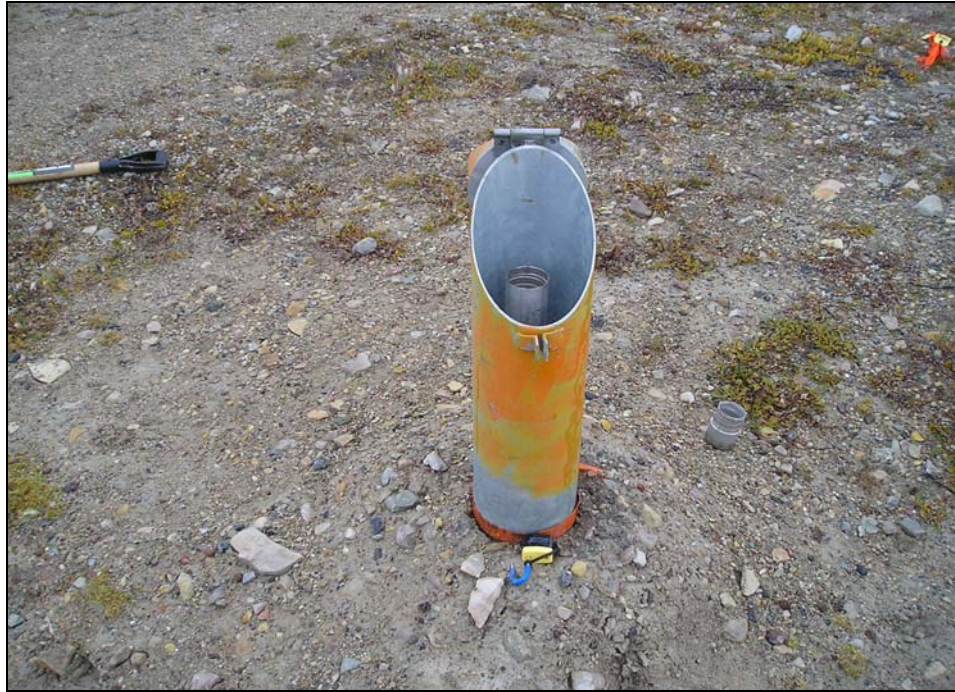
**Photograph 1. Monitoring well MW-1 (Upgradient). Sample C2-MW-1 collected. ↑**

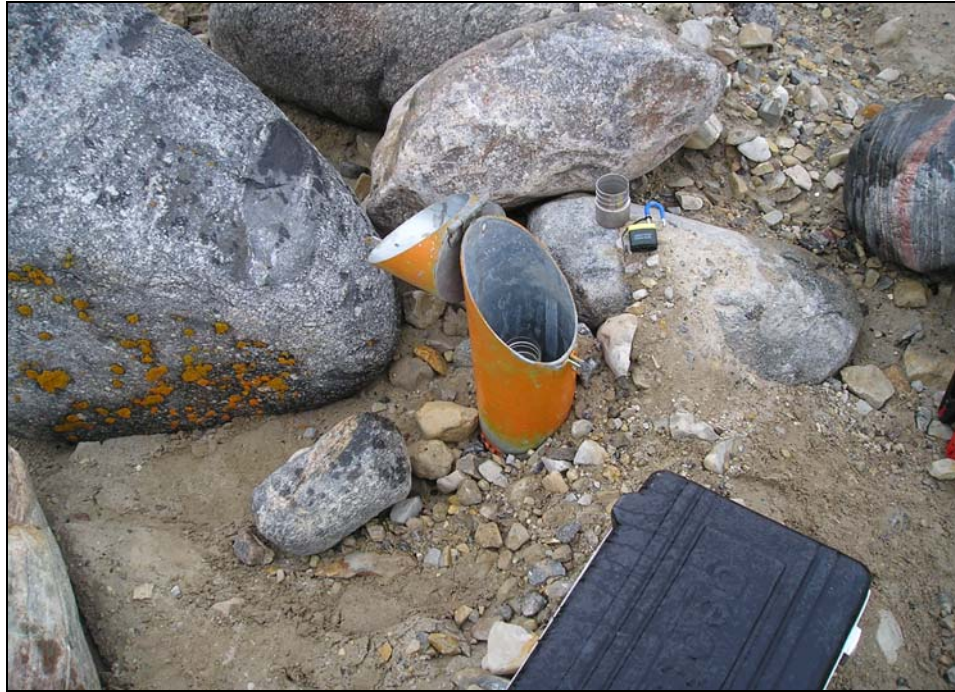
**Photograph 3. Monitoring well MW-2. Sample C2-MW-2 collected. ↑**
