# **The Collection of Landfill Monitoring Data at the CAM-2 Gladman Point – 2007 FINAL Report**

Prepared for  
**Defence Construction Canada**

Submitted by  
**Gartner Lee Limited**

**January, 2008**

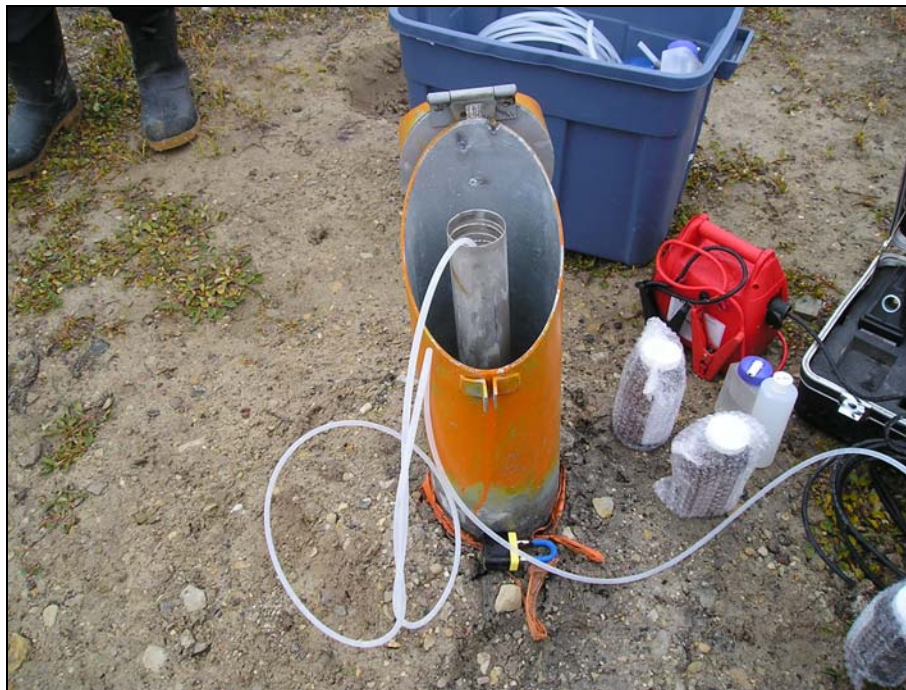
**Photograph 4. Monitoring well MW-3. Sample C2-MW-3 collected. ↑**

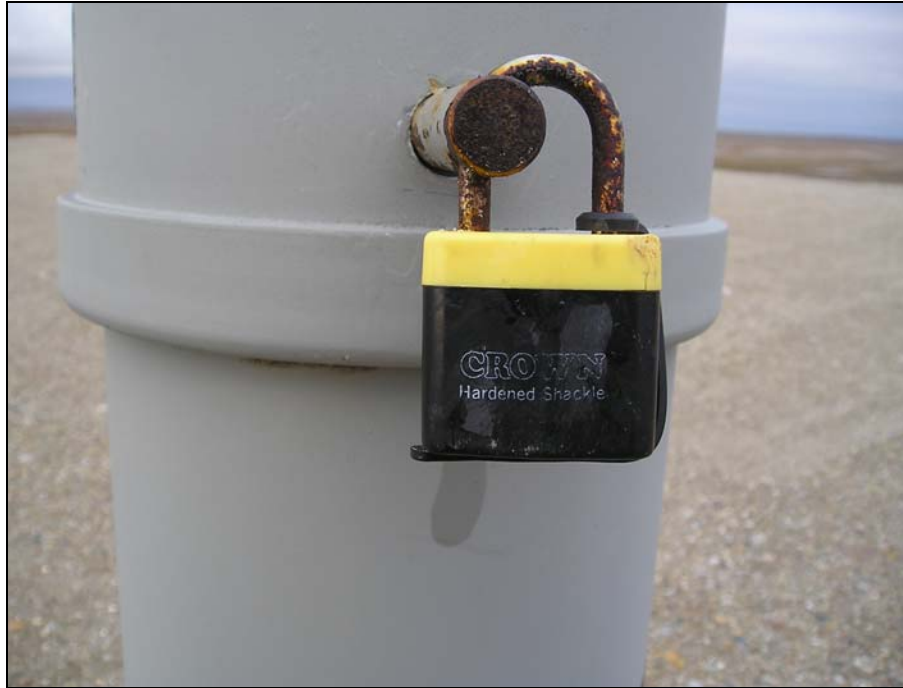
**Photograph 5. Example of a typical lock at CAM-2, PIN-3, and CAM-M. Locks are very rusted, and most are difficult to insert key into and turn. ↑**

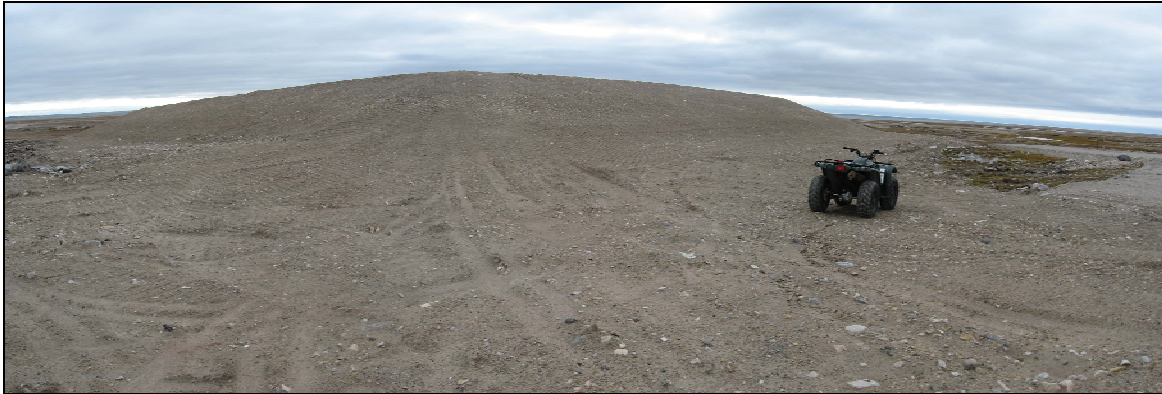
**Photograph 1. Looking SW towards NE corner of the landfill. ↑**

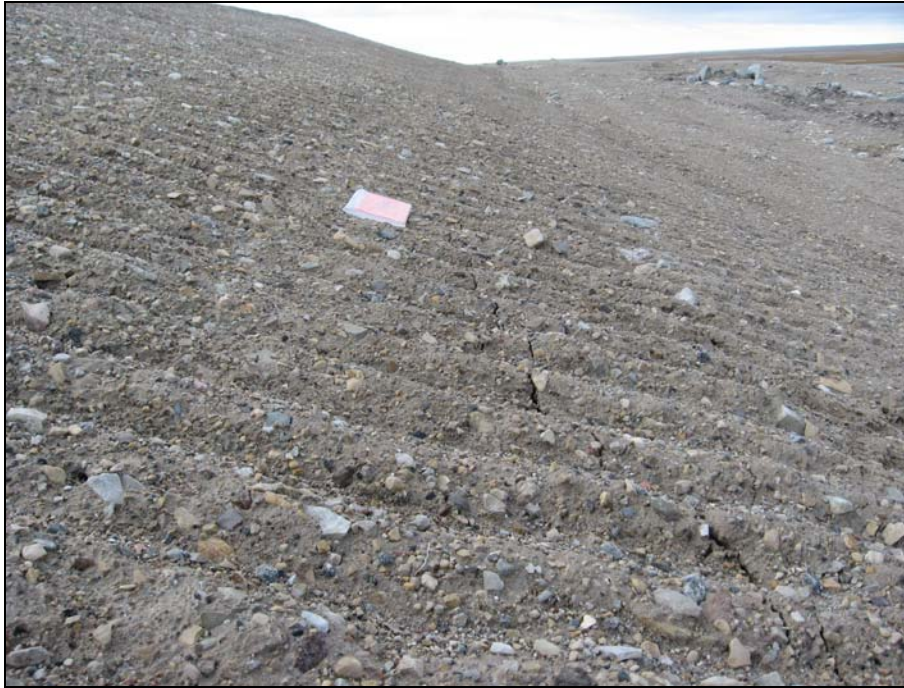
Numerous thin tension cracks, typically on the order of 1mm to 5mm width, were observed around the perimeter and mid-slope of all four sides of the landfill (Refer to Photos 7-10, 12-18, 22-25 and 35 to 38). Thin tension cracks were also observed along the crest of the landfill along the east and west sides of the north slope (Photos 4 thru-6), the eastern portion of the southern crest (Photos 26, 27 and 29) and along the entire length of the eastern crest (Photos 29, 30, 31, 32 and 33). In all instances, the cracks were roughly parallel to the toe of slope and in multiple locations there were several roughly parallel sets of cracks between the toe of slope and crest. The tension cracks along the lower portion of the slope are essentially continuous, although portions of the crack were largely obscured by sediment infilling associated with fines washing out of the granular fill and being deposited in the cracks.

**Photograph 35. Tension crack on east slope starting at SE corner and 1/3 up slope (continues from south side). ↑**

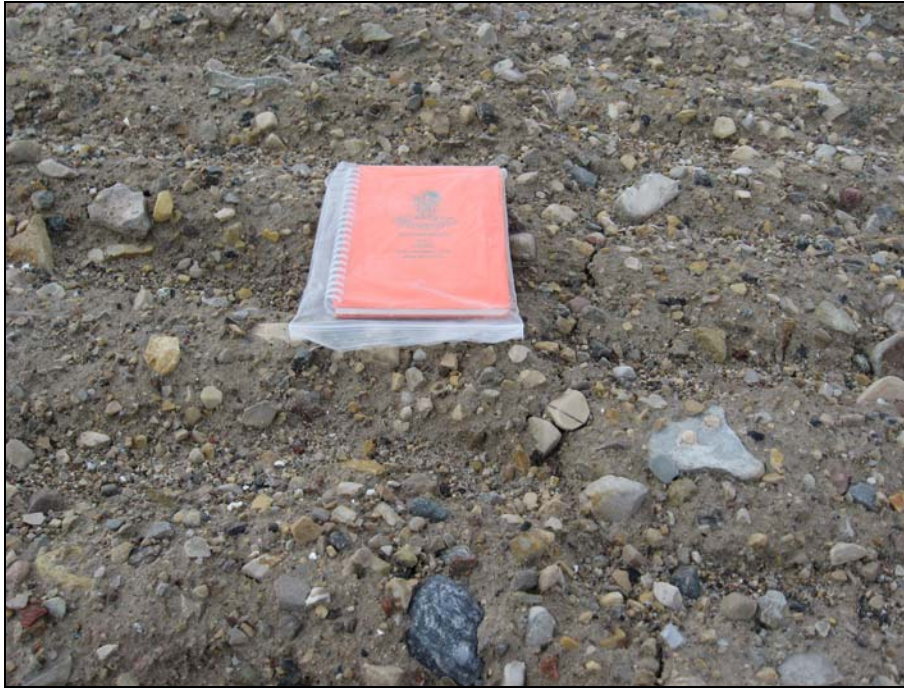
**Photograph 37. Following the tension crack north along the east slope of the landfill.  
Tension crack becomes faint on the northern 1/3 of slope. ↑**

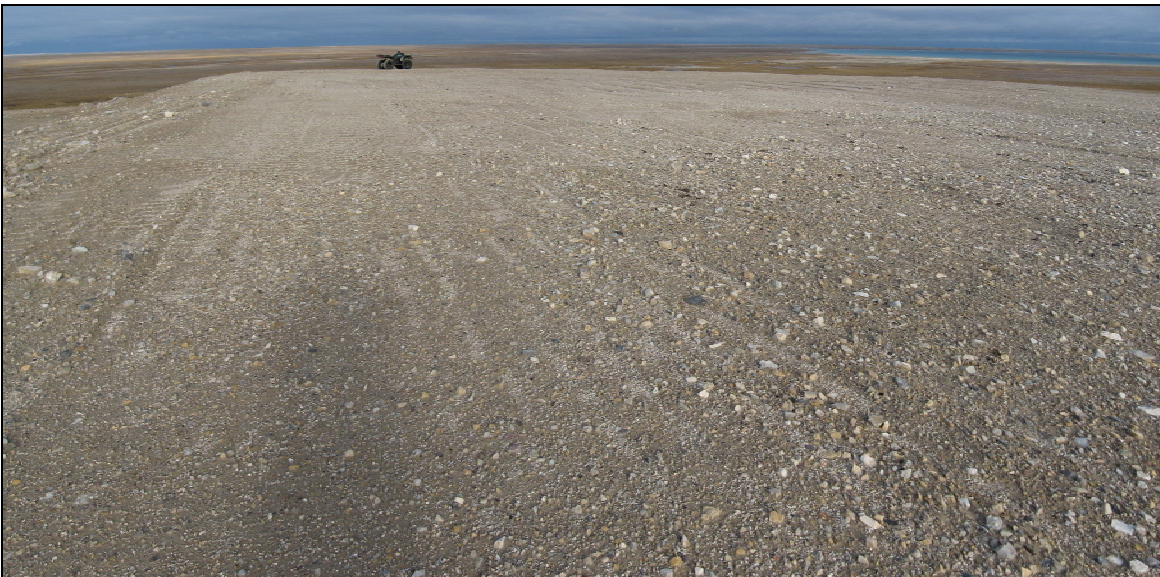
**Photograph 40. Top surface of the landfill looking SE from the NW corner. ↑**
