**THE COLLECTION OF LANDFILL MONITORING
DATA AT THE FORMER
CAM-1 DEW LINE SITE**

Jenny Lind Island, Nunavut

FINAL REPORT– 2013 SEASON

DEFENCE CONSTRUCTION CANADA

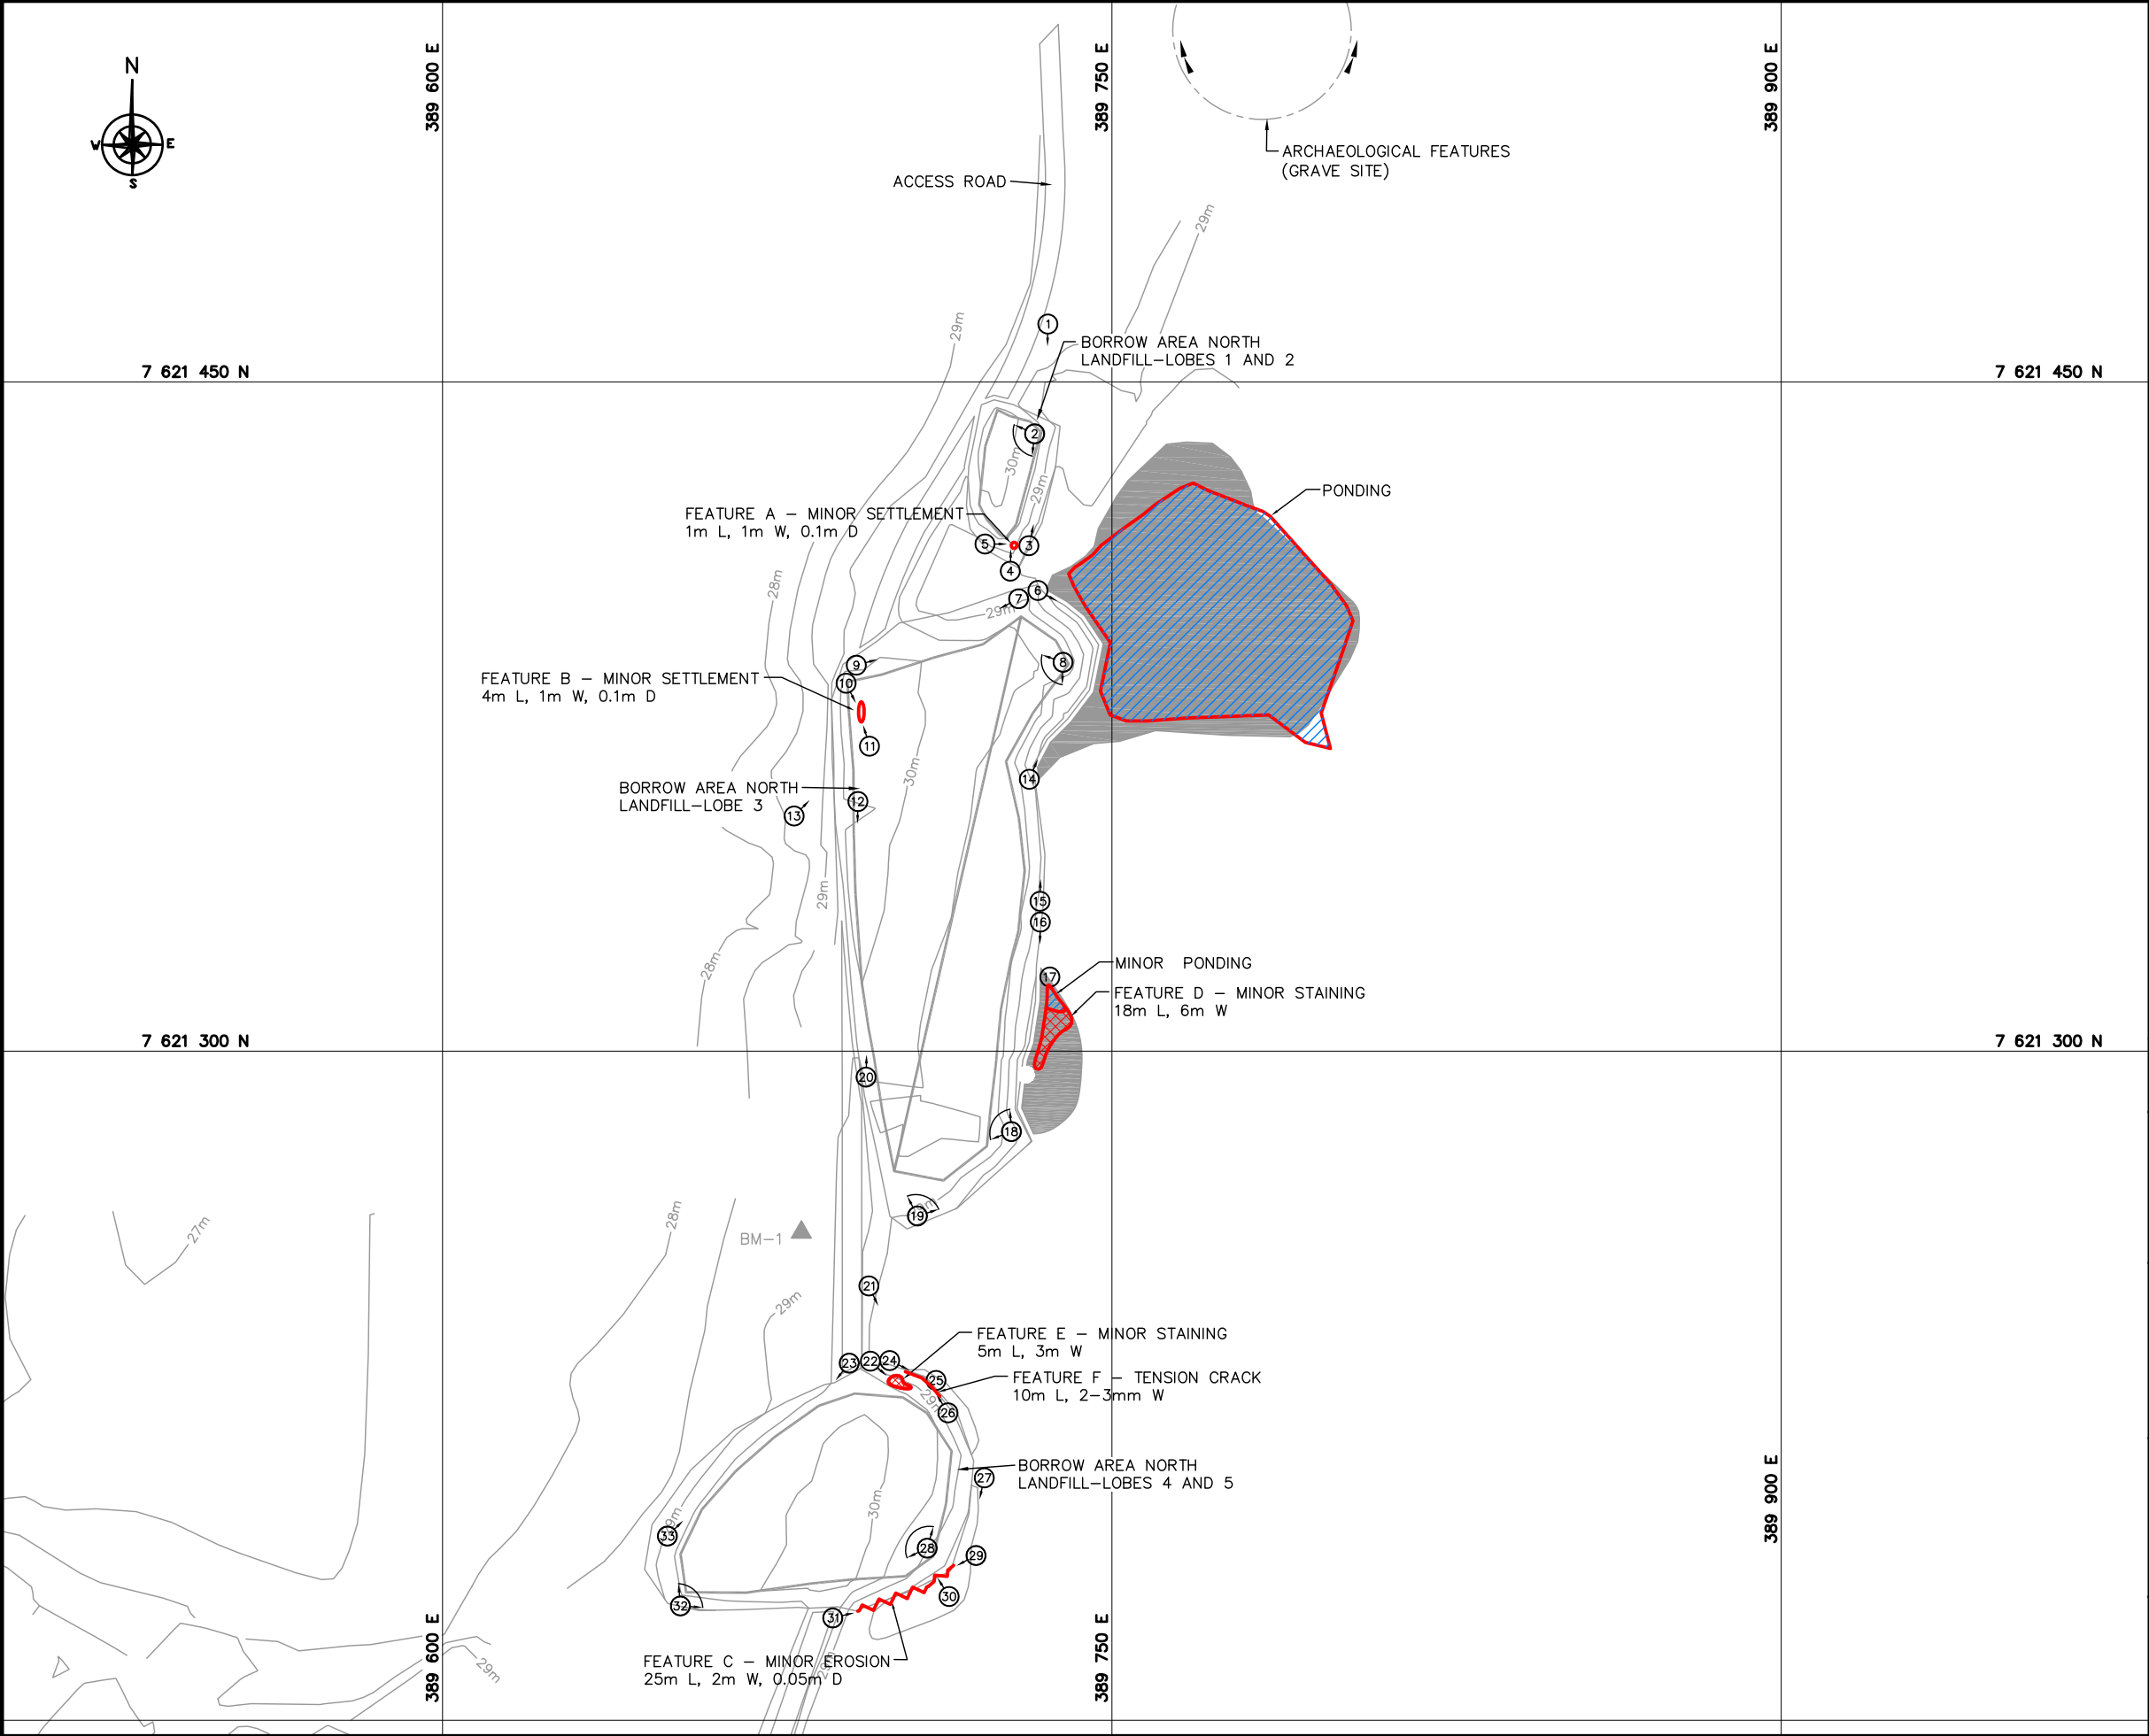
The Location Plan for the Borrow Area North Landfill has been completed as per the ToR and is presented in Figure CAM-1.2.

Indications of minor settlement were noted at two locations, consisting of a 1m by 1 m localized depression on the south side slope of Lobes 1 & 2 (Feature A), and a linear 4 m by 1 m depression on the northwest side slope of Lobe 3 (Feature B). Both features were noted to be consistent with the previous 2012 inspection.

One area of minor erosion was noted on the southeast side slope and along the toe of Lobes 4 & 5 regrade (Feature C). The erosion consisted of fines washing along approximately 4 m of the side slope and along 25 linear meters of the adjoining toe of slope. Erosion along the toe appears to be the result of seasonal ponding bordering the southeast side of the lobe and was consistent with the previous 2011 and 2012 inspections, whereas the minor erosion on the side slope appears recent to the 2013 inspection. The area southeast of the lobe was dry at the time of the 2013 inspection. The erosion along the side slope and toe areas appears to be self-armouring with an acceptable severity rating.

Two areas of discoloration (staining) were noted during the 2013 inspection, including one relatively small area on the north side slope of the Lobe 4 & 5 regrade (Feature E) and a larger area associated with a wetted area immediately east of Lobe 3 (Feature D). There were no odours noted with either area at the time of the 2013 inspection and observations at both areas were consistent with the previous 2011 and 2012 inspections.

Ponding was noted along the northeast side of Lobe 3 during the 2013 inspection. This area was consistent with findings from the 2002 site investigation and 2010, 2011 and 2012 landfill inspections and included observations of rust-colored staining in wetted areas along the toe of the lobe. Direct seepage from the landfill was not observed.
