**CAM-E KEITH BAY LONG TERM MONITORING EVENT
2020 LONG TERM MONITORING REPORT**

**Crown-Indigenous Relations and Northern Affairs Canada
Contaminants and Remediation Division**

Project Number: 200537
February 18, 2021

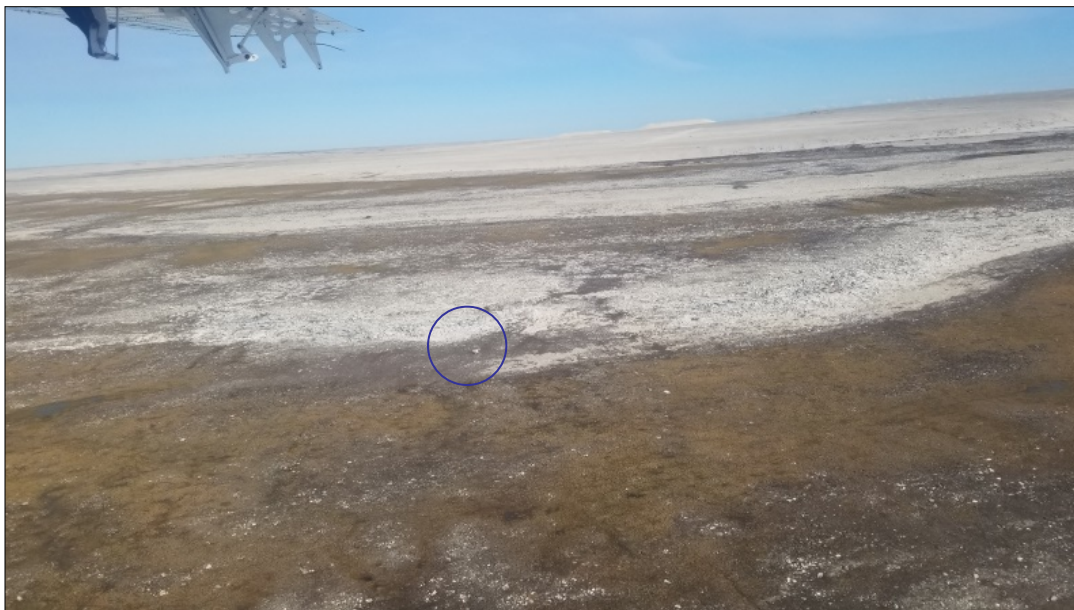
Three (3) polar bears were observed from the plane prior to landing, and two (2) more polar bears were observed while on site (Photo 11). During monitoring activities, a flock of snow geese flew overhead (Photo 12). Evidence of other wildlife on site was observed in the form of caribou droppings (Photo 13).

Photo 11: A polar bear seen from the plane.

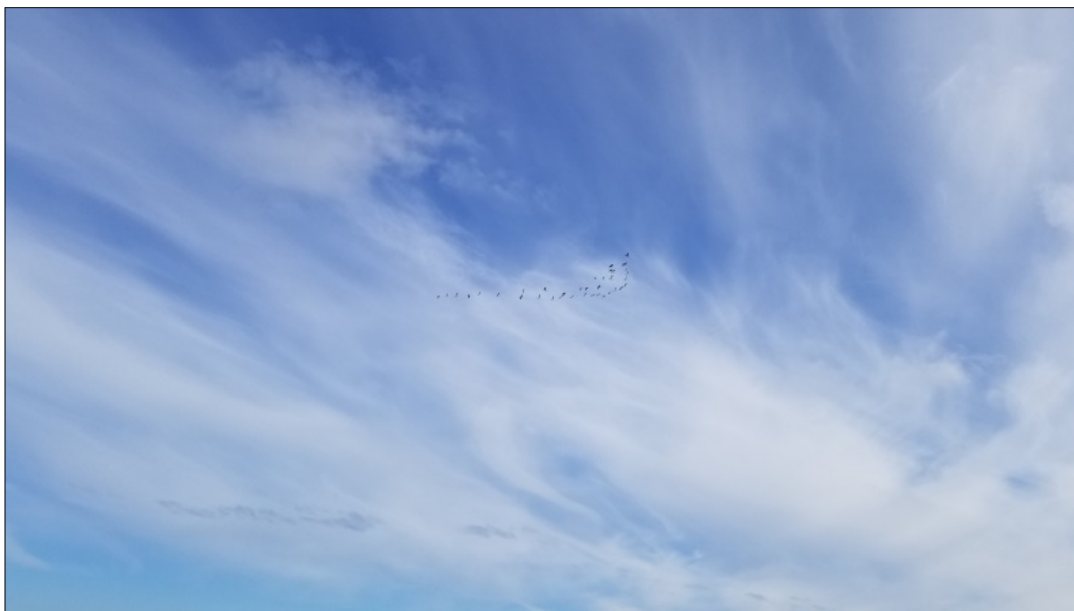
Photo 12: Snow geese flying overhead.

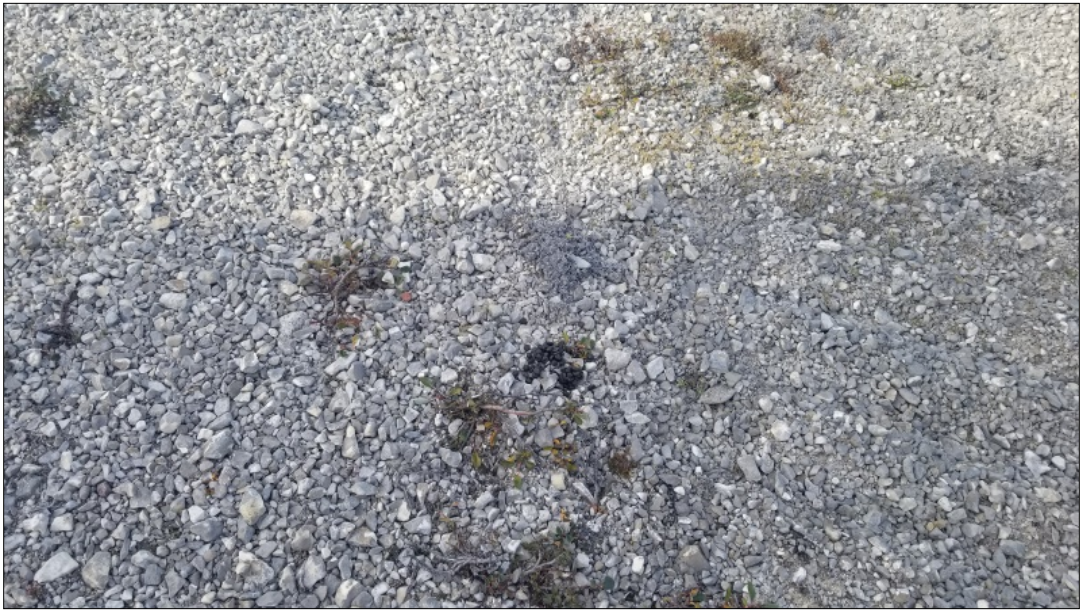
Photo 13: Caribou droppings.

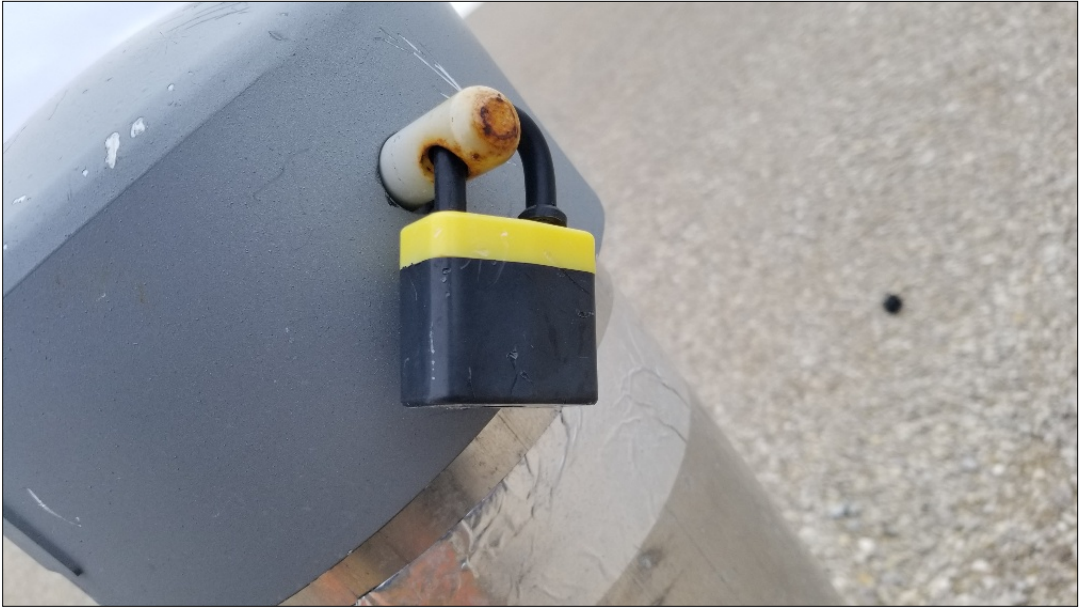
BluMetric was successful at downloading the raw data from the thermistors after which they were reset. It was noted that the key to open the thermistors was not the correct one and the locks were cut to access the thermistors. The security pins were put back in place after the data was downloaded to prevent thermistor exposure to rain, snow, and sunlight and to allow future access (see Photos 15 through 17). Replacement locks should be brought to site during the next monitoring event to secure the thermistors.

Photo 15: Thermistor lock.
