# CAM-E Keith Bay Long Term Monitoring

Year 3 Report

Crown-Indigenous Relations and Northern Affairs Canada

Project number: 60686962

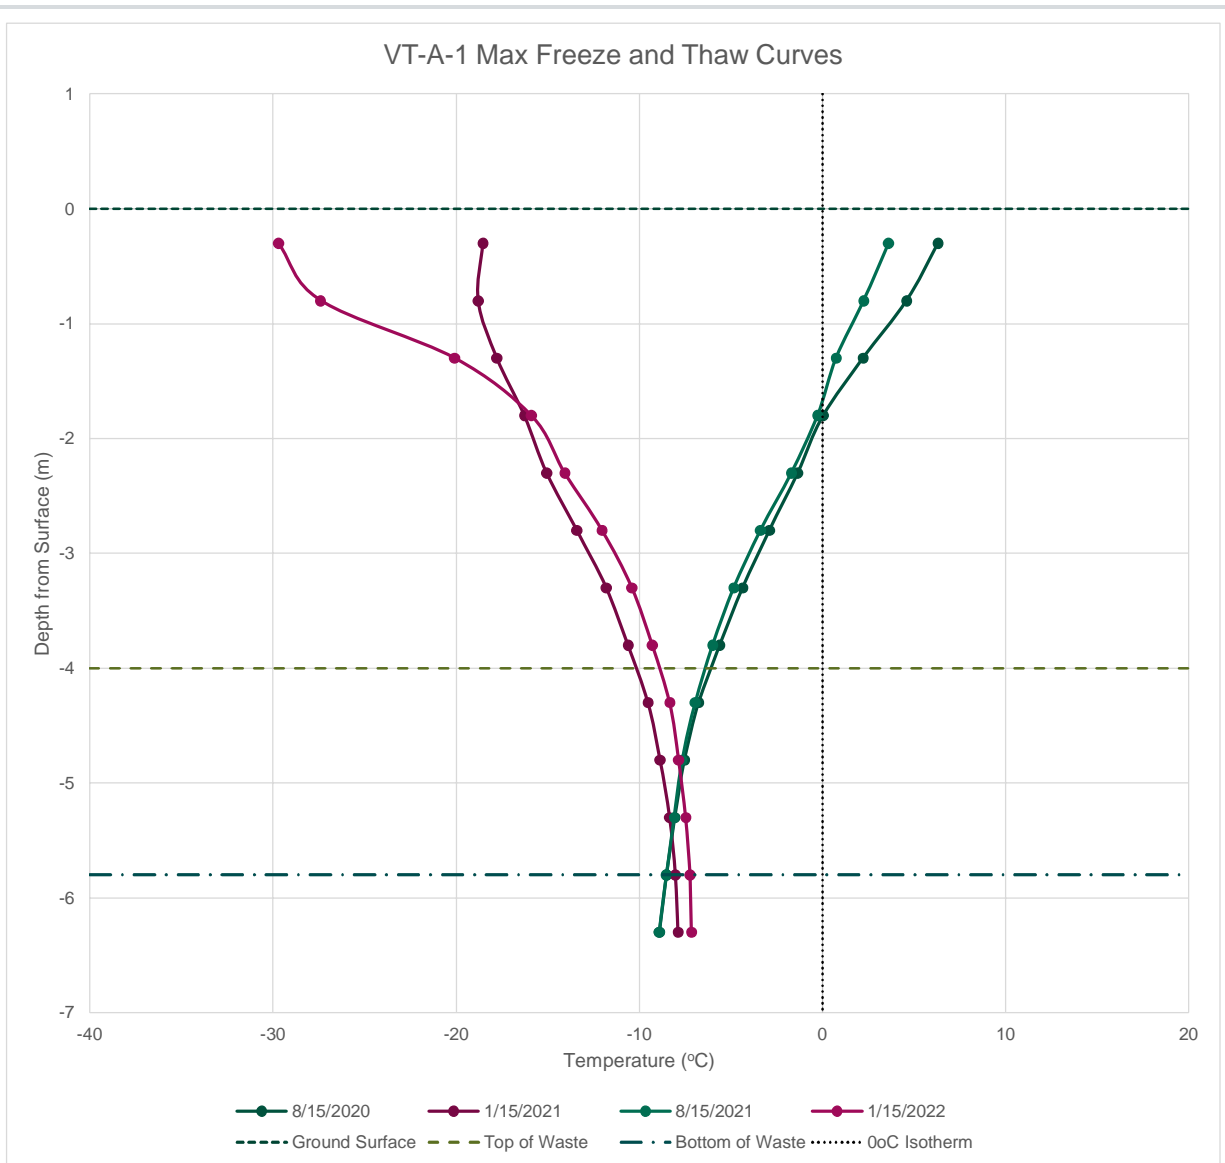
**Figure 1. VT-A-1 Max Freeze and Thaw Curves**

Figures 1 through 4, below, are a simplification of the Ground Temperature Curves in **Appendix E** and provide the maximum freeze (depicted with annual data from January 15) and maximum thaw (August 15 annually) with respect to the landfill cap surface, top of waste, bottom of waste, and 0°C isotherm. The range of temperature variability narrows from approximately 5-degrees at the top of the landfill contents, to approximately 2-degrees at the end of the thermistor strings. The low variability demonstrates an approach towards steady-state conditions indicating the containment method is performing as designed. Intersection of the curves with the 0°C isotherm provides the maximum thaw depth presented in **Table 5-1** and informs the active layer depth. The active layer remains 2 m above the top of waste at all thermistor locations and shows that the Tier II soil has been frozen continuously since 2019.

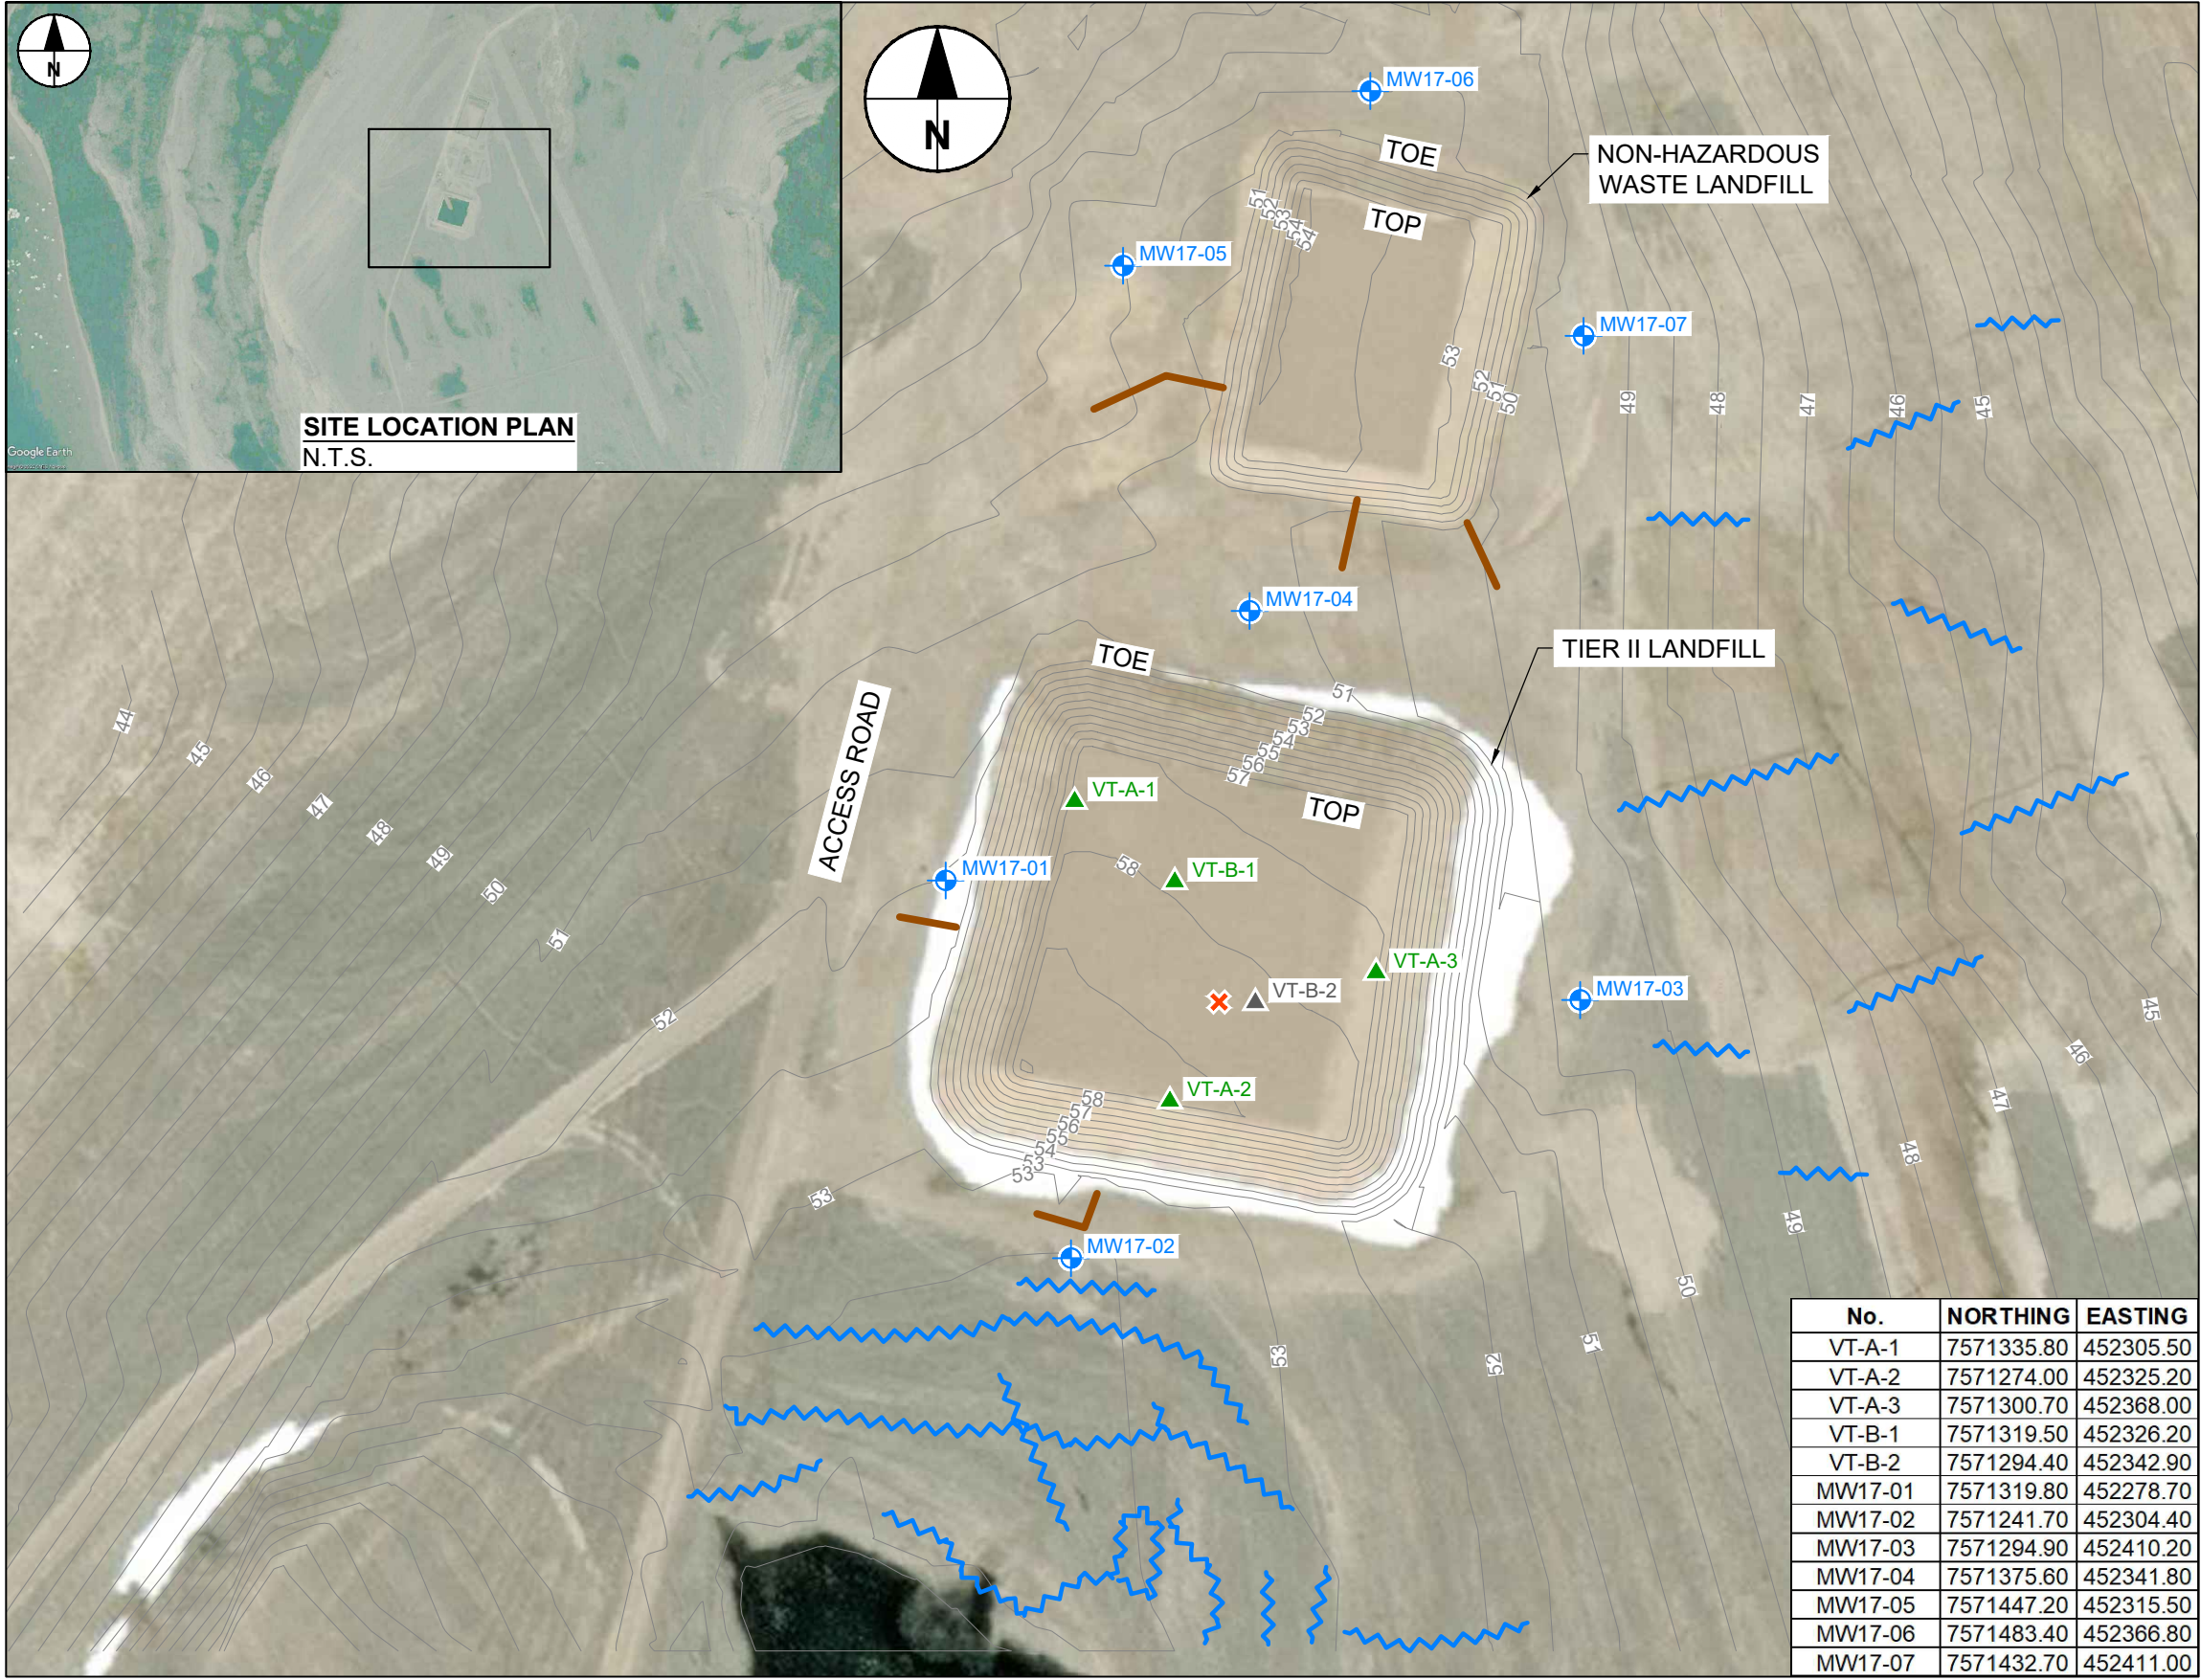
The 2022 inspection did not identify any signs of erosion on site. The Year 1 features identified as erosion have been updated as frost wedge cracking and are naturally occurring features of the surrounding tundra. In their current condition, the frost wedge cracks do not compromise the performance of the NHWL and will only present a potential risk if new cracks develop proximate or within the landfill. These features are most clearly displayed in Photograph 3 of **Appendix B**.

The 2022 inspection did not identify any signs of erosion on site. The Year 1 features identified as erosion have been updated as frost wedge cracking and are naturally occurring features of the surrounding tundra. These features closest to the Tier II Landfill are displayed in Photographs 1 - 4 of **Appendix B**.
