*Former U.S. Coast Guard Loran  
Station, Cape Christian, Nunavut  
Environmental Site Delineation  
and Material Inventory*

## Environmental Site Delineation and Material Inventory

February 2002

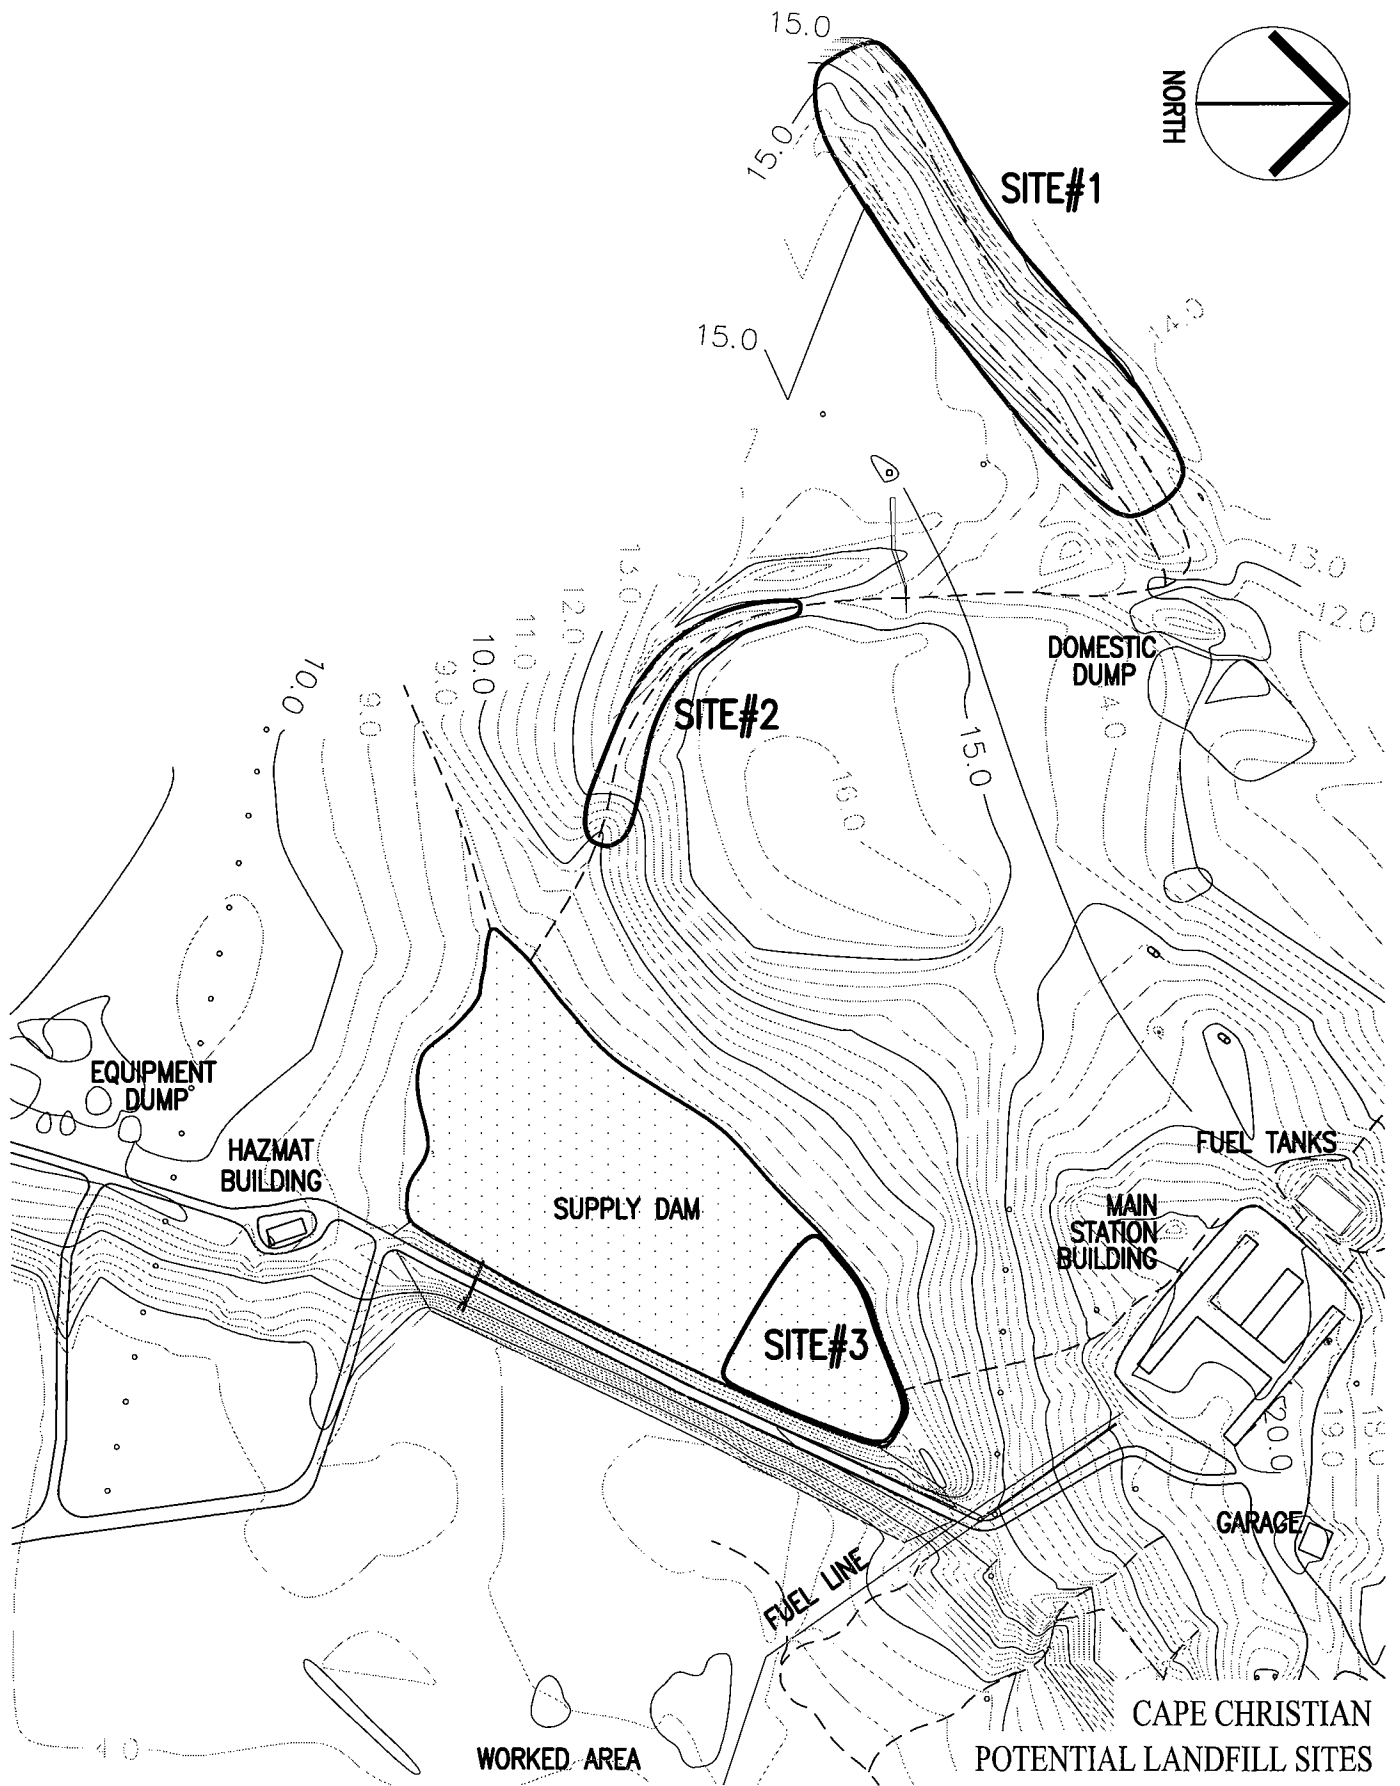
Site 3 – Raw Water Reservoir is shown by Photos 4.5 and 4.6. The reservoir was constructed by a large embankment dam which also doubles as the access road to the site. This road is at risk due to erosion and a wash out at the culvert at the southern end of the reservoir. The soil that forms the embankment was sampled and is mainly sand. It is likely, however that a more fine grained silty material was used to line the bottom of the reservoir which appeared to be very effective in holding water. The depth of water was not determined however the embankment rises approximately 3 m above the water level and it is evident that there is sufficient volume in the reservoir to landfill the non-

hazardous debris from the site. The development of this site as a landfill would require removal of sufficient embankment material to drain the reservoir. This embankment could also serve as fill material. The distance from the Main Building to a landfill constructed at the north end of the reservoir would be 150 m, while the Equipment Dump is 350 m away. The surface area of the entire water supply reservoir at the time of the investigation was approximately 18,500 m<sup>2</sup> as determined from the site survey data. Using a depth of 3 m, the potential capacity of this reservoir as a landfill site is roughly 55,500 m<sup>3</sup>, which far exceeds the requirement for site remediation. It is evident that only a small portion of the northern end of the reservoir, such as shown on Figure 4.1, would be required. The area shown would have an approximate capacity of 10,000 m<sup>3</sup>.
