**Transport Canada  
LTU Annual Report 2008  
Iqaluit Airport, Nunavut  
Water License No. 1BR-LTU0608**

**March 2009**

**Re: Fertilizing Two LTUs**  
**Iqaluit Airport, Iqaluit, Nunavut Territory**  
**File No.: E1001-077-08**

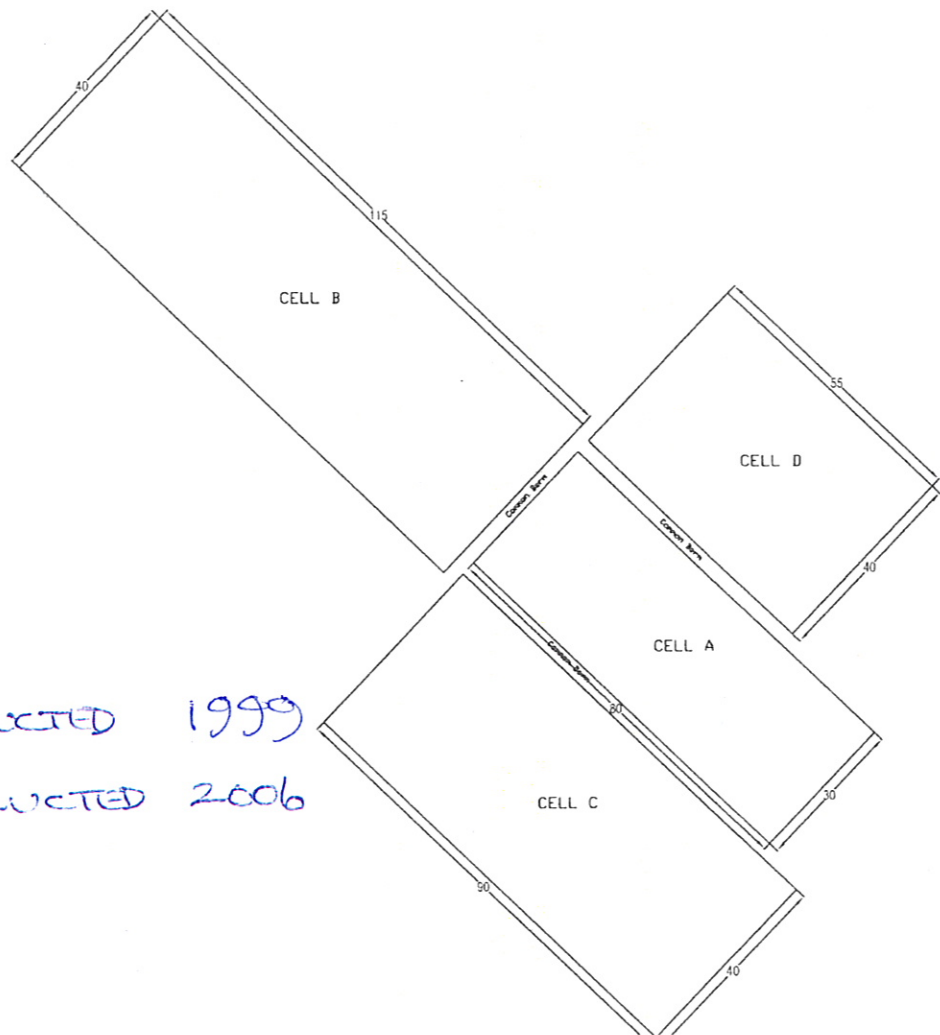
# IGALUIT, AIRPORT LTU

CELL A & B CONSTRUCTED 1999

CELL C & D CONSTRUCTED 2006

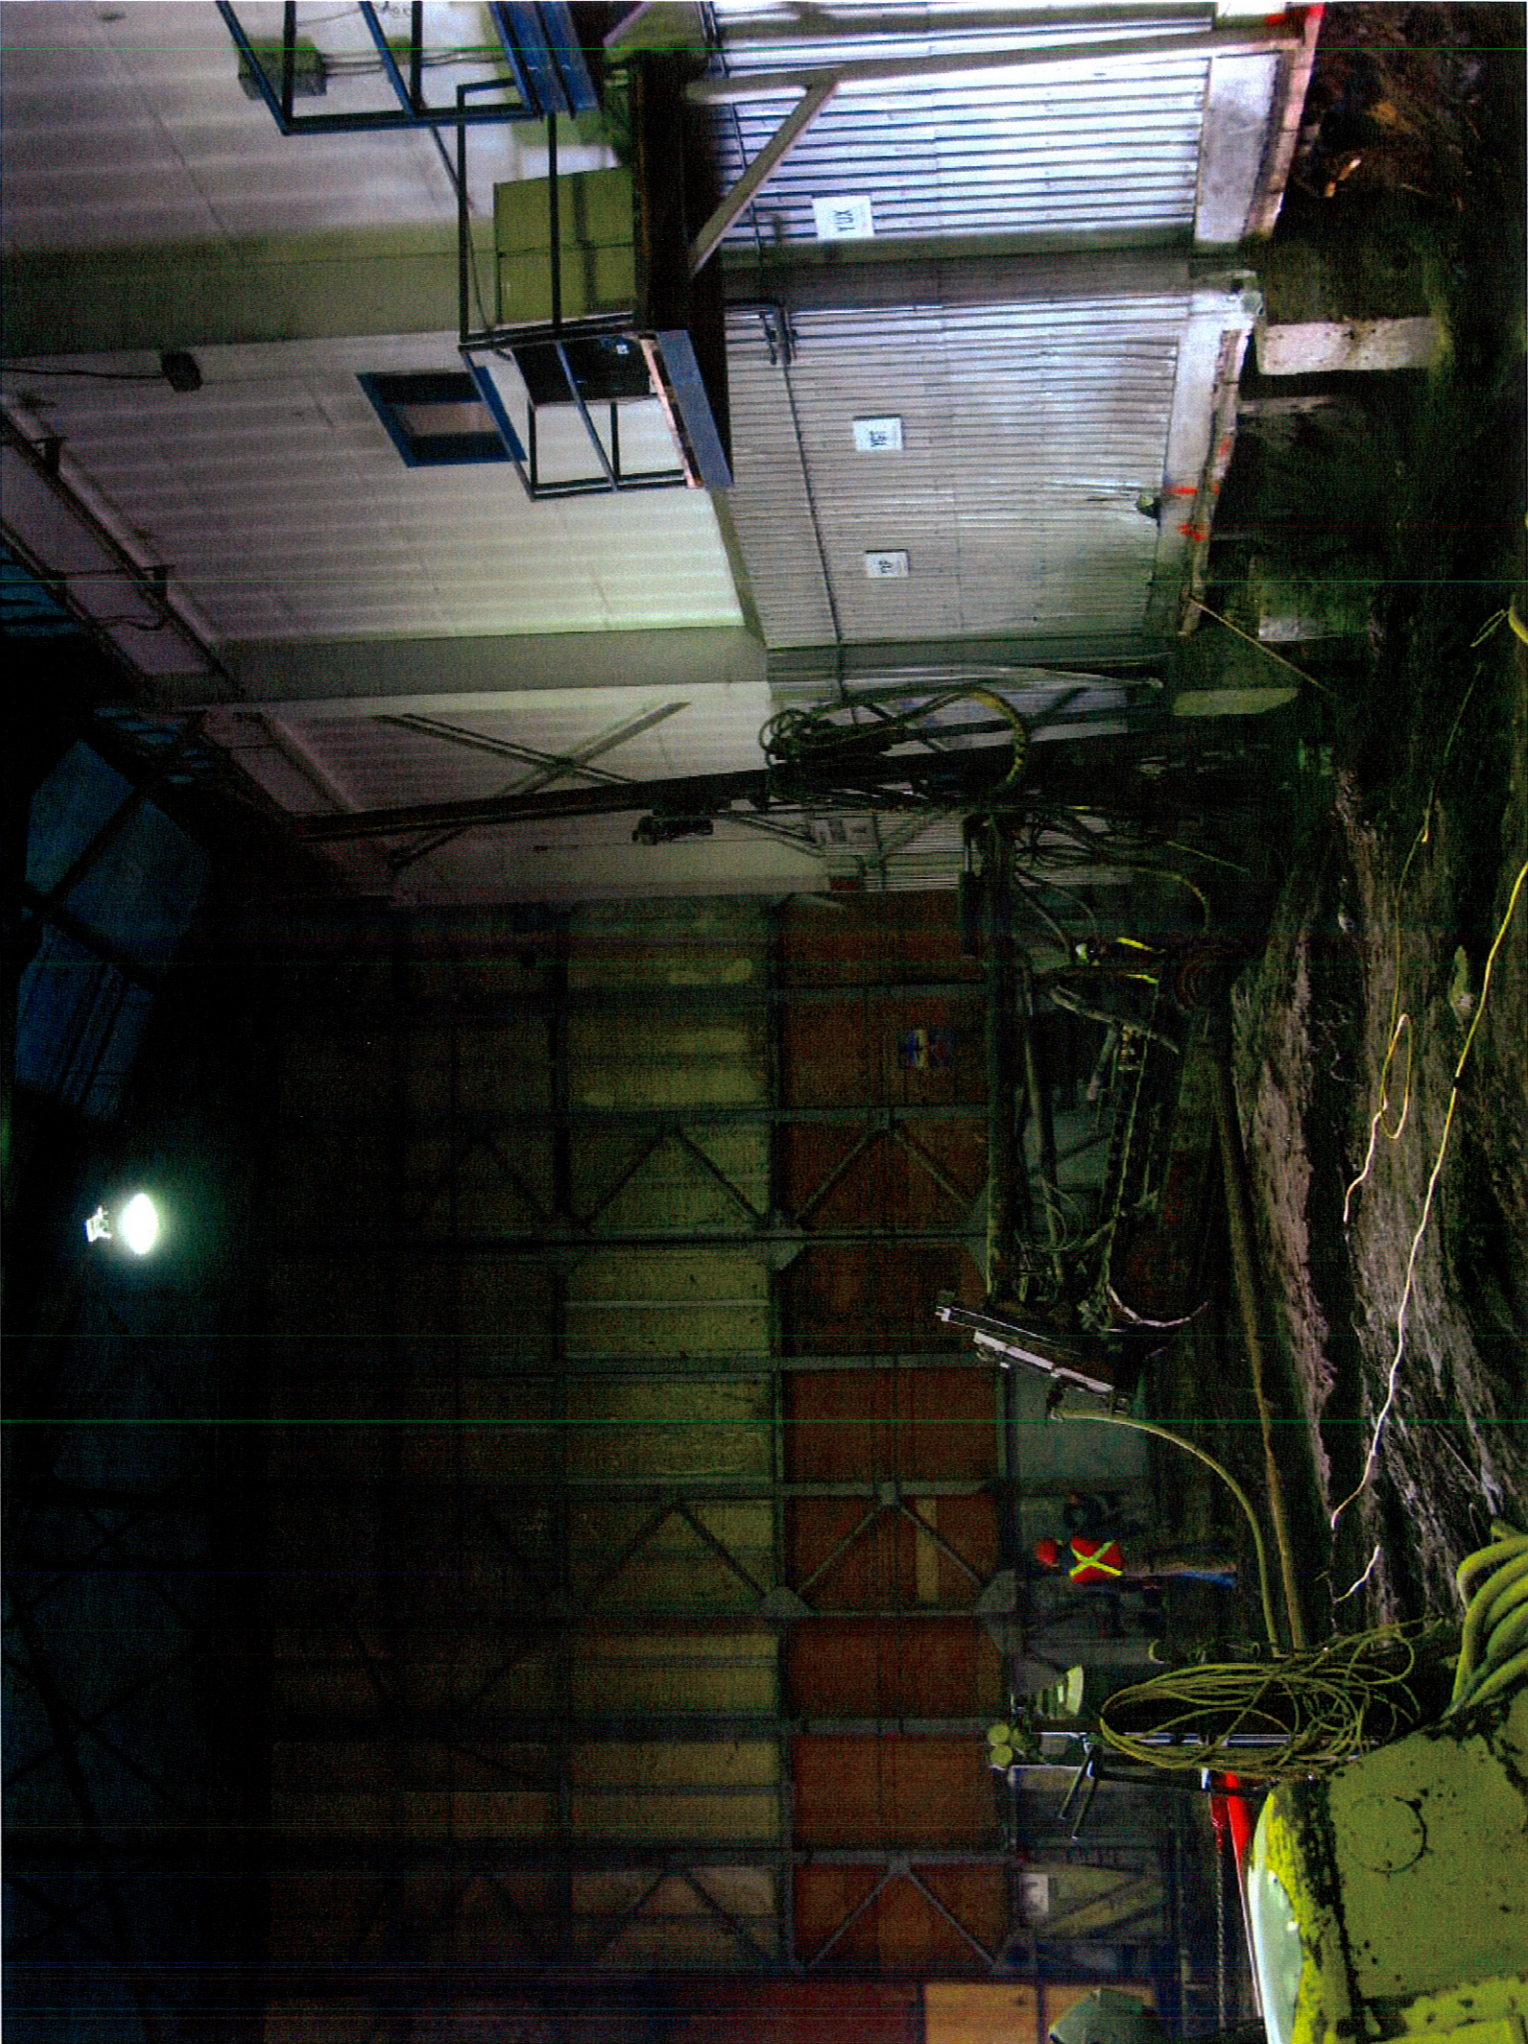
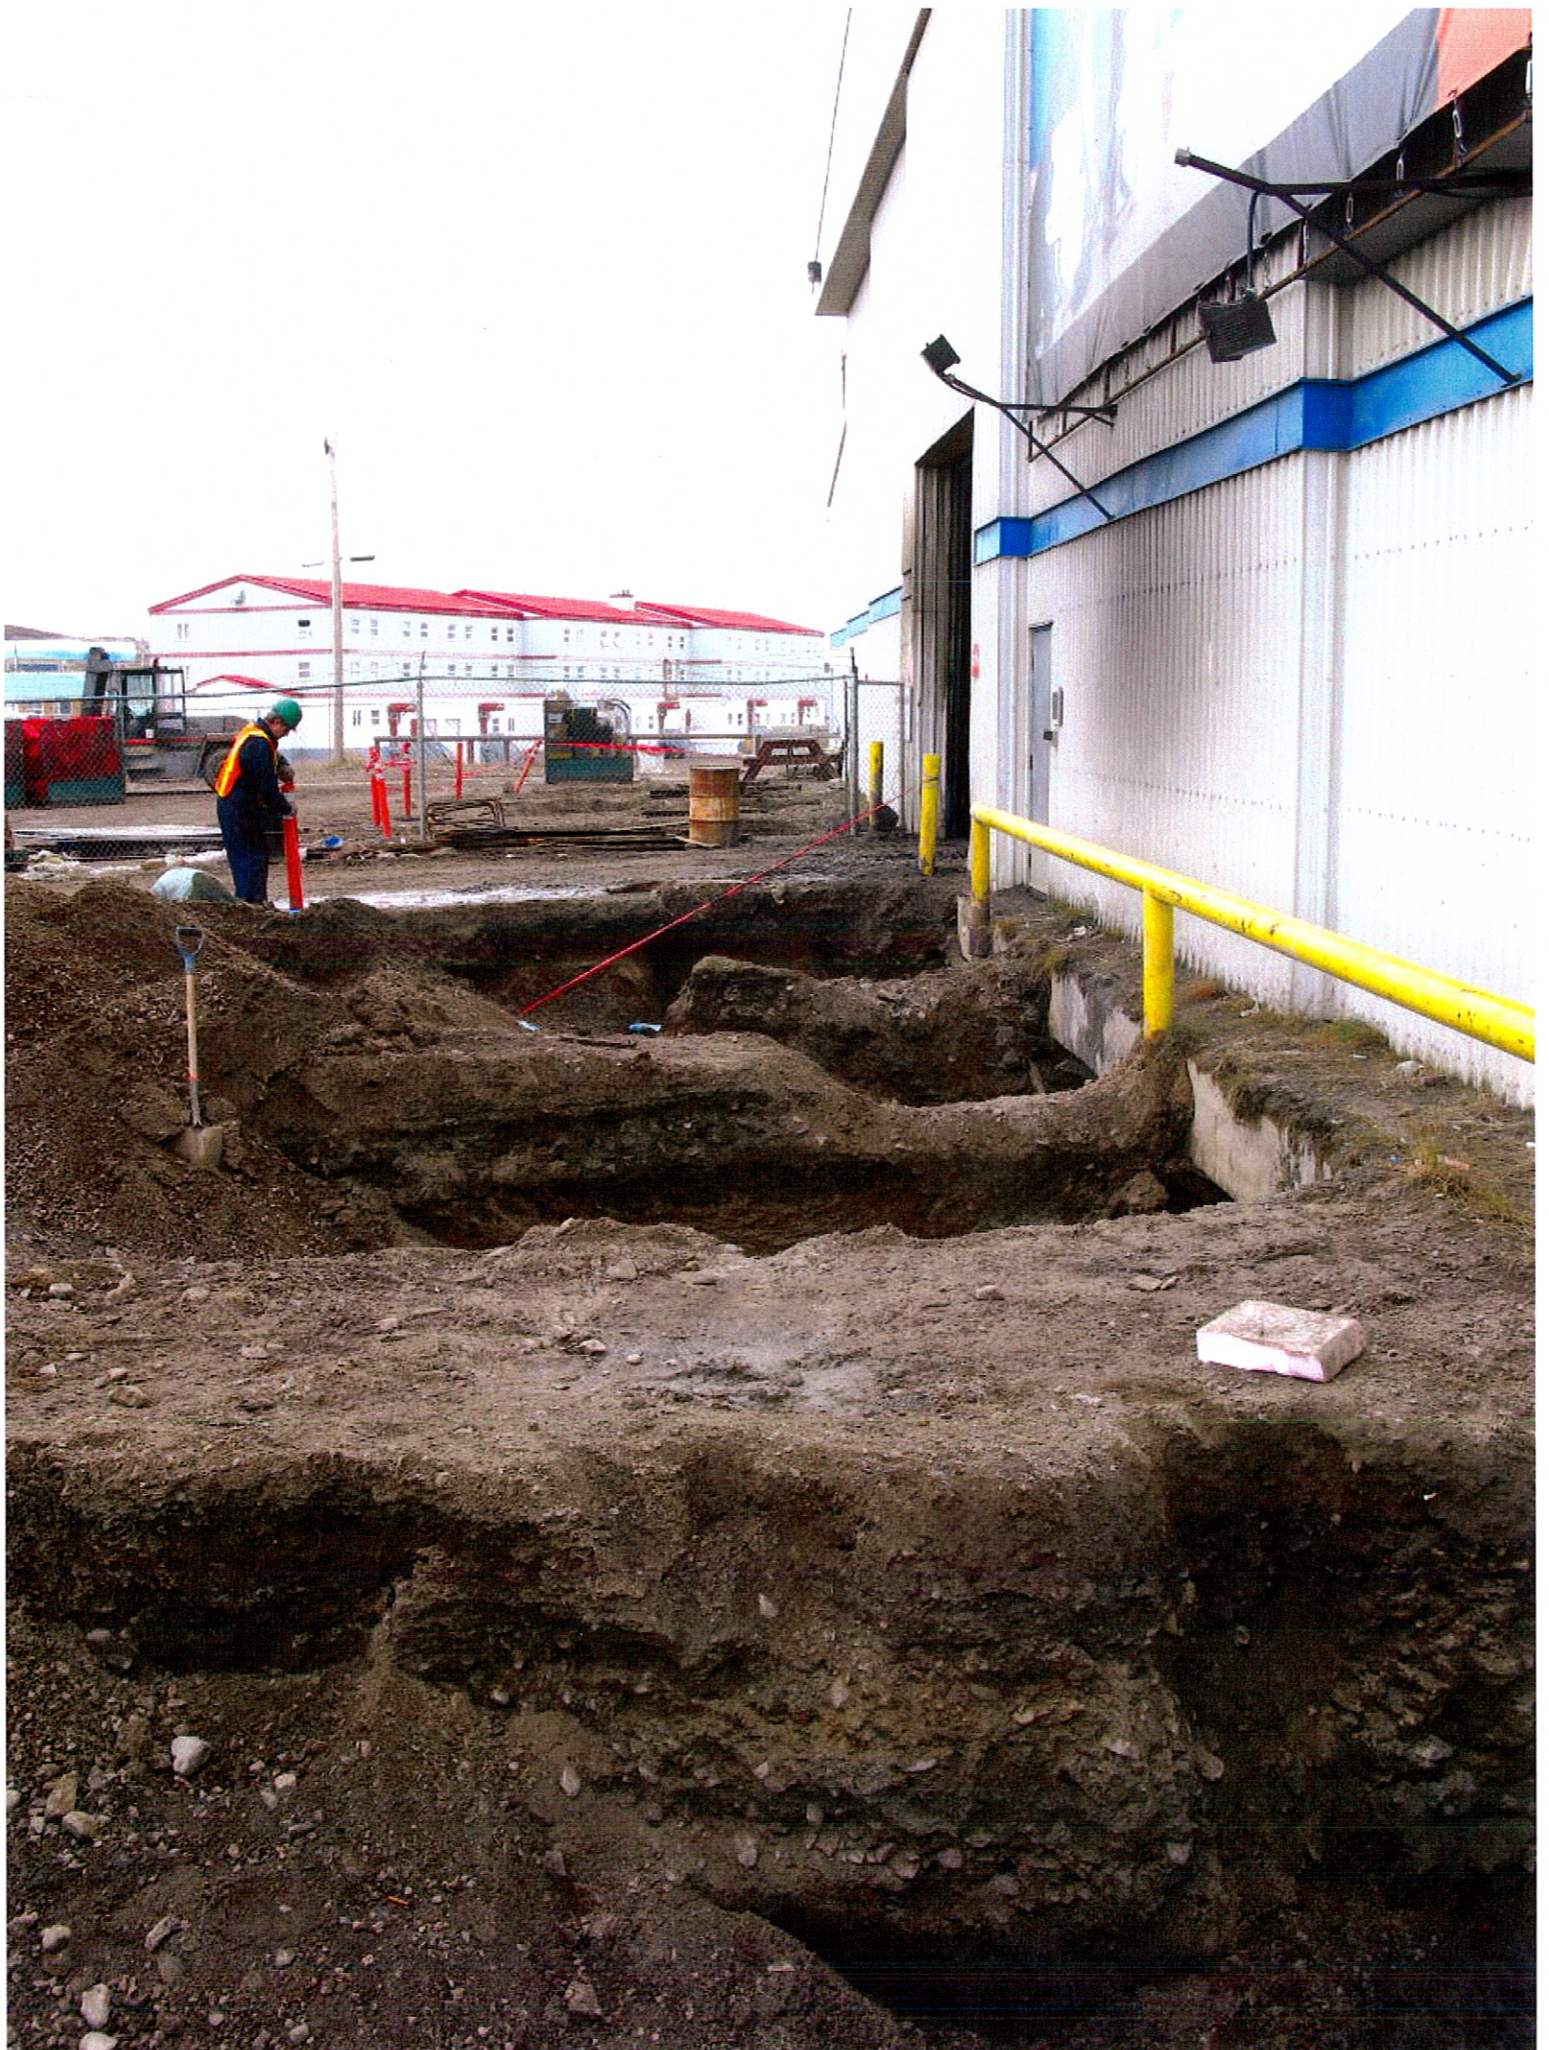
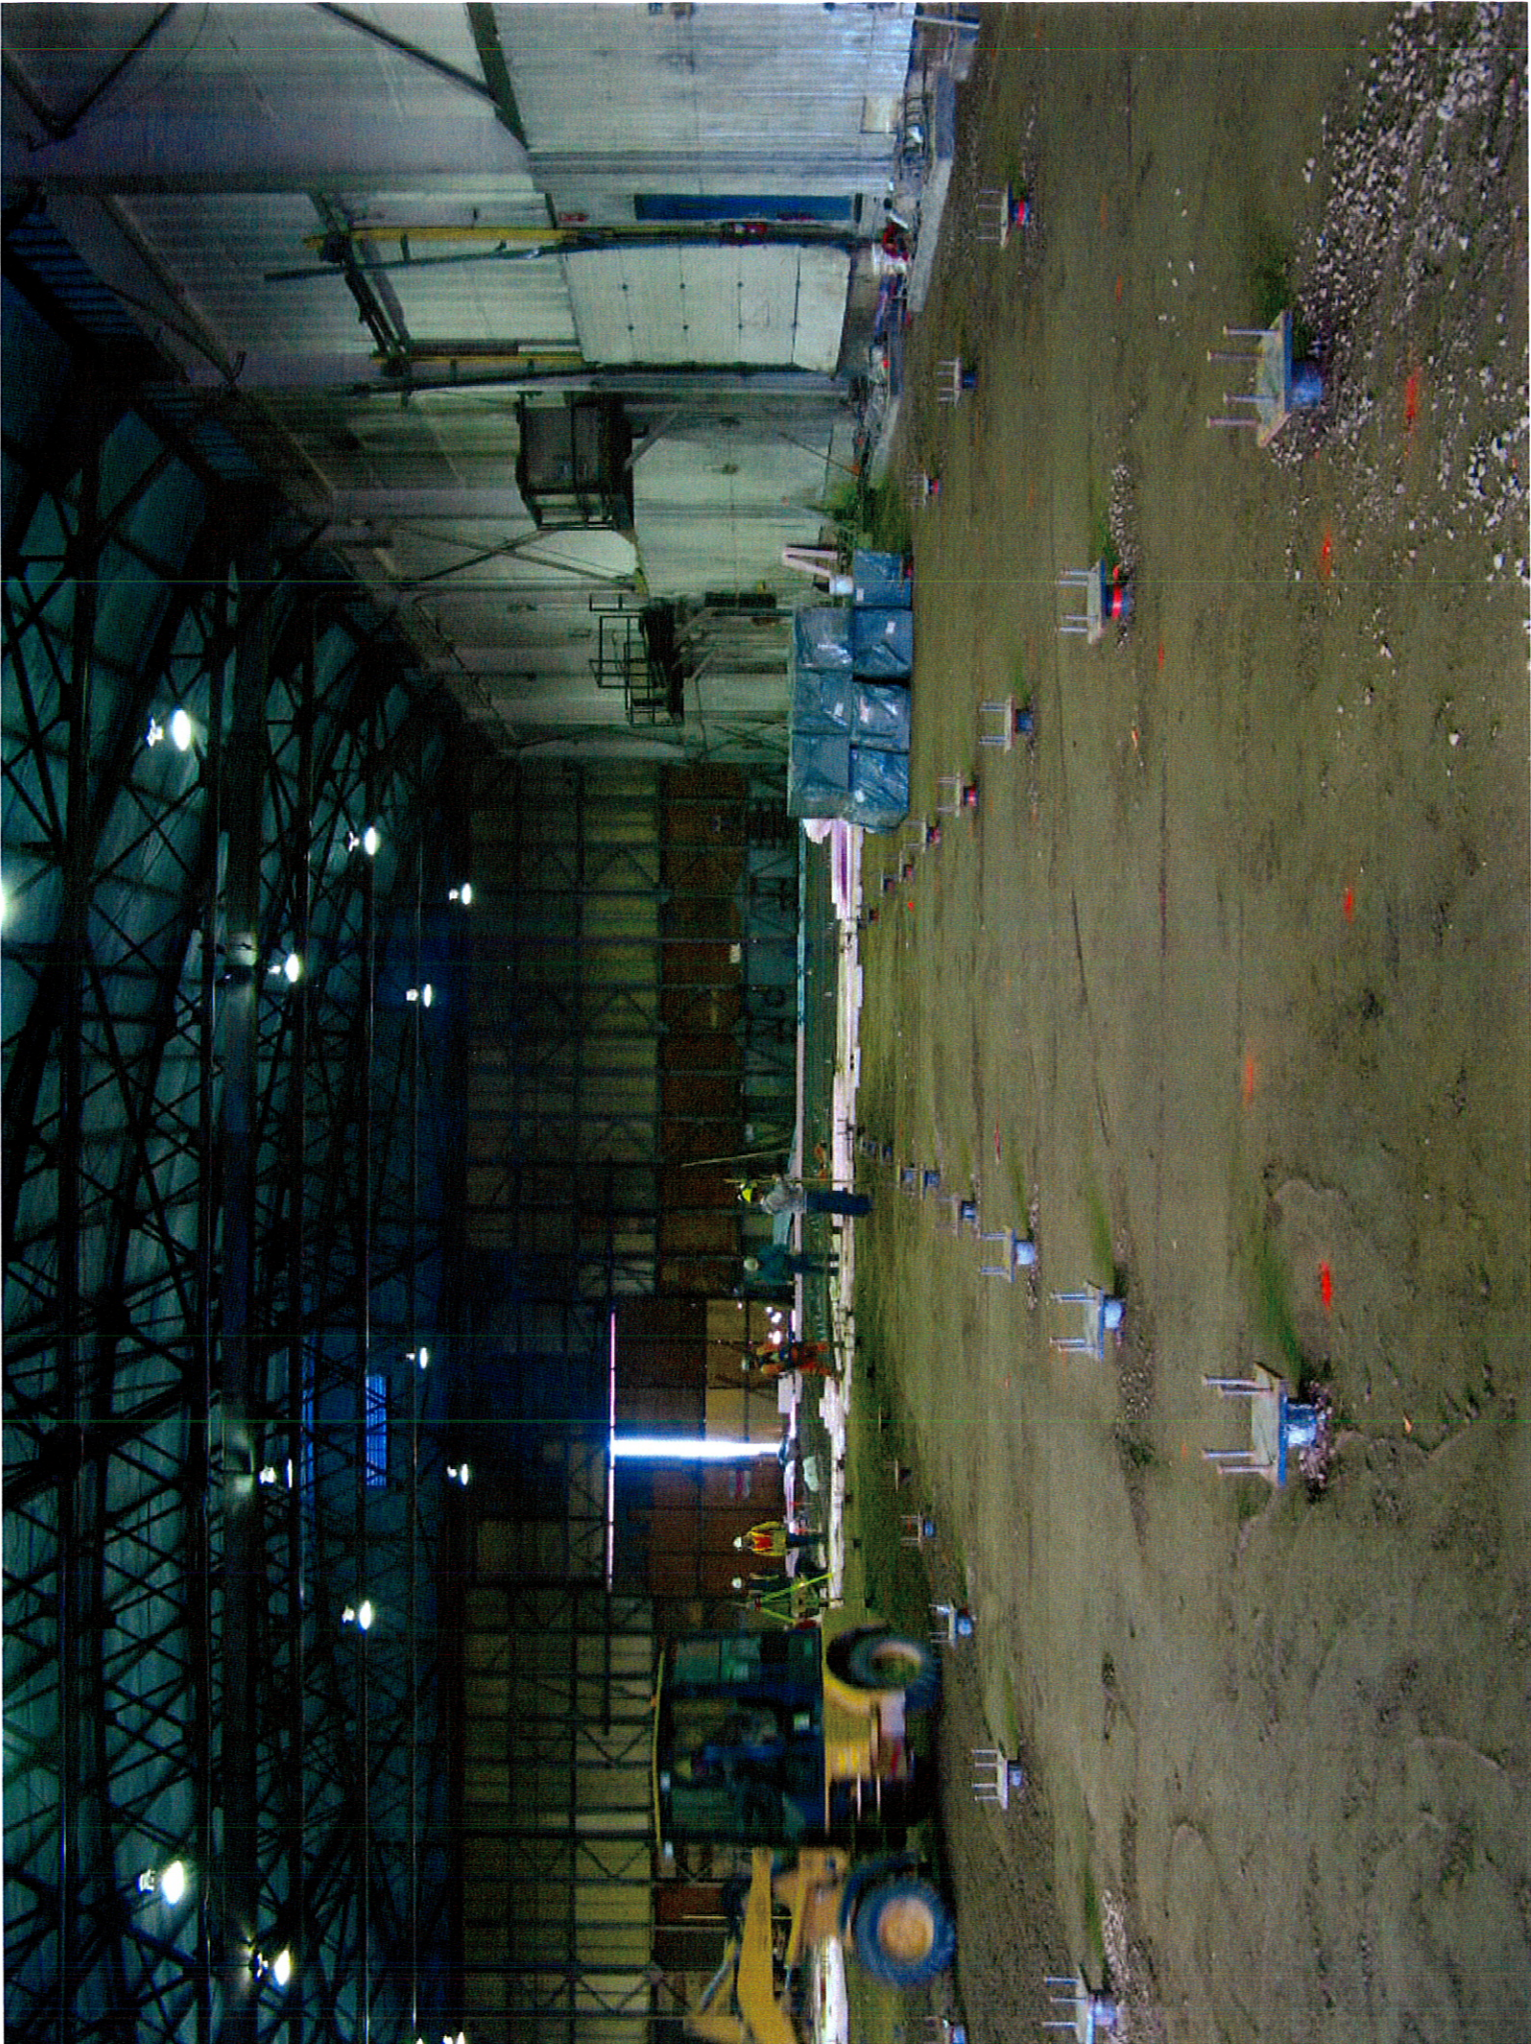
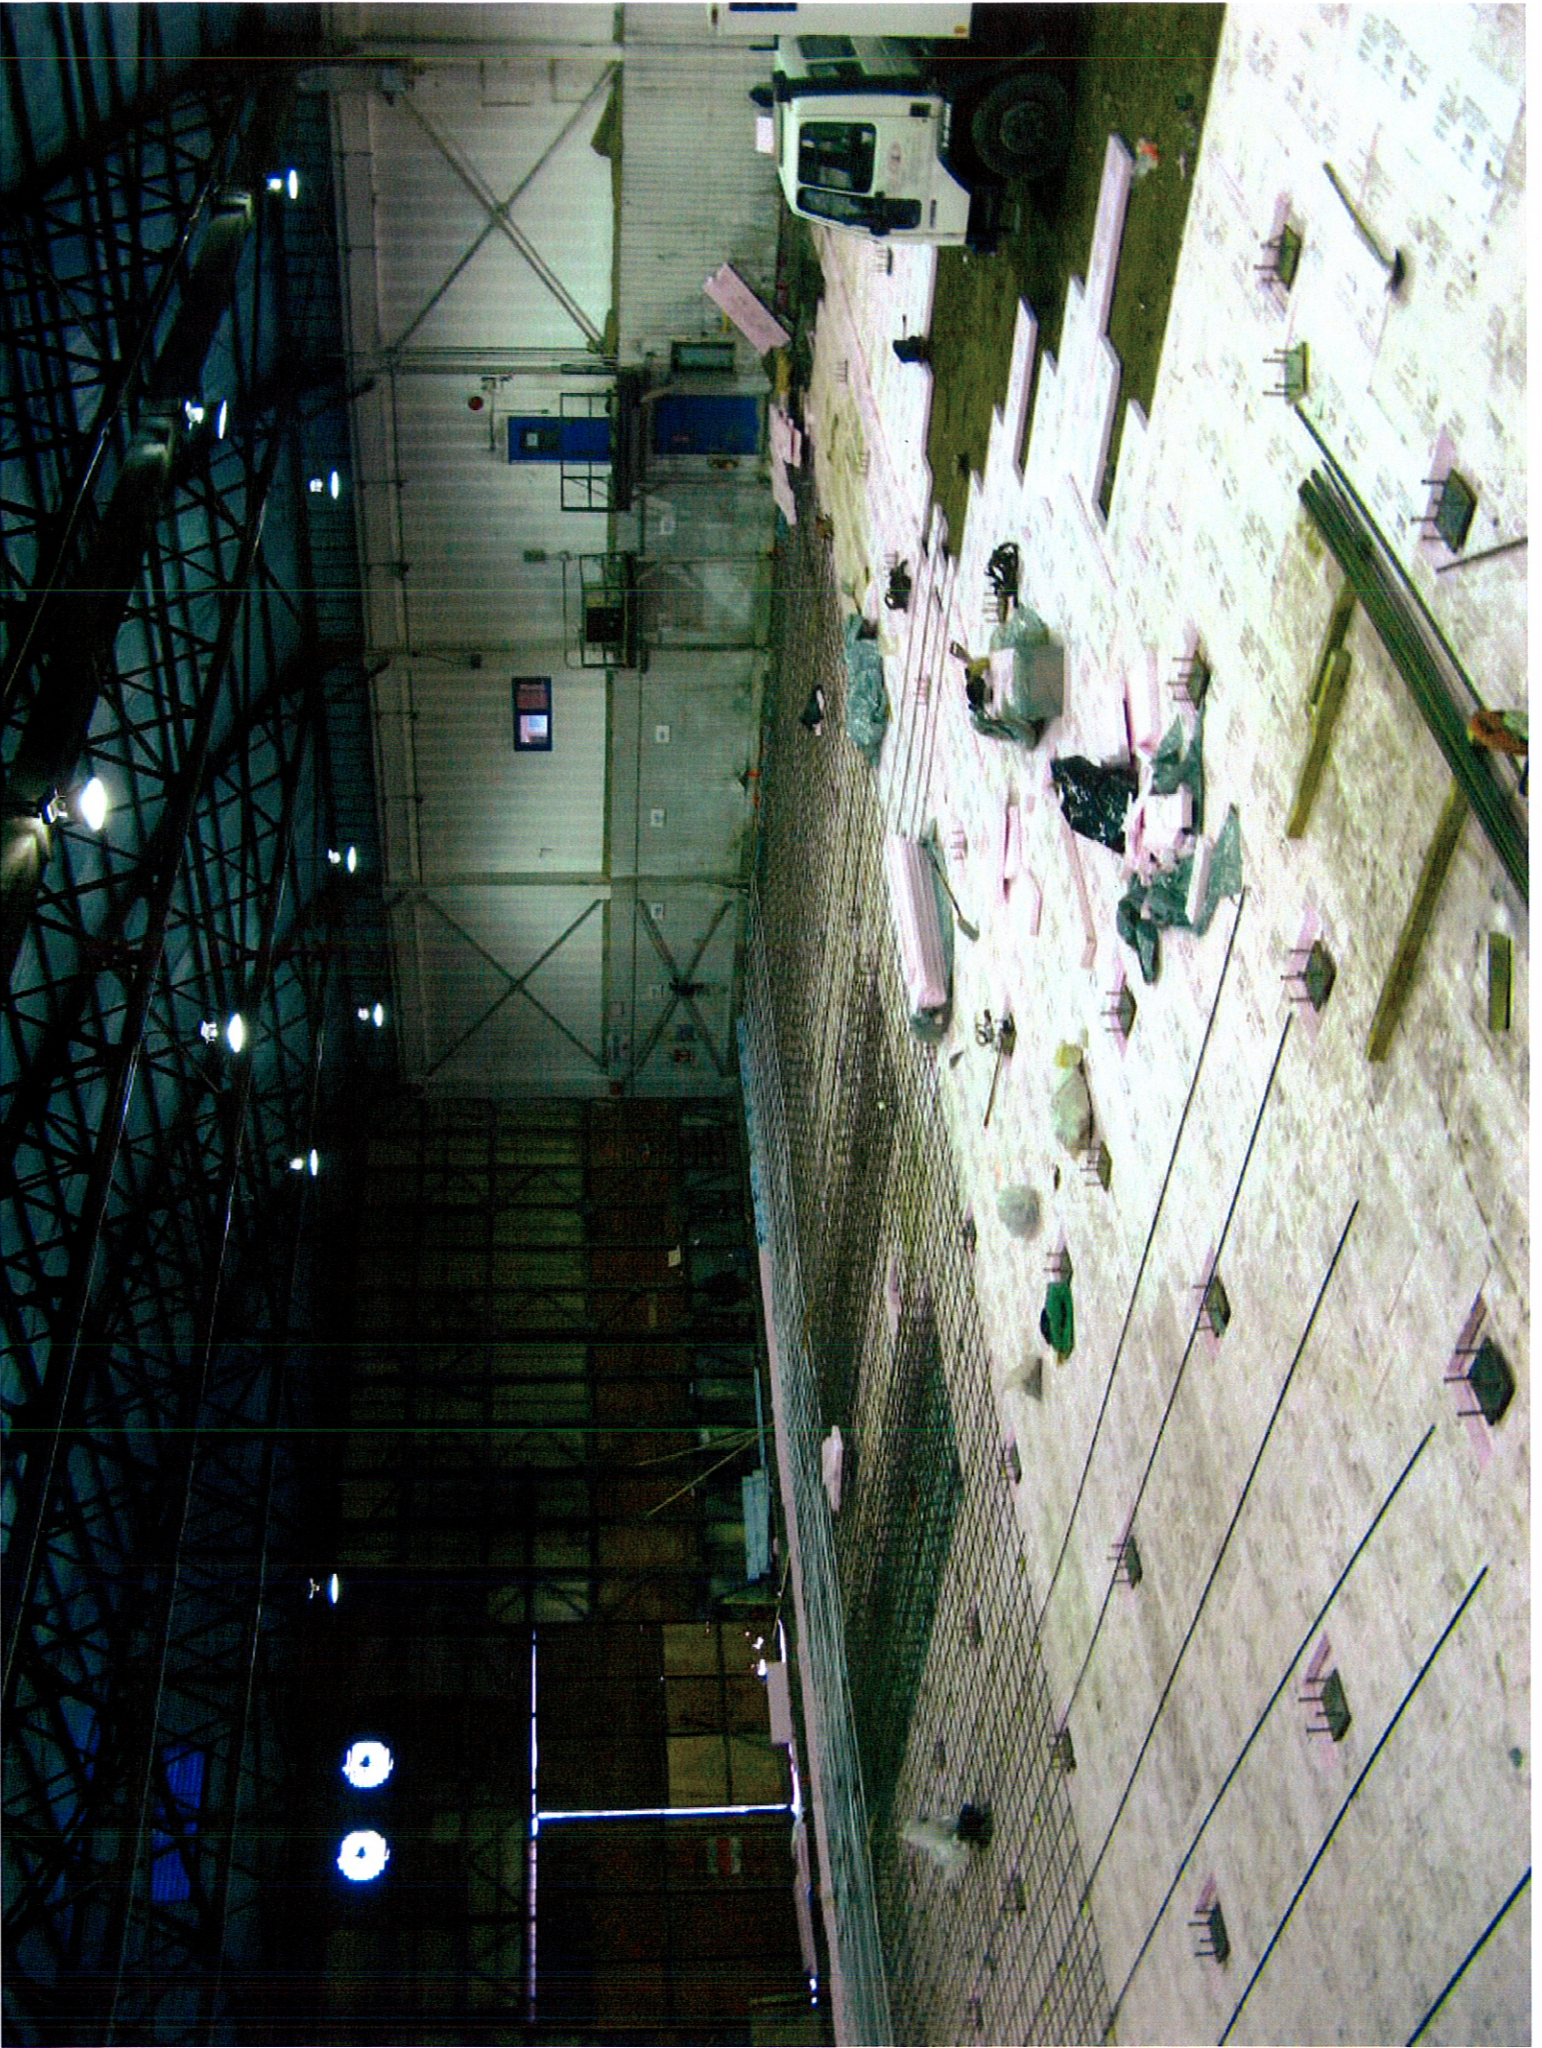
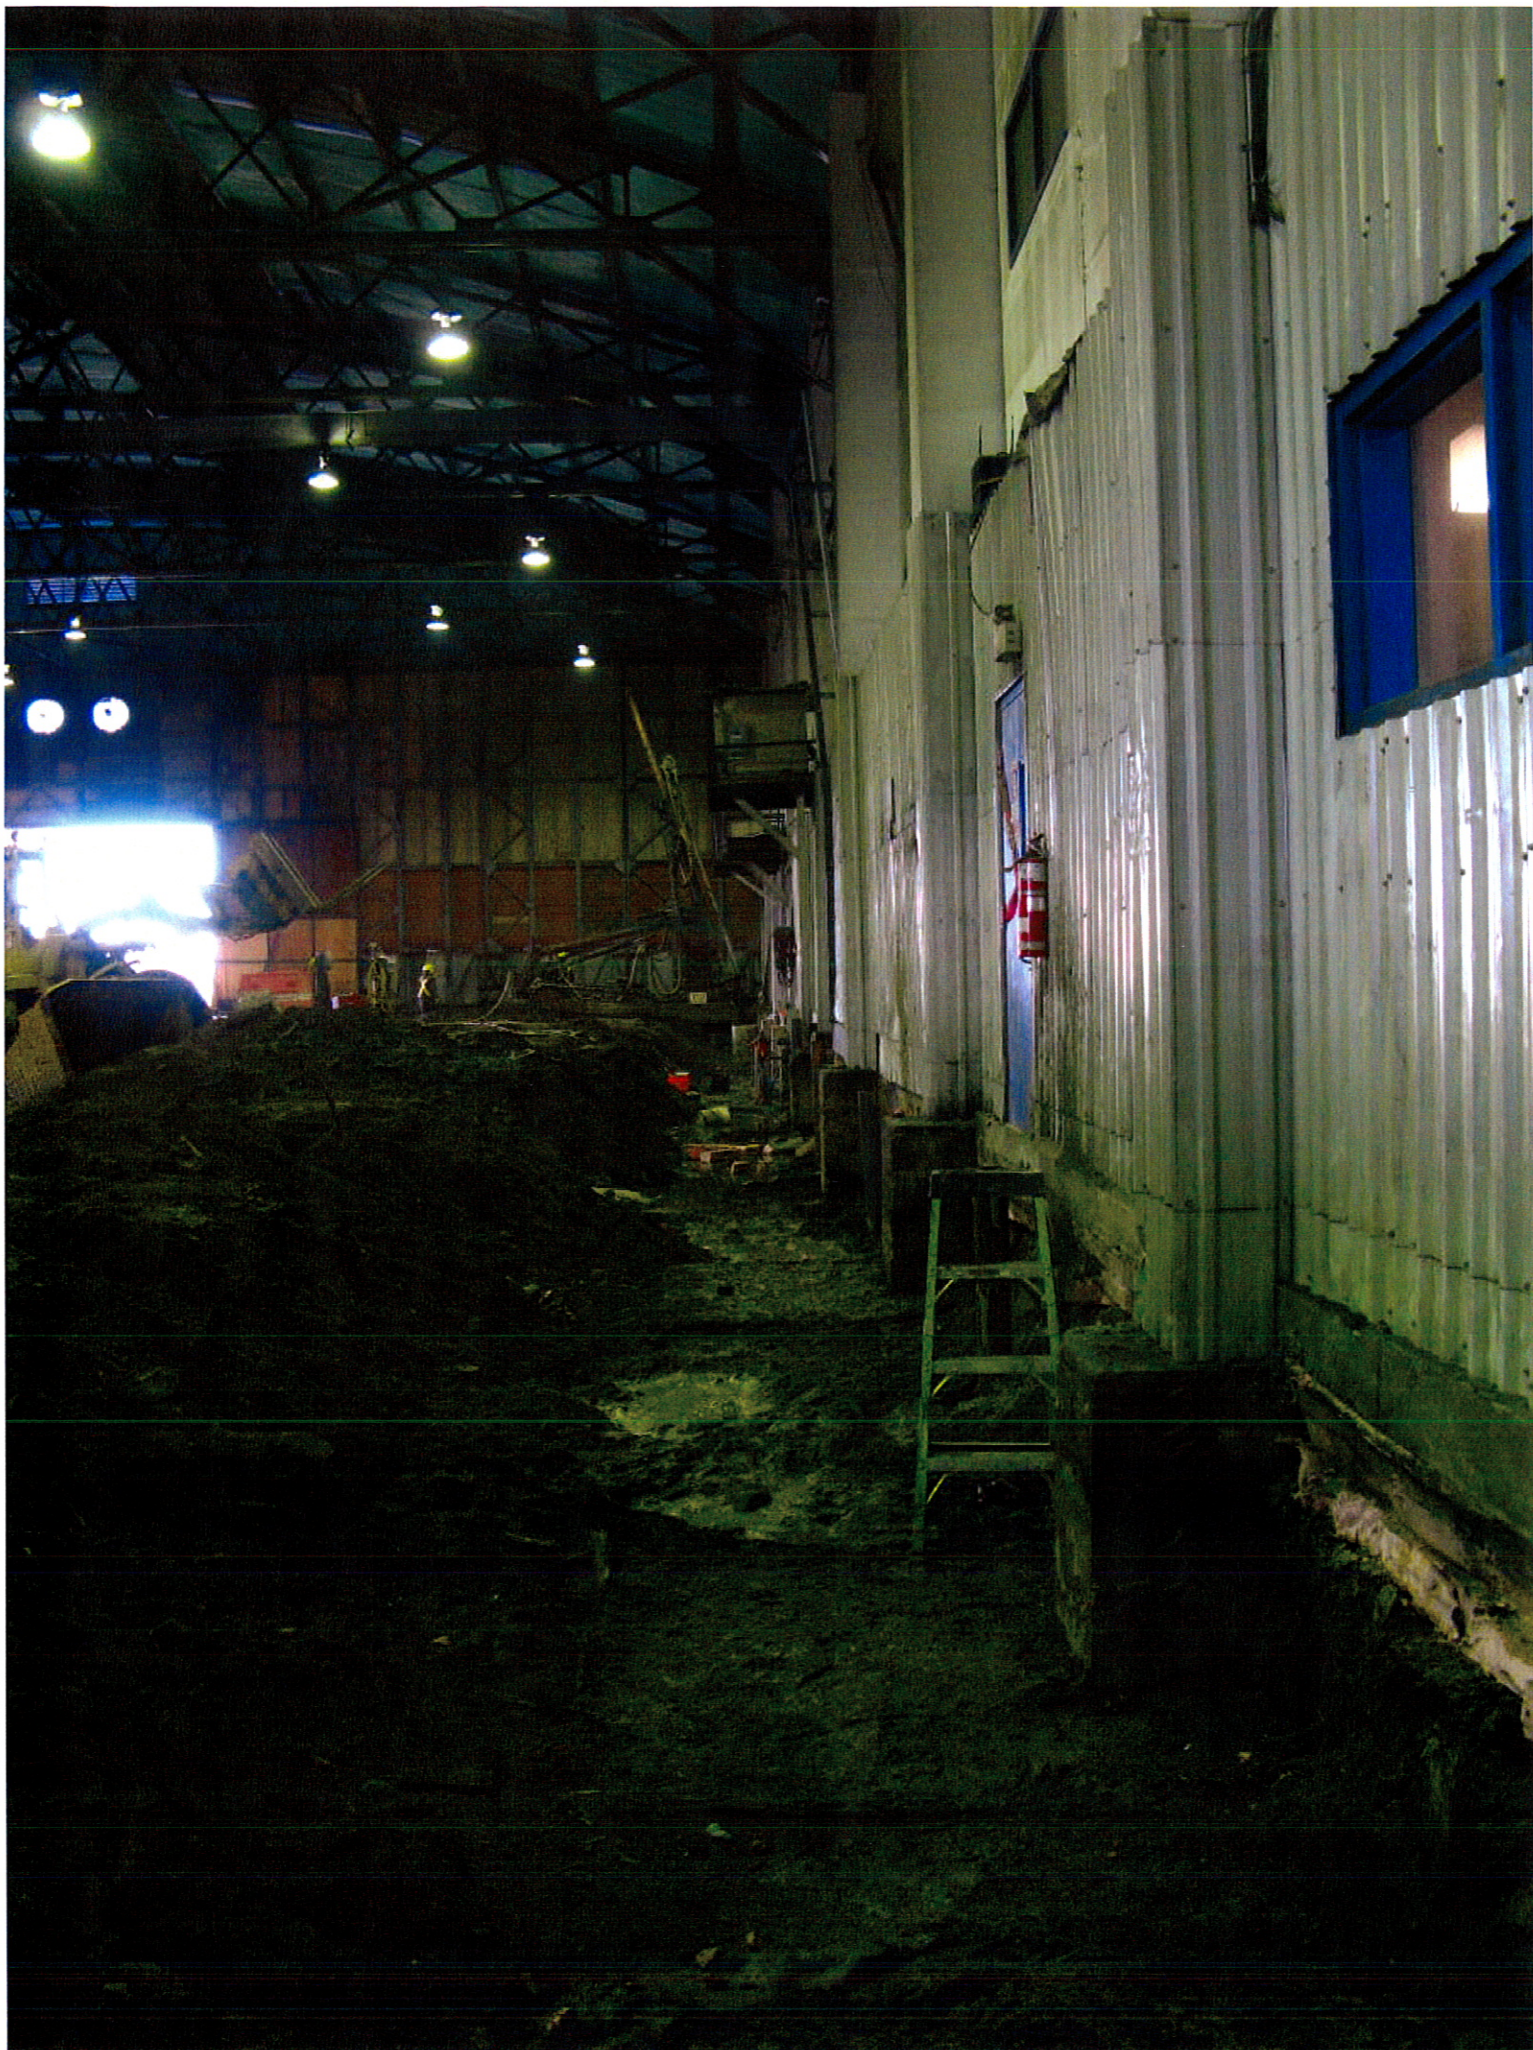
The contractor has noted the smell of hydrocarbons being present during the fertilizing phase in both cells. It is possible that the concentration of petroleum hydrocarbons in the soil may exceed the applicable remediation criteria. The contractor recommends that TC should conduct a sampling program comprehensive enough to determine the concentration of hydrocarbons in these LTUs. Subject to the findings of a sampling program (laboratory analysis) showing hydrocarbon contaminated soil exceeding applicable criteria, TC could develop an Environmental Remediation Action Plan (ERAP). This plan would detail how the remaining soil could be treated allowing the LTUs to be decommissioned or additional contaminated soil to be brought to be remediated.

The contractor conducted a walk around the perimeter and noted no deterioration of the LTU berm liner where it is exposed to the elements. The liner used on the berms is a reinforced polyethylene liner which is meant for short term use. Transport Canada could reduce or eliminate any risk posed to the environment by the LTU, by creating and implementing an aggressive ERAP.

The contractor applied fertilizer at a slightly lighter rate than what is usually done for hydrocarbon impacted soil of the nature present in the LTUs. The contractor recommends that a soil sampling program be conducted to allow for an appropriate fertilizing program to be developed. The fertilizer already spread will allow for the reduction of hydrocarbons, however the appropriate amount of fertilizer would optimize bio-degradation.
