Resolution Island 2009 Monitoring and Research

Analytical Services Unit Queen's University Kingston, Ontario

Indian and Northern Affairs Canada Affaires indiennes et du Nord Canada

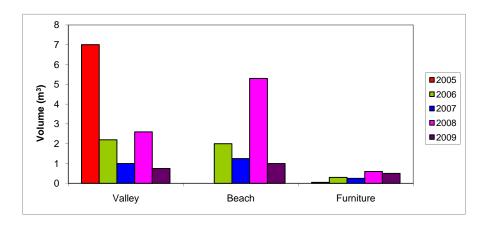
Figure 5 shows the change in volume of sediment collected at the three barriers with time. The surprise in 2008 was the large volume of sediment in the barriers which was expected to fall with time as the loose soil generated during remediation excavations became stabilized. This year all three barrier systems were inspected and sampled but there was no time to dig out the trapped sediment. The volumes of sediment given in Figure 5 for 2009 are therefore estimates based on observation and sediment depth. The volumes for the two barriers in the S1/S4 drainage system were much lower this year and slightly lower than 2007 levels. Revegetation of some areas at the site were noted which should lead to lower sediment levels in the future, though major rain storms may lead to exceptions. The furniture dump barrier contained less sediment than was collected in 2008. The maintenance of the barriers this year involved only replacement of the

Figure 5: Change in Volume of Sediment Collected at the Three Barriers With Time

geotextiles filters in the filter boxes. The gravel and GAC filters were not sampled or recharged with new material due to lack of time at the site.

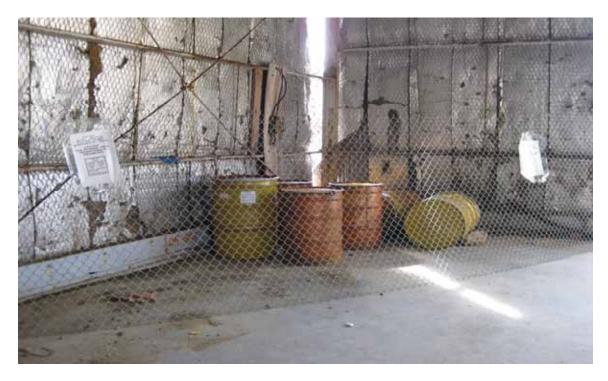
Four drums containing sediment and barrier material above the CEPA (50 ppm PCB) level were placed inside building B2. The south west corner of the building, the side furthest from the beach, where the roof is intact, was chosen as the location for this PCB storage facility. It was divided off from the rest of the area with a chainlink fence and appropriate signs posted (Photograph 18). PCB labels were affixed to each drum in accordance with the September 2008 PCB Regulations signage requirements.

Photograph 18: The PCB Storage Facility Nearing its Completion Within Building B2: Only the Four Drums Containing CEPA Soil Were Left in the Building on its Completion

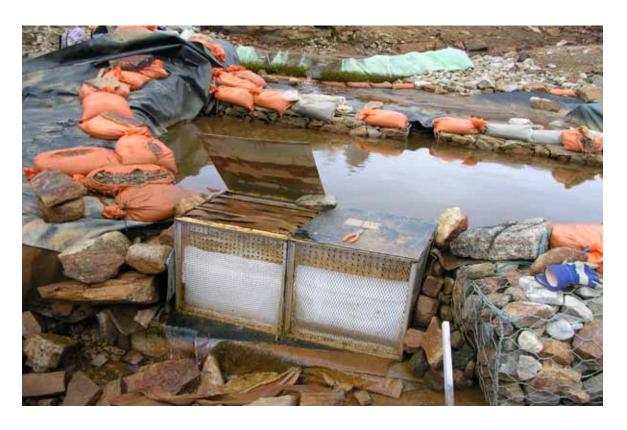
Upon preliminary inspection of the valley barrier in August it was noted that the sediment loading was very much less than in 2008. There was virtually no sediment in the trap between the curlex trap and the gabions in the center of the barrier (Photograph 20). It was estimated that 3 overpack drums of sediment was present between the gabions and the filter box. When the site was visited on 14 July water was observed to be flowing over the barrier (Photograph 21). It had been assumed that this might happen during spring runoff but this was the first time it had been recorded. This might appear, at first sight, to be a major design flaw. However, when this event occurs the ground is considered to be frozen and little sediment is thought to be mobilized at this time. In any event a much larger barrier is impractical. In August during the site visit (Photograph 20) water was flowing nicely through the barrier gate. The uncontaminated sediment in the first clean cell had been mostly washed away but the second cell was in good condition. No repairs were necessary at the barrier. Sediment and water samples were taken from the various monitoring points around the barrier. The 1200R units were sampled and

Photograph 20: The S1/S4 Valley Barrier in August Operating Normally

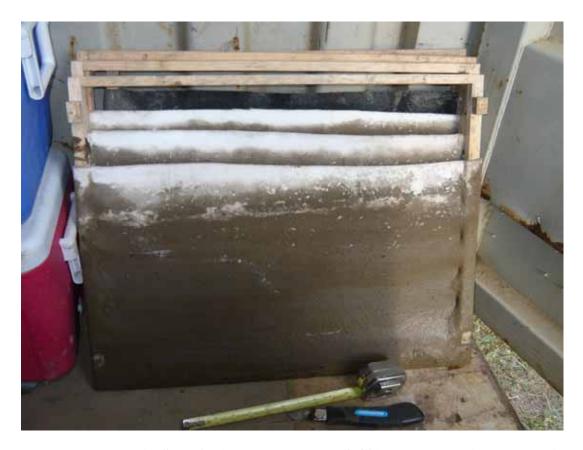
Samples were collected from each filter for PCB analysis. Photograph 22 shows one of the 3 filter box sets from the S1/S4 beach barrier just prior to sampling. For each filter a rectangle of the geotextile material was cut from the filter and dimensions taken and recorded as shown in the Figure 8 for the S1/S4 valley barrier. The mass of PCB in the sample was determined by GC/ECD and from the dimensions recorded the mass of PCBs in the filter calculated. The set of filter samples are shown for the furniture dump on the front cover.

Photograph 22: A Set of Filters From the S1/S4 Beach Barrier Just Prior to Sampling $\,$

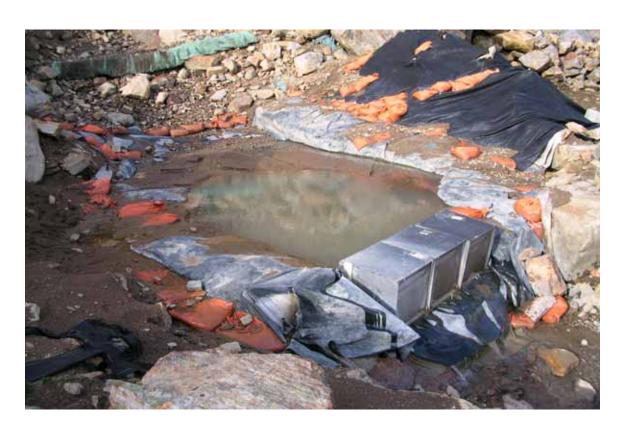
Photograph 23 is a closeup aerial view of the barrier at the start of the monitoring field trip showing the distribution of containers of contaminated sediment from previous years. Photographs 24 and 25 shows the barrier functioning well with water flowing from the filter box. Most of the sediment present in the barrier is from the previous year when only sediment was partially removed from the area between the central gabion and the filter box. Very little sediment appeared to have been added to both the areas above and below the gabion. The sediment level above the central gabions was at the level of the top of the gabion. Between the central gabions and the filter box the hole from which sediment had been taken in 2008 was still clearly visible. The filled containers were removed to B2 on 22 August and the barrier monitoring points and geotextile filters sampled on 25 August 2009. The geotextile filters were then recharged with four 1200R

Photograph 24: The S1/S4 Beach Barrier in 2009

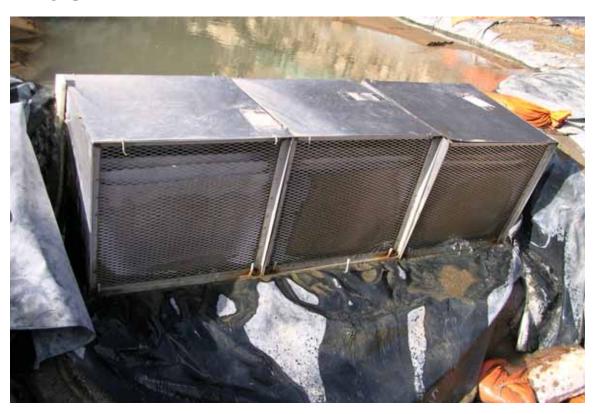
Photograph 25: Water Was Flowing Freely From the Base of the Filter Box
