NWB Annual Report

Project Name: CAM-F Sarcpa Lake Long-Term Monitoring

APPENDIX 2: LONG-TERM MONITORING 2008 CAM-F DEW LINE SITE, NU

Executive Summary

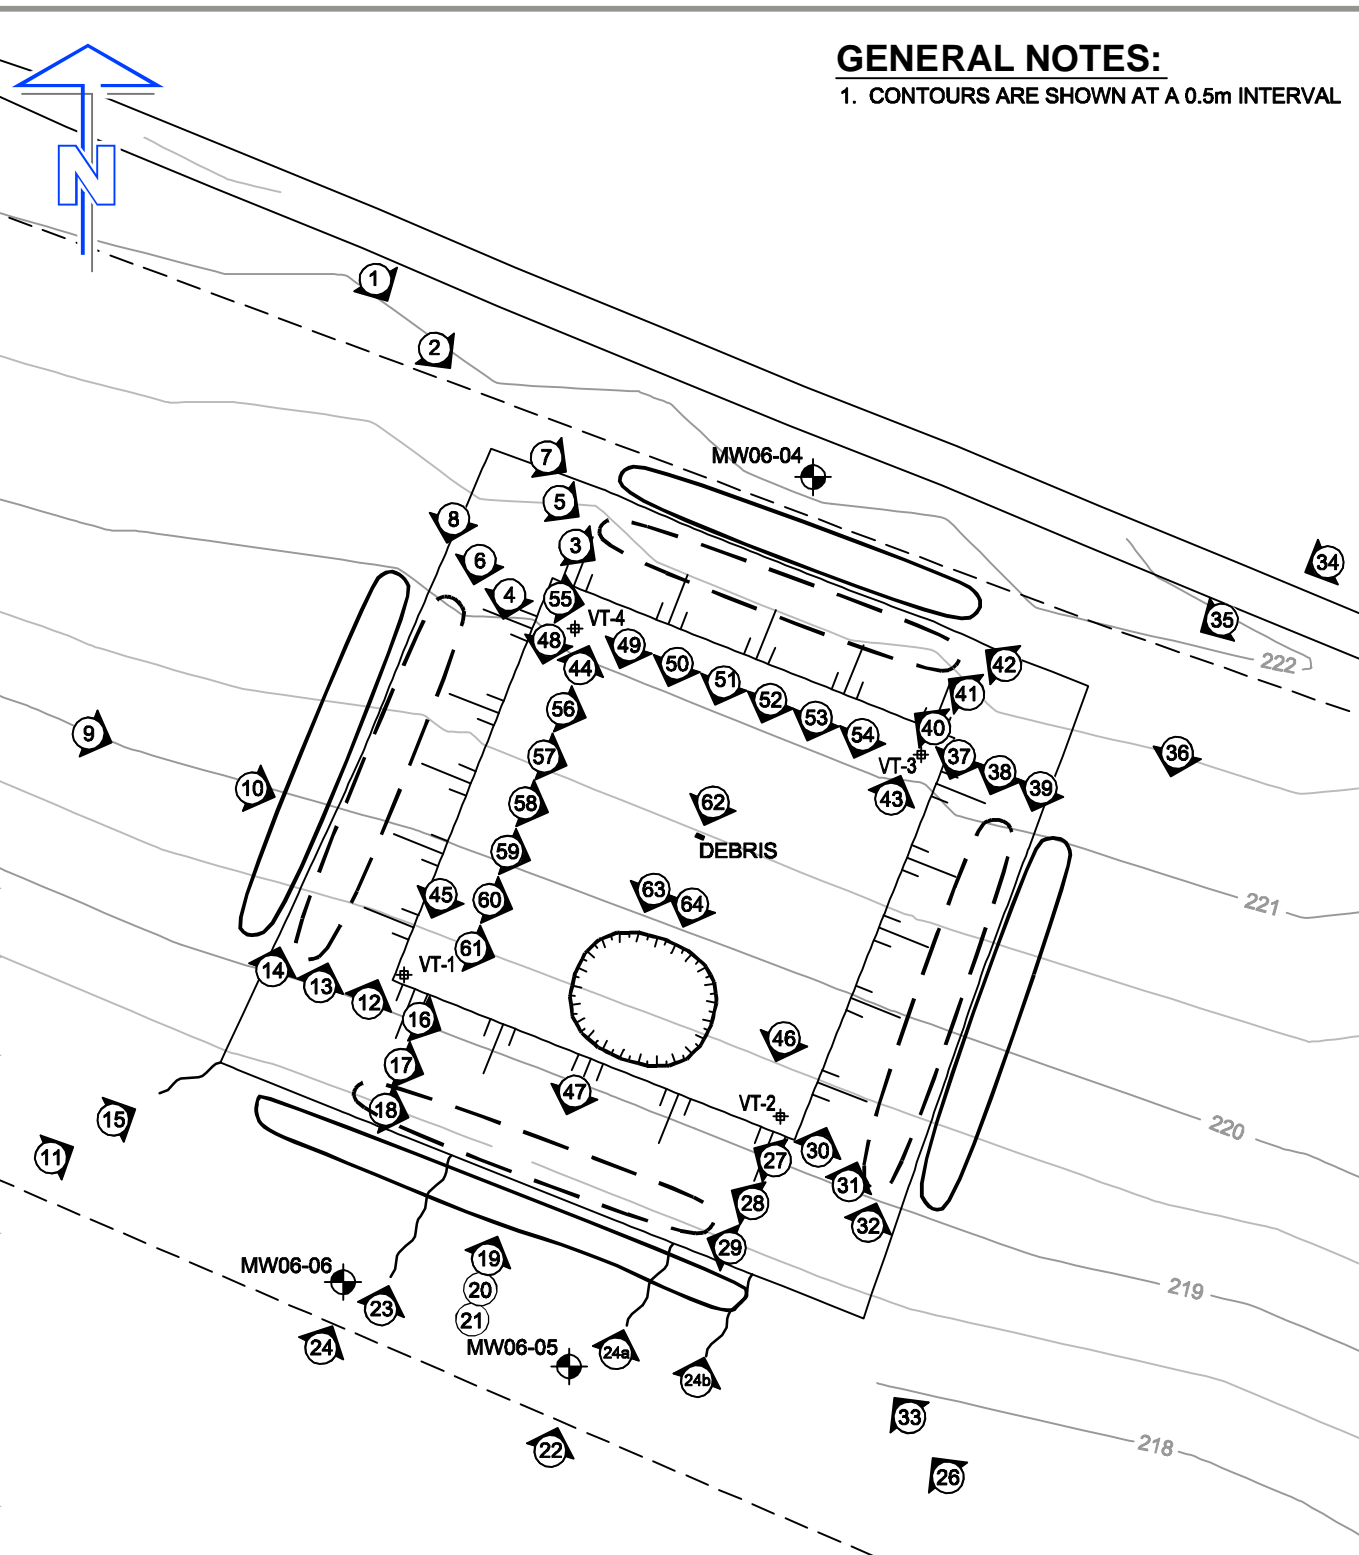
Minor deviations in physical performance of the landfill were observed during inspection including minor settlement on the landfill surface, minor surface erosion and ponding near toe of the side slopes. Based on our observations during the site inspection, the noted features are of little consequence. The landfill is acceptable and is performing as designed.
