## **Long Term Monitoring, 2014 CAM-F, Sarcpa Lake, Nunavut**

### **FINAL REPORT**

Prepared for:

Aboriginal Affairs and Northern Development Canada  
Nunavut Regional Office  
P.O. Box 2200  
Iqaluit, Nunavut  
X0A 0H0

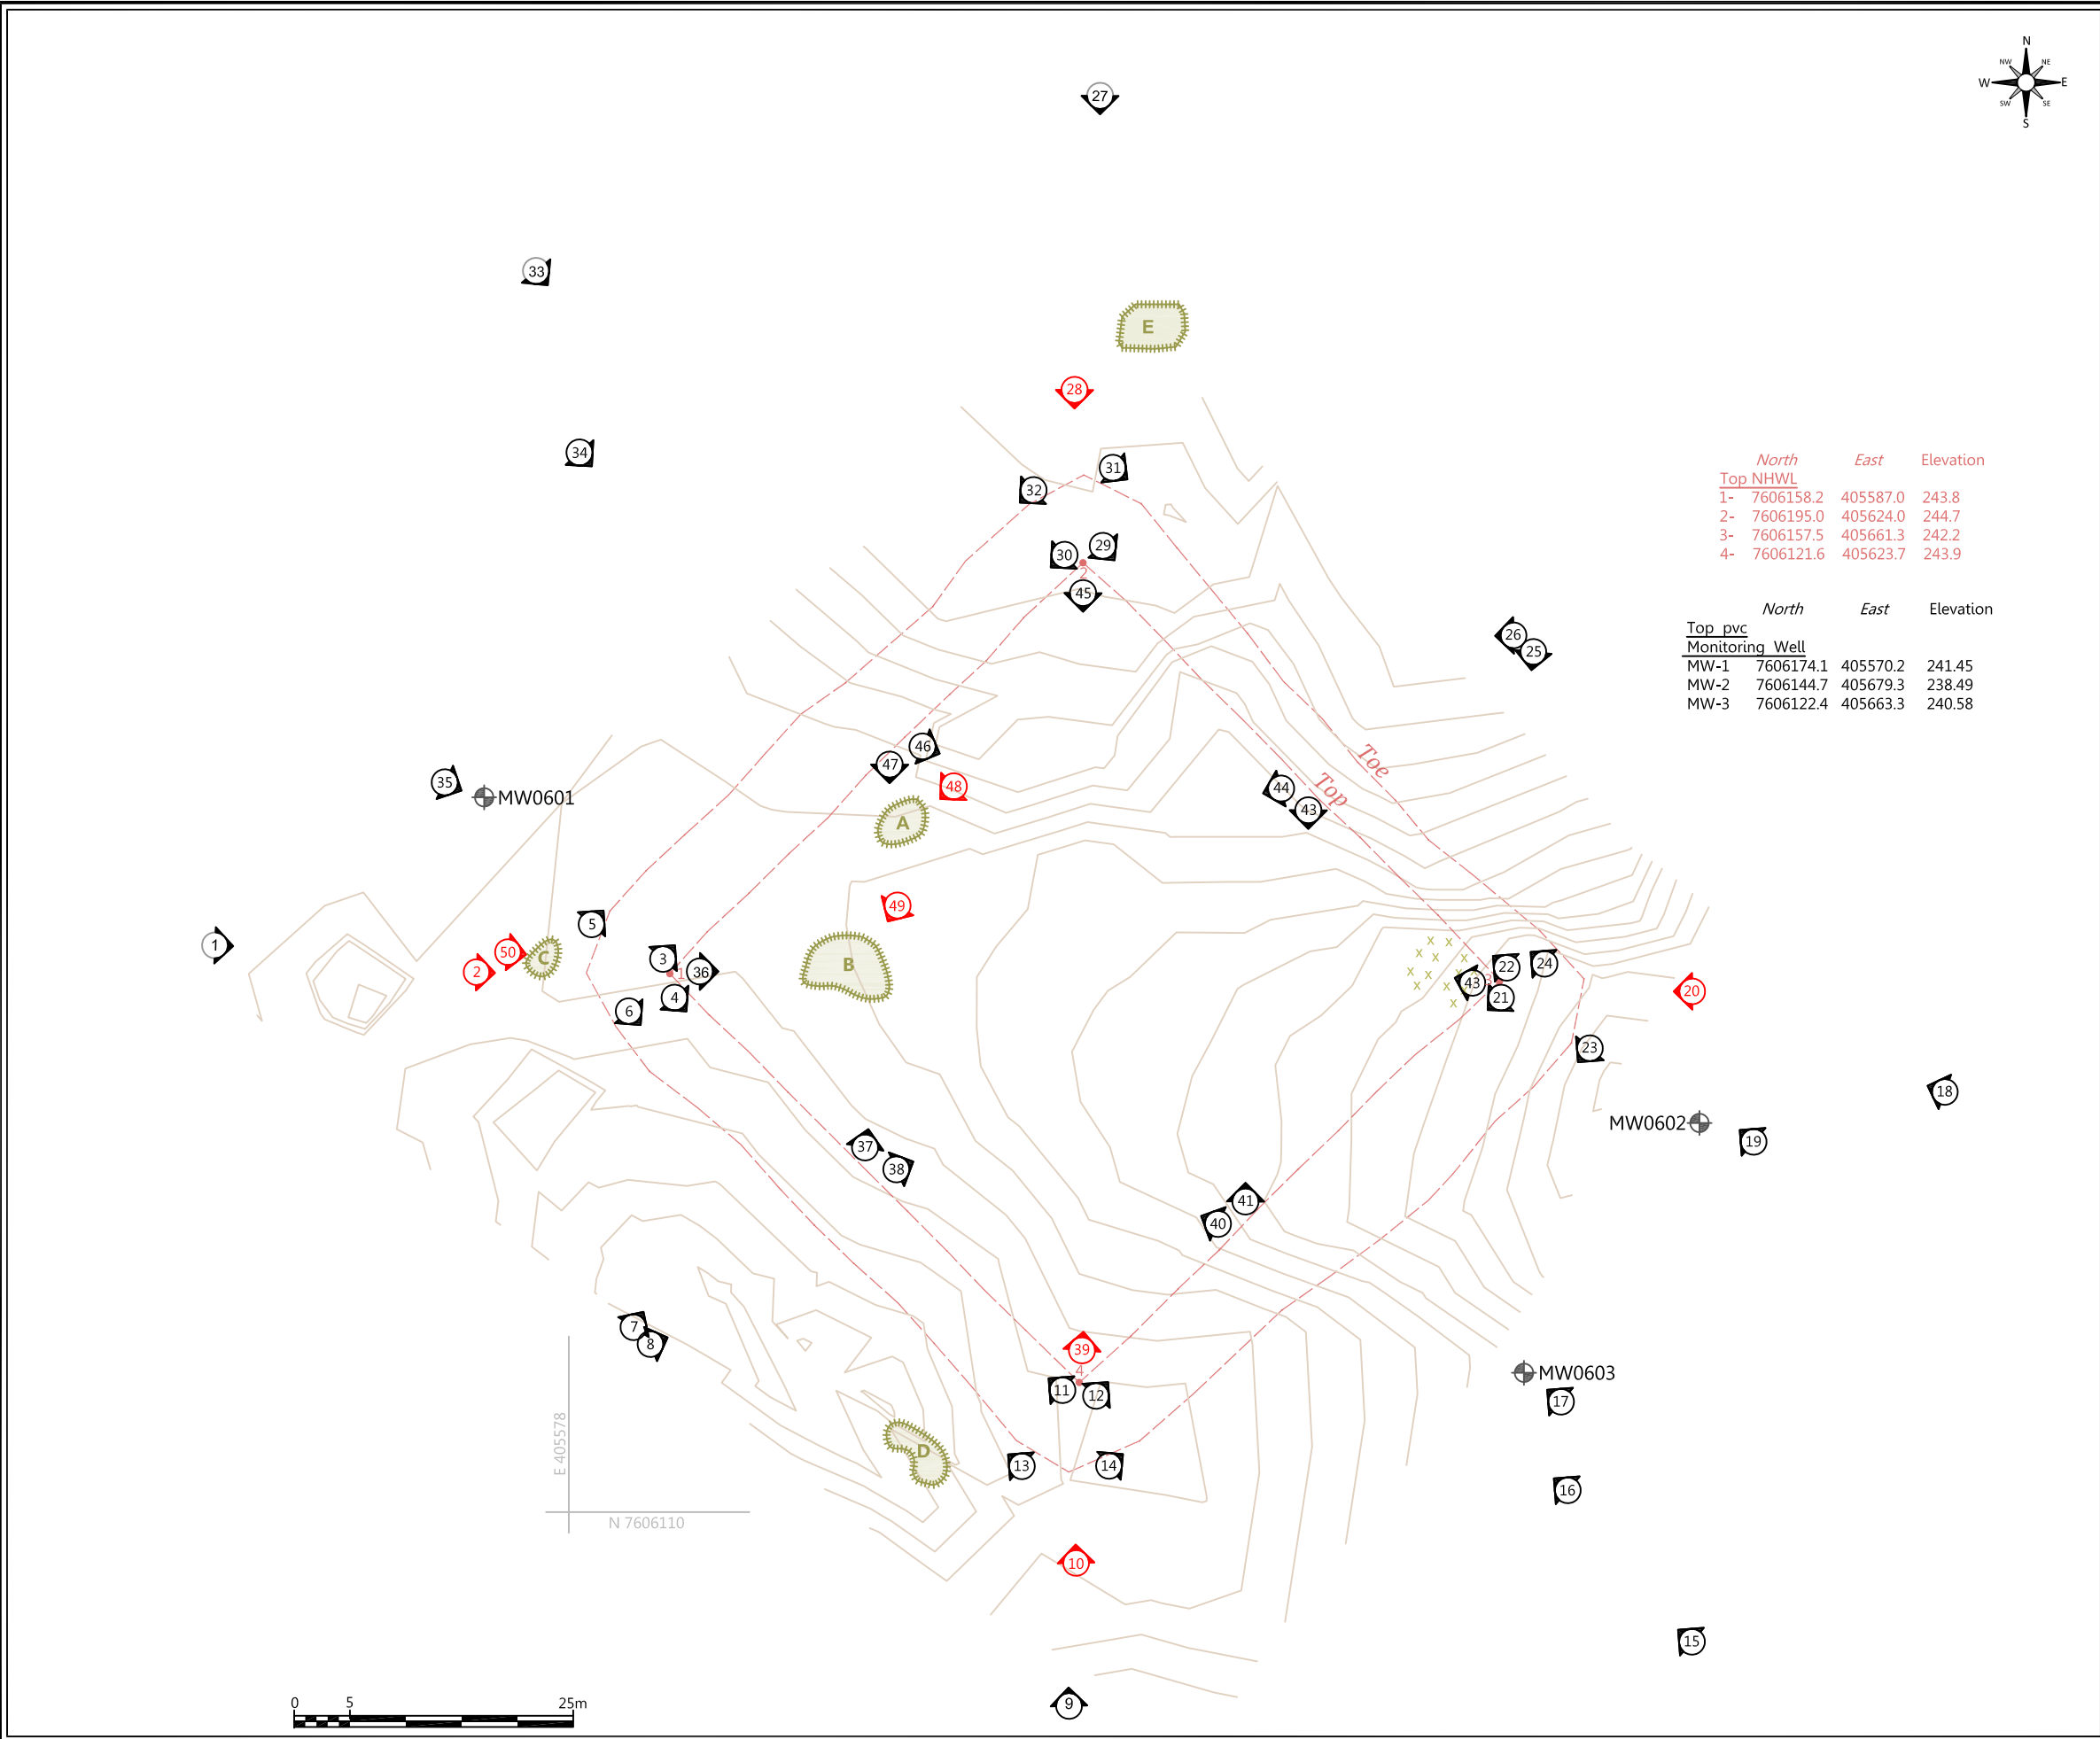
CONSULTING • ENGINEERING • TECHNOLOGIES	Project: <b>CAM-F Sarcpa Lake, NU 1697-1401</b>	
	Date: <b>December 2014</b>	Client: <b>Aboriginal Affairs and Northern Development Canada</b>
Scale: <b>Scale as shown</b>		<b>Figure A-2</b>

The erosion observed in 2014 has not increased significantly since the 2012 landfill inspection.

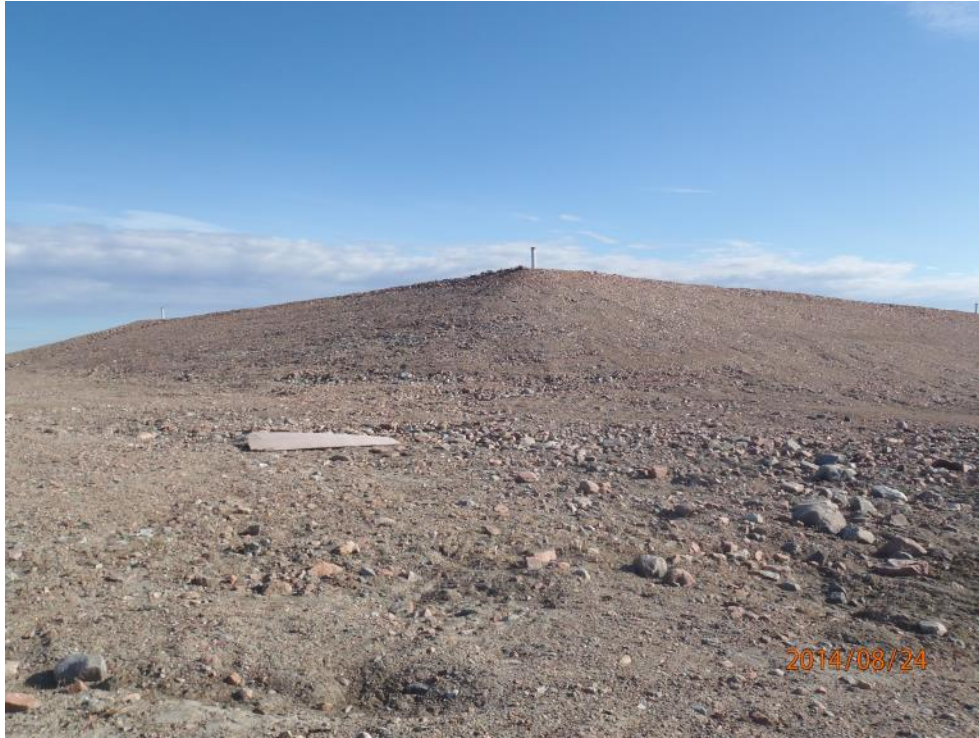
Northwest corner of the SSDF. Viewpoint 2 (Figure A-2; Appendix A). Photograph reference P8240002 (CD-ROM).  
Direction photo taken: SE

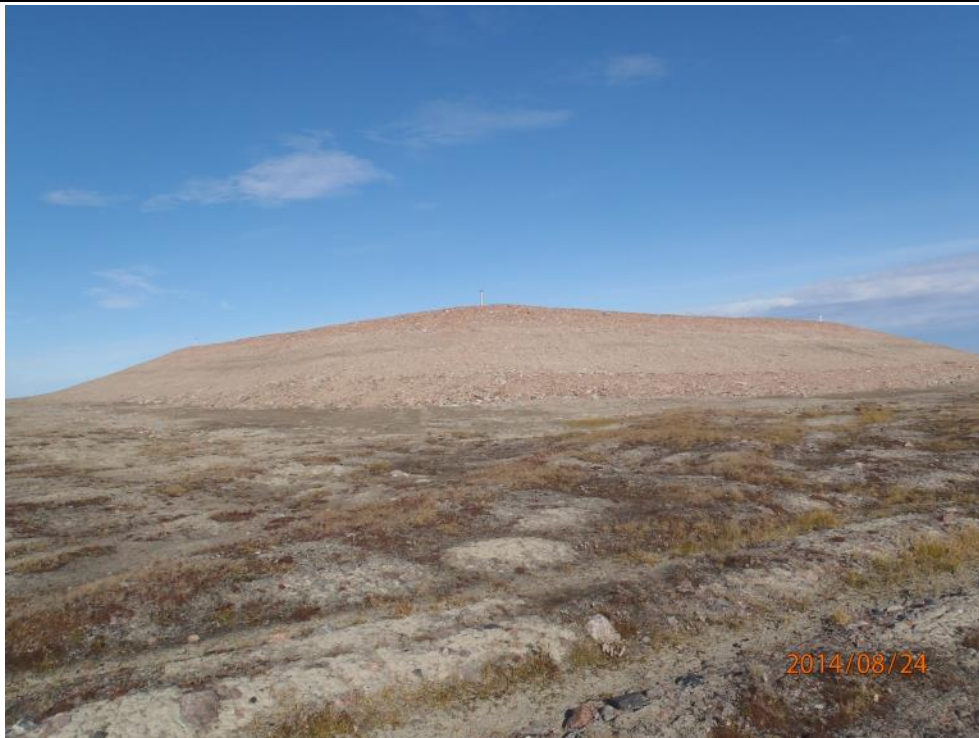
Southwest corner of the SSDF. Viewpoint 11 (Figure A-2; Appendix A). Photograph reference P8240011 (CD-ROM).  
Direction photo taken: NE

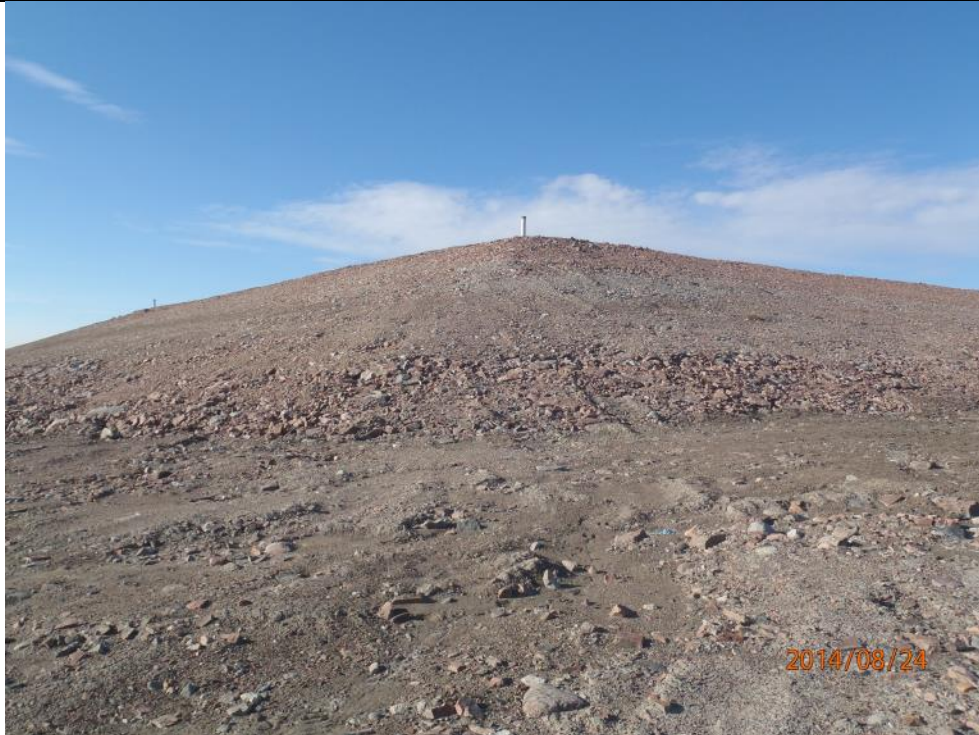
Southeast corner of the SSDF. Viewpoint 23 (Figure A-2; Appendix A). Photograph reference P8240023 (CD-ROM).  
Direction photo taken: NW

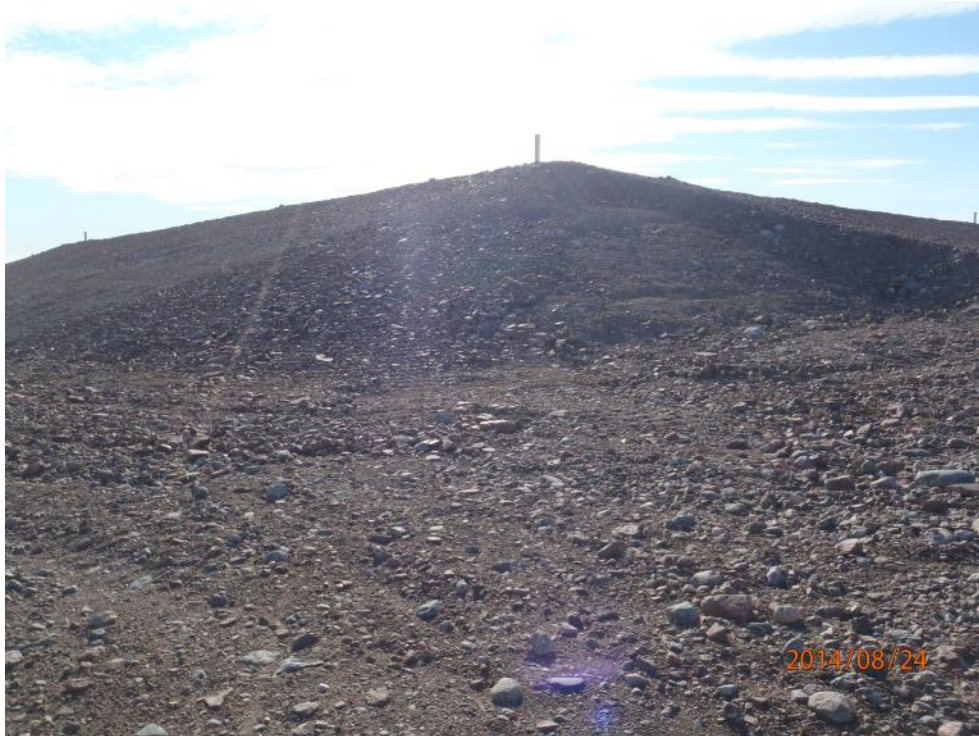
Northeast corner of the SSDF. Viewpoint 33 (Figure A-2; Appendix A). Photograph reference P8240033 (CD-ROM).  
Direction photo taken: SW

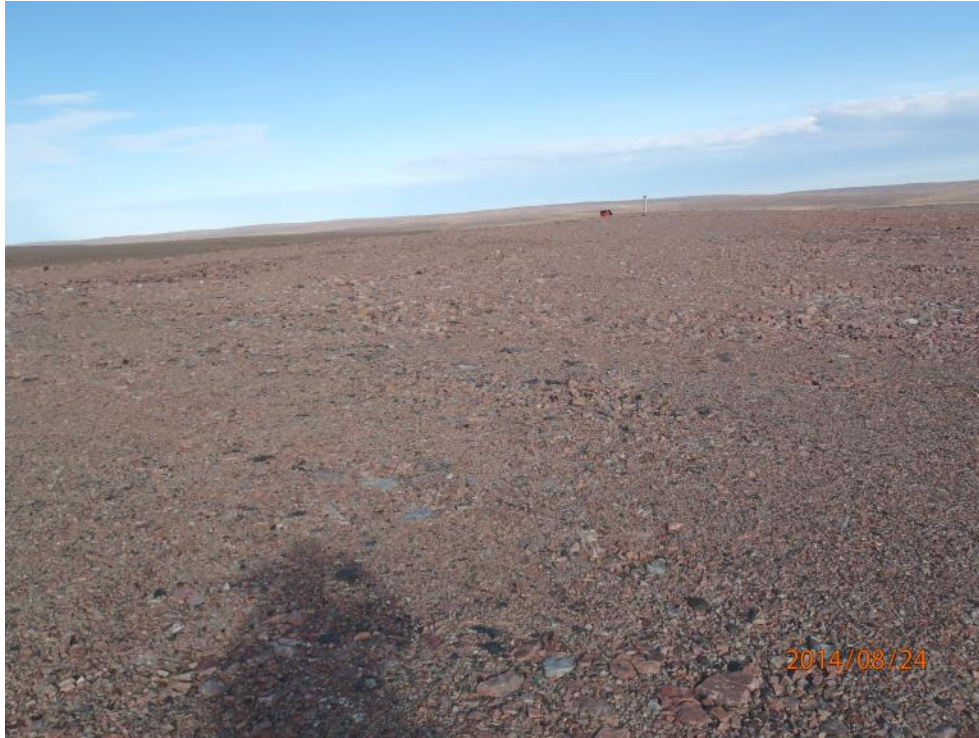
Top of the SSDF. Viewpoint 43 (Figure A-2; Appendix A). Photograph reference P8240043 (CD-ROM). Direction photo taken: E

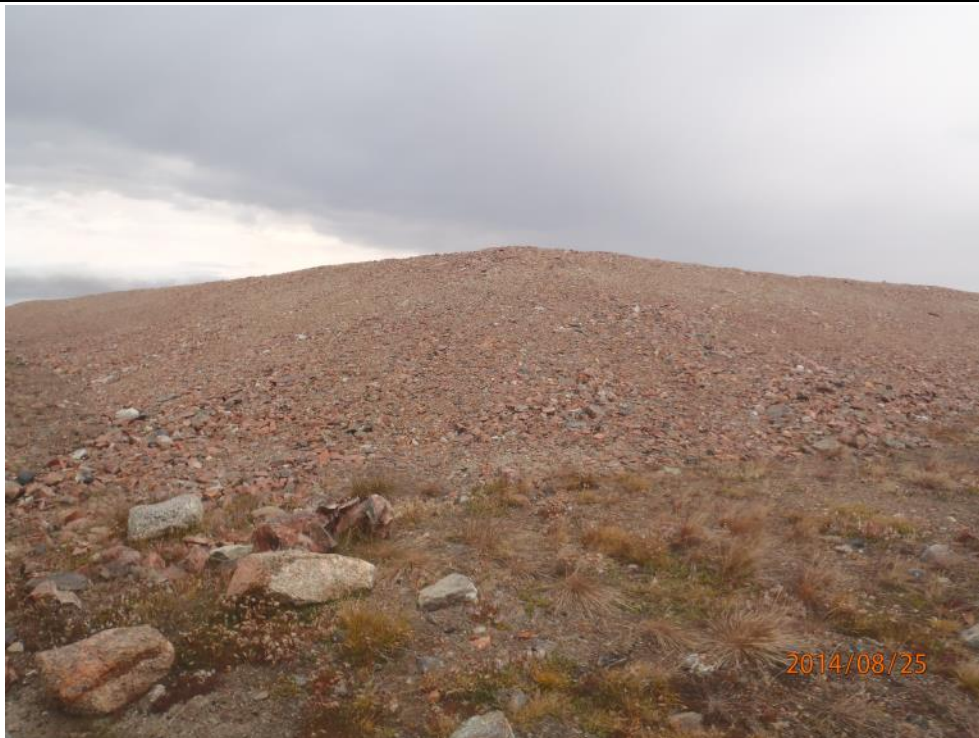
South corner of the NHL. Viewpoint 10 (Figure A-3; Appendix A). Photograph reference P8250010 (CD-ROM). Direction photo taken: N

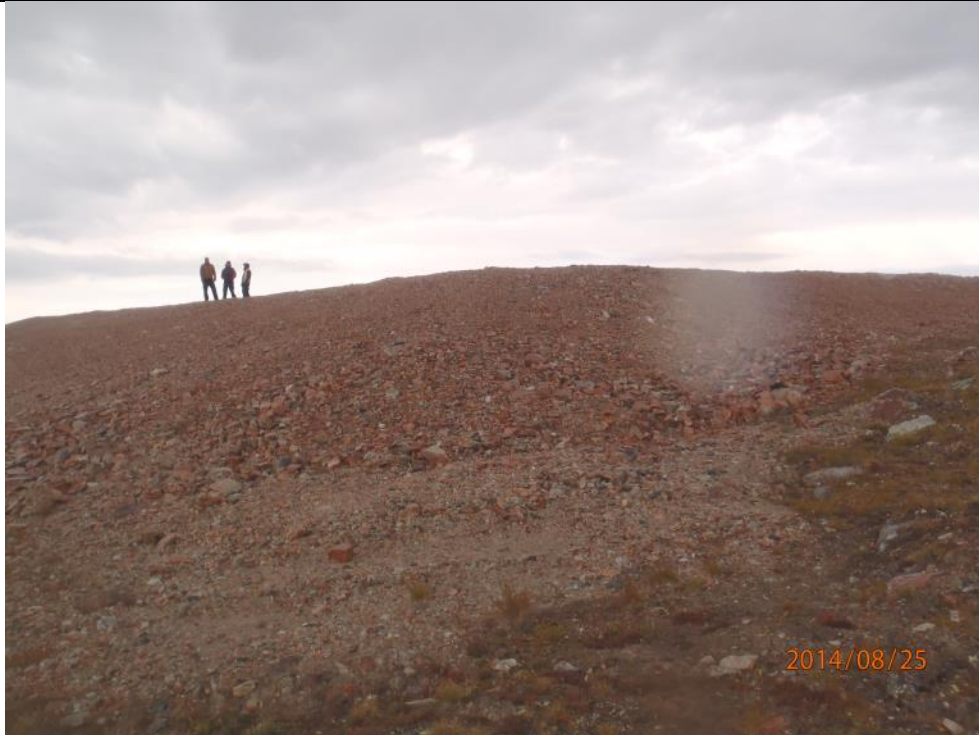
East corner of the NHWL. Viewpoint 20 (Figure A-3; Appendix A). Photograph reference P8250020 (CD-ROM).  
Direction photo taken: W

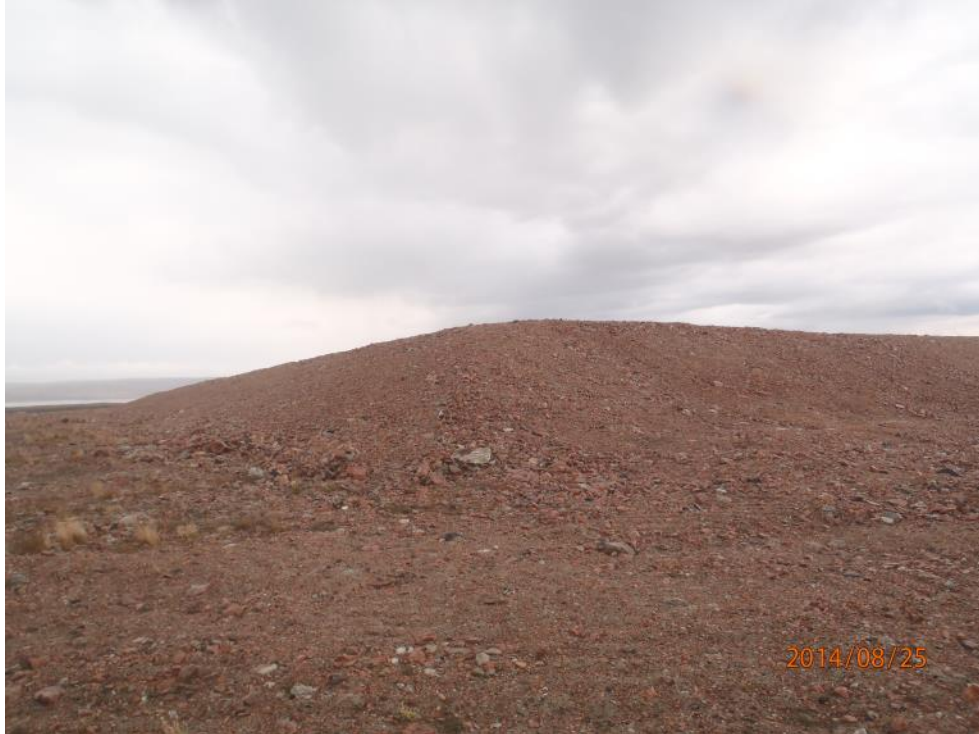
West corner of the NHWL. Viewpoint 28 (Figure A-3; Appendix A). Photograph reference P8250028 (CD-ROM).  
Direction photo taken: S

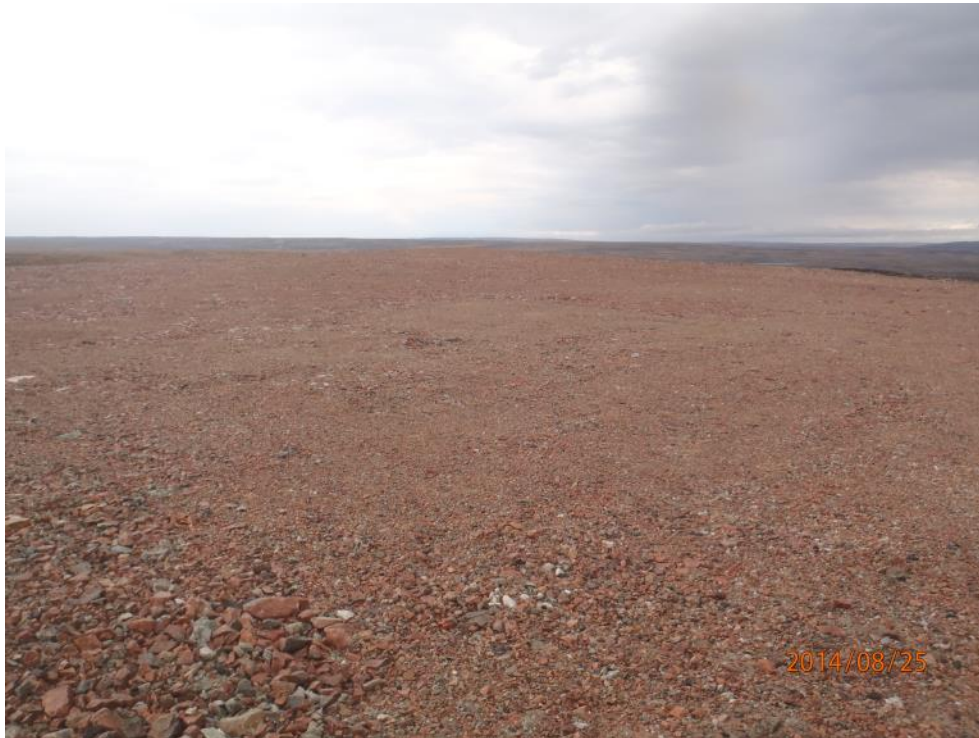
Top of the NHWL from west corner. Viewpoint 39 (Figure A-3; Appendix A). Photograph reference P8250039 (CD-ROM). Direction photo taken: N
