CAM-D Simpson Lake Long-Term Monitoring Report

Year 13

Project number: 60736036

March 31, 2025

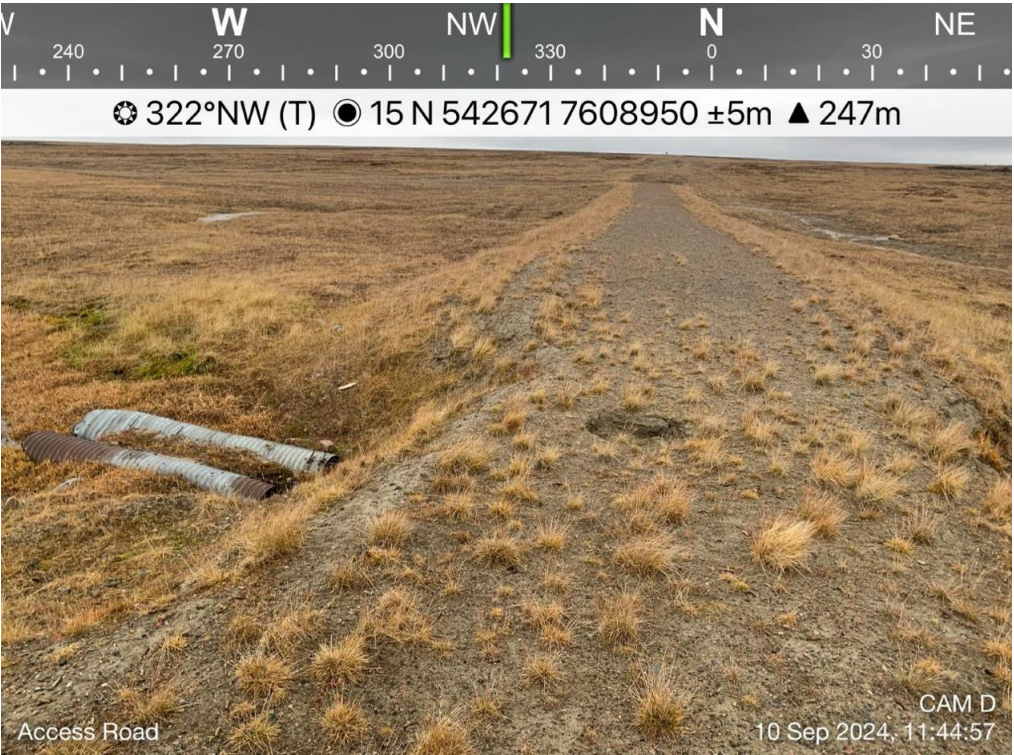
Photo No. 6	Date 9/10/2024

<p>Access Road</p> <p>CAM D 10 Sep 2024, 11:44:57</p>
Direction Photo Taken NW		
Area Access Road		
Description Close up of west portion of culvert showing settlement and slumping.		
Settlement hole present above culvert (originally a siksik burrow identified in Year 7).		
Revegetation of the ground surface following the culvert alignment.

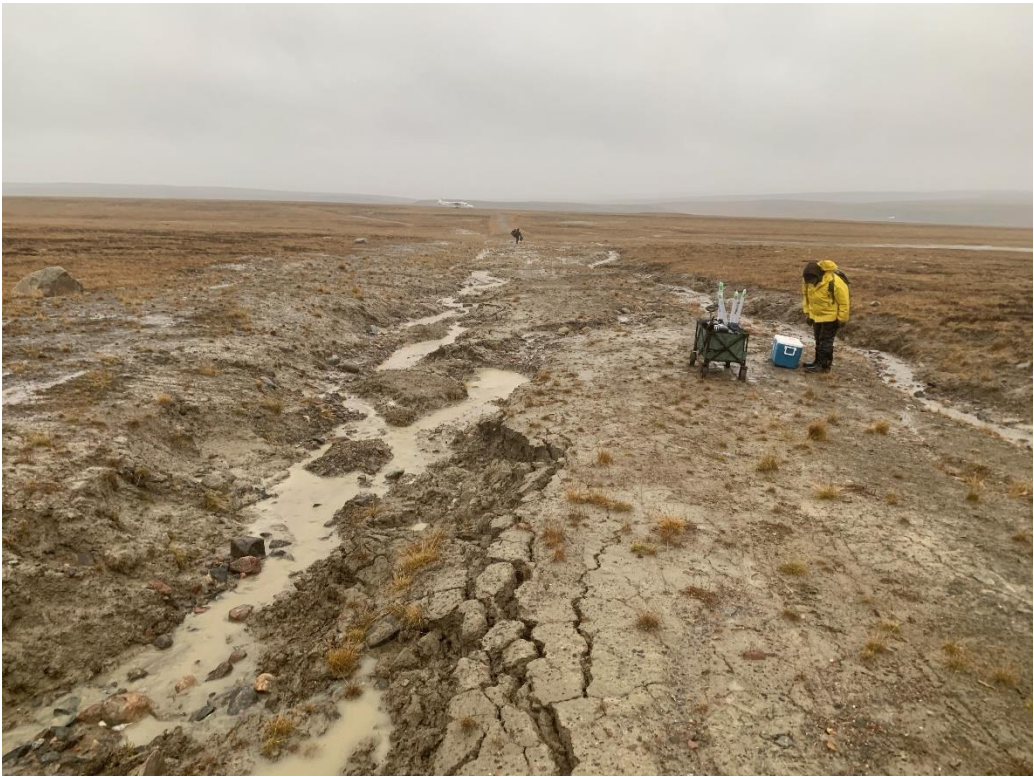
13	9/10/2024	
Direction Photo Taken		
SE		
Area		
Access Road		
Description		
<p>Erosion channels on either side of the road.</p> <p>Sloughing of the edges of the road.</p> <p>Flowing water through erosion channels.</p> <p>Occasional tufts of vegetation.</p>

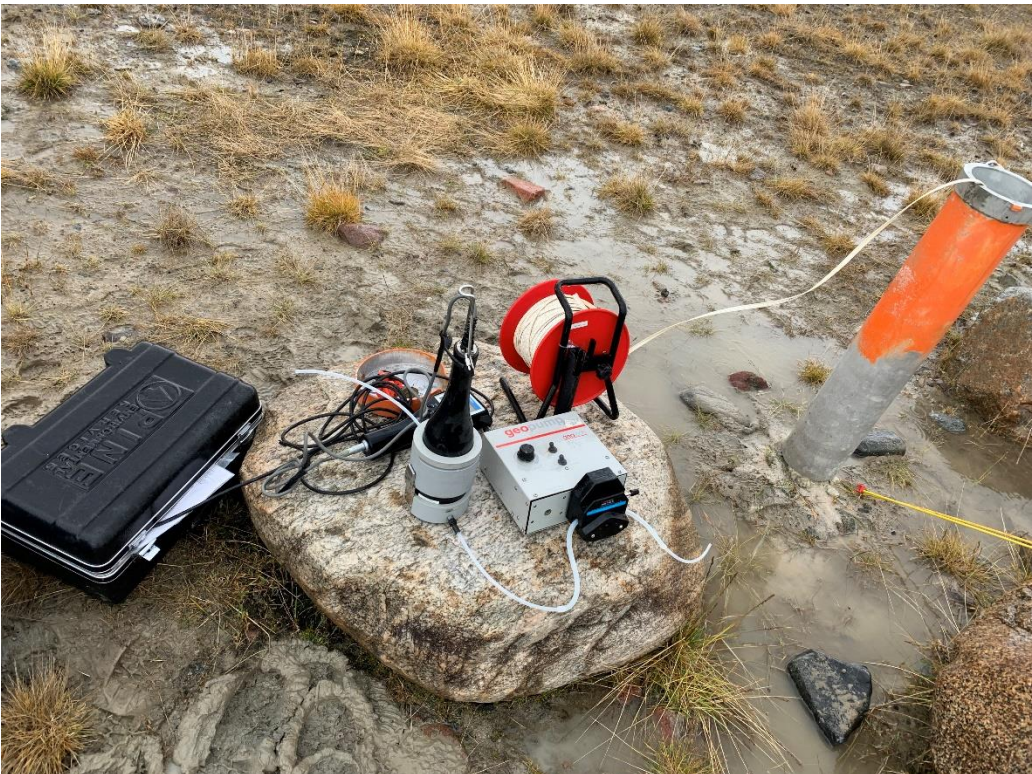
18	9/10/2024	
Direction Photo Taken		
N/A		
Area		
Monitoring Instruments		
Description		
<p>Low flow sampling equipment set up at MW01.</p>

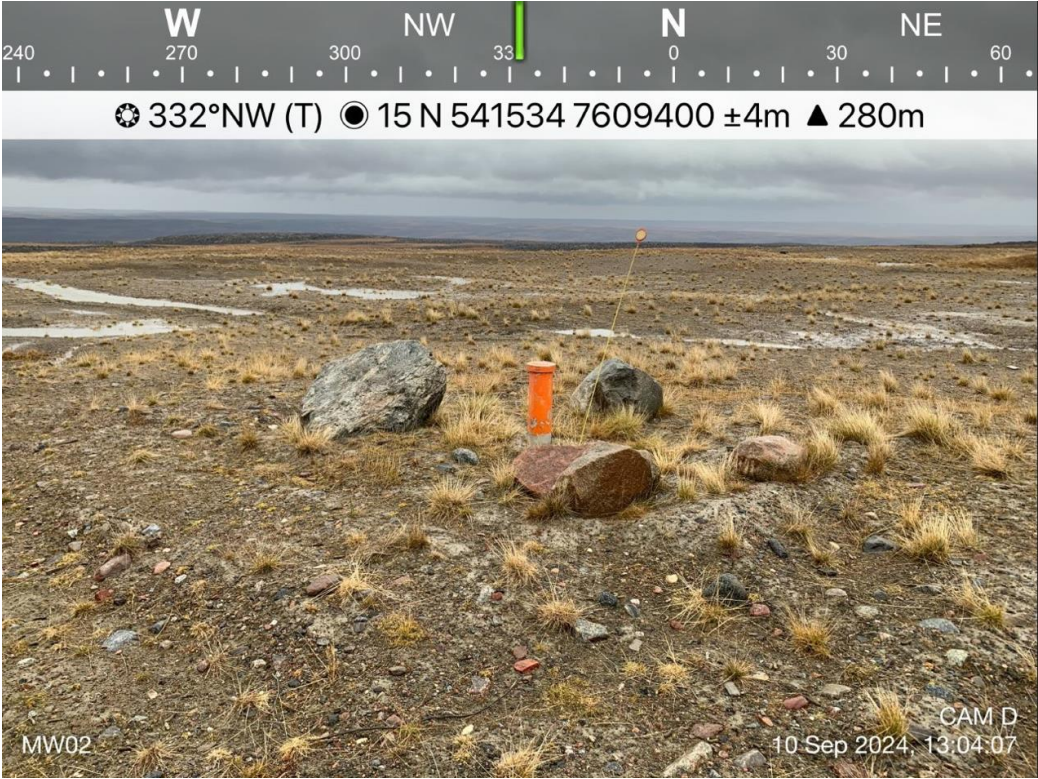
Photo No. 19	Date 9/10/2024

Direction Photo Taken N-NW		
Area		
Monitoring Instruments		
Description MW02. No groundwater sample collected. Numerous tufts of vegetation in surrounding area.

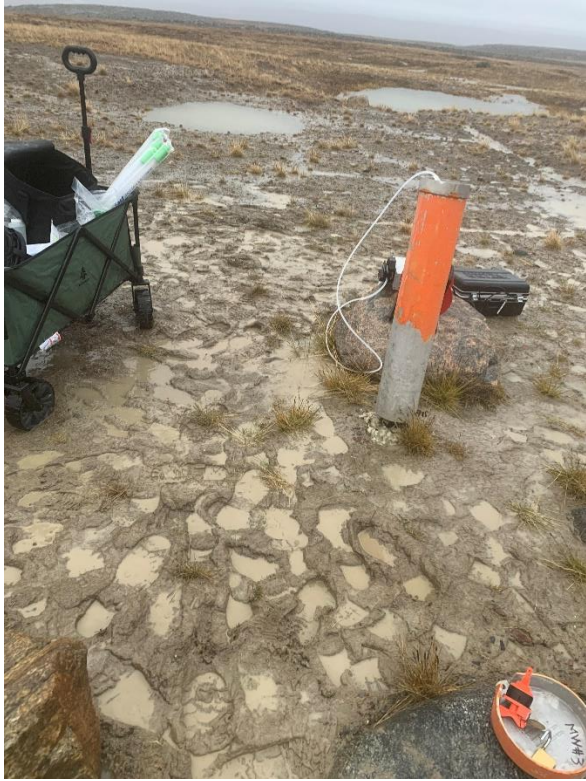
Photo No. 21	Date 9/10/2024

Direction Photo Taken NW		
Area		
Monitoring Instruments		
Description Ground surrounding MW03 very soft and saturated. Boot prints filled with water. Pump set up for groundwater sample collection.

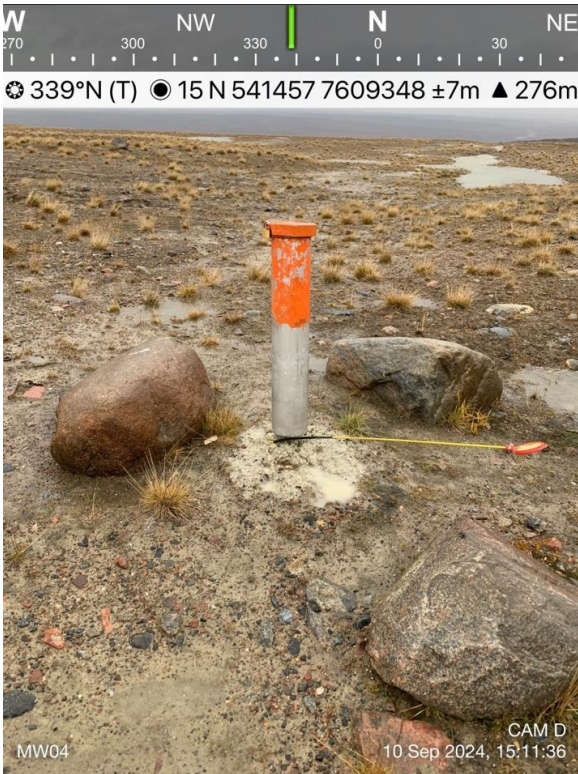
Photo No. 24	Date 9/10/2024

Direction Photo Taken N/A		
Area Monitoring Instruments		
Description MW04 heaved with exposed bentonite at base. Standing water in vicinity of MW04.

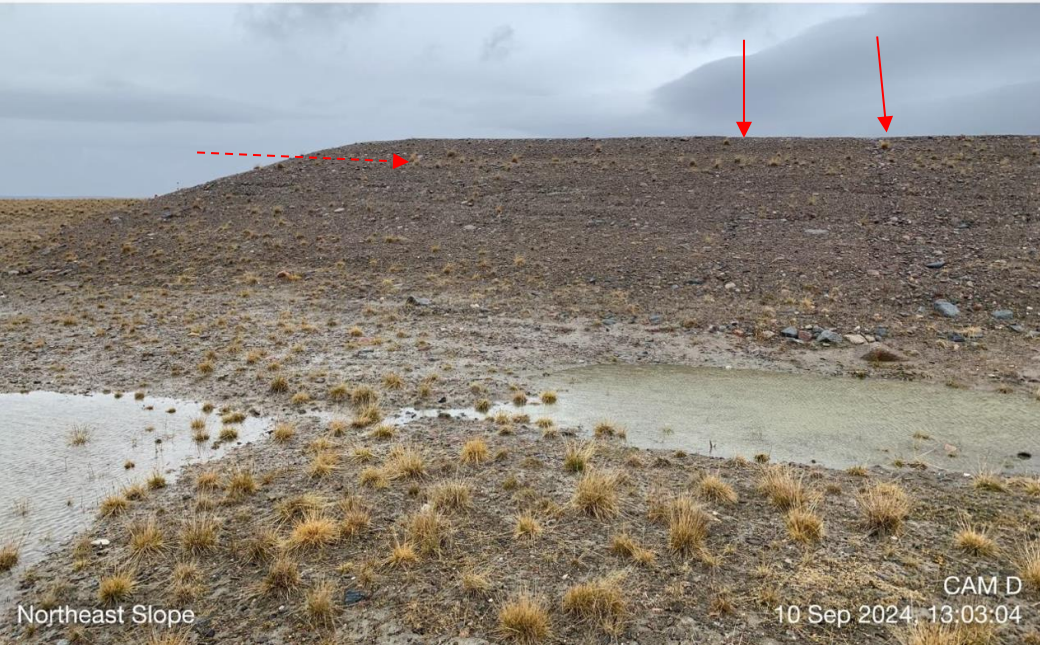
Northeast Slope	
CAM D 10 Sep 2024 13:03:04

Photo No. 25	Date 9/10/2024
Direction Photo Taken SW-W	
Area NHWL	
Description South portion of northeast slope. Horizontal tension crack extending the length of slope near the crest (dashed arrow). Vertical erosion channels from top to toe of slope (see arrows). Ponding water at base of slope.

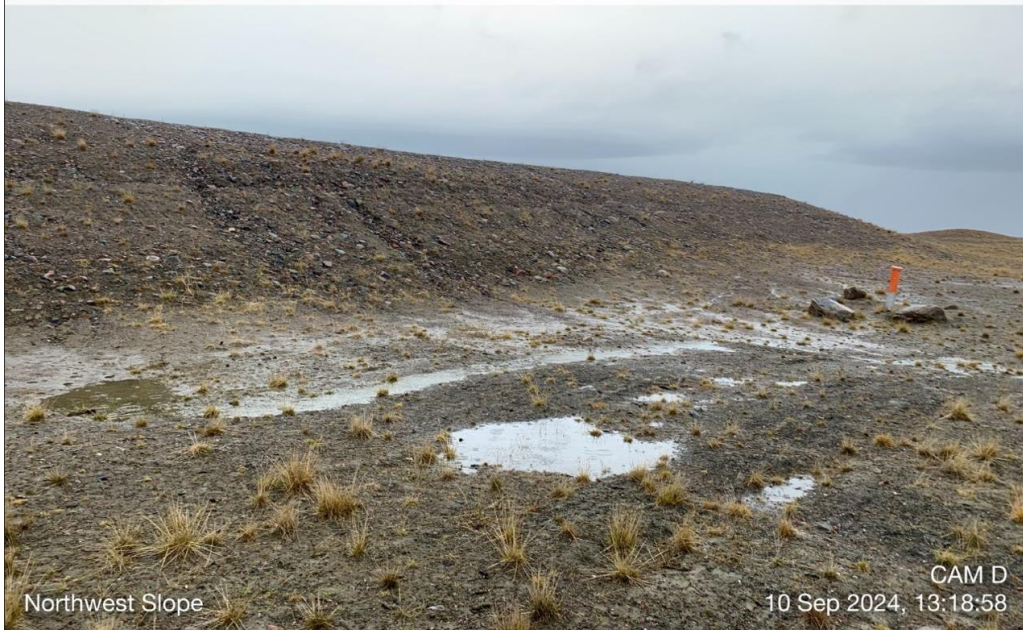
Northwest Slope					
CAM D 10 Sep 2024, 13:18:58

Photo No. 42	Date 9/10/2024
Direction Photo Taken SW	
Area NHWL	
Description South portion of northwest slope. MW03 to the right. Horizontal tension crack extends length of slope. Several vertical erosion channels along slope extents. Numerous tufts of vegetation. Ponding water at toe of slope.

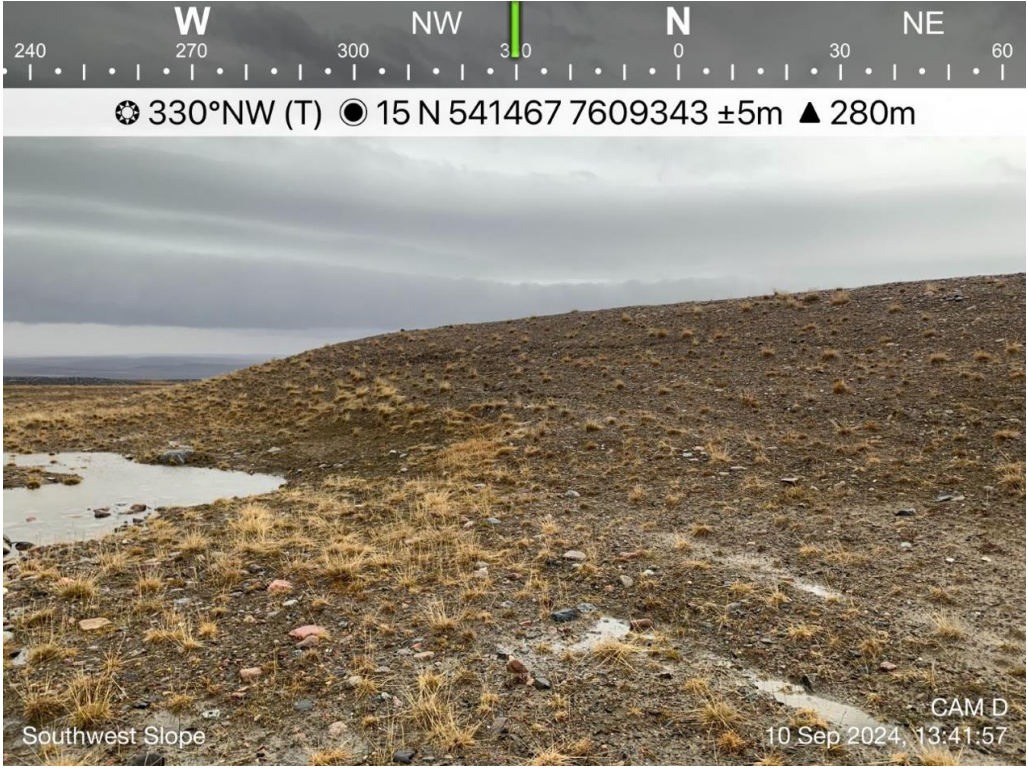
Photo No. 55	Date 9/10/2024

Direction Photo Taken NW-N		
Area NHWL		
Description North portion of southwest slope. Ponding water at the toe of the southwest sloughing zone.

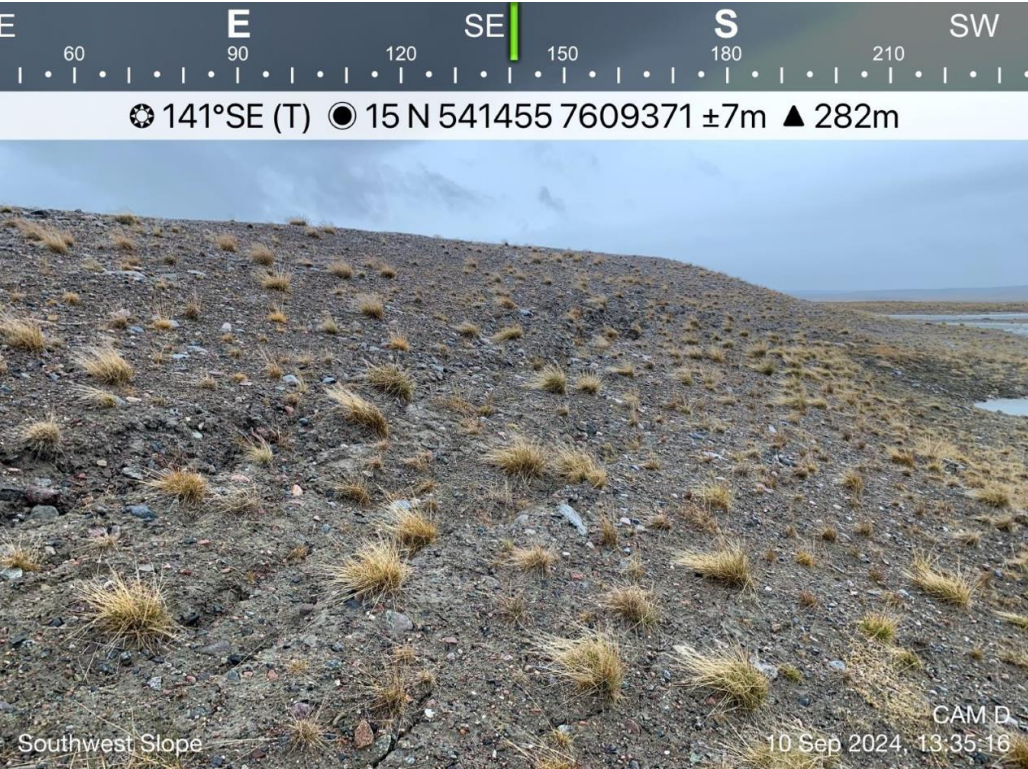
Photo No. 56	Date 9/10/2024

Direction Photo Taken SE		
Area NHWL		
Description Looking southeast down length of southwest slope.

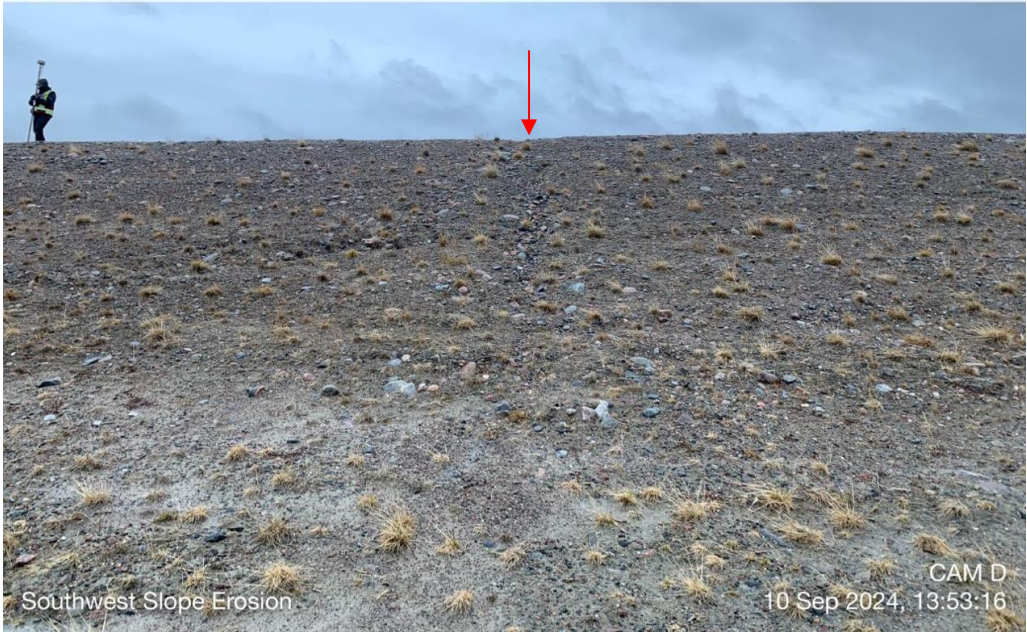
Southwest Slope Erosion	CAM D 10 Sep 2024, 13:53:16

Photo No. 59	Date 9/10/2024
Direction Photo Taken N-NE	
Area NHWL	
Description Looking up erosion channel down southwest slope (arrow; see Photo 60).

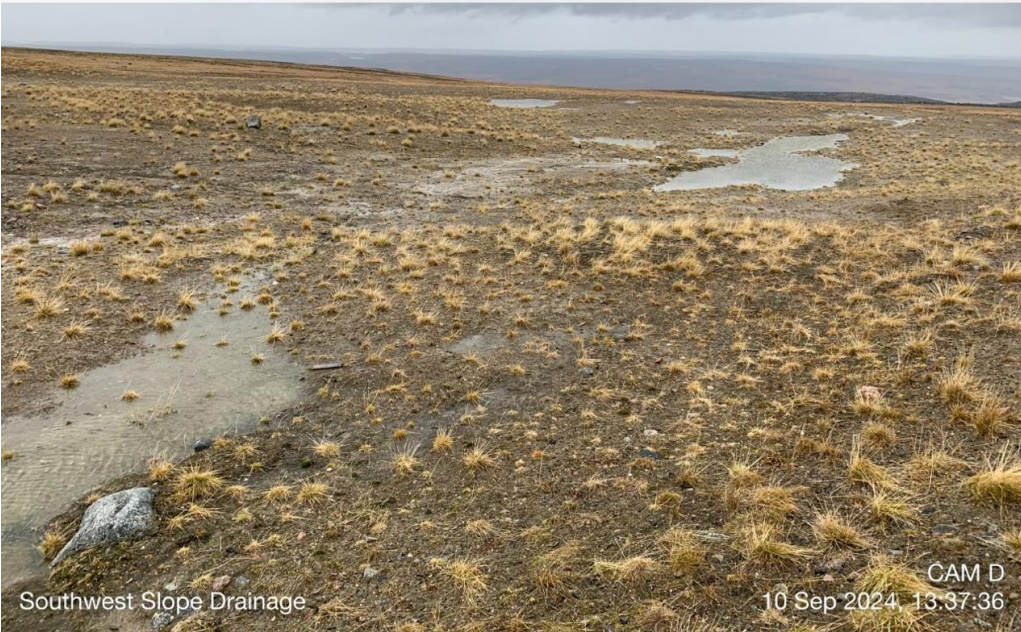
Southwest Slope Drainage										CAM D 10 Sep 2024 13:37:36

Photo No. 65	Date 9/10/2024
Direction Photo Taken W	
Area NHWL	
Description Permanent ponds off toe of southwest slope. Drainage flow moving northwest.

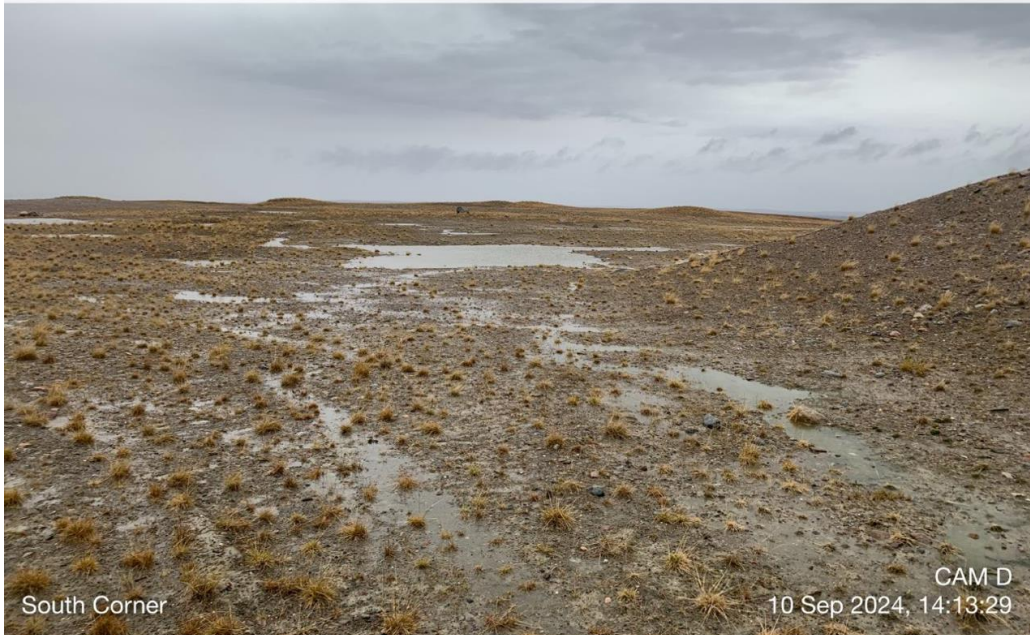
South Corner	CAM D 10 Sep 2024, 14:13:29

Photo No. 69	Date 9/10/2024
Direction Photo Taken SW-W	
Area NHWL	
Description Ponding water off south corner and drainage paths along southeast slope.

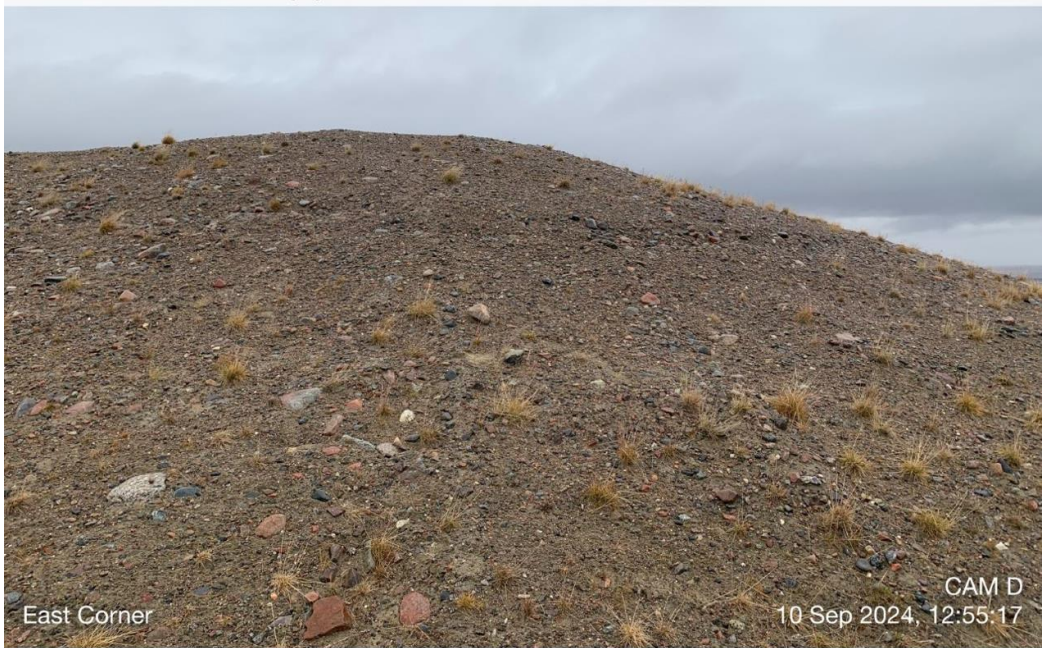
East Corner				CAM D 10 Sep 2024, 12:55:17

Photo No. 79	Date 9/10/2024
Direction Photo Taken W-NW	
Area NHWL	
Description Looking up east corner. Horizontal tension crack traversing corner (see Photo 80). Occasional tufts of vegetation.

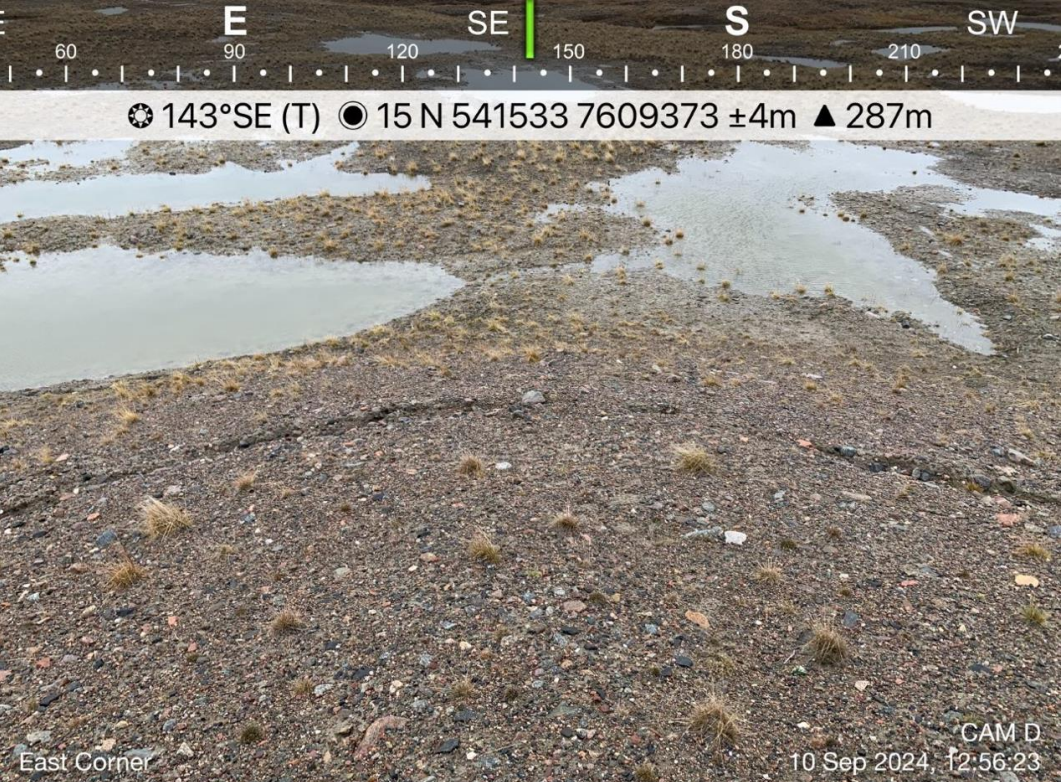
East Corner
CAM D
10 Sep 2024, 12:56:23

Photo No. 82	Date 9/10/2024
Direction Photo Taken SE	
Area NHWL	
Description Looking down east corner. Tension crack traversing corner. Ponded water at corner base. Occasional tufts of vegetation on slope, increasing in number at toe where moisture is present.

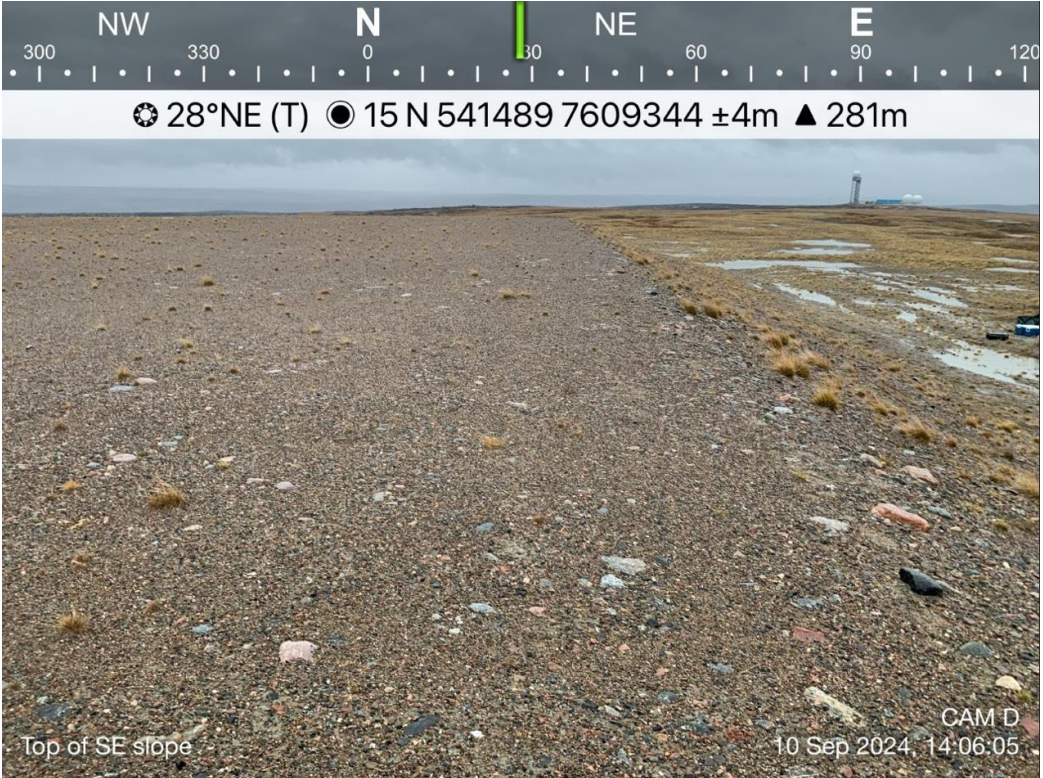
Photo No. 92	Date 9/10/2024

Direction Photo Taken N-NE		
Area NHWL		
Description Top of landfill along southeast slope.		
Short Range Radar Station in background.

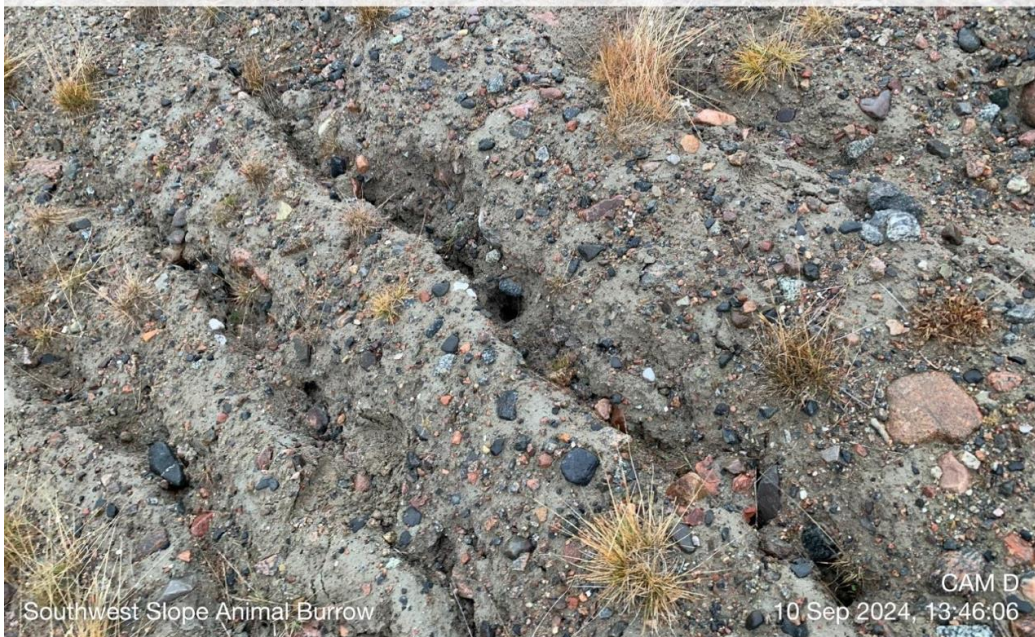
Southwest Slope Animal Burrow										CAM D 10 Sep 2024, 13:46:06

Photo No. 107	Date 9/10/2024
Direction Photo Taken N/A	
Area NHWL	
Description Animal burrow in tension crack along southwest landfill slope.

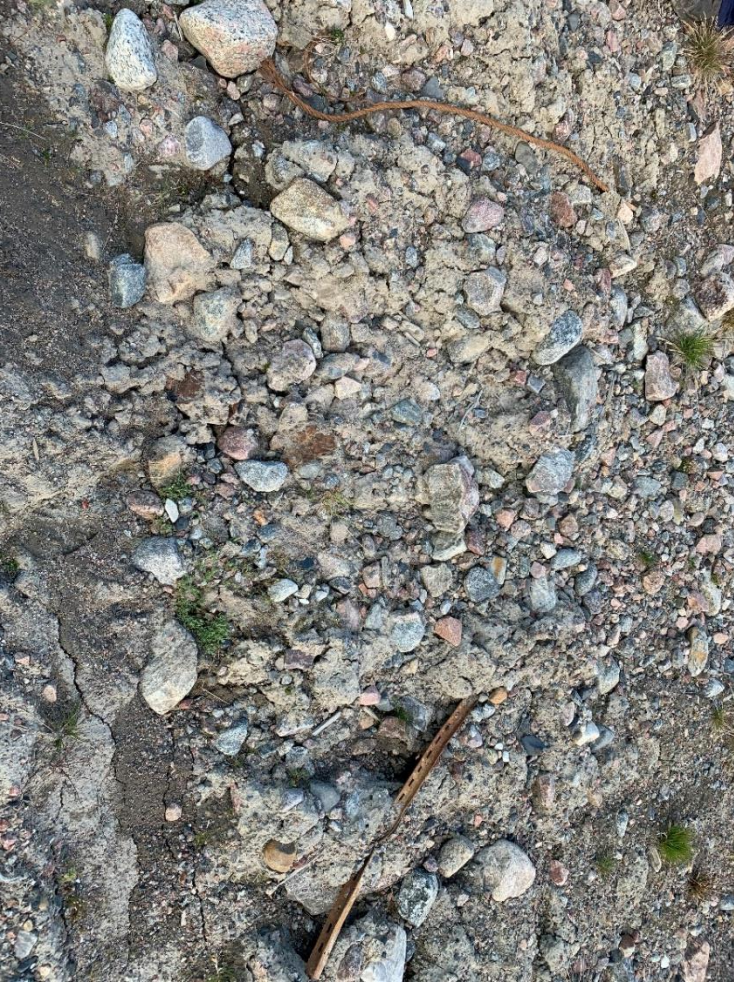
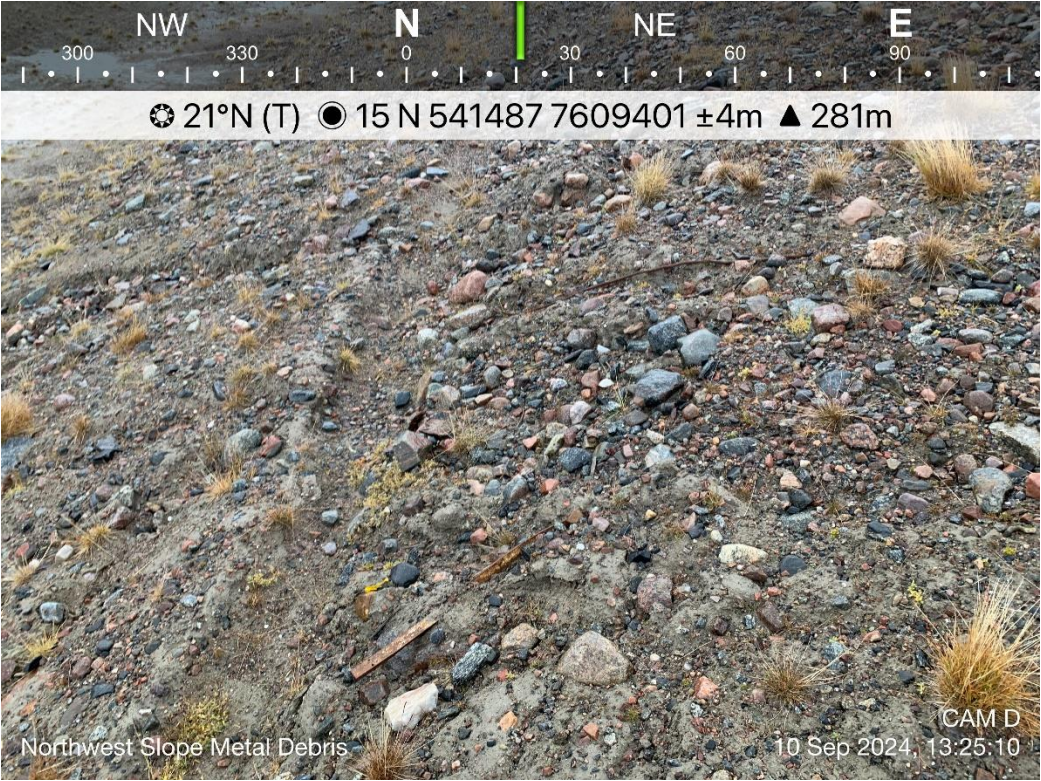
Comparison No. 12	Previous Condition	Date 8/6/2022	Current Condition	Date 9/10/2024
		Direction Photo Taken N/A		Direction Photo Taken (see photo header)
Description Debris on northwest slope near MW03. Similar extents to those observed in 2022. Debris items appear to be superficial and were not observed to be originating from the NHWL.

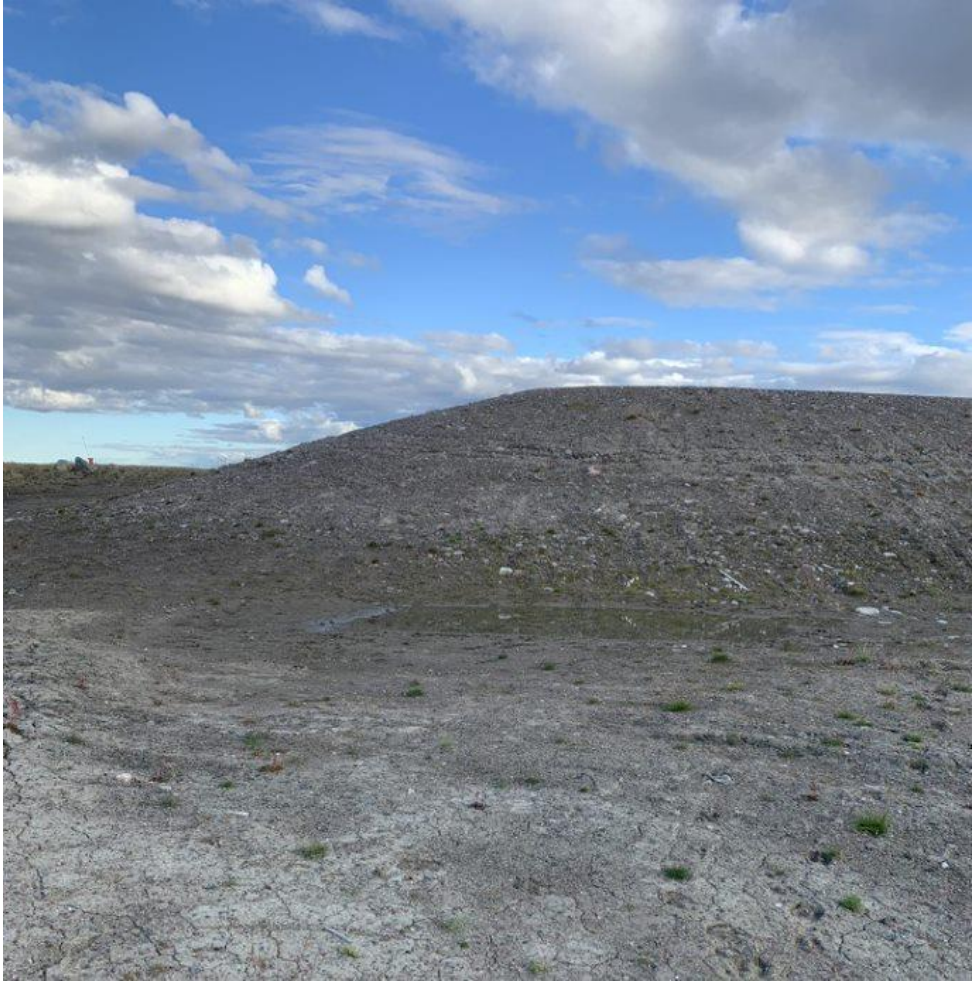
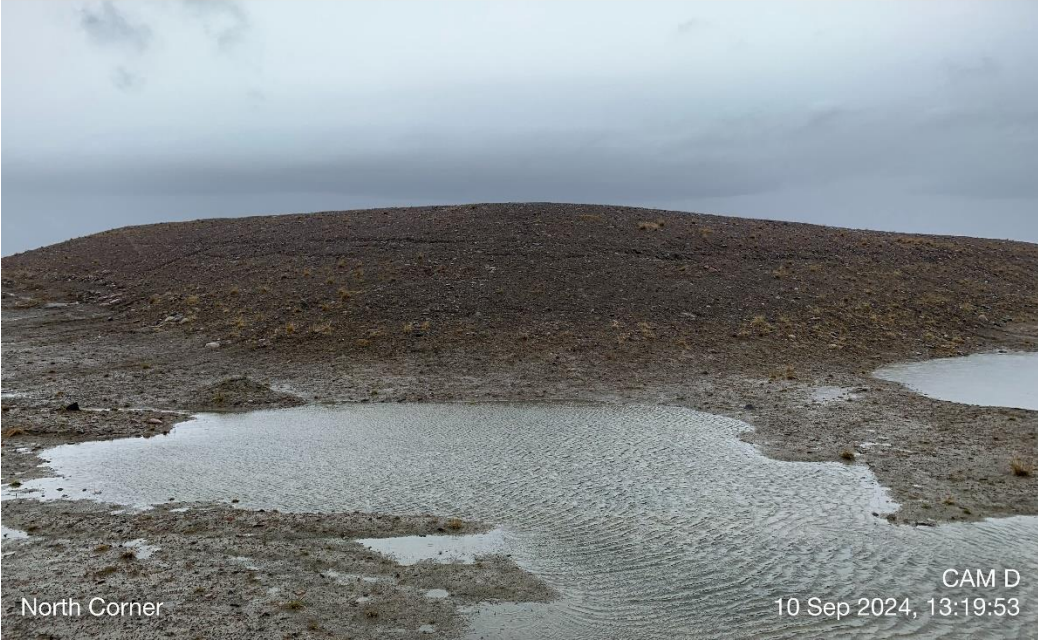
Comparison No. 13	Previous Condition	Date 8/6/2022	Current Condition	Date 9/10/2024
		Direction Photo Taken South		Direction Photo Taken (see photo header)
<p>Description</p> <p>North corner of NHWL.</p> <p>Tension cracks have progressed around north corner. Tension crack development is higher from middle of northwest slope, clockwise around north corner, to middle of northeast slope (maximum 30 cm deep, 30 cm wide).</p> <p>Significant water pooling below the toe of the north corner slope.</p>

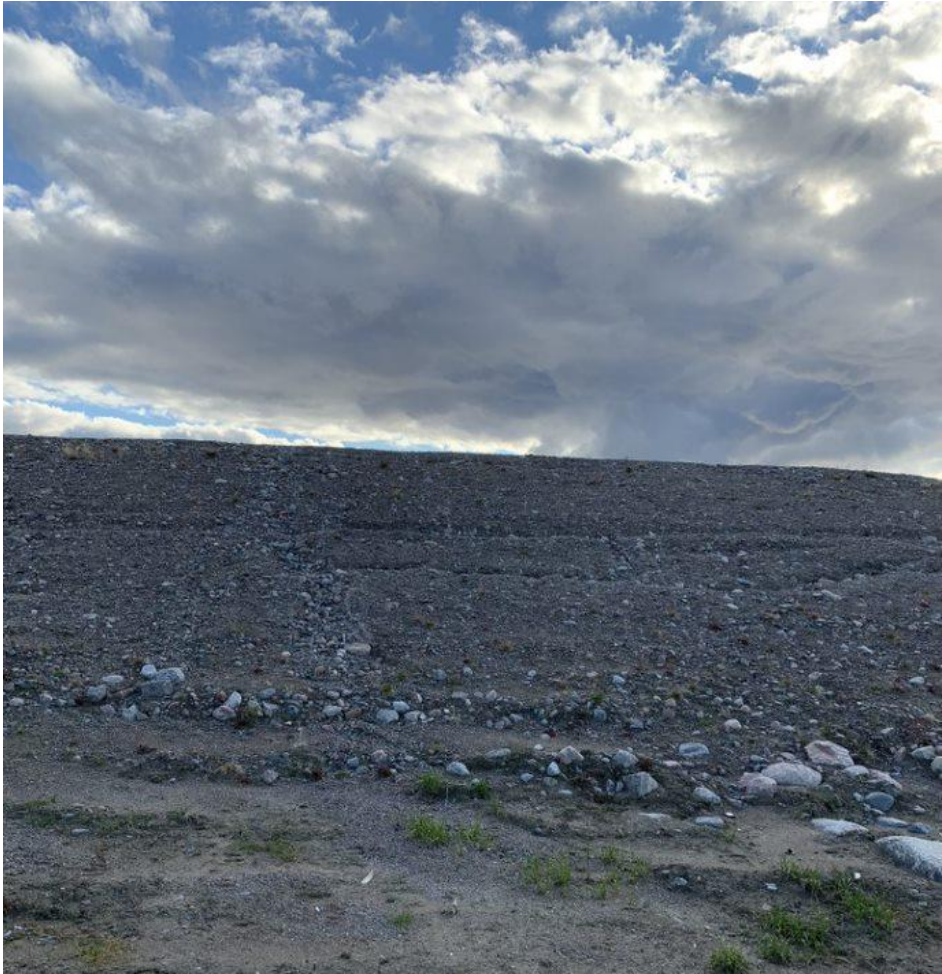
Comparison No. 14	Previous Condition	Date 8/6/2022	Current Condition	Date 9/10/2024
		Direction Photo Taken South		Direction Photo Taken (see photo header)
<div>Description</div> <div>Northeast slope of NHWL.</div> <div>Erosion channels appear to be self-armouring. No significant increase in channel depths observed.</div> <div>Preferential drainage path found paralleling the toe to the north. All runoff from northeast slope is draining to several pools of water downslope of NHWL.</div> <div>Settlement cracks of varying width present near crest of the northeast slope.</div>

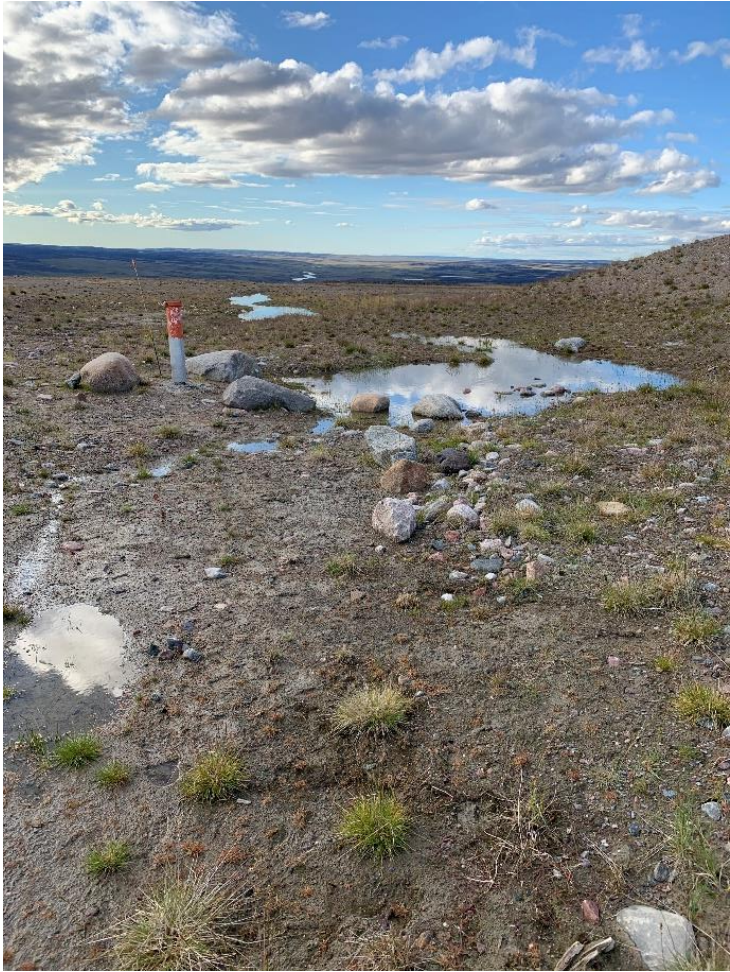
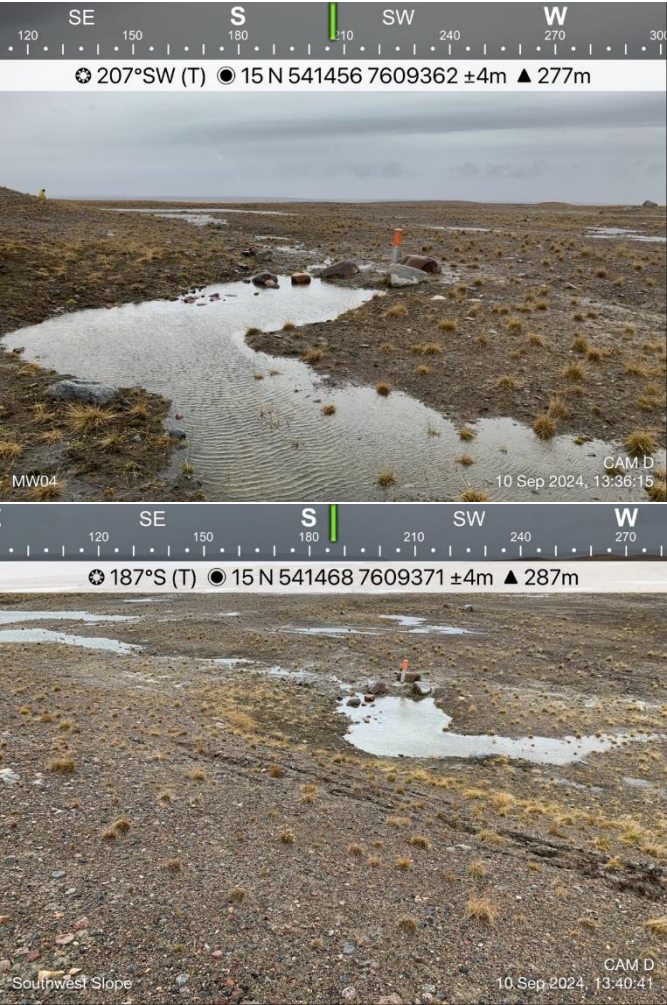
Comparison No. 15	Previous Condition	Date 8/6/2022 Direction Photo Taken South	Current Condition	Date 9/10/2024 Direction Photo Taken (see photo header)
Description Permanent pond between MW04 and the southwest slope. Feature has grown in its extent compared to the 2022 condition and is progressing towards the toe of the NHWL slope.

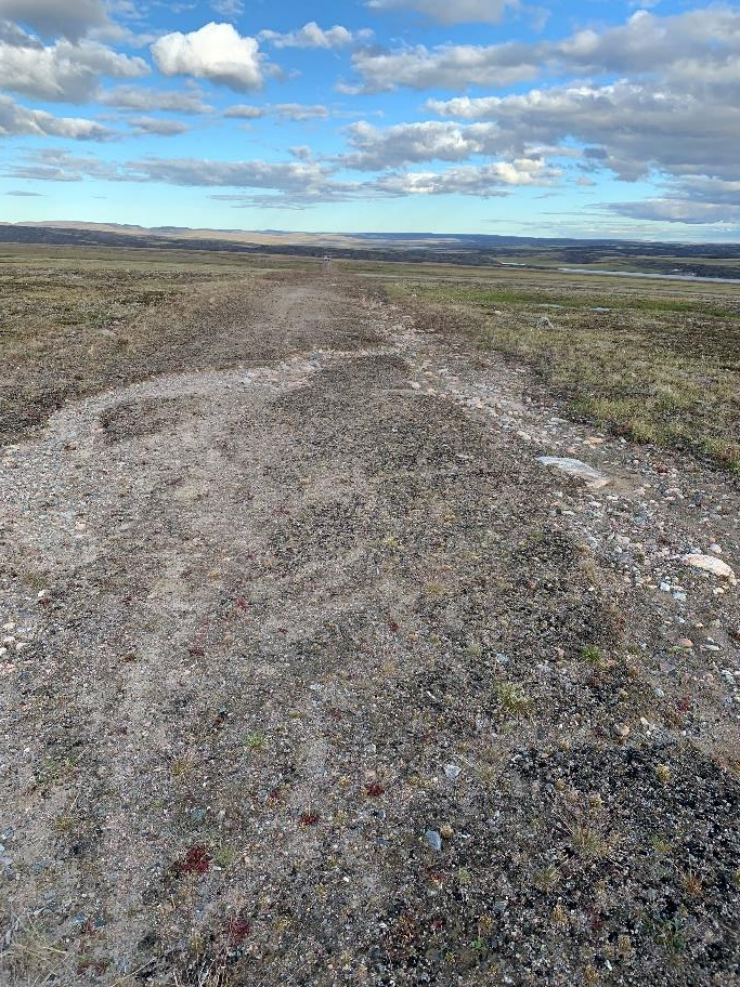
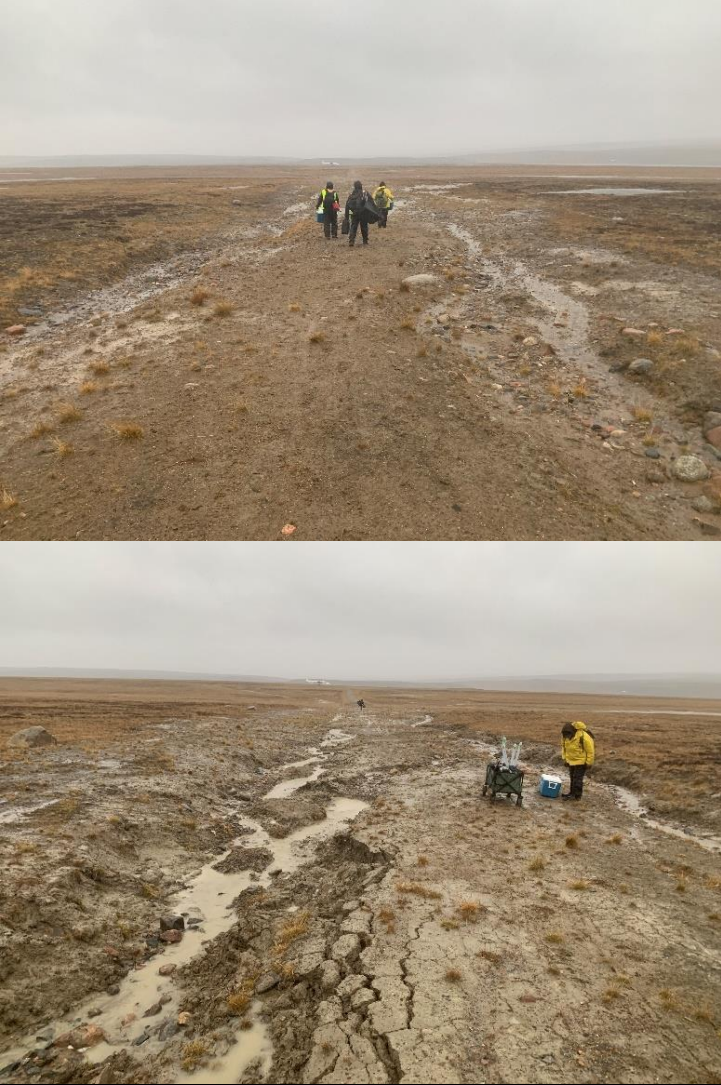
Comparison No. 16	Previous Condition	Date 8/6/2022 Direction Photo Taken Southeast	Current Condition	Date 9/10/2024 Direction Photo Taken Southeast
Description Access road between NHWL and Airstrip. Washout and erosion channels show considerable development since 2022. Water was actively flowing in previously shallow and dry channels observed in 2022. Increased revegetation of road surface.

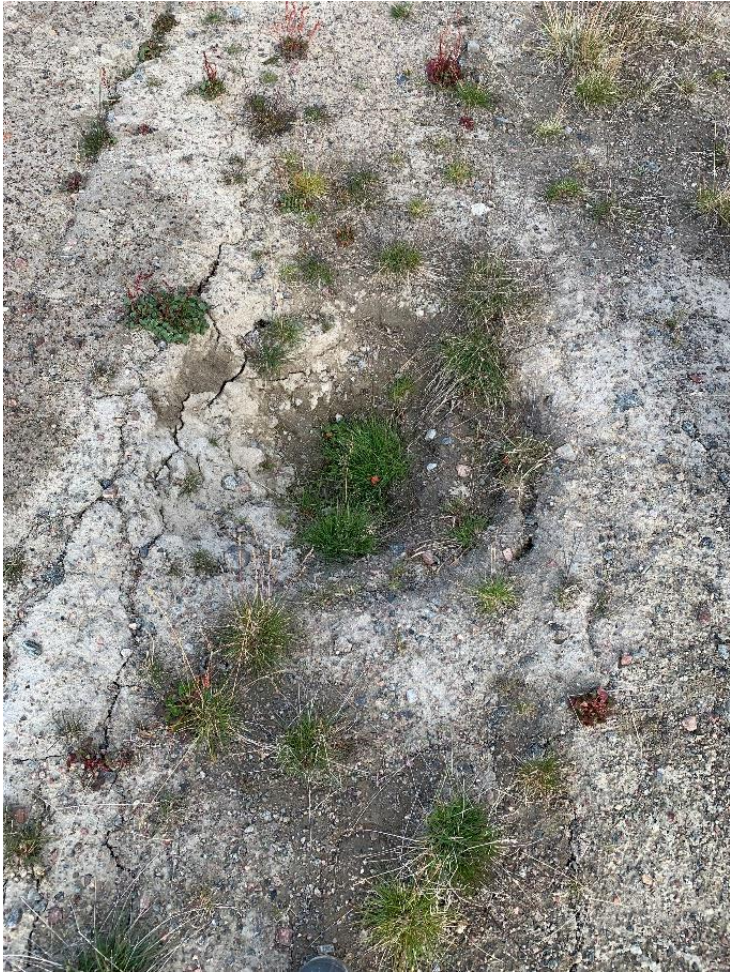
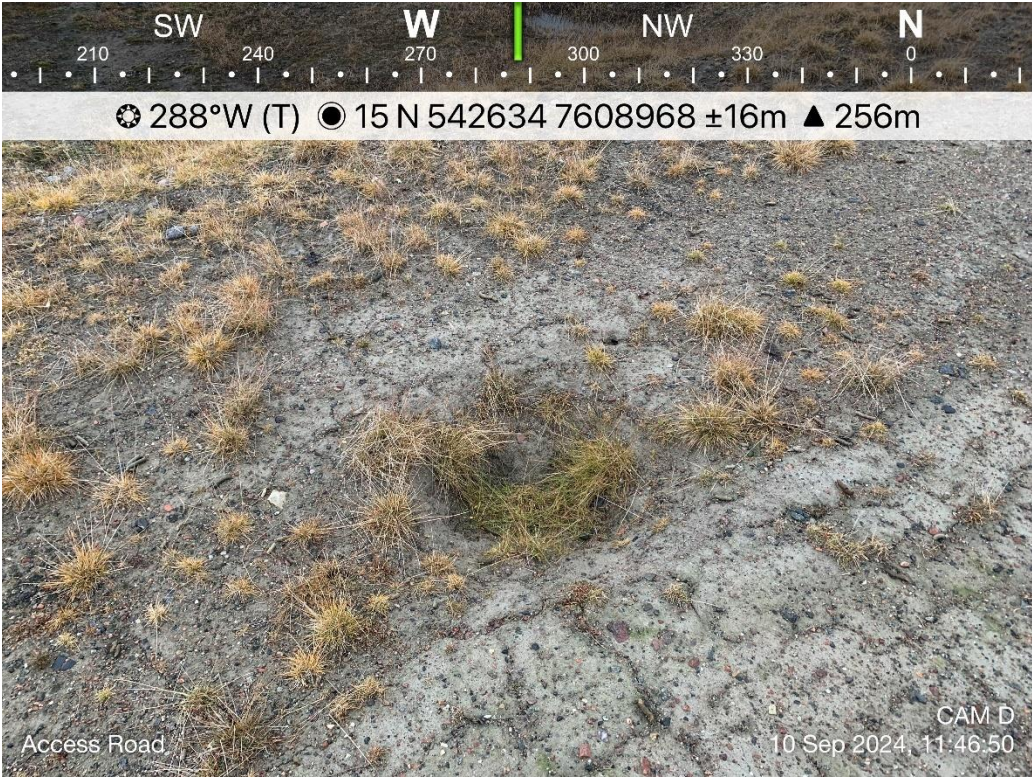
Comparison No. 17	Previous Condition	Date 8/6/2022 Direction Photo Taken N/A	Current Condition	Date 9/10/2024 Direction Photo Taken N/A
Description Access road sink hole. Sinkhole size is comparable to 2022 conditions (approximately 30 cm wide). Slight increase in revegetation.
