CAM-D Simpson Lake Long-Term Monitoring Report

Year 13

Project number: 60736036

March 31, 2025

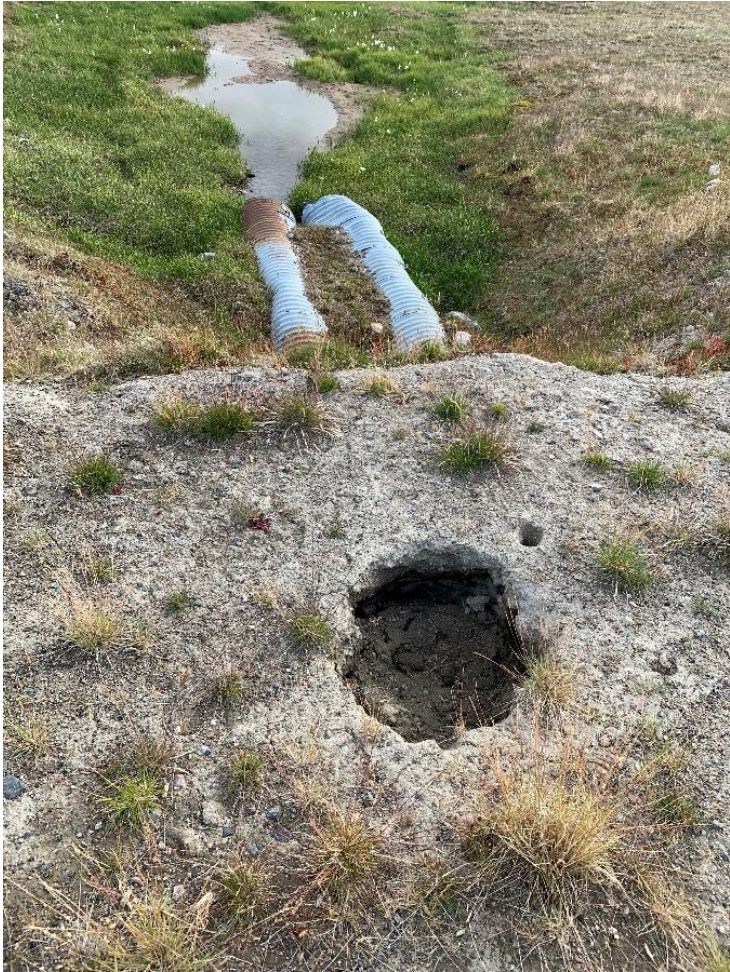
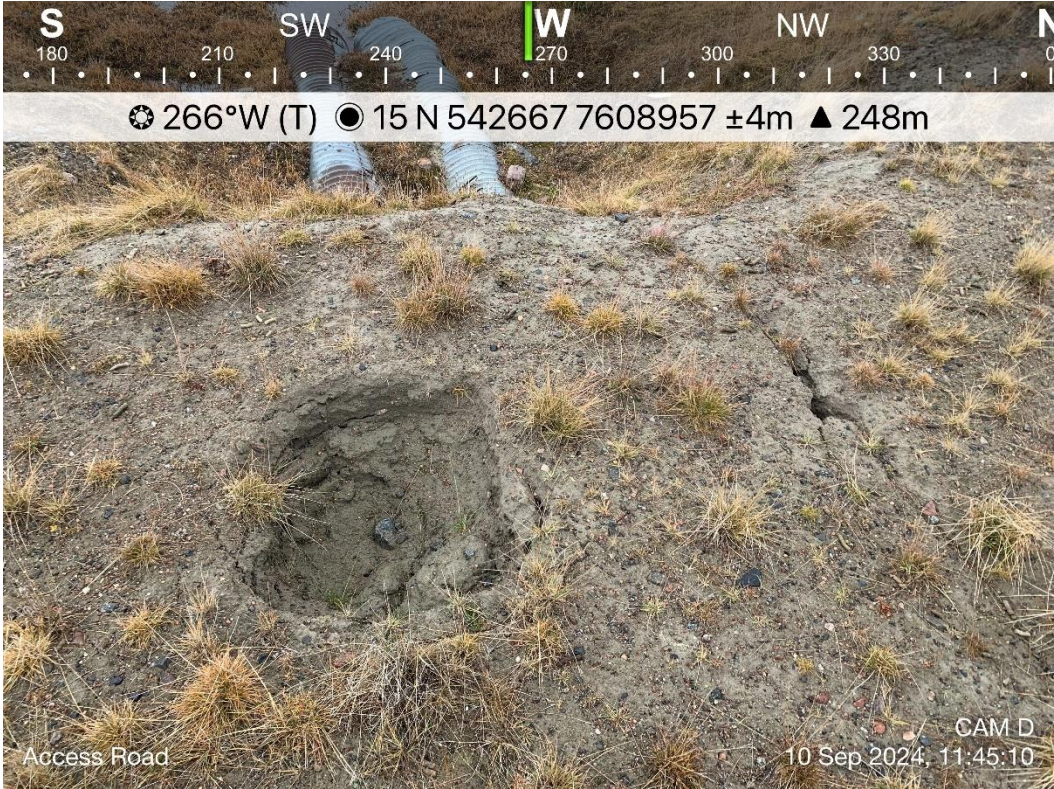
Comparison No. 18	Previous Condition	Date 8/6/2022 Direction Photo Taken West	Current Condition	Date 9/10/2024 Direction Photo Taken (see photo header)
<p>Description</p> <p>Settlement hole above culvert (Note: previously misidentified as a sinkhole in Year 11 LTM Report, originated as a siksik burrow and has progressed into a settlement hole).</p> <p>Settlement hole is expanding and collapsing in on itself (approximately 40 cm wide).</p> <p>Headslope of outlet is sloughing onto the top of the twin culverts.</p> <p>Slight increase in revegetation.</p>

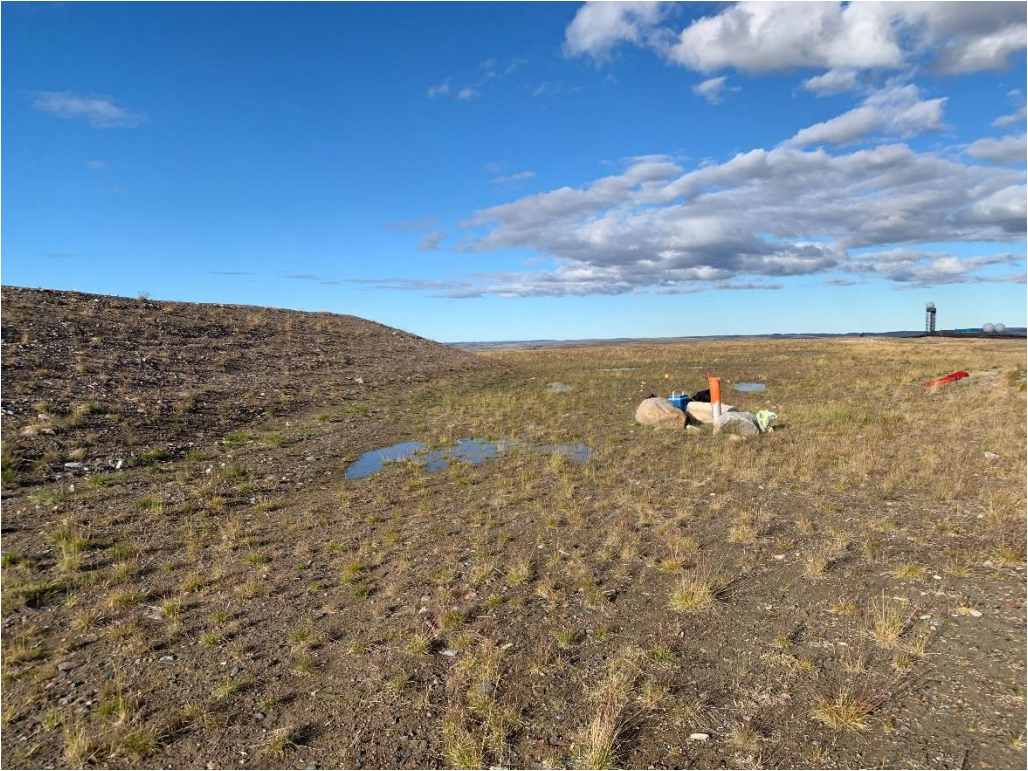
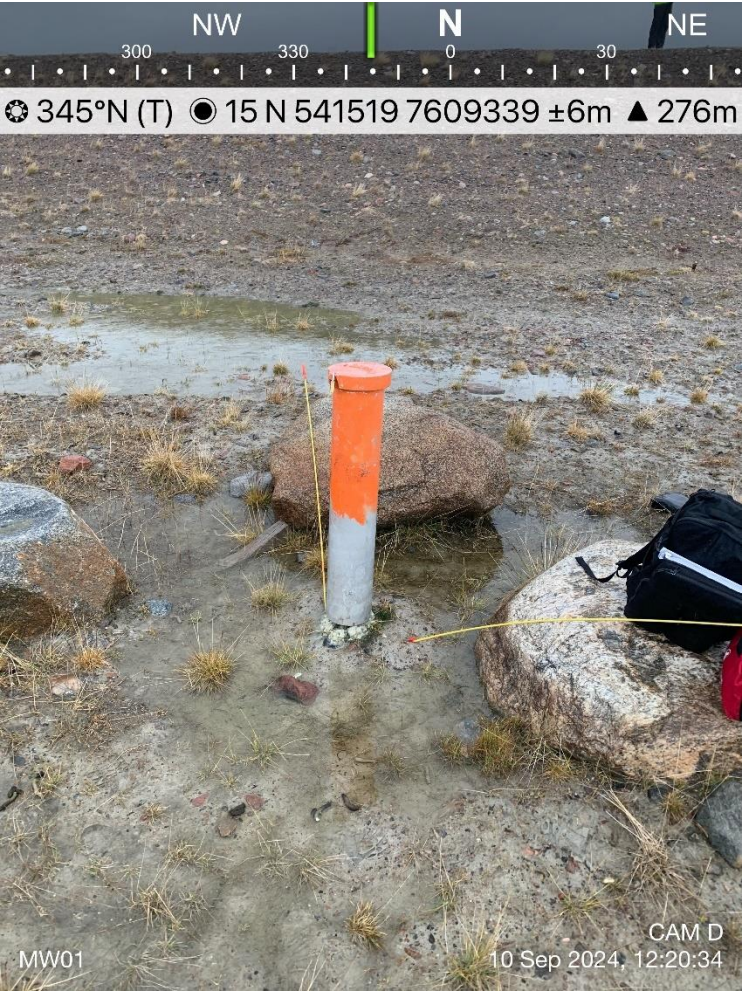
Comparison No. 19	Previous Condition	Date 8/6/2022	Current Condition	Date 9/10/2024
		Direction Photo Taken North		Direction Photo Taken (see photo header)
Description MW01. MW01 casing has heaved and bentonite seal is now exposed at the ground surface. Pooling water observed surrounding the MW01 installation and surrounding area. It was noted on-site that sand within casing had heaved and covered the internal well cap.

- MW01 shows signs of heave (10cm)
↳ bentonite seal was exposed
- ring tension crack is between 4-5m from top/crest of NHWL
- MW04 and MW03 show signs of heave (10cm)
↳ bentonite seal exposed
- caribou tracks @ MW03
- wind up to 55+ kmh after 3pm
↳ very rainy
- on site 11:30am / off site 5:45pm
- gusts to 70 kmh, 8°C down to 2°C
↳ pilots said after shift

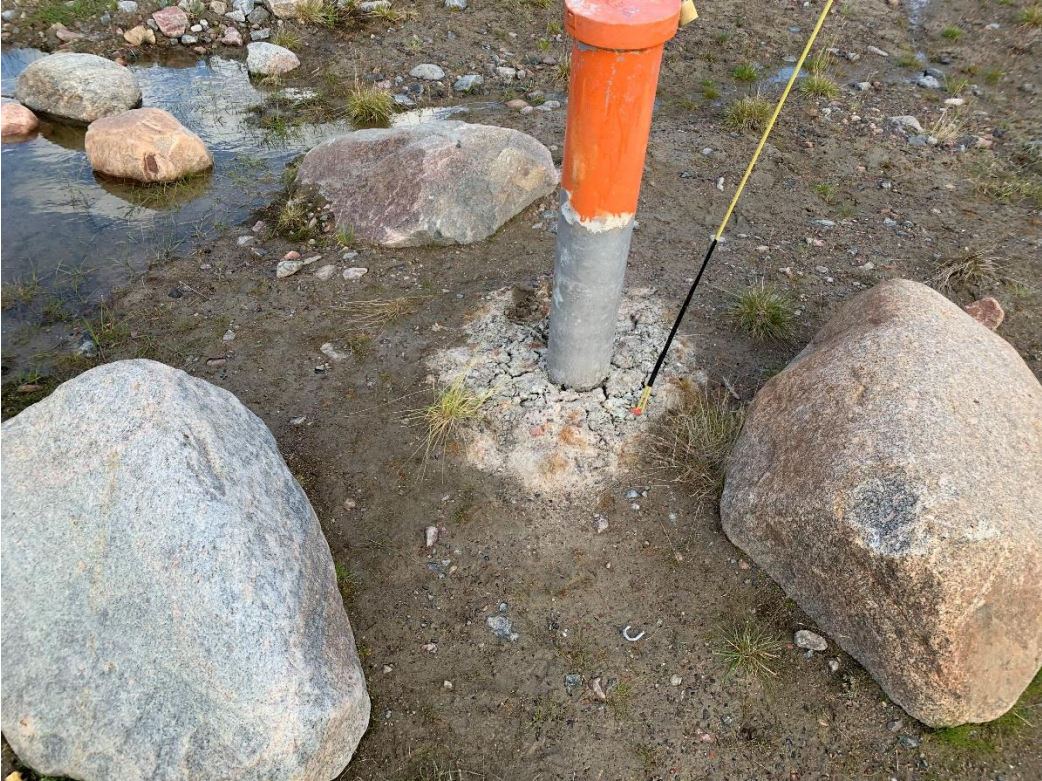
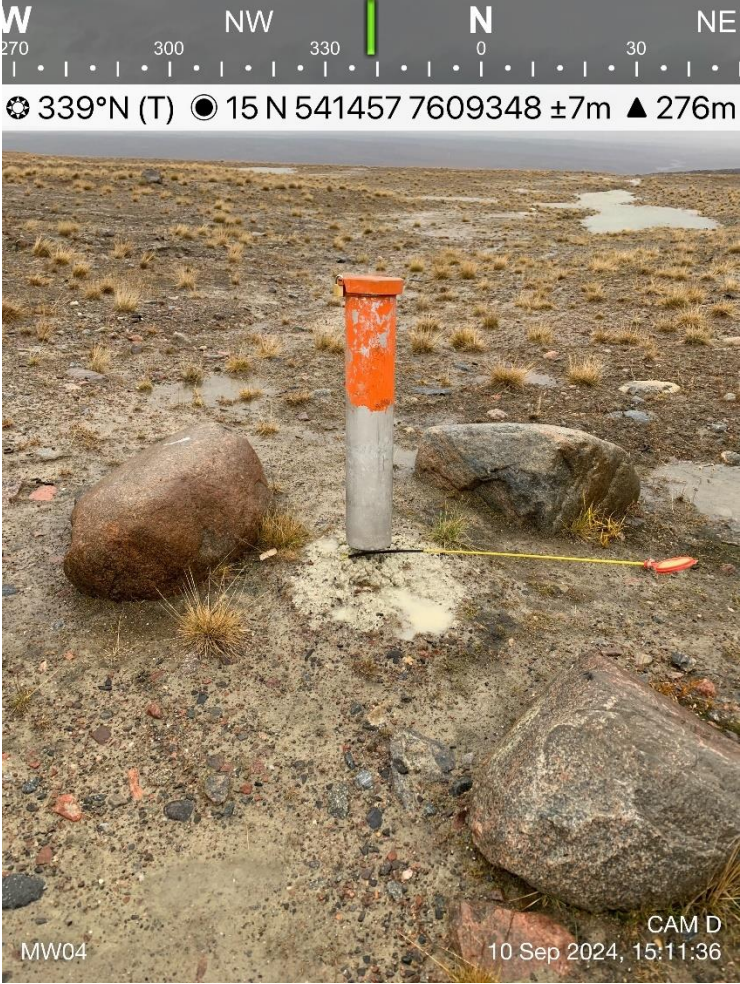
Comparison No. 20	Previous Condition	Date 8/6/2022 Direction Photo Taken N/A	Current Condition	Date 9/10/2024 Direction Photo Taken (see photo header)
Description MW04. Casing has heaved. Previously noted cracking covered by exposed and saturated bentonite.

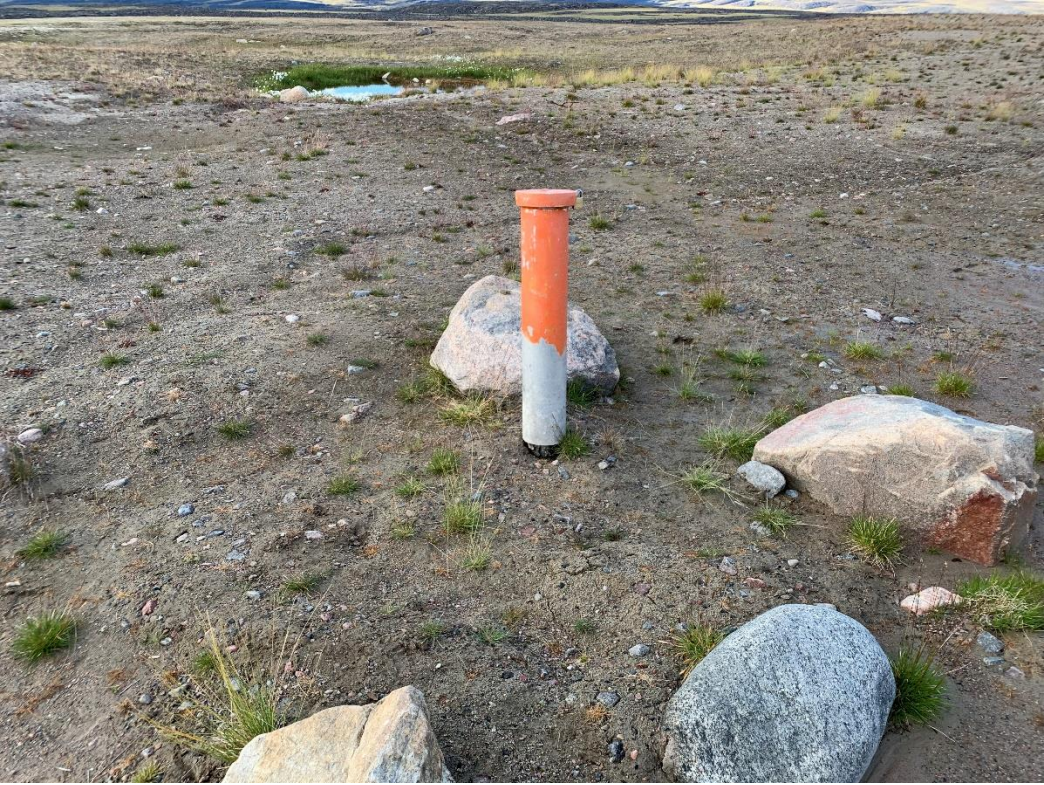
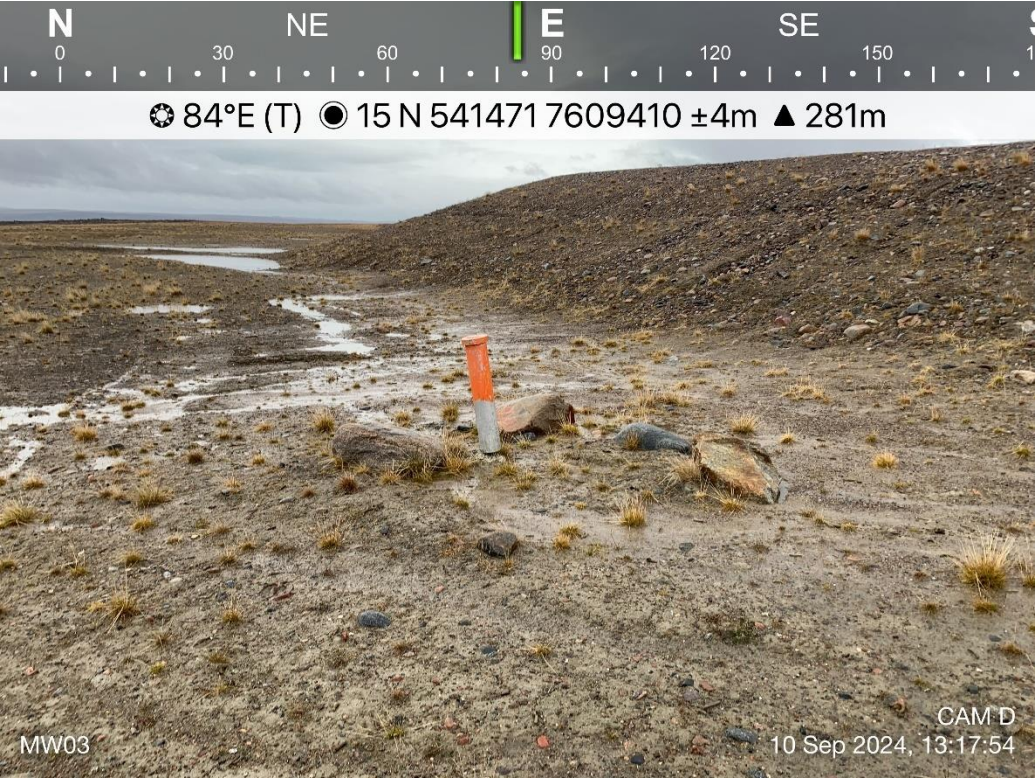
Comparison No. 21	Previous Condition	Date 8/6/2022 Direction Photo Taken N/A	Current Condition	Date 9/10/2024 Direction Photo Taken (see photo header)
Description MW03. Casing has heaved. In 2022 no exposed bentonite was observed at the ground surface. Bentonite seal is now exposed at the ground surface which suggests ongoing frost heave is pushing the bentonite seal out of the hole. Slight increase in revegetation of surrounding area.

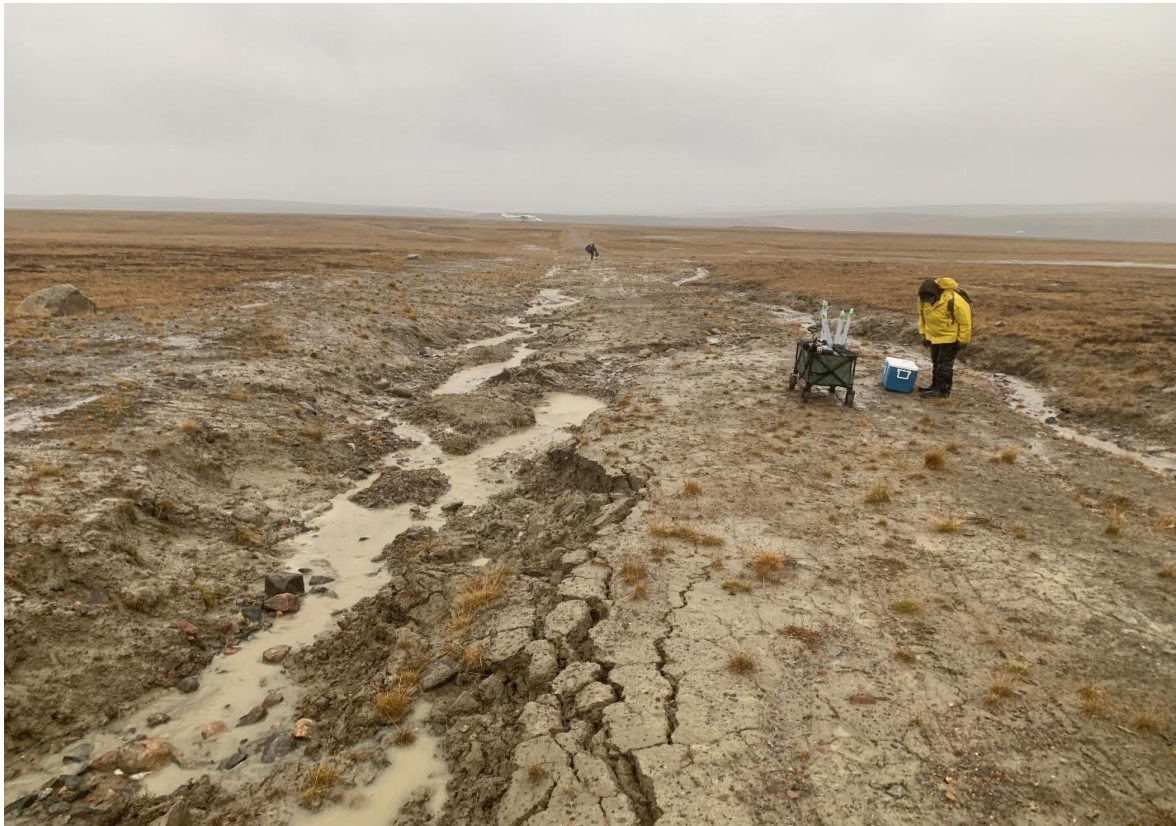
Photograph 1: Access road condition.

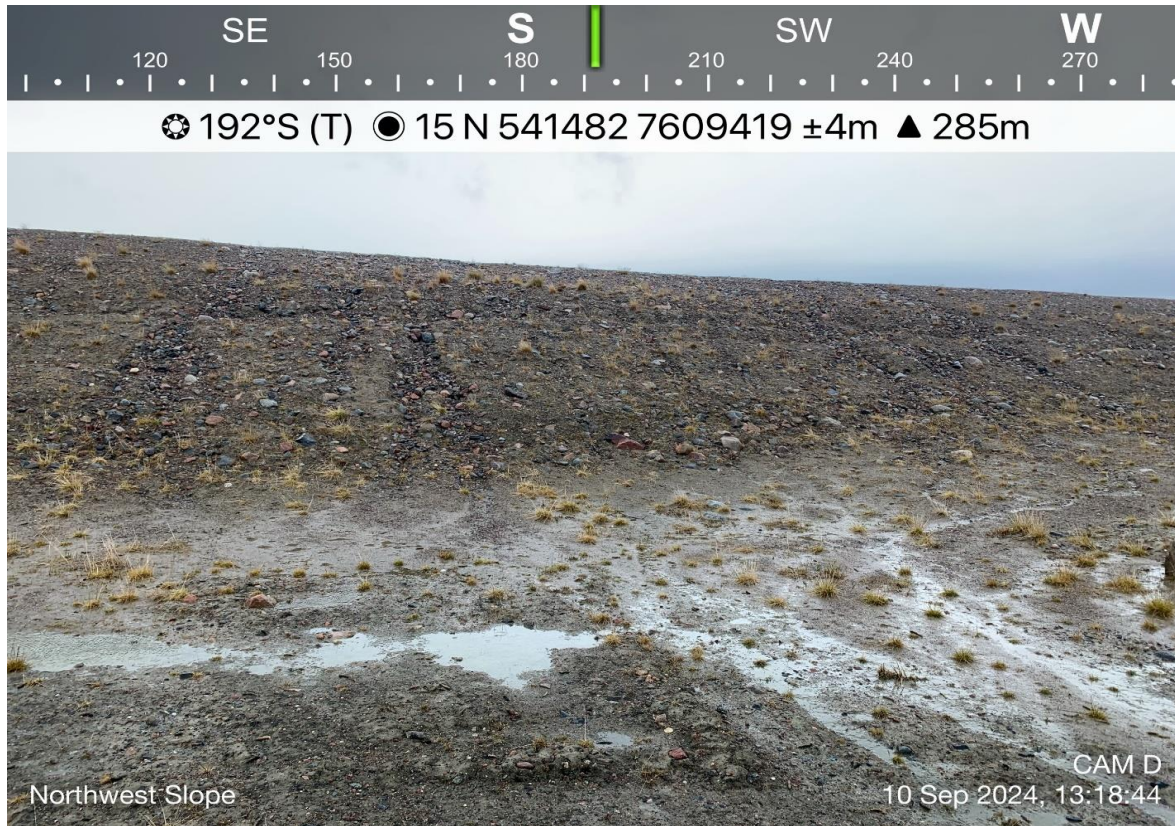
Photograph 3: Northwest landfill slope.

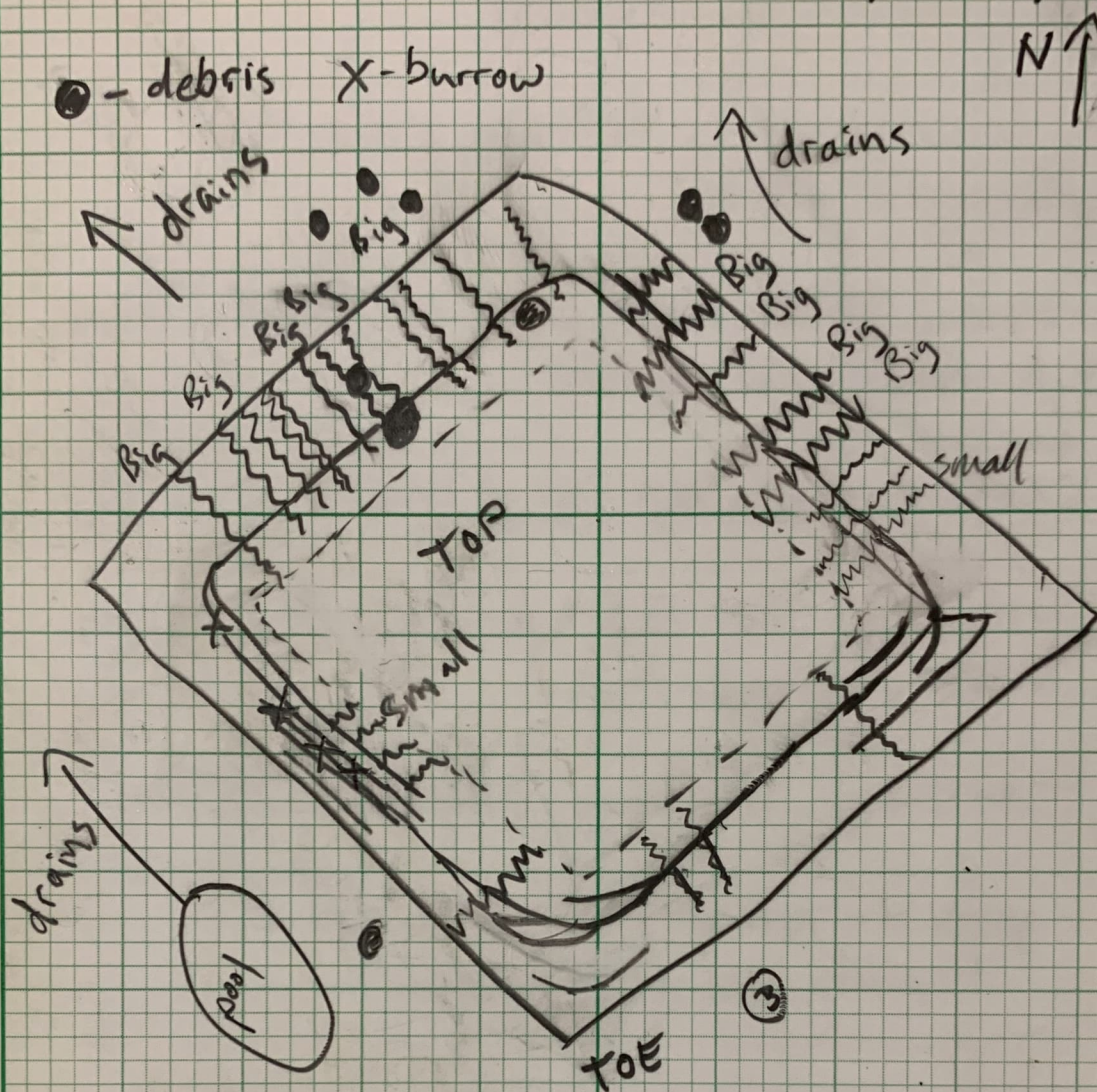
- NE slope has many small to medium sized erosion channels all draining to the North
- NW slope has many medium sized erosion channels all draining to the NW
- tension crack development is higher from 2nd half of NE slope, around N corner and along 1st half of NW slope
 ↪ max 30 cm deep, 30 cm wide
 ↪ CCW ↺
- 4 burrow in SW slope, evidence of shallow slough (many condensed tension cracks 10-20 cm wide)
- top has no debris, no cracks, some tight veg and animal droppings
