Remedial Action Plan
Former Navigational Aid and Weather Station
Radio Island, Nunavut

January 2006

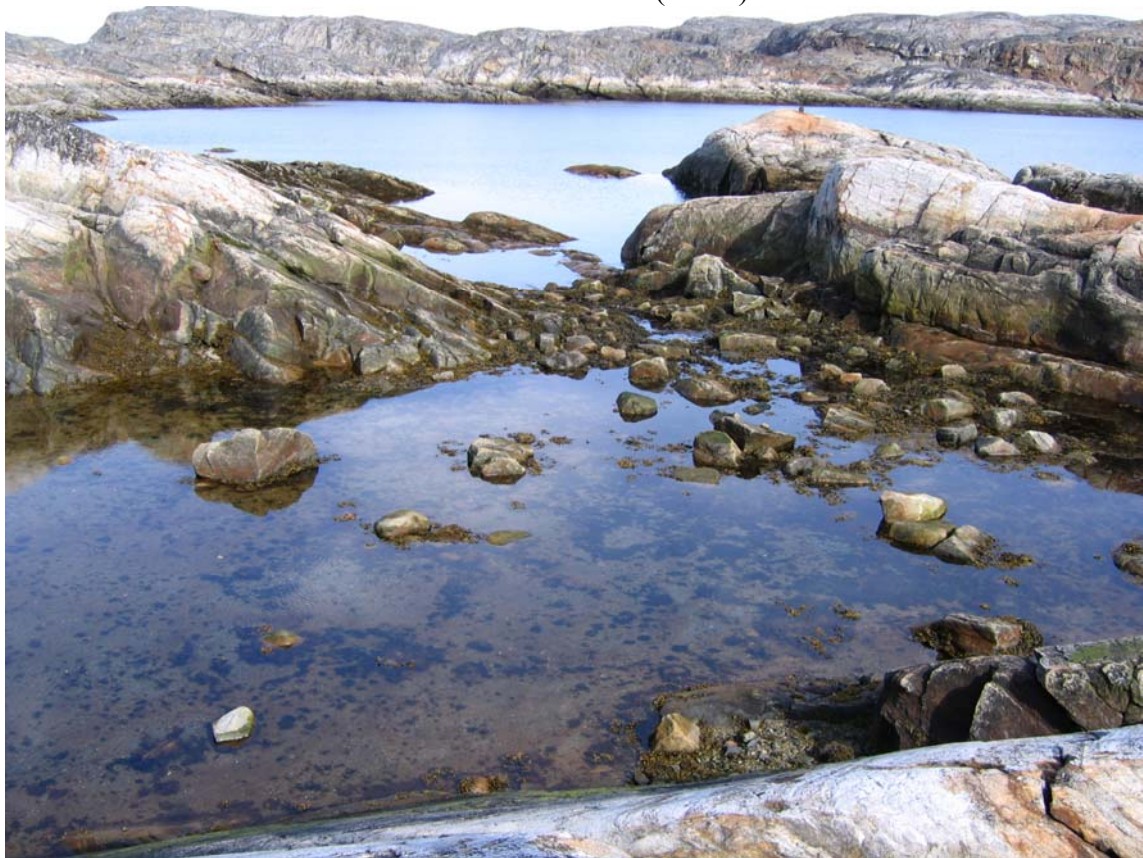
View of Acadia Cove and probable sea lift access location
