**NUNAVUT TUNNGAVIK
INCORPORATED**

MEMORANDUM

To: Carson Gillis – Director of Lands and Resources
Re: HBJV - Windy Lake Camp – Petroleum Product Spill
Date: August 29th, 2002

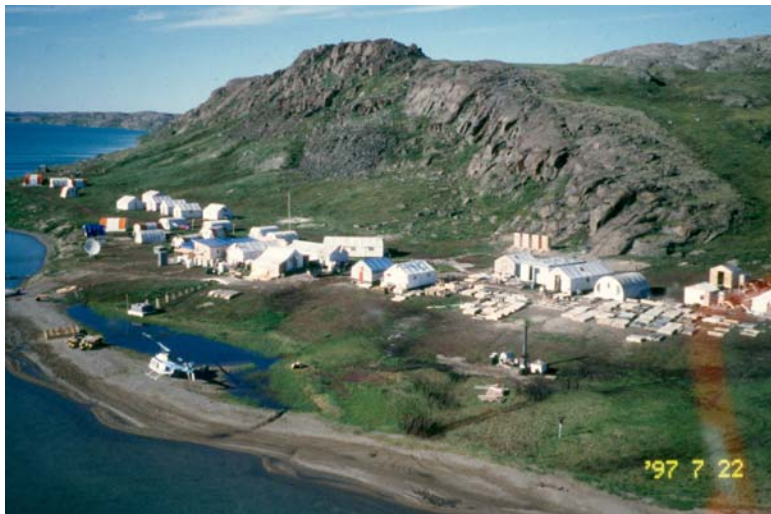
While in the Windy Lake Camp, it was requested that I follow-up the investigation of a petroleum product spill that occurred on August 1st, 2002. The following short report and accompanying digital photos are the results of that investigation. The information was received from Darren Lindsay, the Project Geologist, while I received a tour of the site.
