June 4, 2010

Project No. 1584-0902

RE: Iqaluit Airport Land Treatment Units (LTUs) As-built inspection results (LTU C & LTU D)

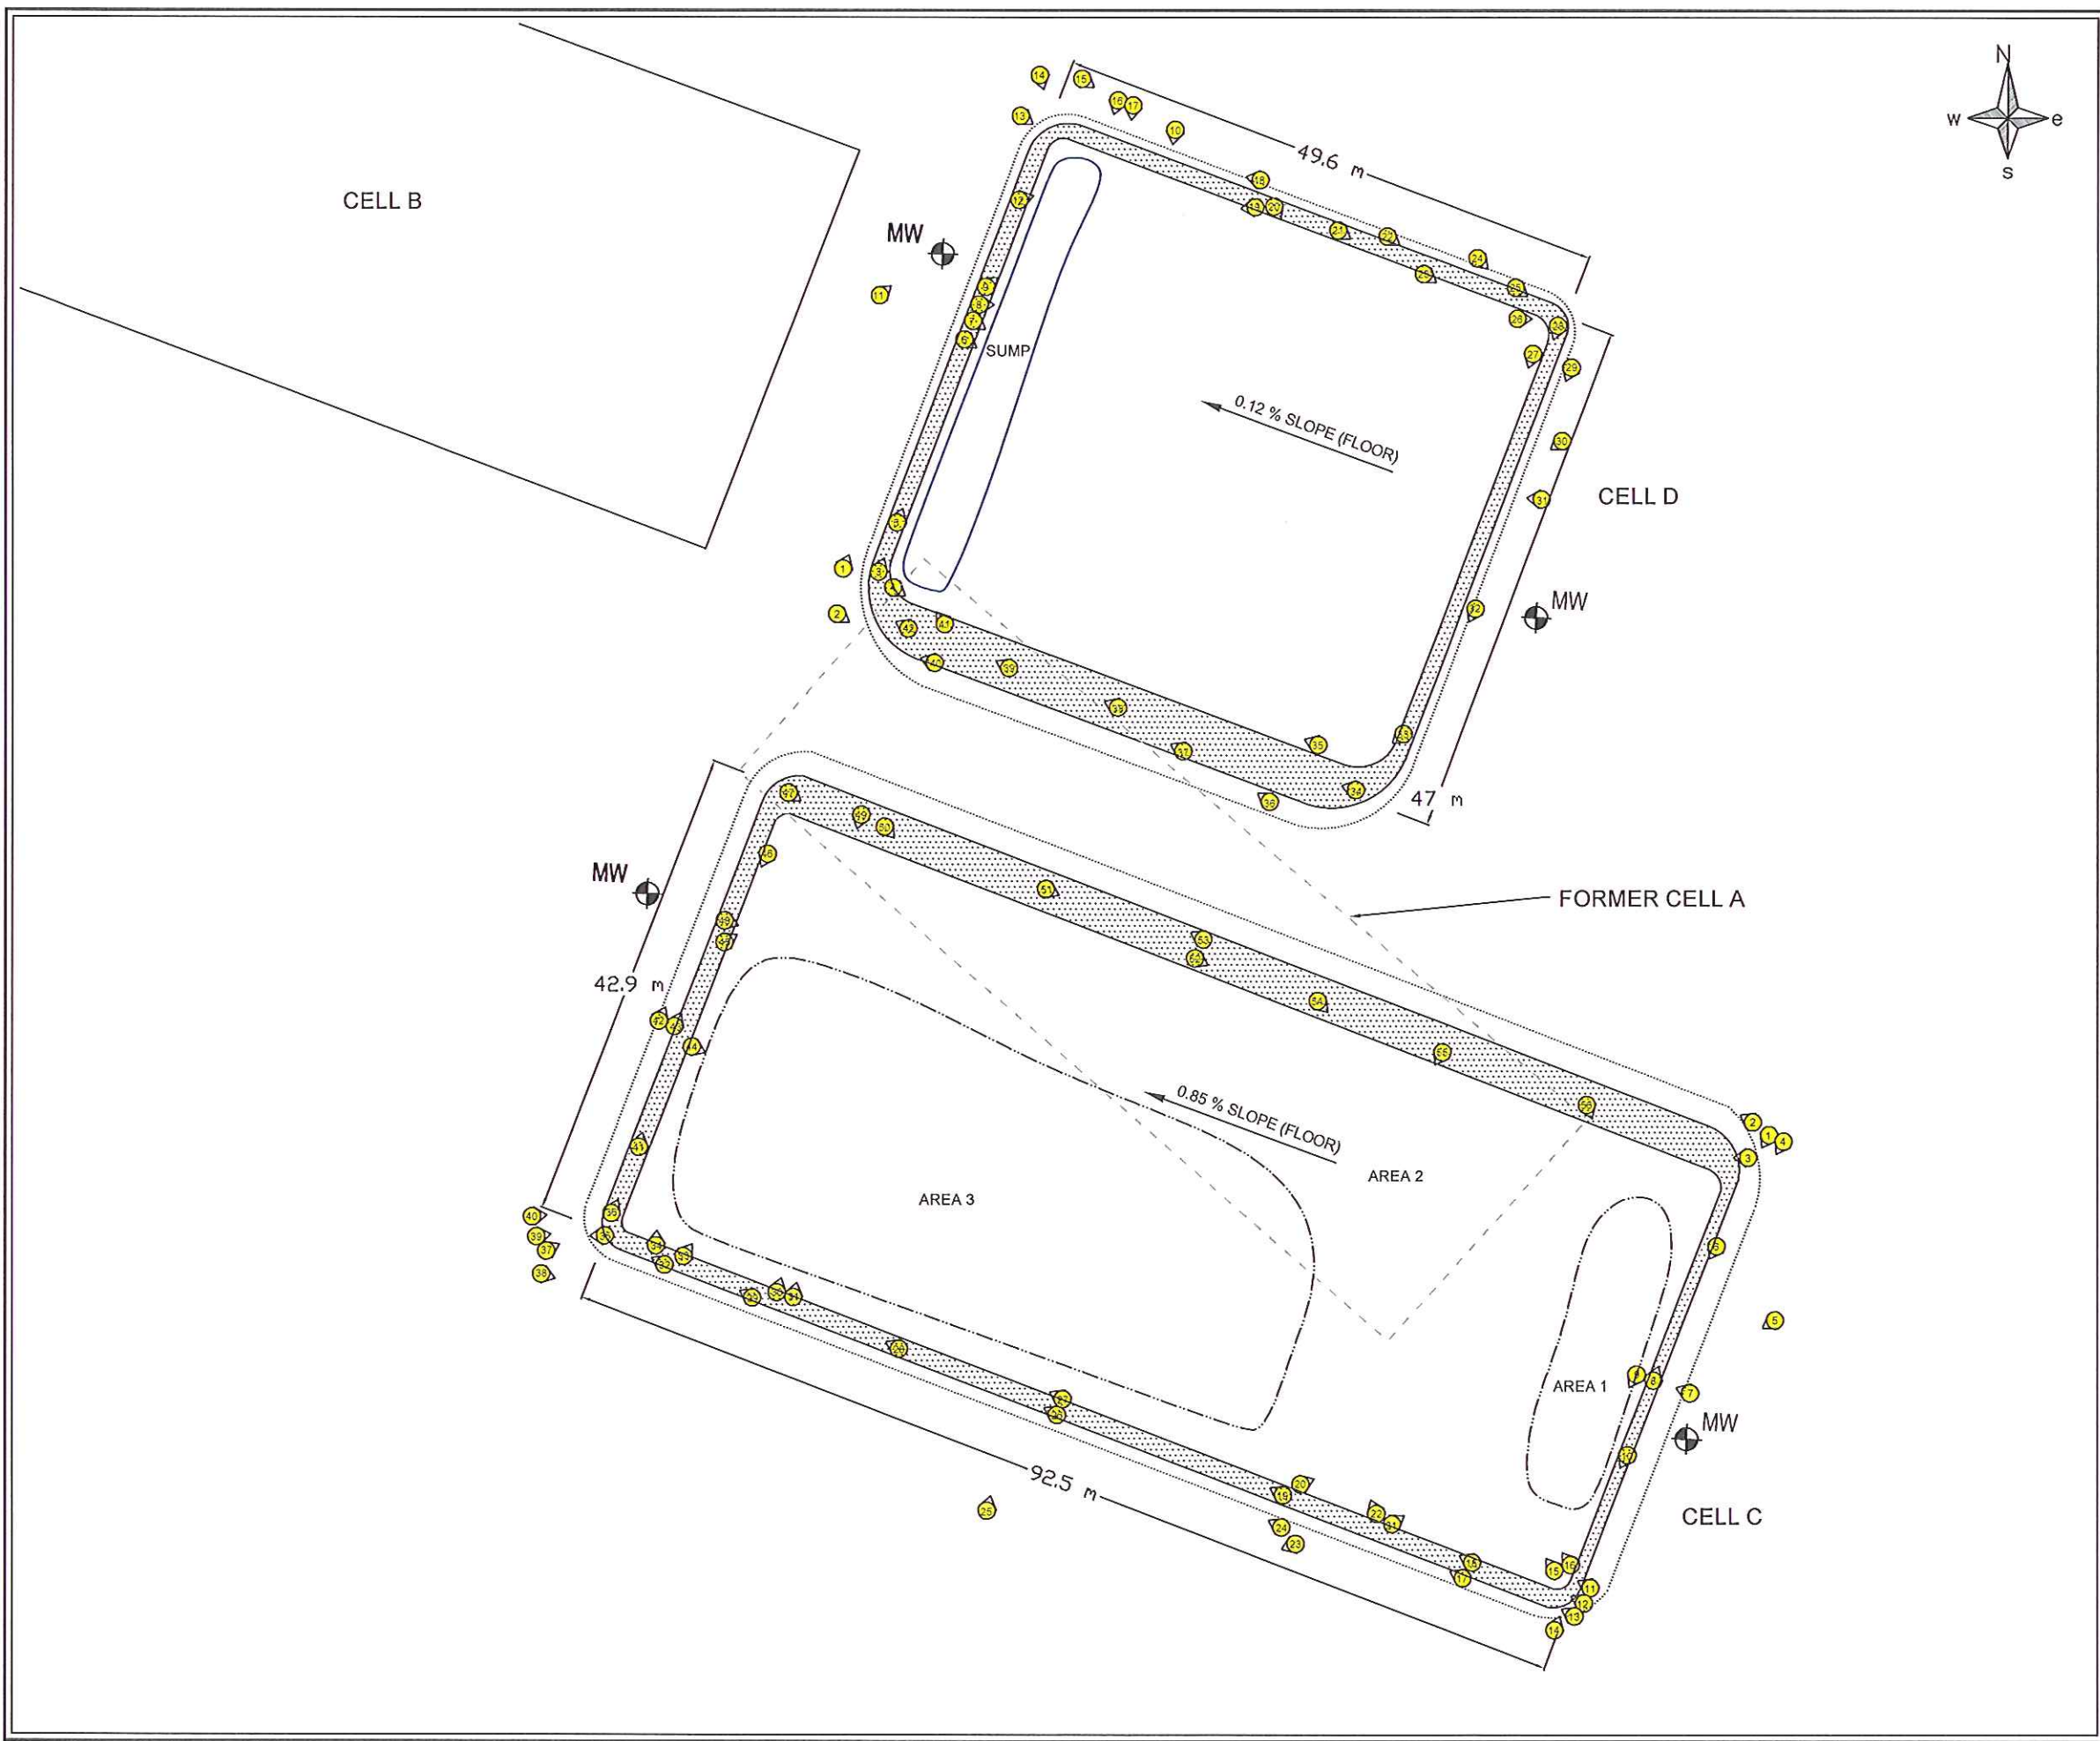
FIGURE 2

- Cell contains soil piled in the down-gradient sump area (Area 1 – See Figures 2, 3, and 4); therefore, inhibiting proper drainage of excess water
- Cell contains only one down-gradient monitoring well, while two were indicated on the design specifications
- Soil depths exceed the specified maximum of 1 m in Area 1 (See Figures 2, 3, and 4)
- Some larger pieces of asphalt and/or concrete exist in the impacted soils

1. Soil piled in the sump area of LTU Cell C should be removed and spread out across the cell to allow for adequate drainage and achieve desired maximum soil thickness of 1 m
2. Additional fill material should be added to the NE and SE berms of LTU Cell D to ensure adequate anchoring of the liners incase of high wind events
3. Soil berms in Cell D should be reinforced with additional fill material to obtain the specified 50% grade to ensure structural integrity incase of high precipitation events
4. Larger items (concrete and asphalt) should be removed to allow for adequate aeration of the material.
