**RE: Final Plan – Vale Exploration Canada Inc. NWB Water Licence 2BE-MVP1217**

## **Melville Project**

# **Annual Report & Final Closure and Restoration Plan**

Water Licence 2BE-MVP1217

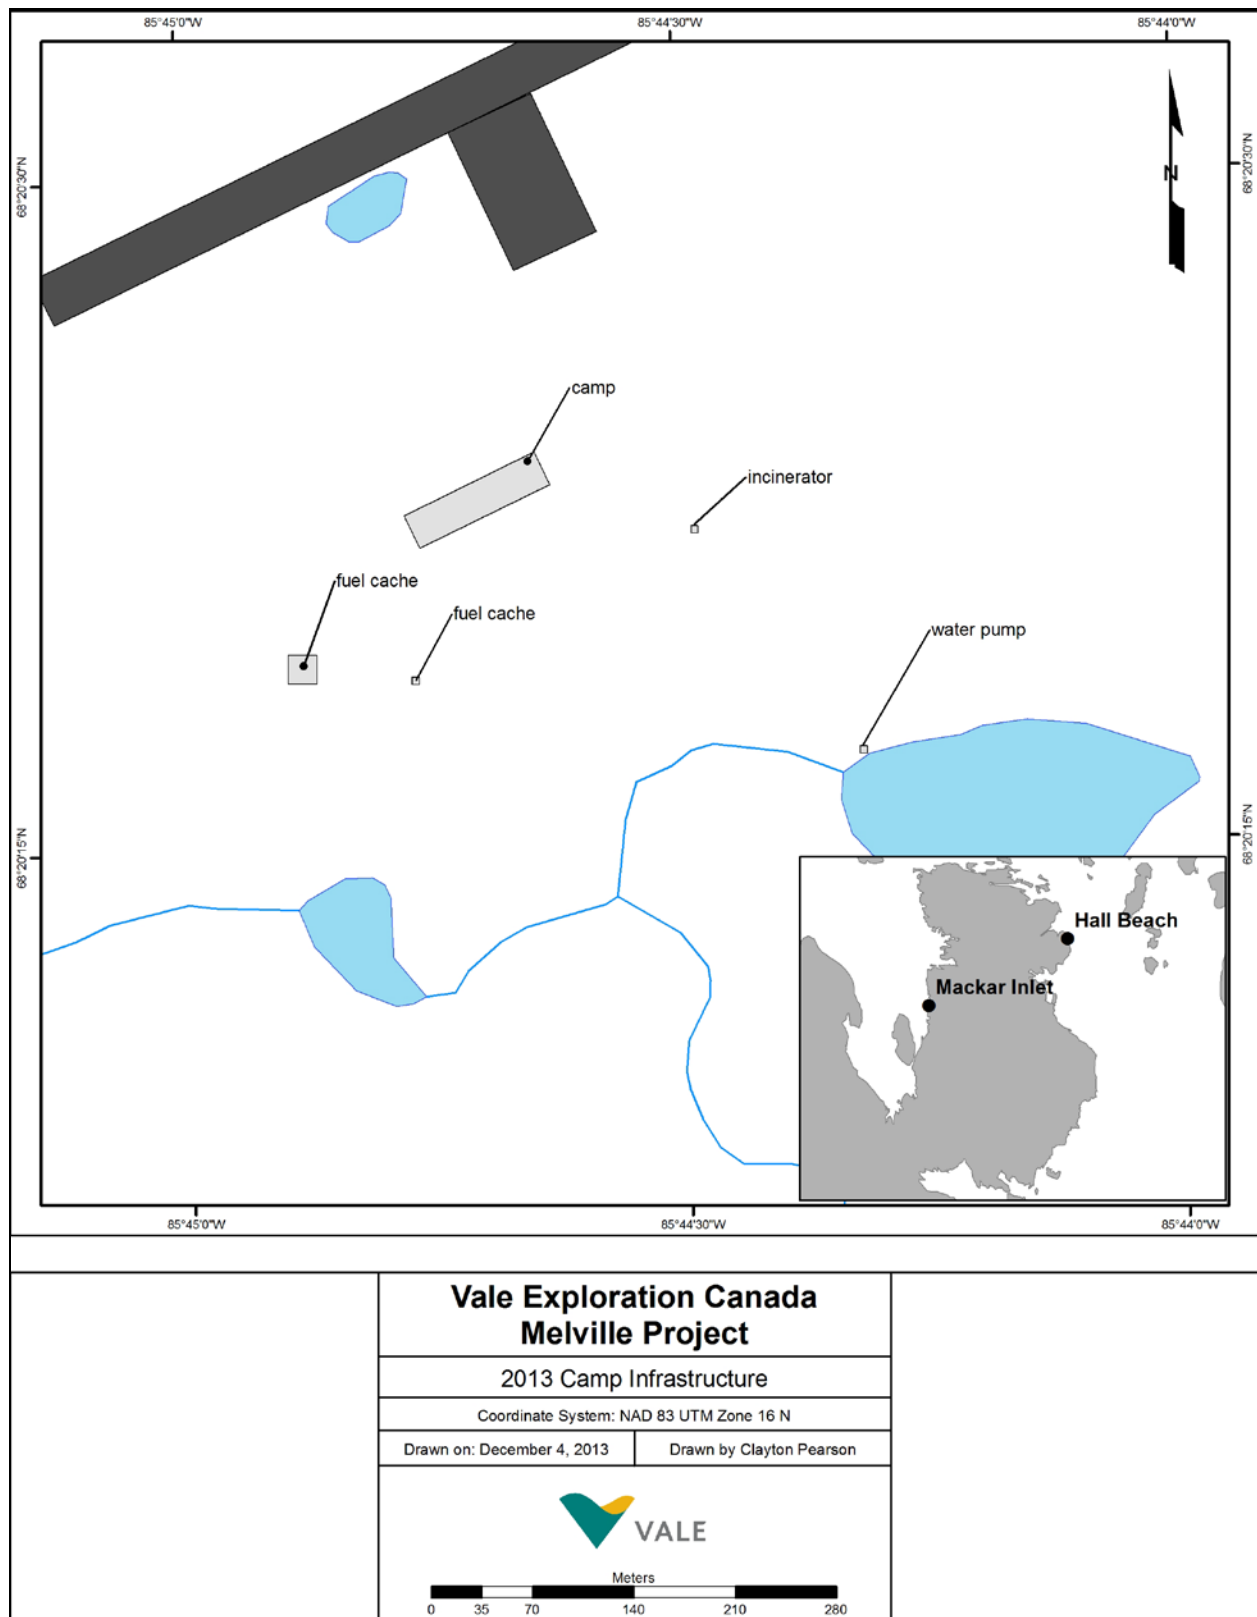
**Figure 2** Map showing location of camp infrastructure

The total area of Crown land occupied is 0.2975 ha, broken down as follows: 0.25 ha for the camp, 0.0425 for two fuel caches, 0.0025 for the pump site, and 0.0025 for the incinerator site.
