PHASE 2 OF THE HOPE BAY PROJECT
DRAFT ENVIRONMENTAL IMPACT STATEMENT

2008 Roberts Bay Fisheries Authorization Monitoring Report

**2008 ROBERTS BAY JETTY
FISHERIES AUTHORIZATION
MONITORING REPORT**

- FINAL REPORT -

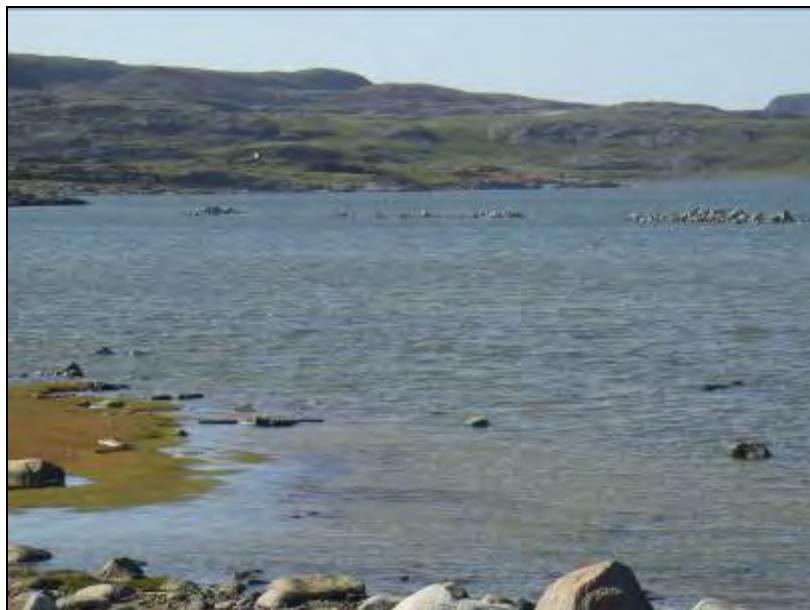
Photo 2.26 Looking South-East at Compensation Structures, 13 July 2008. Note the Structures are Settling as the Ice Below Them Melts.

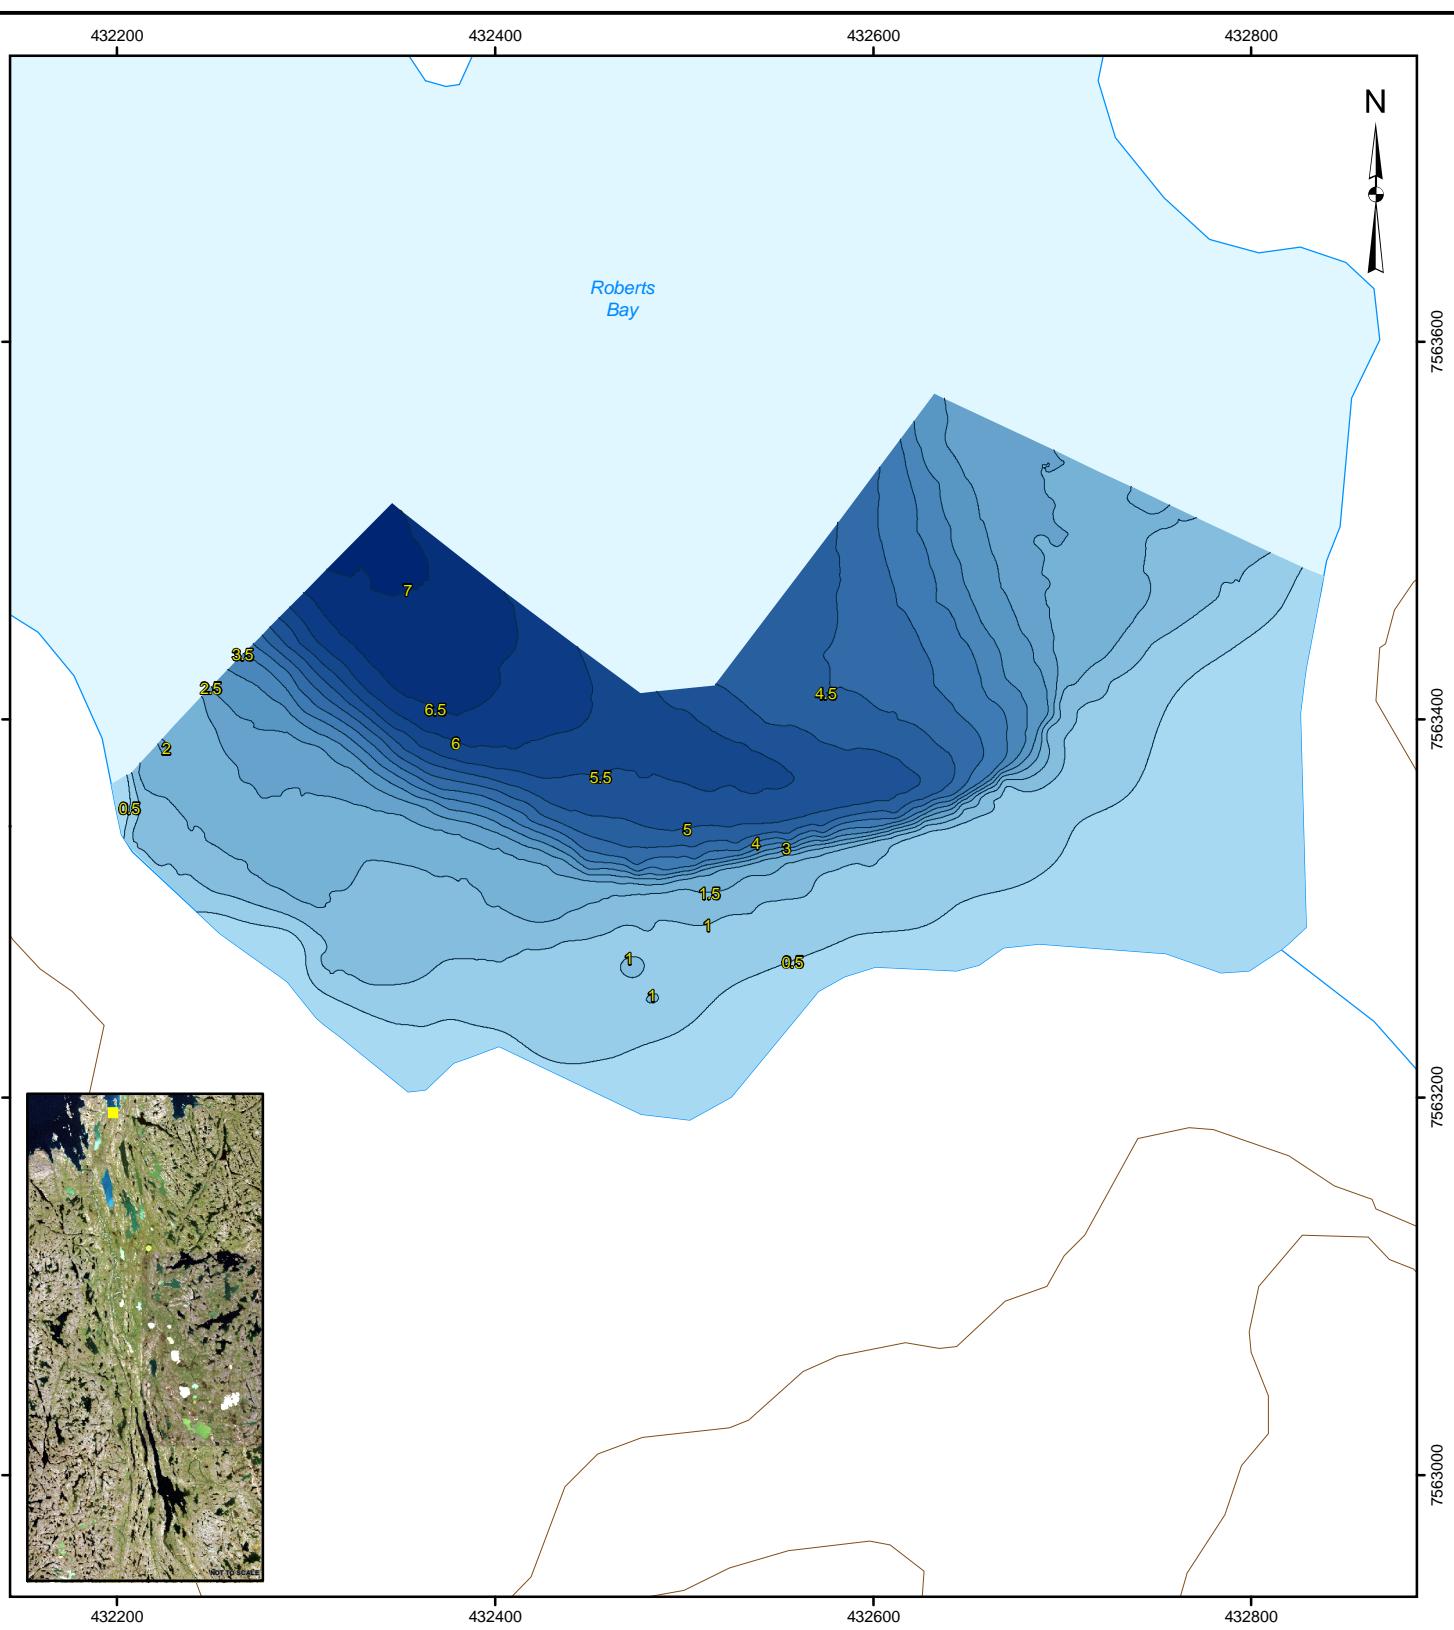
Major changes to bed elevations occurred in the area where the jetty and fish habitat compensation shoals were constructed (Figure 3.3). Shoal modifications occurred in the area between the 0.5 and 2.0 m isobaths in the jetty area of the bay. The shoal locations are visible west of the jetty on the map presented in Figure 3.2.

At the jetty, the greatest changes occurred at its north end, where the jetty is in the deepest water with the steepest natural bed slope. Here, the increase in bed elevation is between 1 and 4 m. Bed surface elevations at the shoals have increased by 0.3 to 1.0 m relative to the natural bed elevation before rock placement (Figure 3.3).

On the west side of the jetty, the majority of the surveyed area showed little change in bed elevation, with measured differences mainly being between -0.1 and 0.1 m. East of the jetty, the bed elevations showed little change for the shallow, nearshore areas (Figure 3.3).

Only a small area in the steep slope region west of the jetty showed lower bed elevations in 2008, of between -0.1 and -0.3 m compared with the 2006 surveys (Figure 3.3).

The steep slope region east of the jetty displayed a larger area with bed elevations between -0.3 and -0.5 m lower in 2008 than in 2006, with a smaller area with bed elevations reduced by between 0.7 and 0.9 m. East of this area, the bed elevations over the steep slope showed values increased by 0.5 to 1.0 m for a small area.
