Water Licence Inspection Report

Authorization	Representative
Sabina Gold & Silver (B2Gold)	Christoph LeGoffe
Authorization No. / Expiry	Representative's Title
2AM-BRP1831/December 31, 2031	Environmental Superintendent
Inspection Date	Inspector
March 18-20	James Bolt
Other Authorization/s	
2BE-GOO2028, 2BE-GEO2025, 2BE-MLL2328, N2024C0024, N2024F0027, Goose Lease 076G9-1-2, MLA Lease 076J12-7-2	
Activities Inspected	
<input type="checkbox"/> Municipal <input type="checkbox"/> Camp, Commercial <input type="checkbox"/> Drilling <input checked="" type="checkbox"/> Mining <input type="checkbox"/> Construction <input type="checkbox"/> Reclamation <input checked="" type="checkbox"/> Fuel Storage <input checked="" type="checkbox"/> Roads/Hauling <input checked="" type="checkbox"/> Winter Hauling <input type="checkbox"/> Camp, Private <input type="checkbox"/> Other Click or tap here to enter text.

On March 18, 2025 Resource Management Officer Isaiah James Bolt (Inspector) for Crown Indigenous Relations and Northern Affairs Canada (CIRNAC), conducted an inspection of 2AM-BRP1831 (License) issued to B2Gold (Proponent) to ensure compliance against their license.

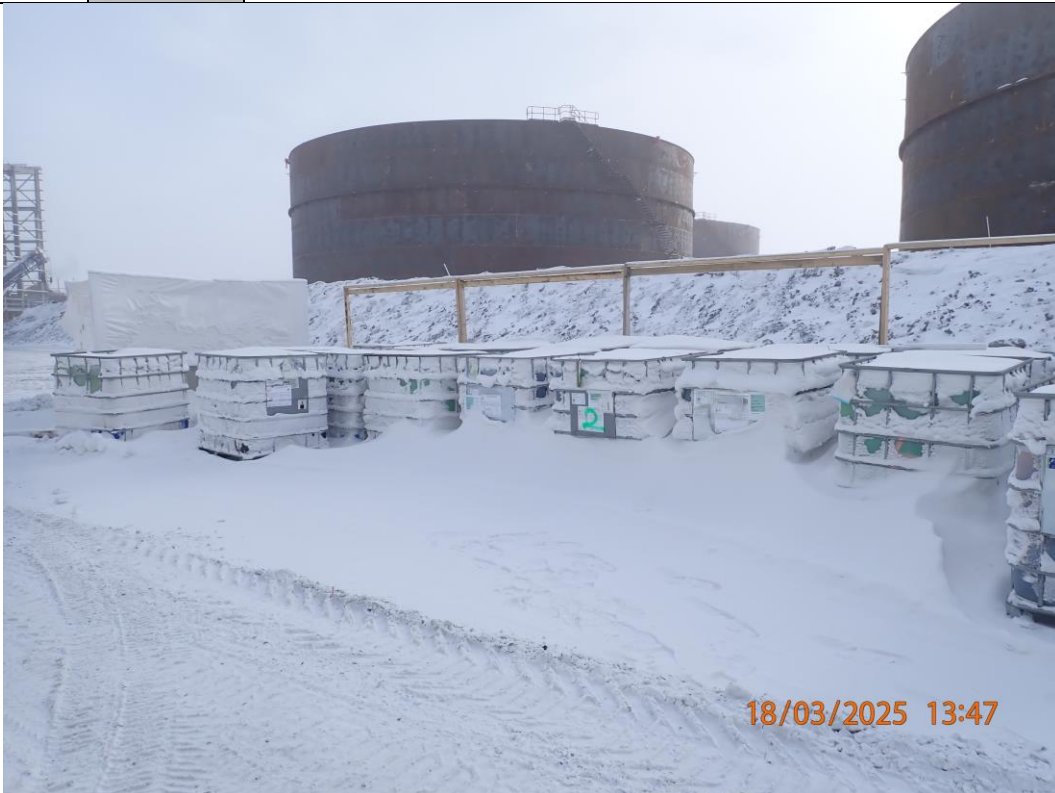
Photo # 21

2. The totalizer at the water intake barge had been observed and photographed.
3. 1000L totes were observed stored outside of containment throughout the project (Photo #4,#7,#19,#21). (Photo#20 shows a stack of secondary containment designed for 1000L totes that are unutilized.)

1000L totes stored outside of containment on the north side of the tank farm at Goose camp.

- Ensure all fuel and oil vessels are placed in secondary containment.
- Ensure heating fuel on stands are placed in appropriate secondary containment.
- Ensure segregation of metals from open burn material and place in landfill or haul off site if required.
- Clean up and store contaminated soils from truck shops/garages to ensure contaminates/hydrocarbons are not making their way into the environment.
- Ensure all contaminated snow around site is consolidated and stored appropriately for treatment.
- Ensure signage is present on all discharge locations/sampling sites/monitoring stations.

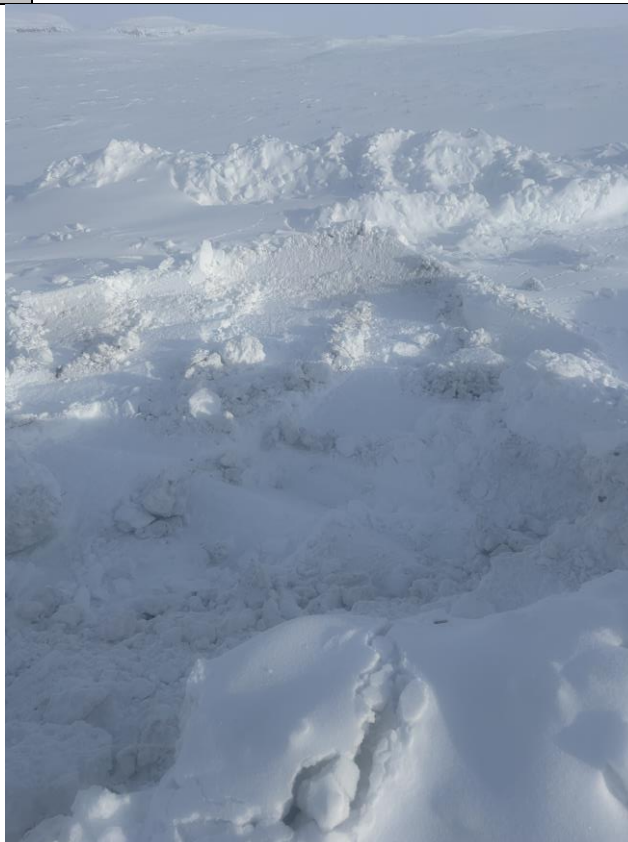
Photo # 25

Location of the tanker truck fire. Water used to extinguish fire observed on the ice.

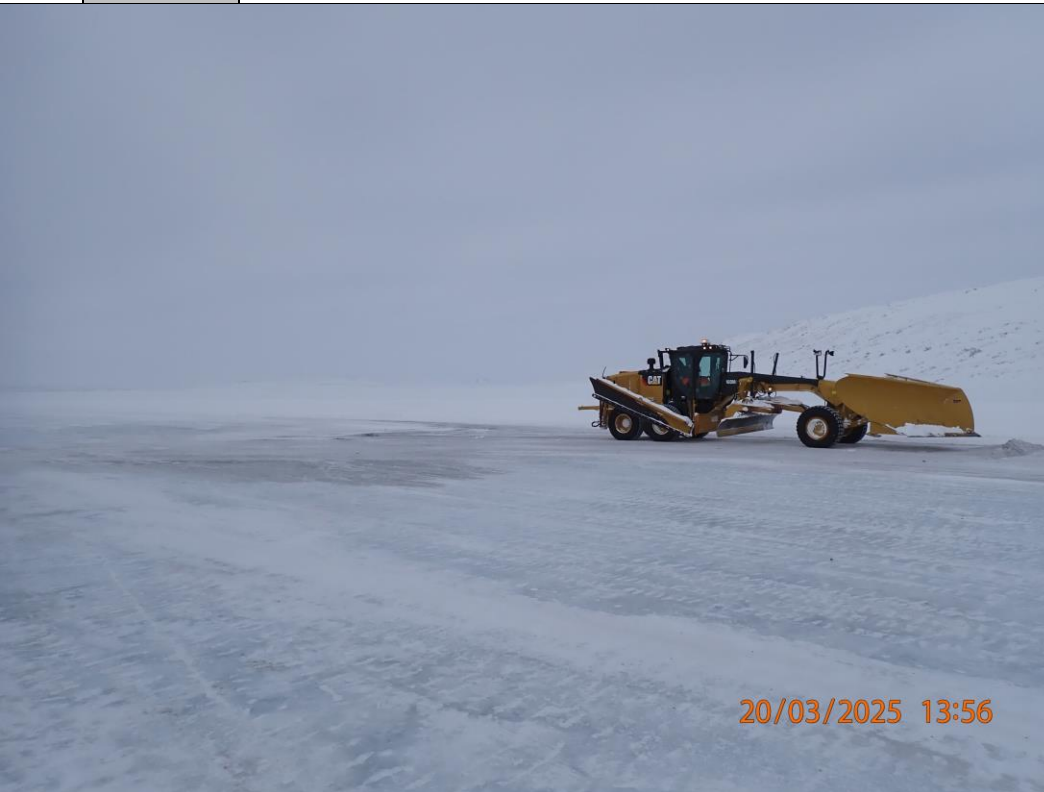
27

15. Inspector James Bolt and Chris LeGoffe of B2gold observed the location where a tanker trailer had tipped over (Spill-2025117, ECCC incident #325149) (Photos #22,#23,#24) show the location of clean up. Most of the contaminated snow had been excavated and removed. On March 25, 2025 Chris LeGoffe had sent me more clean up photos (Photo #25). More snow had been removed and he had mentioned there was no smell of fuel left over. All the snow that was removed had been placed in the tank farm at MLA for storage and eventual treatment.
16. A tanker truck had caught fire on the south side of the saddle on Bathurst Lake a day before inspection (Photo #26). The water run off from extinguishing the fire had become frozen to the lake and a dark stain was apparent. Inspector Bolt had mentioned that it would require a clean up and a grader was used to scrape up the contaminated ice (Photo #27).

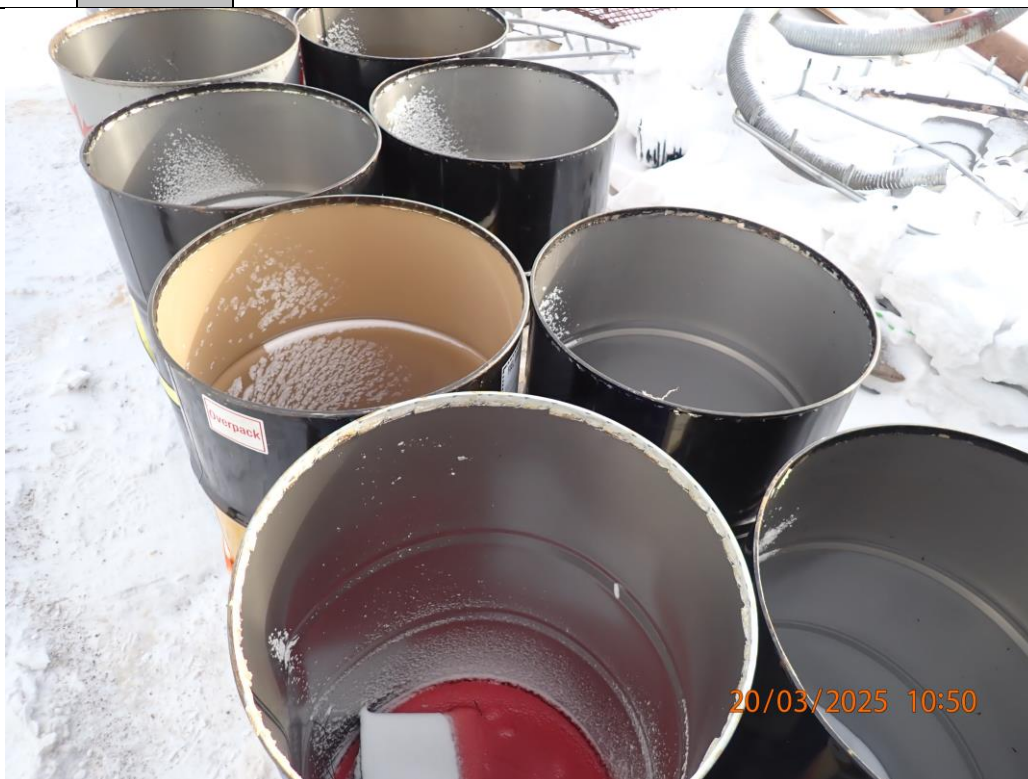
Photo # 31

18. An example of the new restrooms has been provided (Photo #29).
19. Pacto toilets are still utilized at MLA site. (Photo #30)
20. Behind the truck shop (North side) were open drums. 1 of which showed product at the bottom. Snow was observed in the drums (photo #31).

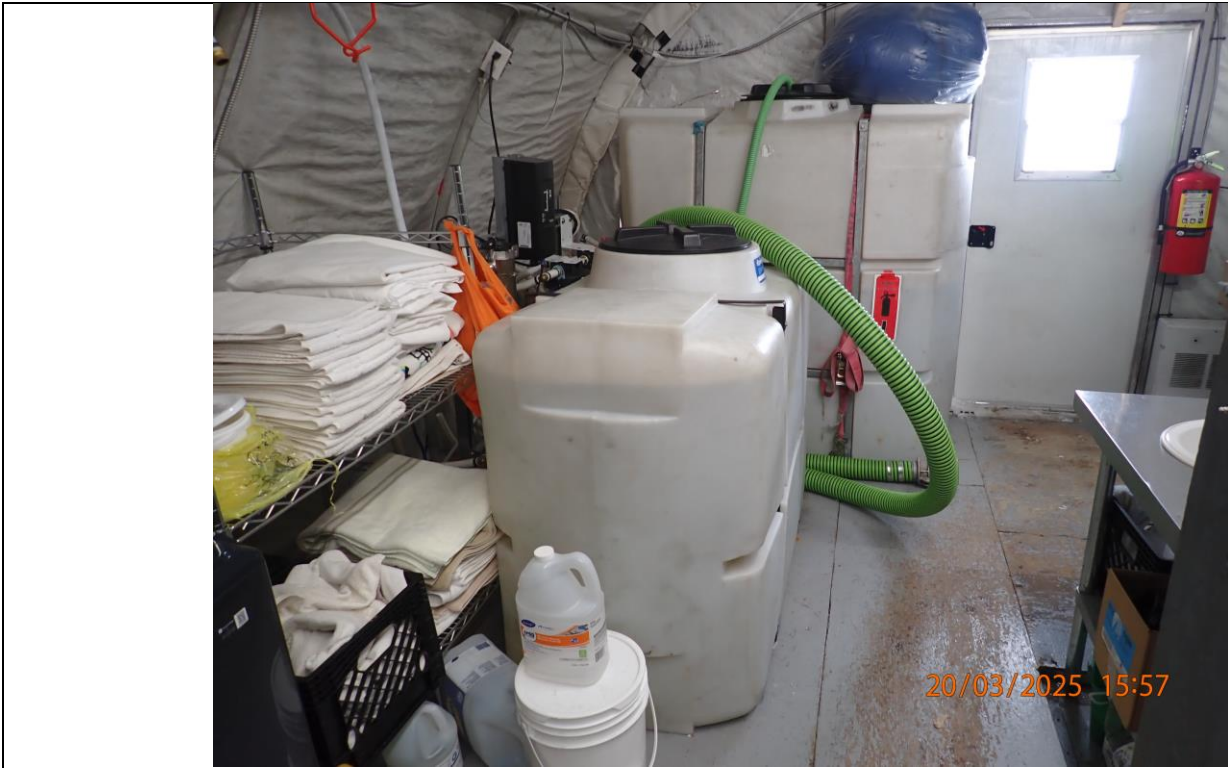
Photo # 52

35. Photos of the water storage tanks inside the tent were taken (Photo #52) No concerns noted. The tanks provide water to the showers, sinks, kitchen and washing machines. A photo of the hot water heater was taken (Photo #53). A photo of the water treatment system were taken (Photo #54).

Water tanks inside the tent at Goose Forward.

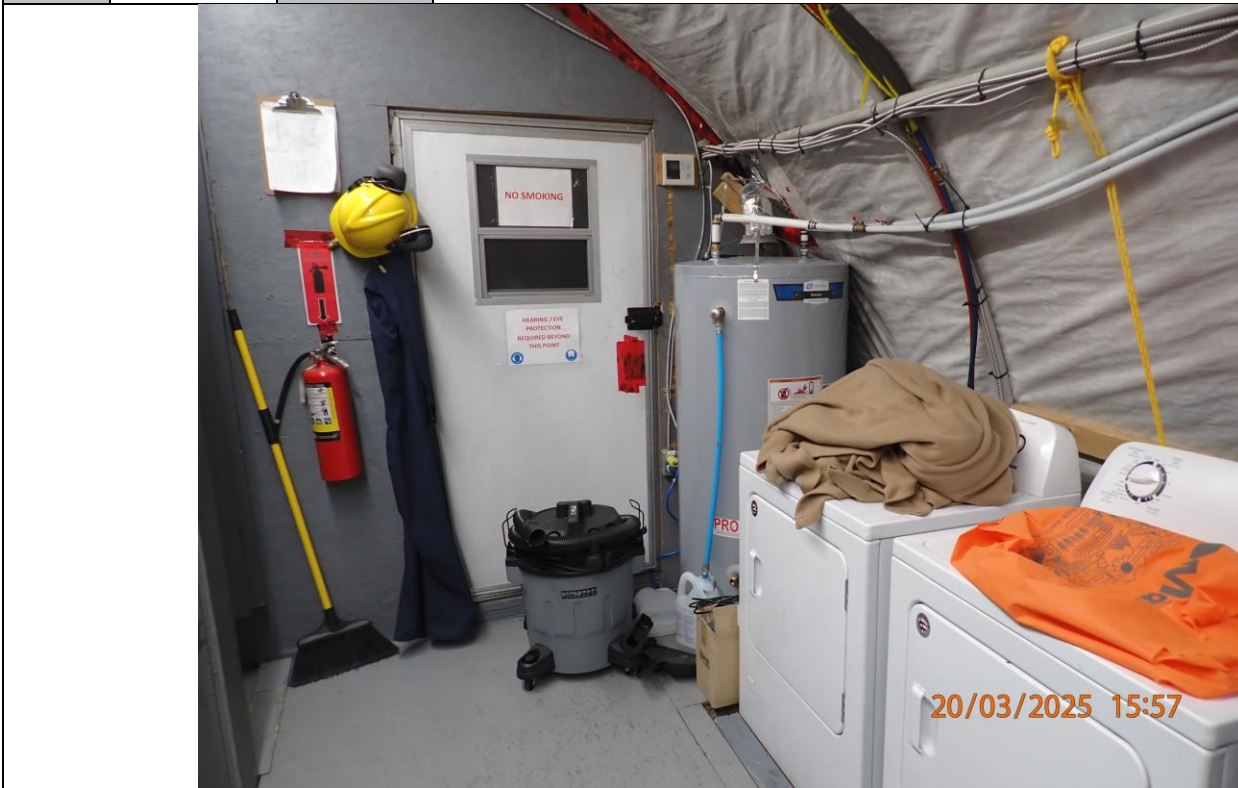
Photo # 53

Hot water heater in the tent at Goose Forward.

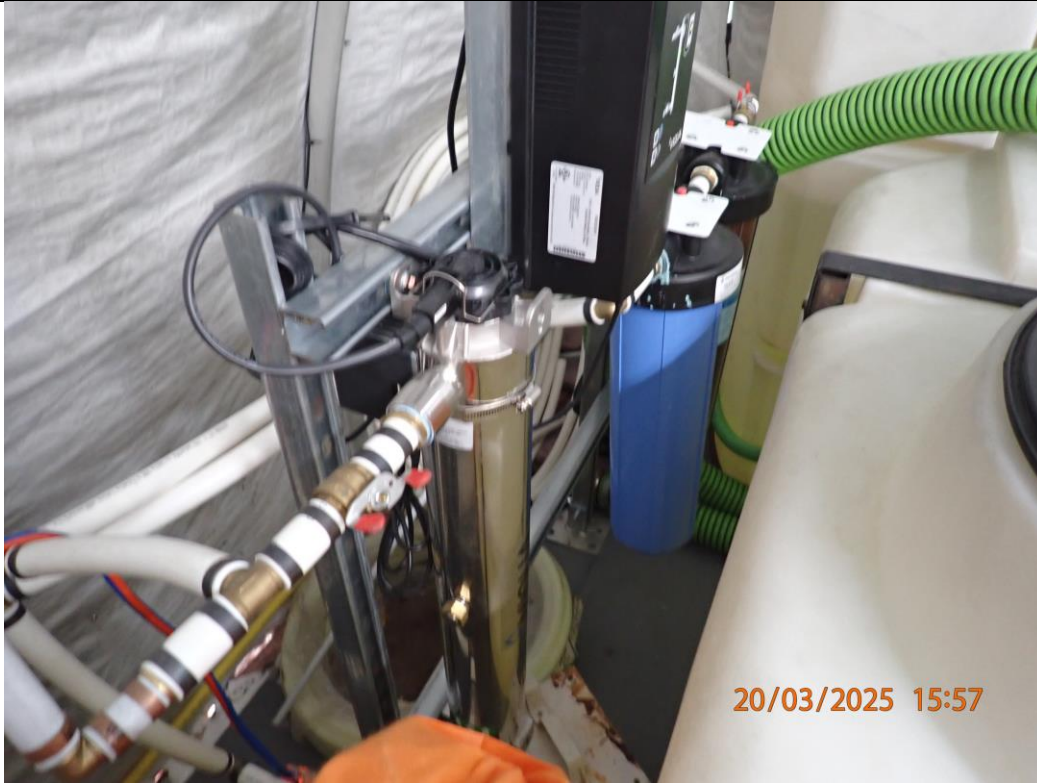
Photo # 54

Water treatment system in the tent at Goose Forward.
