Goose & MLA Project Sites – 2023 Annual Geotechnical Inspection

Back River Project, Nunavut, Canada
B2Gold Corp.

SRK Consulting (Canada) Inc. ■ CAPR003105 ■ April 2024

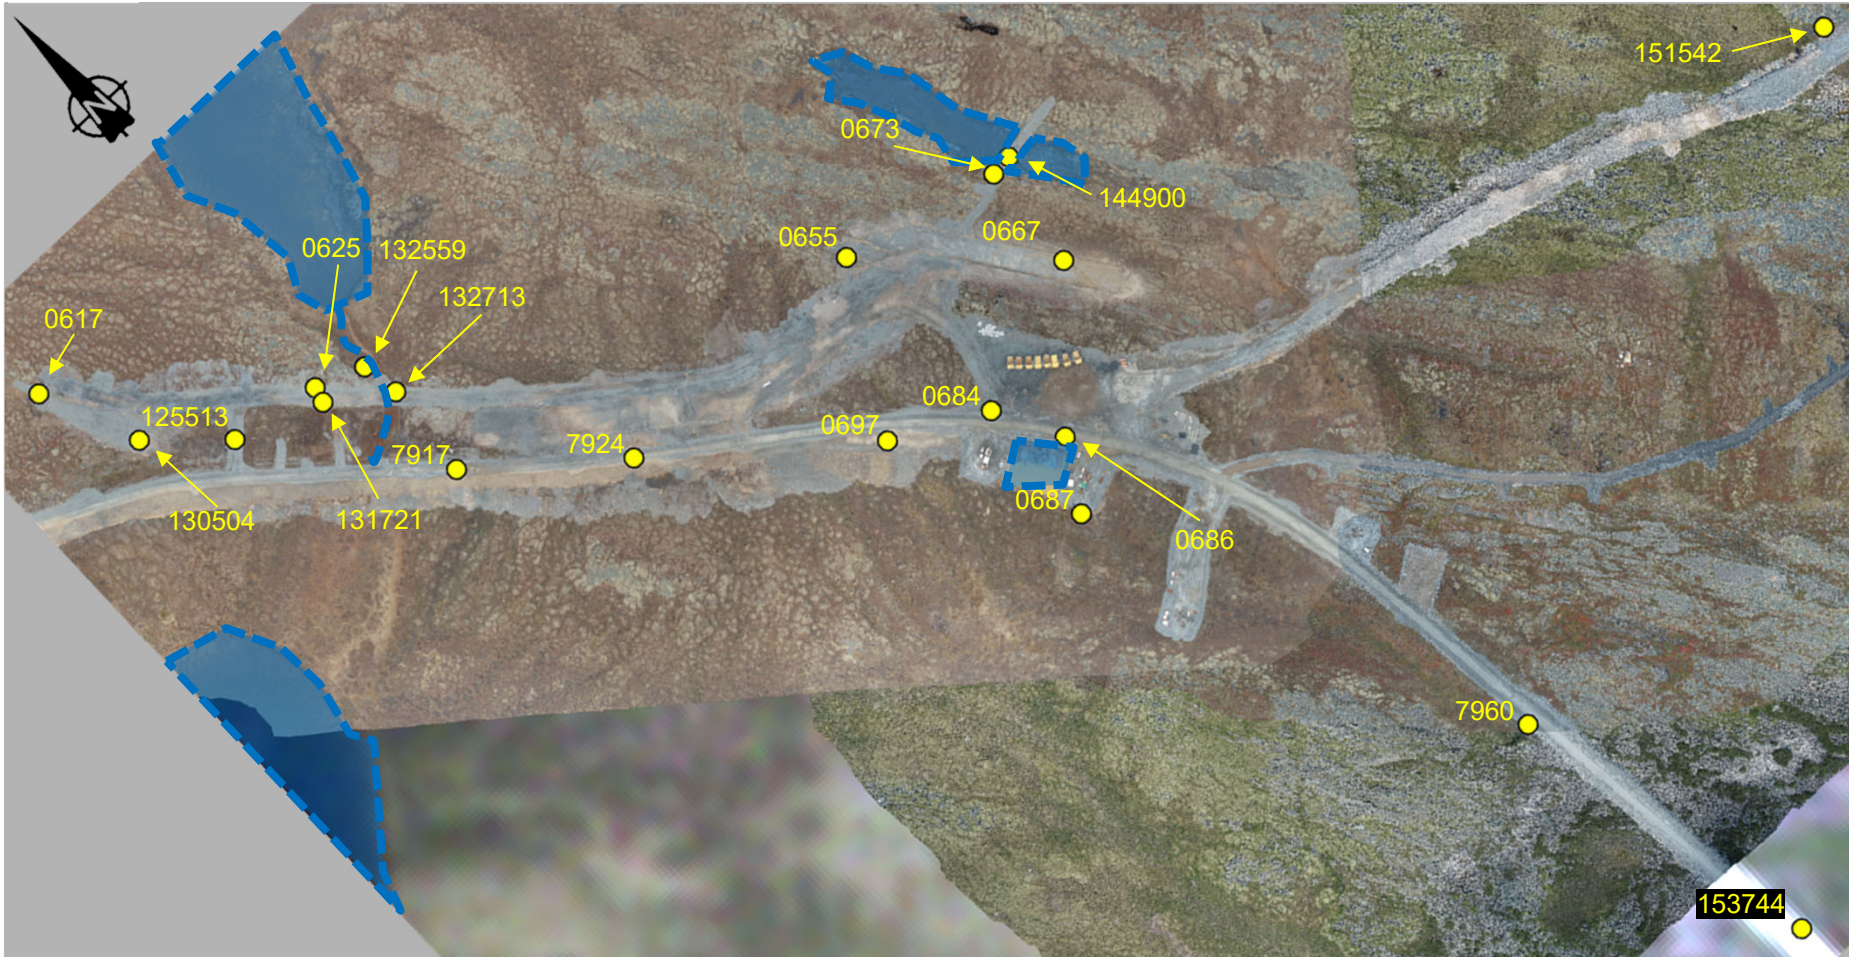
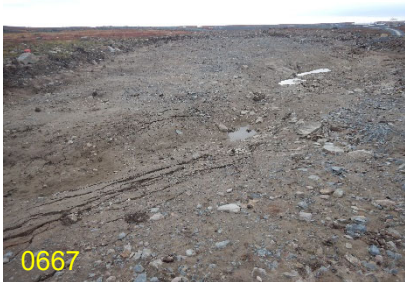
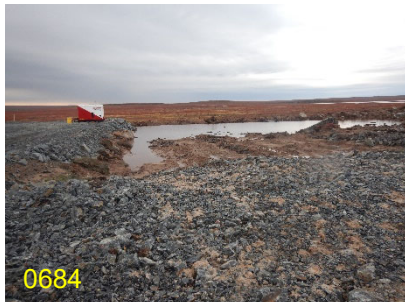
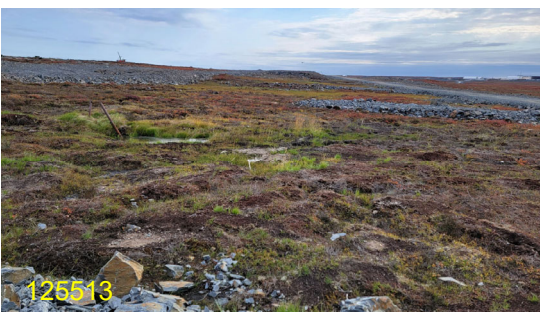
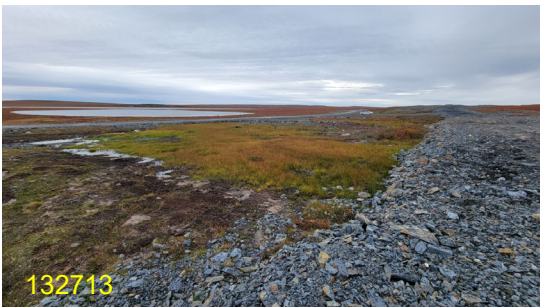
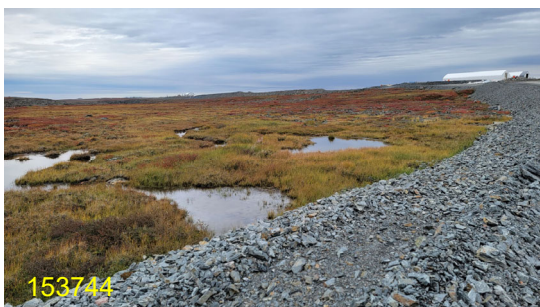
**Ponding Water
Goose Airstrip**

- Goose airstrip extension to the South is currently in progress. As this airstrip extends to the south, it intersects some more notable surface water flow pathways / ephemeral streams (Figure 5). The Rascal Diversion berm started to be constructed in October – November 2023 (Appendix D) and should be completed before the 2024 freshet if the airstrip is planned to be extended further south or used in the areas where the main natural surface water flow paths are intersected. The South end of the extended Goose Airstrip is expected to be an area that will need to be closely monitored and more permanent long term water conveyance through portions of the airstrip should be considered by site (again depending on the length and use of the airstrip that site is targeting).

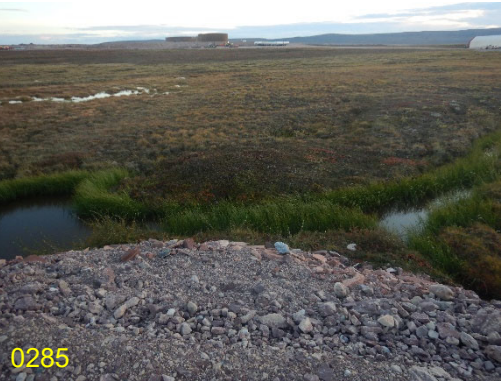
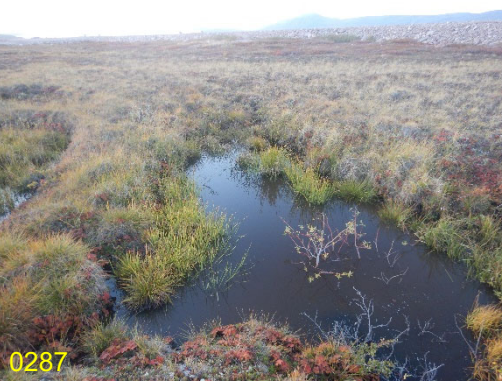
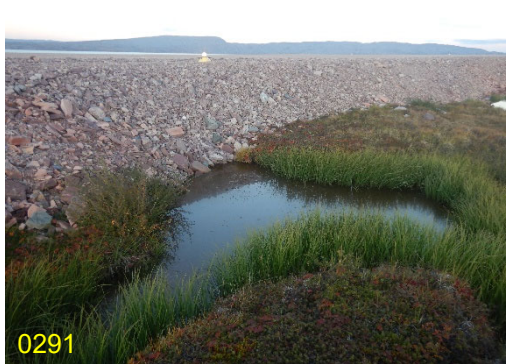
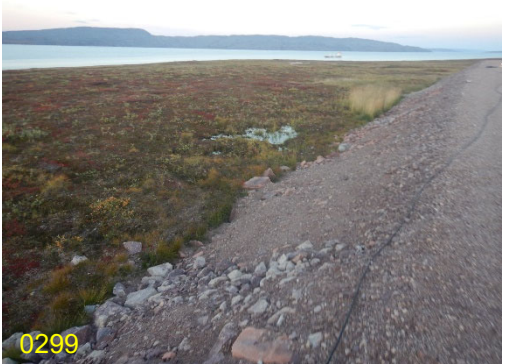
2023 Annual Geotechnical Inspection		
		Ponding Water MLA Airstrip		
Job No: CAPR003105 Filename: BackRiver_2023AGI_Figures..pdf	Back River Project	Date: 2024-02-28	Approved: JBK	Figure: 11

Ponding water and bodies of water near pads.

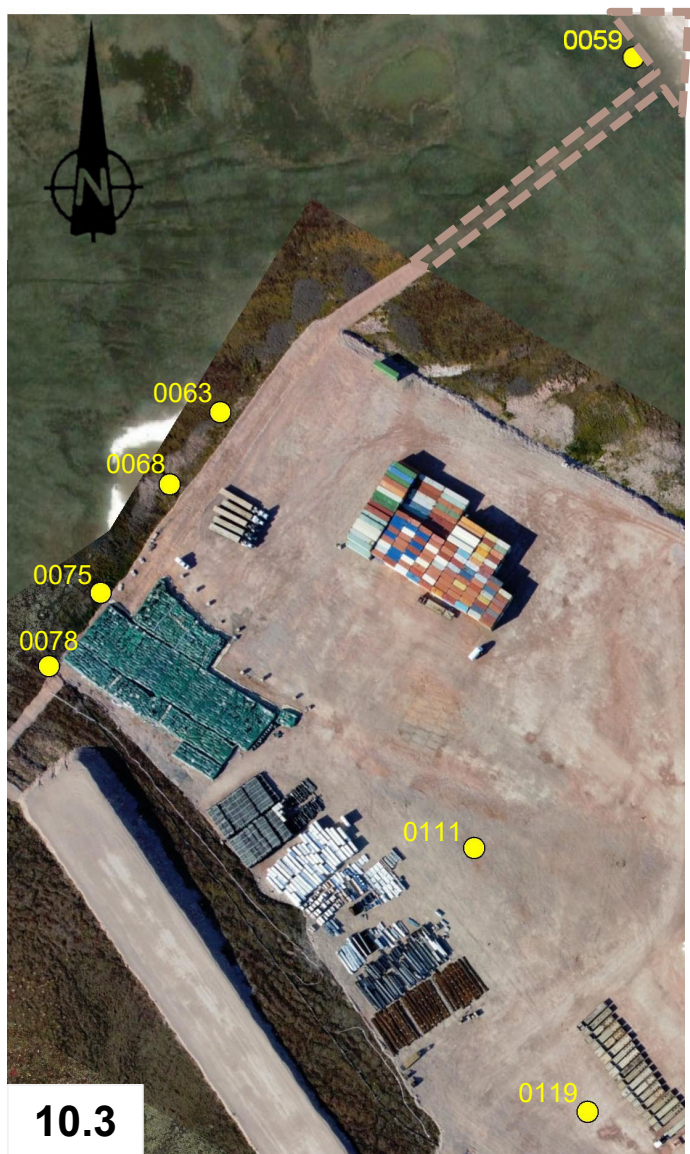
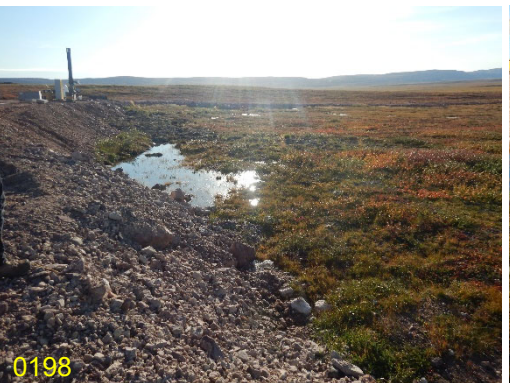
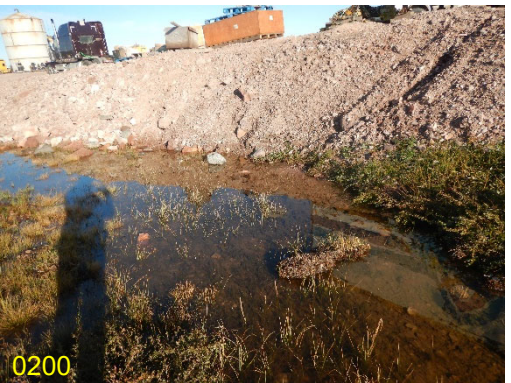
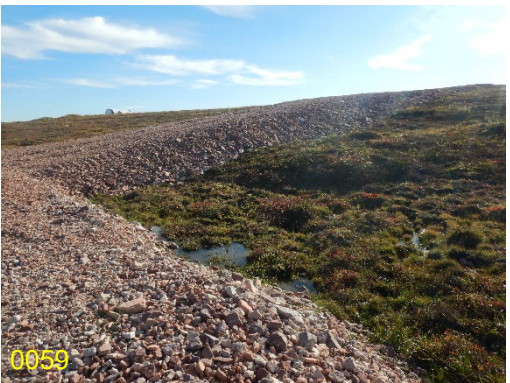
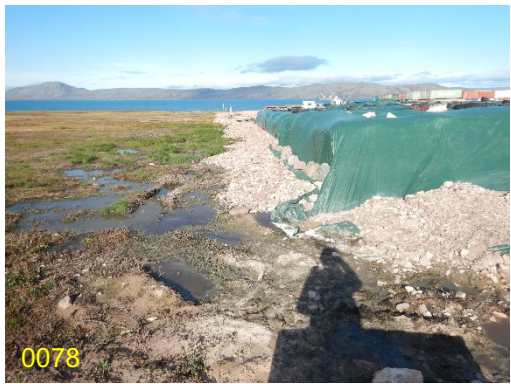
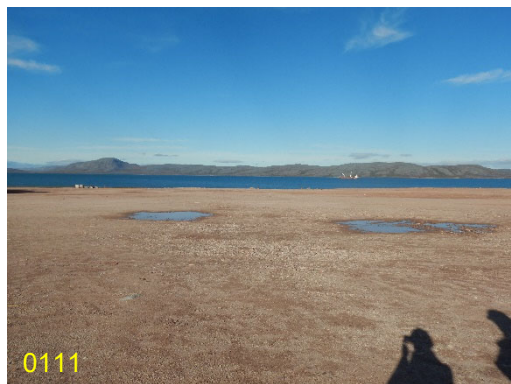
2023 Annual Geotechnical Inspection		
		Ponding Water MLA Lower Laydown Pad and Temporary Fuel Storage		
Job No: CAPR003105 Filename: BackRiver_2023AGI_Figures..pdf	Back River Project	Date: 2024-02-28	Approved: JBK	Figure: 12

Ponding water and bodies of water near pads.
