### **3.28 Doris Primary Vent Raise Pad**

### **3.30 Doris North Dam**

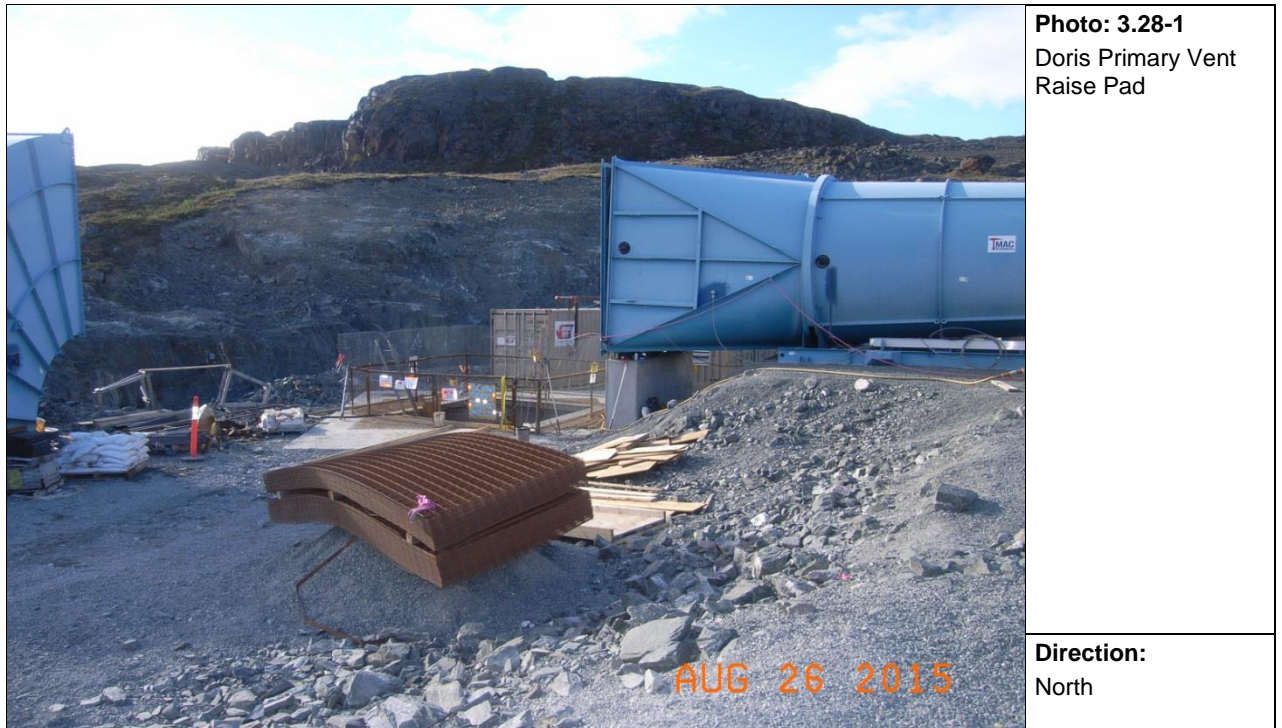
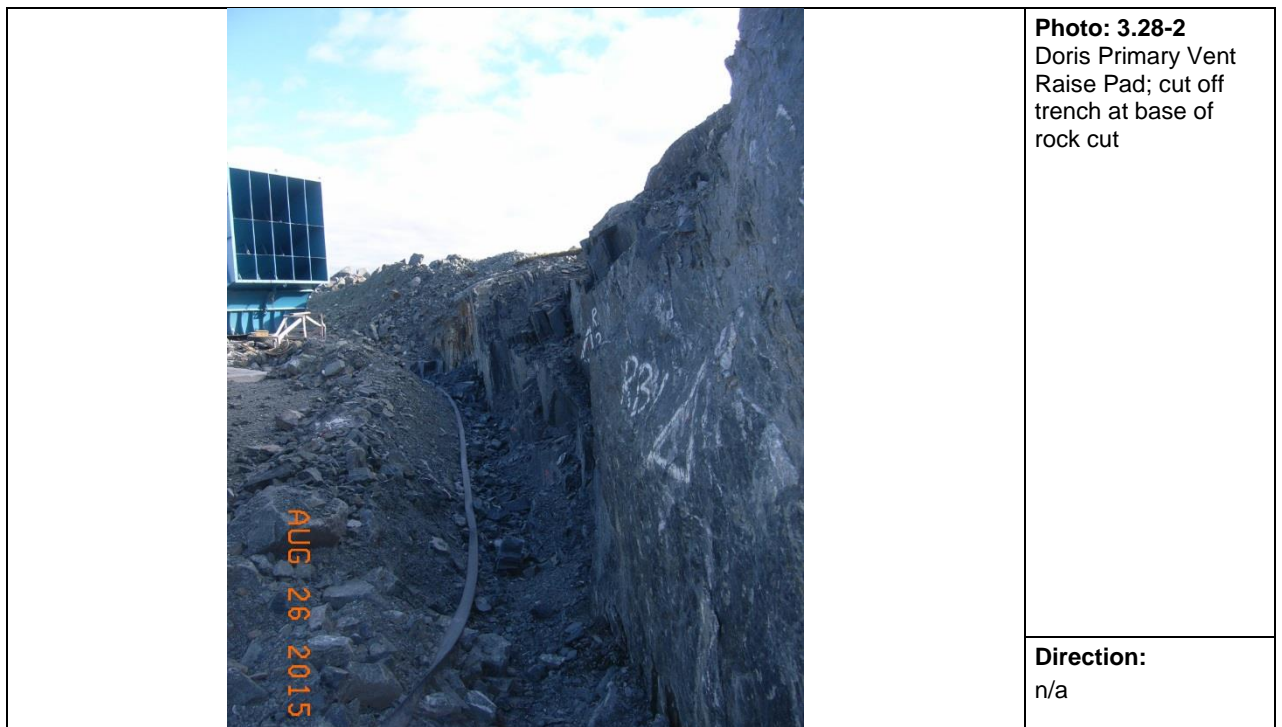
The Doris North Primary Vent Raise is located along the Secondary Road. The west end of the facility was cut into bedrock so that the raise could be collared on sound bedrock. A thermal pad extends east from the rock cut. A higher level or tier adjacent to the raise, houses the vent raise collar building, and the lower tier further east contains a fuel storage tank inside a bunded secondary containment structure. (Photos 3.28-1 to 3.28-3)

Surface runoff from the top of the bedrock wall surrounding the west and east sides of the vent raise has presented problems with seepage into the raise opening. A sump has been excavated into the bedrock at the base of the wall. It will be connected to a bedrock ditch that will run along the toe of the wall and will intercept run off from the top of the wall.

There were no signs of standing water on the surface of the pad and no areas of significant settlement. There was no standing water noted along the toe of the pad, and no tension cracks were observed along the crest of the pad.

The rock wall is in close proximity to the vent raise. Previous recommendations with respect to the installation of appropriate barricades and signage should be implemented to keep people and equipment at a safe distance from the wall.

The sump and cut-off trench should be completed to divert surface runoff from the bedrock into the vent raise.

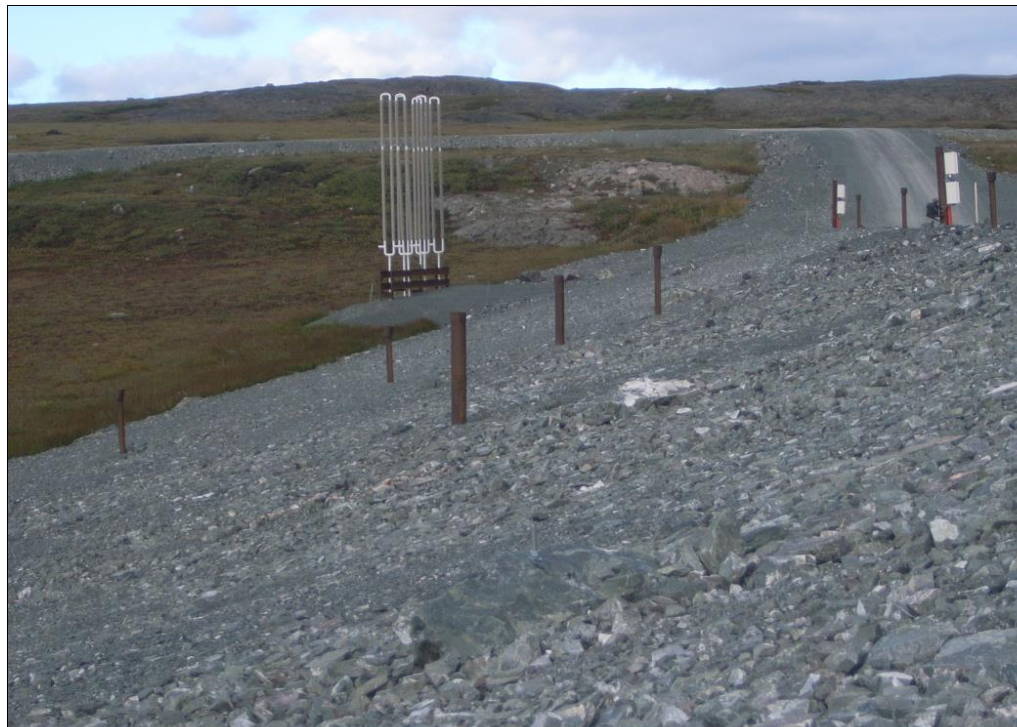
The TIA presently consists of a frozen core dam at the north end of Tail Lake, called the North Dam. It was constructed across a narrow portion of the valley that contains Tail Lake. It will form the downstream limit of the TIA and retain the reclaim pond once mining operations begin. (Photos 3.30-1 to 3.30-6)
