**Re: 2021 Annual Geotechnical Inspection Report for the Doris and Madrid Sites, Hope Bay Project, Nunavut**

**Attention**      **Nancy Duquet Harvey**  
**Subject**        **Doris and Madrid - 2021 Annual Geotechnical Inspections**  
**Project**        1CT022.077

## Summary of Primary Observations and Recommendations - Table 1: Doris Project - 2021 Annual Geotechnical Inspection

**Summary of Recommendations - Table 2: Madrid Project 2021 Annual Geotechnical Inspection**

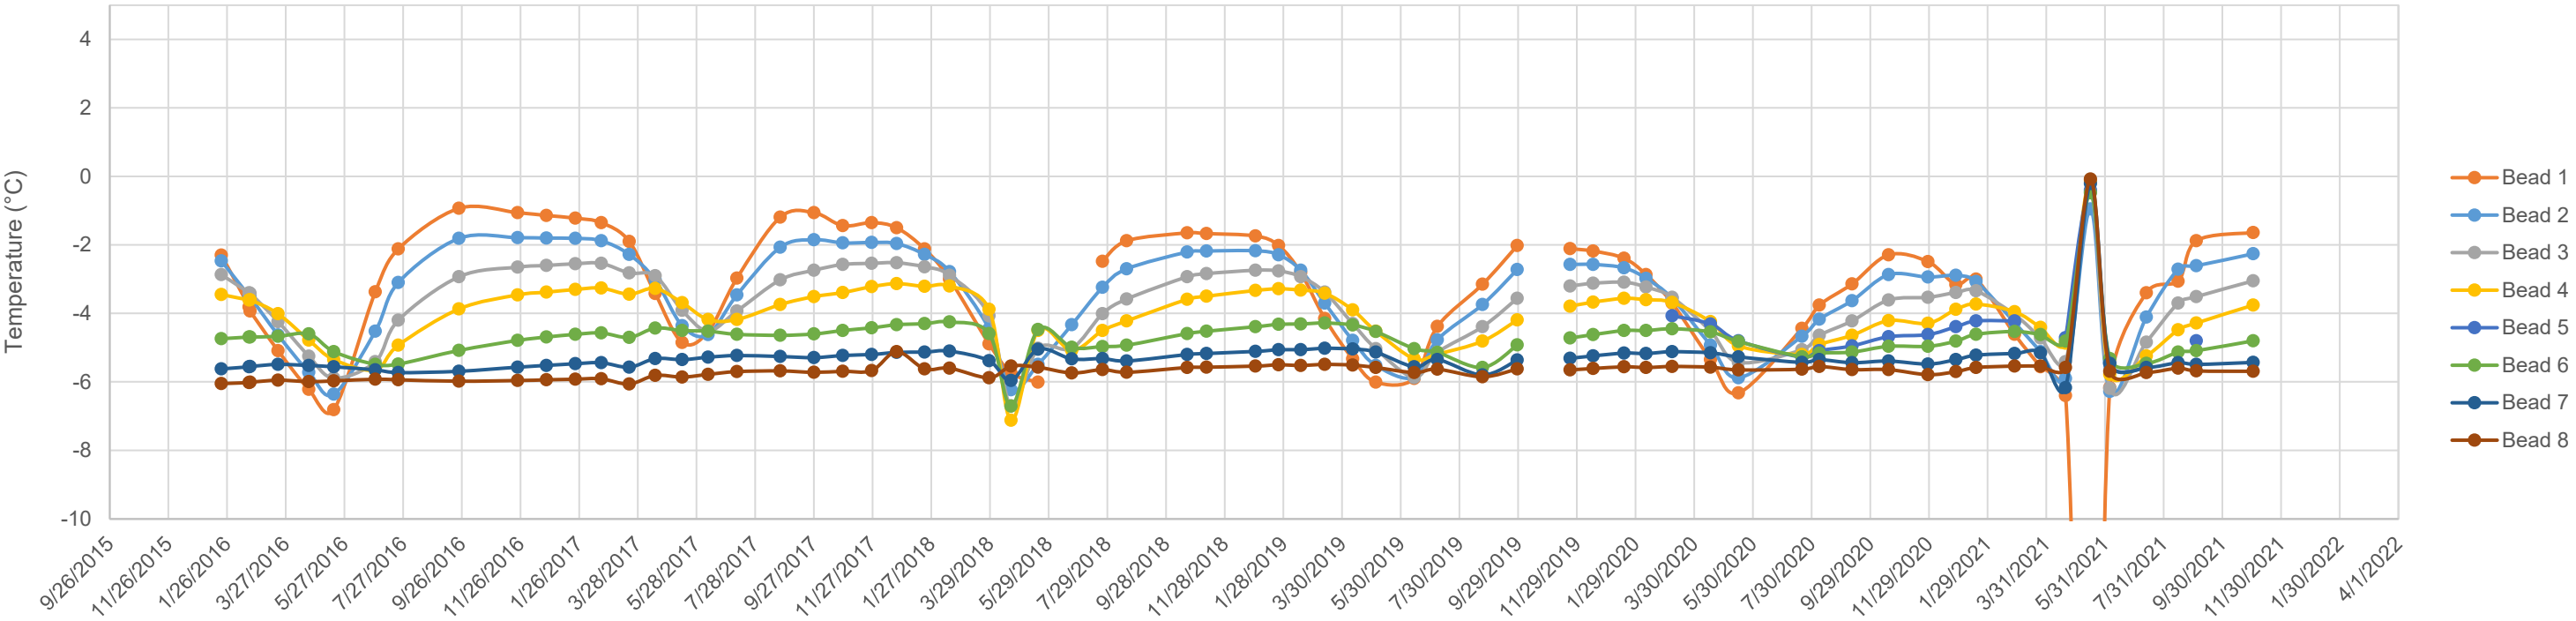
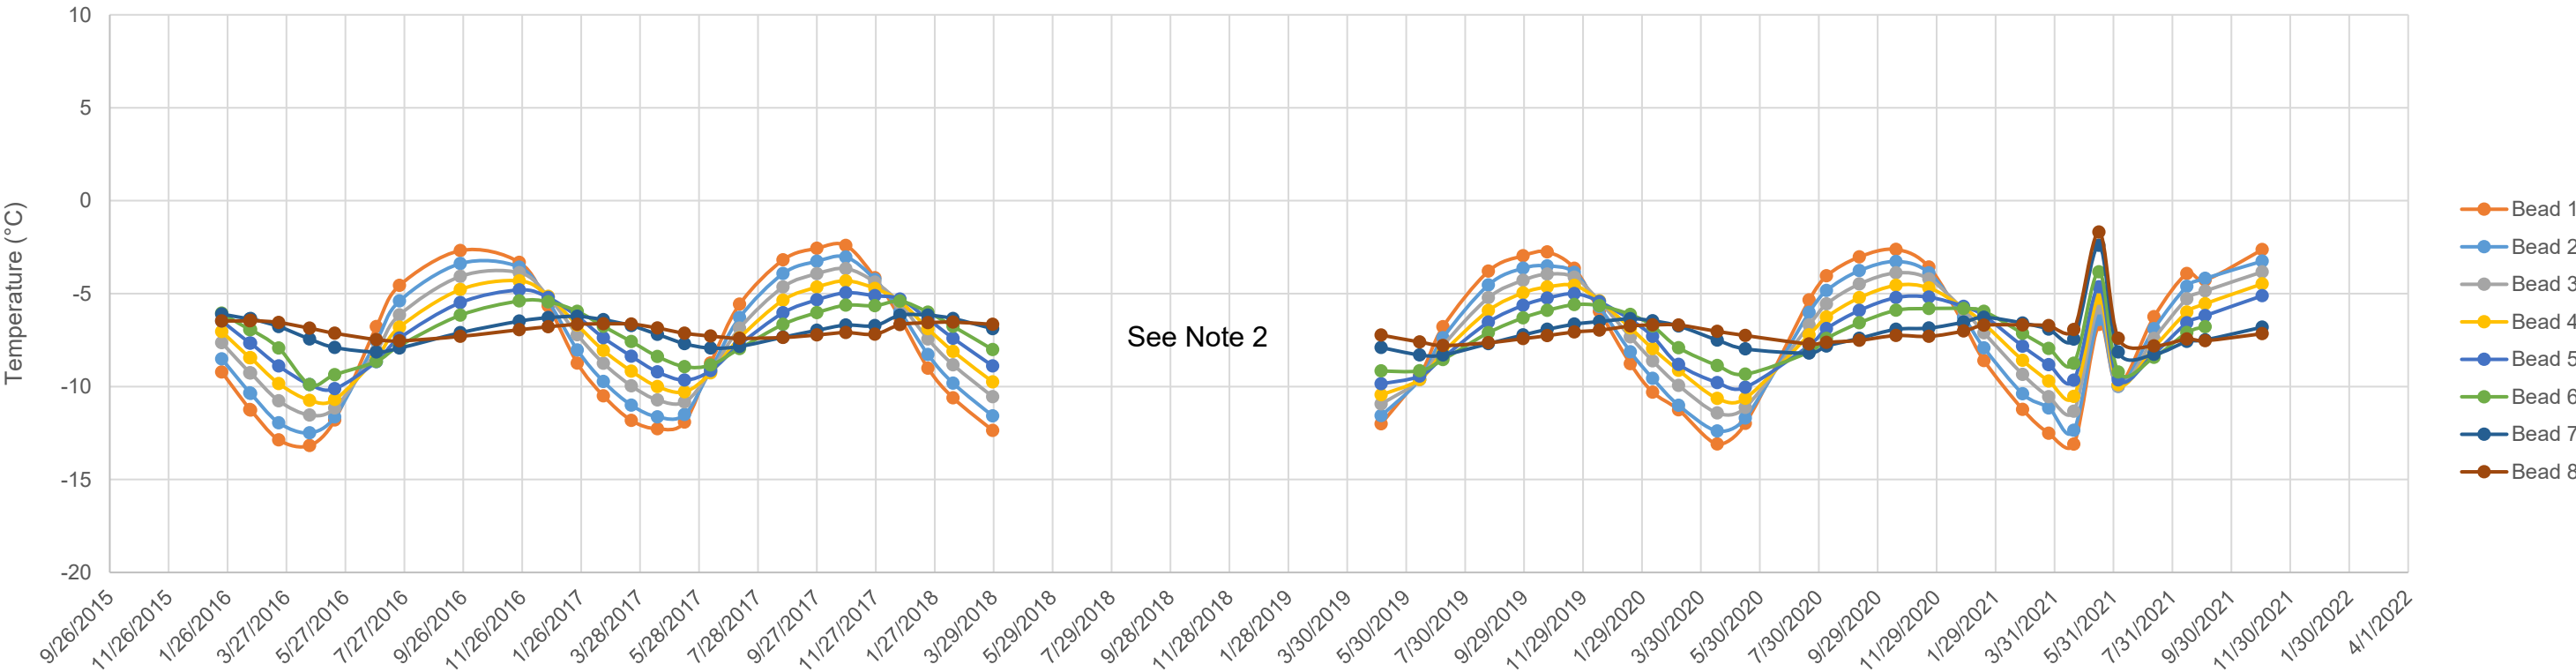
- 1) Data is presented for the past five years, between Jan 2016 and Dec 2021, data records began in 2012.
- 2) Data gap resulted from damage to the thermistor cable in 2018, repaired in 2019.
