Memo

To: Oliver Curran, VP Environmental Affairs Client: TMAC Resources Inc.

From: Ryan Williams, Senior Consultant, PEng Project No: 1CT022.055

Subject: Hope Bay Project: Doris and Madrid 2019 Construction Summary Report

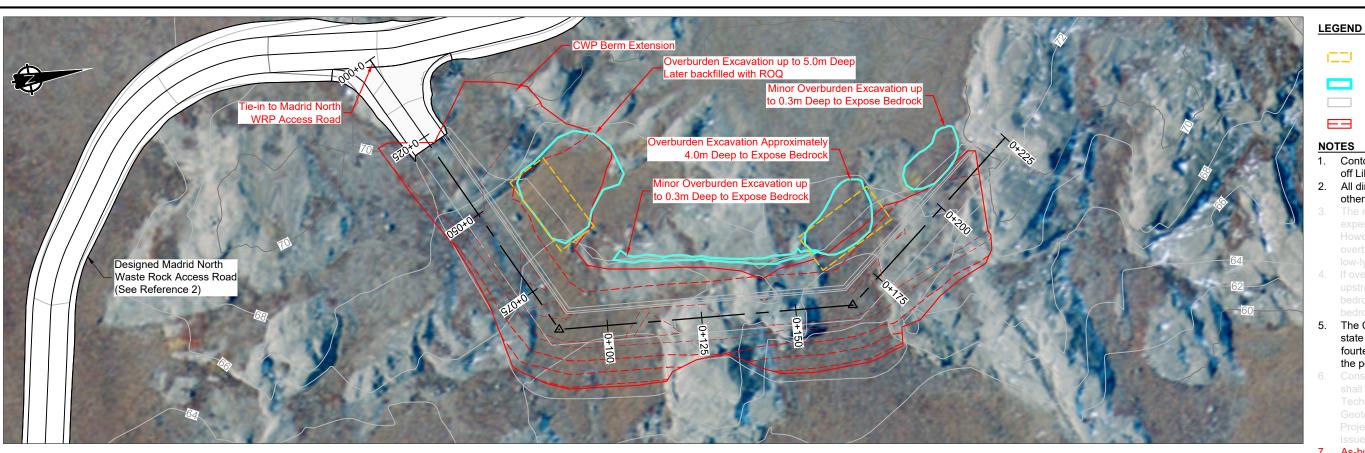
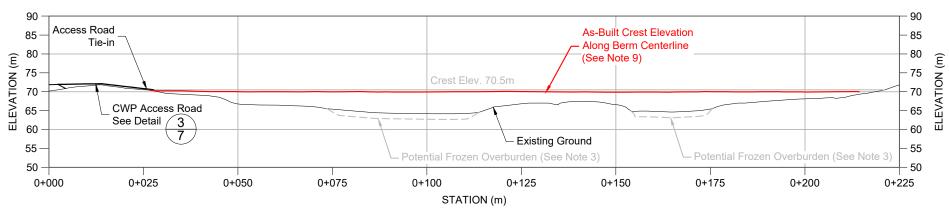
MN-CWP-03

During excavation of overburden to expose bedrock for the HDPE liner tie-in, a significant pocket of overburden material was encountered at the southern end of the CWP berm. This overburden pocket was found to be approximately 5 m deep. As a result, a decision was made in the field by TMAC and the SRK Site Engineer to backfill the excavated overburden pocket with ROQ and shift the liner tie-in point to higher ground upstream. Deeper than anticipated overburden was also encountered in the northern end of the CWP. Overburden was up to 4 m deep at its deepest. However, concrete plinths were able to be used and the liner to bedrock tie-in did not shift significantly from the original projected design.

Contact Water Pond Berm Profile View

Anticipated Overburden Excavation Area (Design)
