Subject: Doris North Project

Project #: 1CH008.033

SRK Consulting (Canada) Inc. (2011). <u>Robert's Bay Tank Farm Slope Remediation</u>, Doris North Project, Nunavut, Canada. Technical Memo prepared for Hope Bay Mining Limited, Project Number 1CH008.033.0201, August 3, 2011

Subject: Robert's Bay Tank Farm Slope Remediation

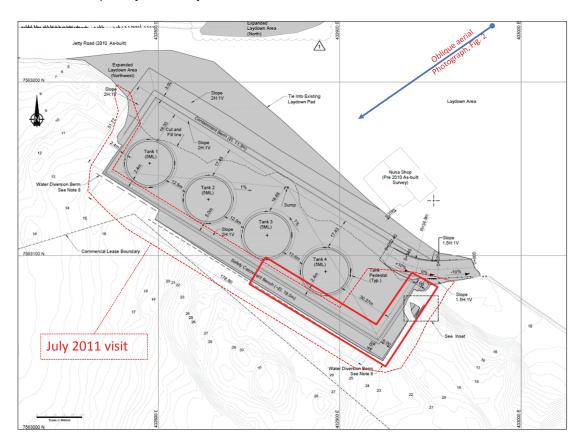
Figure 1: Roberts Bay Tank Farm showing inspected area and approximate viewing direction for photograph displayed in Figure 2.
