## DAILY REPORT #09 – DORIS NORTH INFRASTRUCTURE/ NORTH DAM

| Prepared by: | John Kurylo | Date: | 2012.01.14 |
| Reviewed by: | | Project #: | 1CH008.058.0320 |

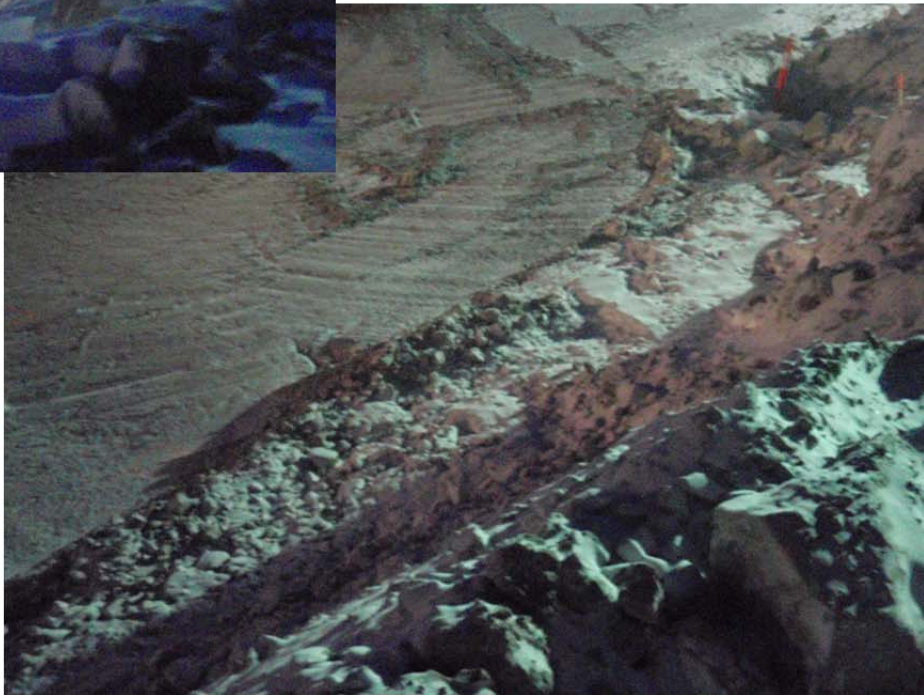
- The final location of Sump 1 will be determined in the coming days. The current snow pad appears to be in a suitable location however, the final Sump 1 location is expected to move inwards towards the NNE of the proposed stake location noted in SRK daily #8.

**Photo 7 (above/ top right):** ~ ESE view of snow pad construction around the Sump 1 location.
