## DAILY REPORT #10 – DORIS NORTH INFRASTRUCTURE/ NORTH DAM

Prepared by:	John Kurylo	Date:	2012.01.15
Reviewed by:		Project #:	1CH008.058.0320
Role	Company	Personnel – Position	On Site
Client	Hope Bay Mining Limited (HBML)	Angela Holzapfel – ESR Compliance Manager David Vokey – ESR Coordinator Don Ethelston – HSLP Advisor Dean Wold - Safety Jill Turk – ESR Coordinator Katsky Venter – ESR Manger Michelle Tanquay – ESR Site Manager Stirling Kelly – HSLP Advisor	No Yes No No No No Yes Yes
	JDS	Lloyd Jackson – Mechanical Superintendent Sven Archimowtiz – Electrical Superintendent Doug Fielding – Construction Manager Ishan Fechter – Construction Coordinator Jerry Graham – Construction Manager Kevin Whieldon – Project Coordinator Mark Valeriote – Construction Manager	Yes Yes No Yes Yes No No
Engineering Design Consultants	SRK Consulting (Canada) Inc.	John Kurylo – Site Engineer Megan Miller – Site Engineer Lawrence Borowski – Site Engineer Murry McGregor – Site Engineer Lowell Wade – Senior Engineer	Yes No No No No

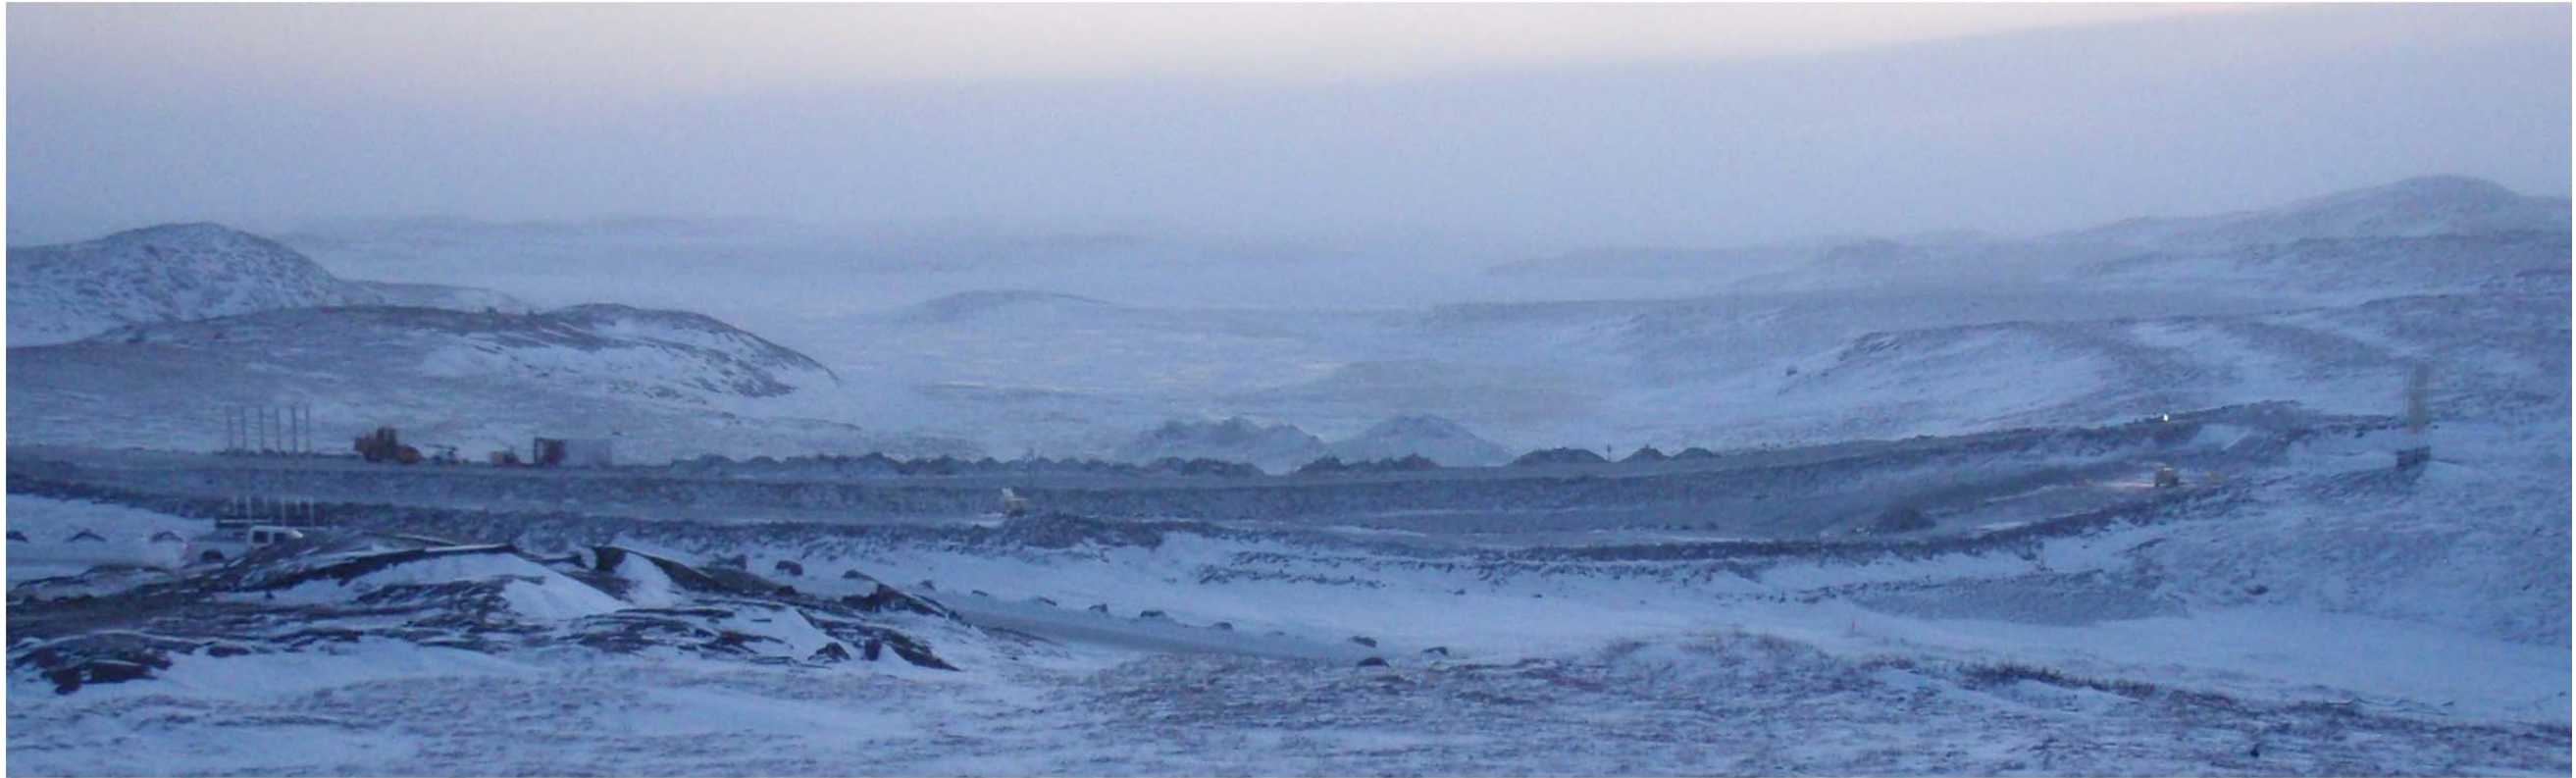
**Photo 5:** ~E view of the Doris Creek Bridge and the Vent Raise Pad.

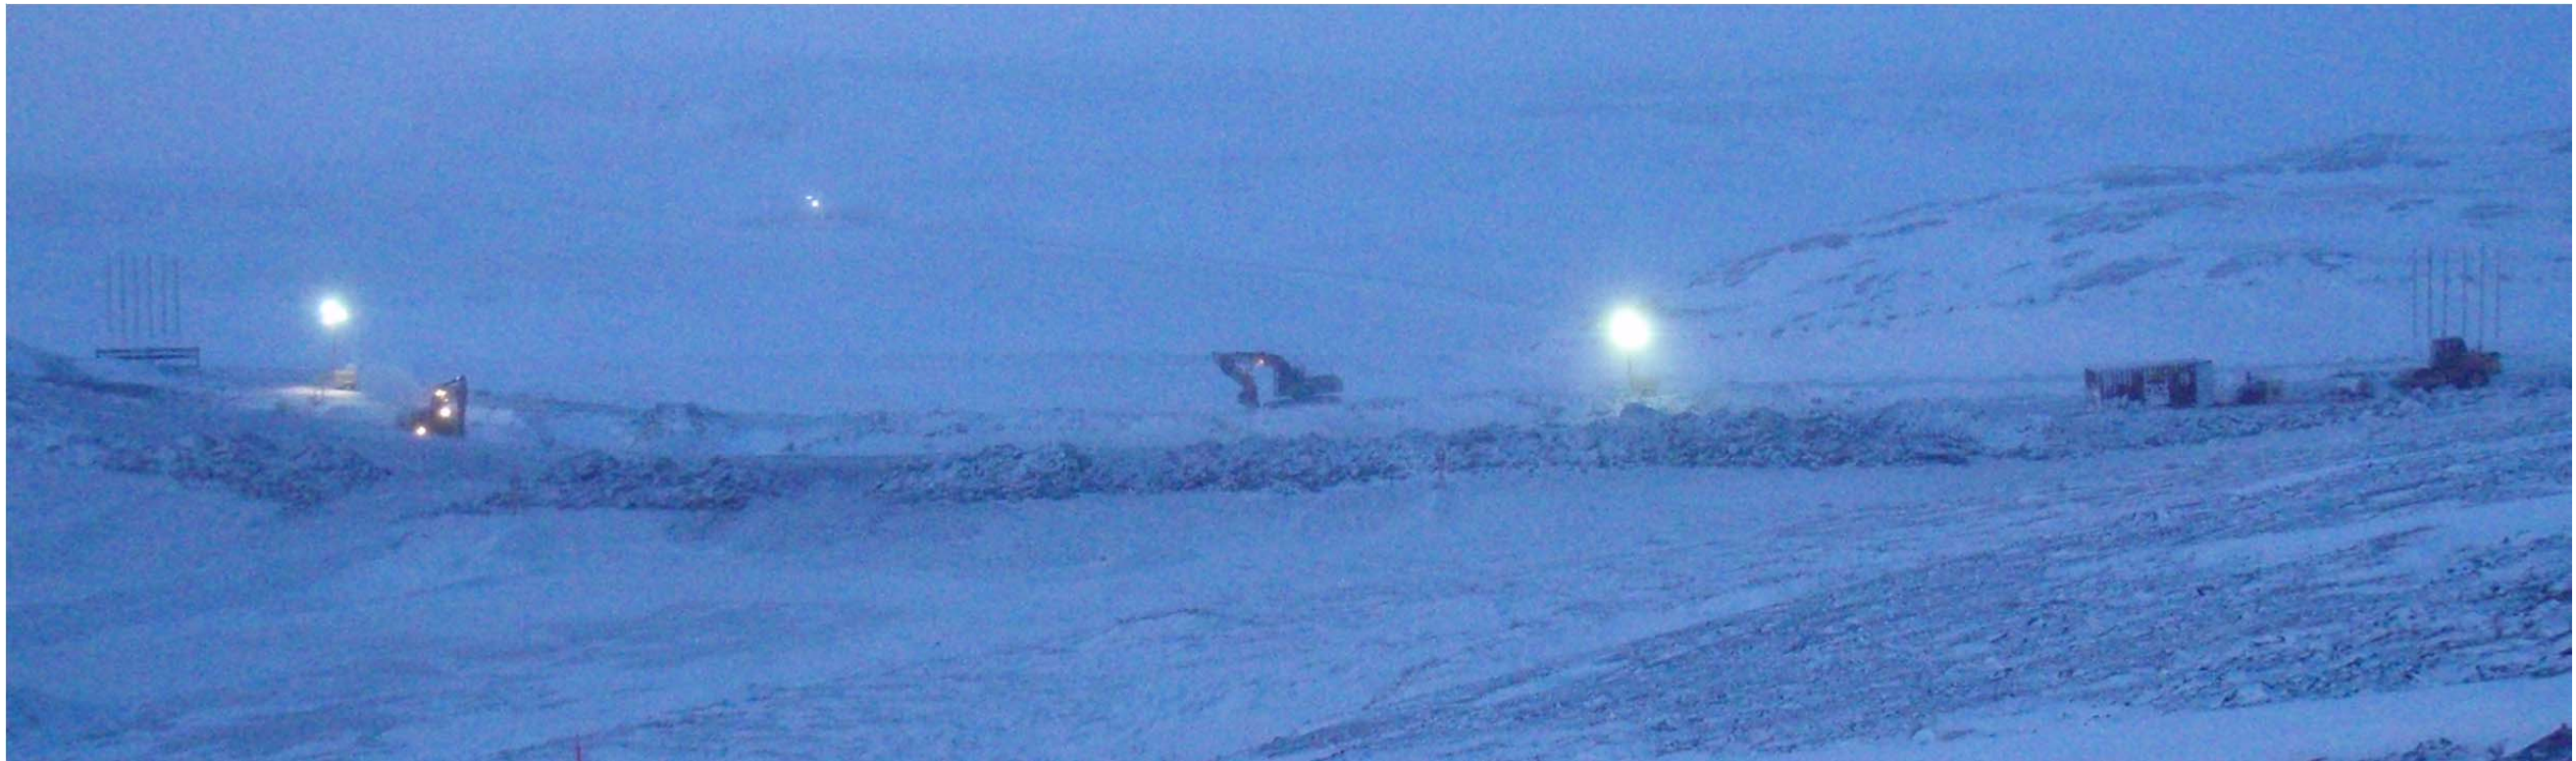
**Photo 6:** Progress photo of the North Dam construction. Photo taken from Photo Point 1, looking ~ south-east.

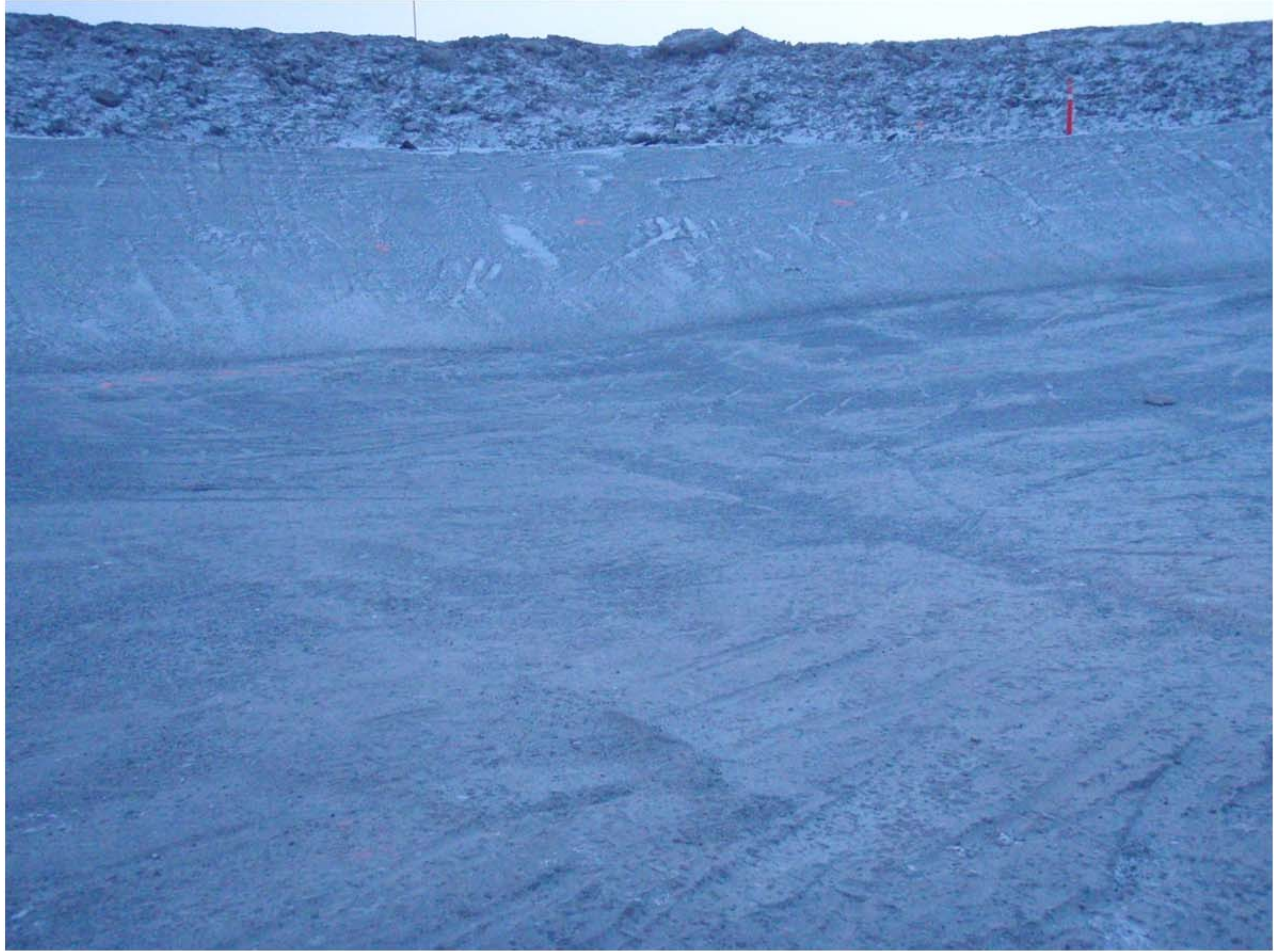
**Photo 7:** Progress photo of the North Dam construction. Photo taken from Photo Point 2, looking ~ north-west.

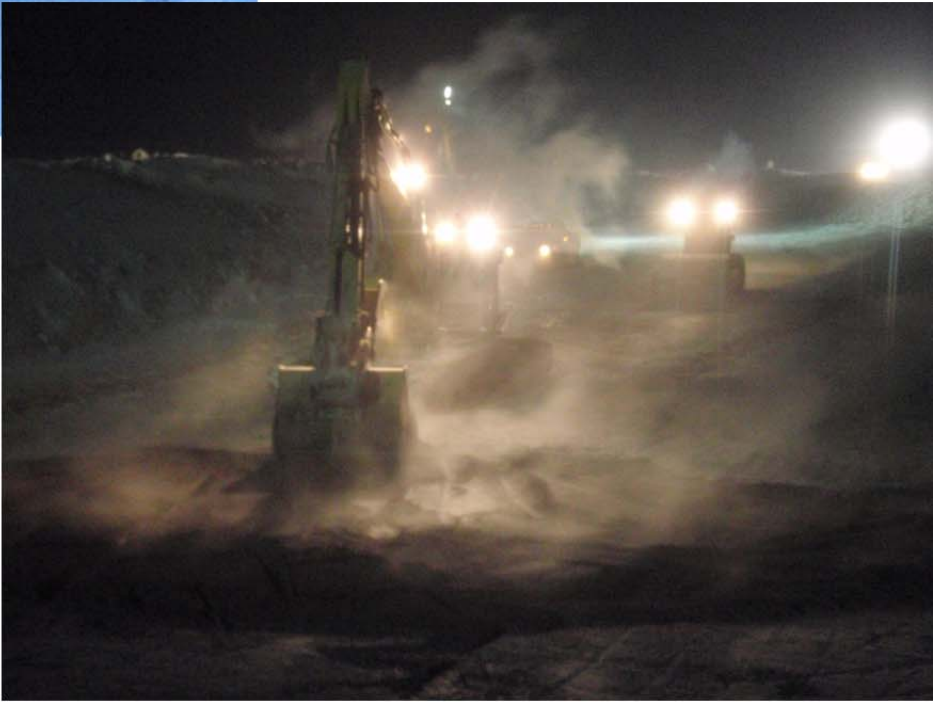
- 3.5 loads of frozen core material were placed in the key trench today.
  - Material was spread with a CAT 325D excavator, then compacted.
  - The periodic frozen clumps noted in the FCP chute were not readily noted in the material being placed in the dam (expect some broke up when combined with hot FCM in truck boxes).

Photo 10 (below/ center right): Excavator working to place frozen core material (~3.5 loads) in the central area of the key trench; ~ NE view.

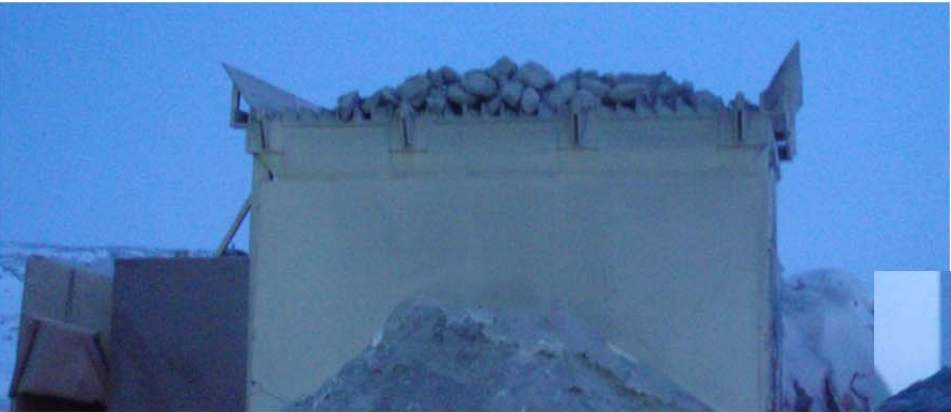
- After the first load of FCM was produced the 'grizzly bars' of the hopper became clogged with frozen clumps of FCM material and V-belt was noted to be having issues. These items were addressed and production resumed.

Photo 12: (above/ center): View after V-belt slipped and hopper became clogged with non saturated frozen core clumps from the frozen stockpile.
