DAILY REPORT #113 – DORIS NORTH INFRASTRUCTURE/ NORTH DAM

Prepared by:	Lowell Wade	Date:	2012.04.28
Reviewed by:		Project #:	1CH008.058.0320
Role	Company	Personnel – Position	On Site
Client	Hope Bay Mining Limited (HBML)	Angela Holzapfel – ESR Compliance Manager David Vokey – ESR Coordinator Dean Wold - Safety Jill Turk – ESR Coordinator Katsky Venter – ESR Manger Michelle Tanquay – ESR Site Manager Stirling Kelly – HSLP Advisor	No No No Yes Yes No Yes
	JDS	Doug Fielding – Construction Manager Ishan Fechter – Construction Coordinator Jerry Graham – Construction Manager Mark Valeriote – Construction Manager Calvin Goldschmidt – Construction Coordinator	No No Yes No Yes
Engineering Design Consultants	SRK Consulting (Canada) Inc.	Lowell Wade-Site Engineer Lawrence Borowski – Site Engineer	Yes No
Earthworks Contractor	Nuna Logistics	Doug Haverland - Area Superintendent Gary Sodhi – Field Engineer Georges Cornelissen – Survey Manager Jeff Roberts - Surveyor Jim Cardinal – Foreman Jordan Gunter – Foreman (Day Shift) Mike MacMaster – Surveyor Mike Price – Field Engineer Rick Peter – Foreman (Night Shift) Trevor Sorken – Superintendent	No No Yes No Yes No No Yes Yes Yes

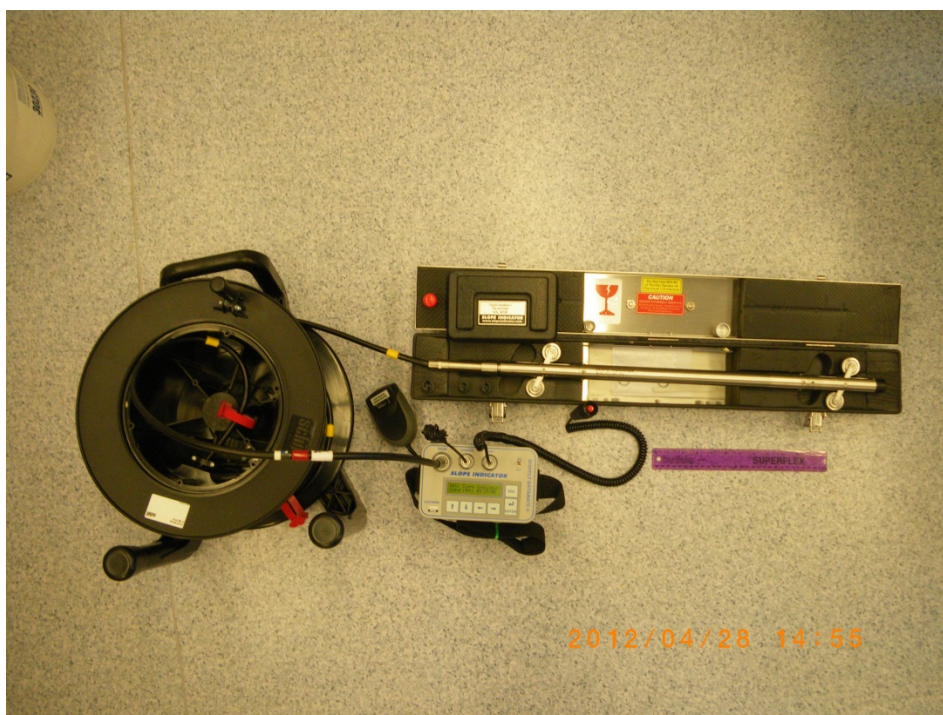
Photo 3: Slope Indicator's Digitilt Inclinerometer Probe with Digitilt DataMate II datalogger with battery charger and remote hand switch, and 30 m Digi Control Cable on a 50 m Capacity Digitilt Cable Storage Reel,
