DAILY REPORT #12 – DORIS NORTH INFRASTRUCTURE/ NORTH DAM

Prepared by:	John Kurylo/ Jeff Orr	Date:	2012.01.17
Reviewed by:		Project #:	1CH008.058.0320
Role	Company	Personnel – Position	On Site
Client	Hope Bay Mining Limited (HBML)	Angela Holzapfel – ESR Compliance Manager David Vokey – ESR Coordinator Don Ethelston – HSLP Advisor Dean Wold - Safety Jill Turk – ESR Coordinator Katsky Venter – ESR Manger Michelle Tanquay – ESR Site Manager Stirling Kelly – HSLP Advisor	No Yes No No No No Yes Yes
	JDS	Lloyd Jackson – Mechanical Superintendent Sven Archimowtiz – Electrical Superintendent Doug Fielding – Construction Manager Ishan Fechter – Construction Coordinator Jerry Graham – Construction Manager Kevin Whieldon – Project Coordinator Mark Valeriote – Construction Manager	Yes Yes No Yes Yes No No
Engineering Design Consultants	SRK Consulting (Canada) Inc.	John Kurylo – Site Engineer Megan Miller – Site Engineer Lawrence Borowski – Site Engineer Murry McGregor – Site Engineer Lowell Wade – Senior Engineer	Yes No No No No

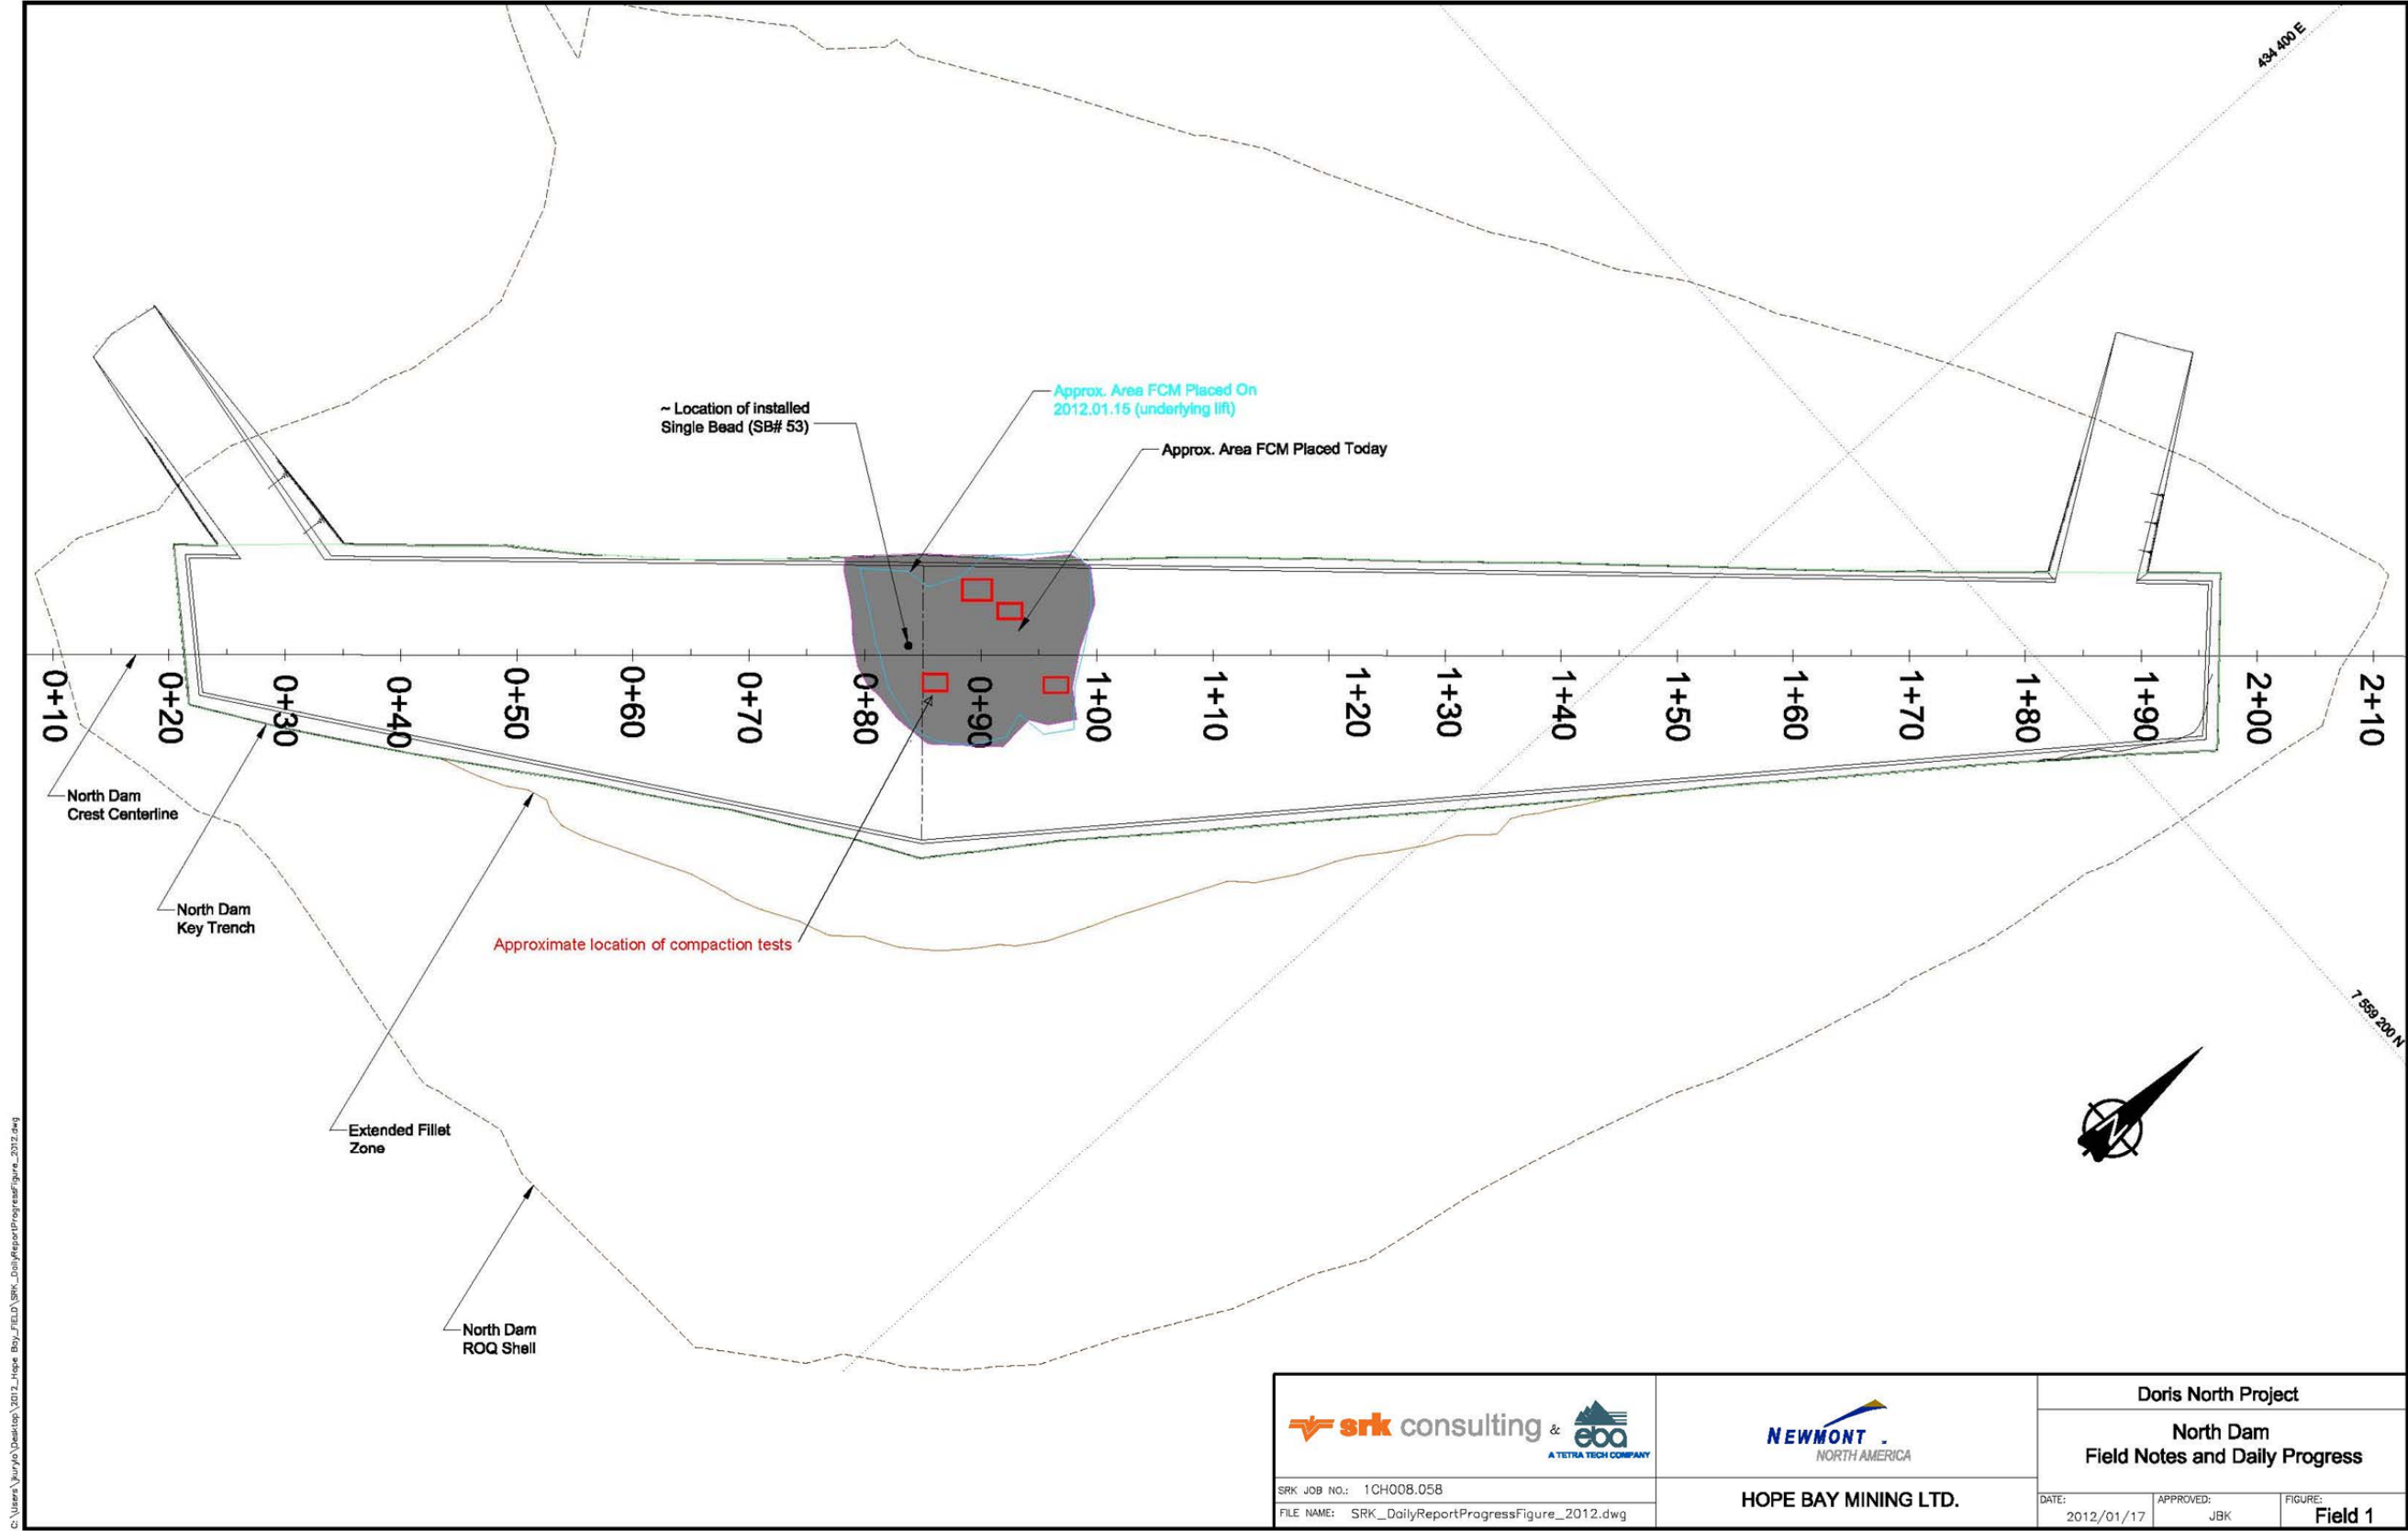
FIGURES: - Field notes/ progress figure for FCM placed today (based on visual observation, i.e.as-built survey still to be picked up)
